## Re: Marysville Corporate Center / 156<sup>th</sup> Street NE Extension – 30 Day Mitigation Memo; City of Marysville File No. PA20-052

## MARYSVILLE CORPORATE CENTER 30 DAY MONITORING PHOTOS

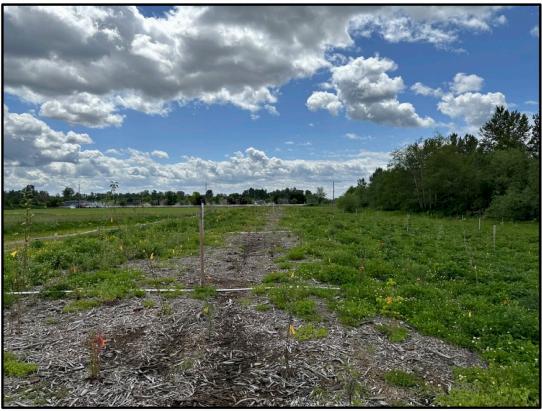
PHOTO 1: Looking south through the eastern portion of the southern buffer enhancement area.

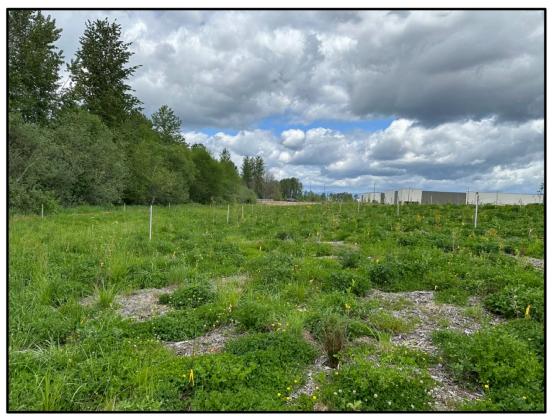
PHOTO 2: Looking north through the western portion of the southern buffer enhancement area.

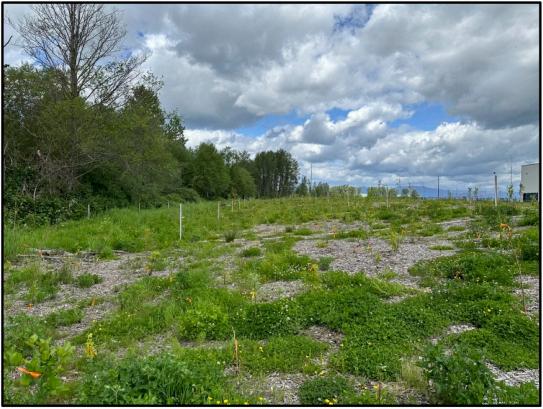
PHOTO 3: Looking north through the western portion of the northern buffer enhancement area.

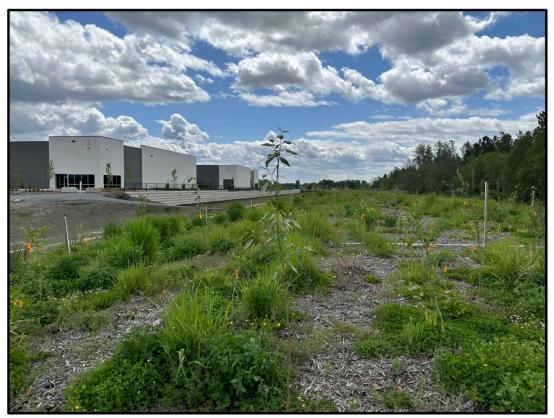
Patches of reed canarygrass have begun to establish in the eastern half of the northern buffer enhancement area. Maintenance should occur within the next 30 days to address this issue. Typically, we recommend weed whacking the canarygrass and then allow it to grow for 7-10 days. While actively growing, and before it goes to seed, have a commercial applicator spray it with an appropriate herbicide. The applicator should check the status of the canarygrass within two weeks of the first application and take appropriate action to ensure it has been eradicated. It may require one or more additional herbicide applications.

PHOTO 4: Looking south through the eastern portion of the northern buffer enhancement area. Small patches of reed canarygrass are present.
