Field Report

File Number:
024145-001-01

Project:
Sunnyside Village Co-Housing Project

Purpose of visit:
Bald Eagle Nest Assessment

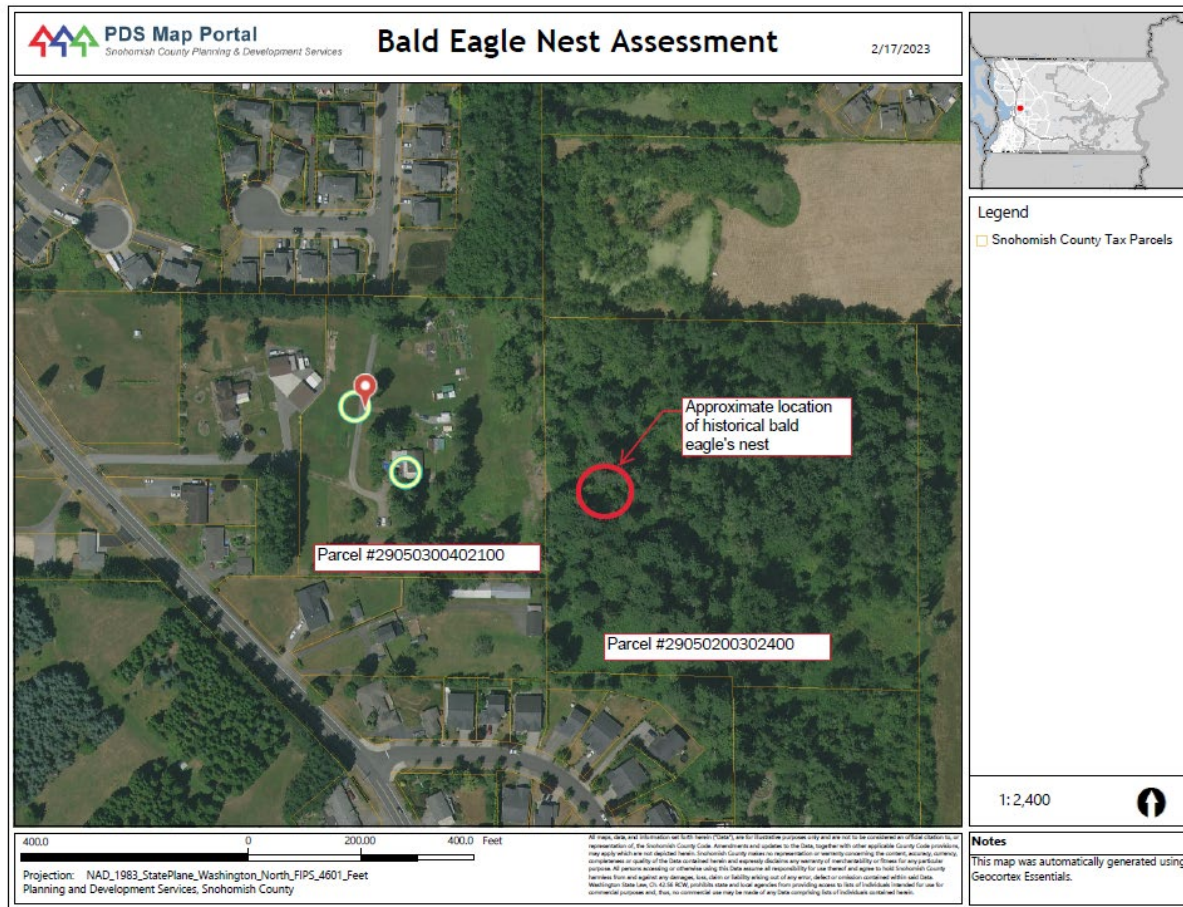
One GeoEngineers scientist (Emily Hurn) completed a site visit on February 17, 2023 to evaluate the Sunnyside Village Co-Housing (SVC) Project parcel and adjacent parcel for bald eagle nesting activity. I was joined by one of the Sunnyside Village Cohousing coordinators, Paul Cullen, who identified the tree where historical bald eagle nesting activity had been observed. The subject tree is a Douglas fir with a double leader at the top. The tree is located on the adjacent parcel to the east, owned by the City of Marysville, approximately 65-feet from the SVC parcel boundary. This distance was estimated using a rangefinder on site and verified using the Snohomish County PDS Map Portal analysis tool. See attached Figure 1 for approximate location of the subject tree.

Figure 1. Site overview figure showing the location of the historical bald eagle nest in relation to the project site.

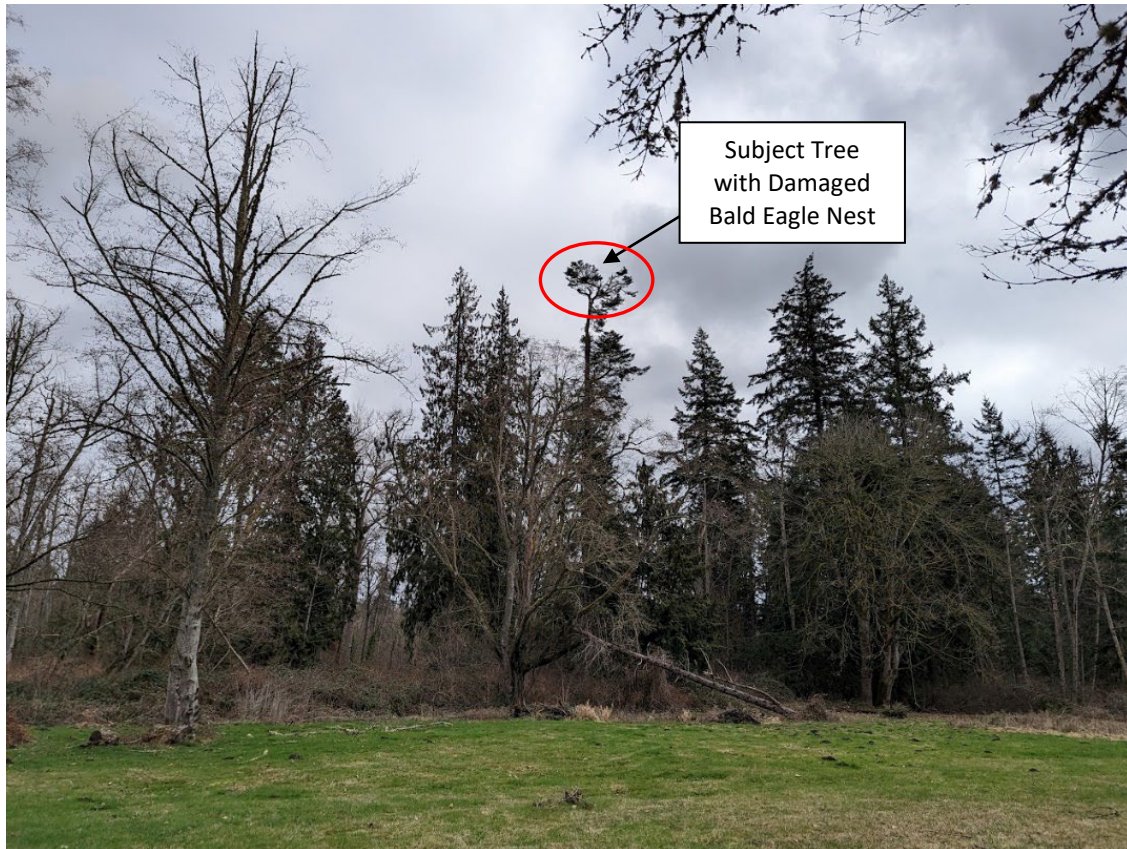
Within the upper 15-feet of the subject tree, a few feet above the double leader fork, fragments of a bald eagle nest were observed with evidence of damage and weathering. The nest was unoccupied for the duration of the site visit. The nest was uneven in shape with a thin/shallow profile. Typically eagle nests are 4-6 feet in diameter and 3 feet deep, although larger nests exist (USFWS 2007)¹. See Photographs 1 and 2 for more details on the subject tree and damaged nest. Photograph 3 shows terrestrial habitat conditions located north of the subject tree within the adjacent parcel. No additional nests or bald eagle nest building behaviors were observed within this area.

Photograph 1. Looking east towards the adjacent parcel. Douglas Fir with double leader and damaged eagle nest is shown.

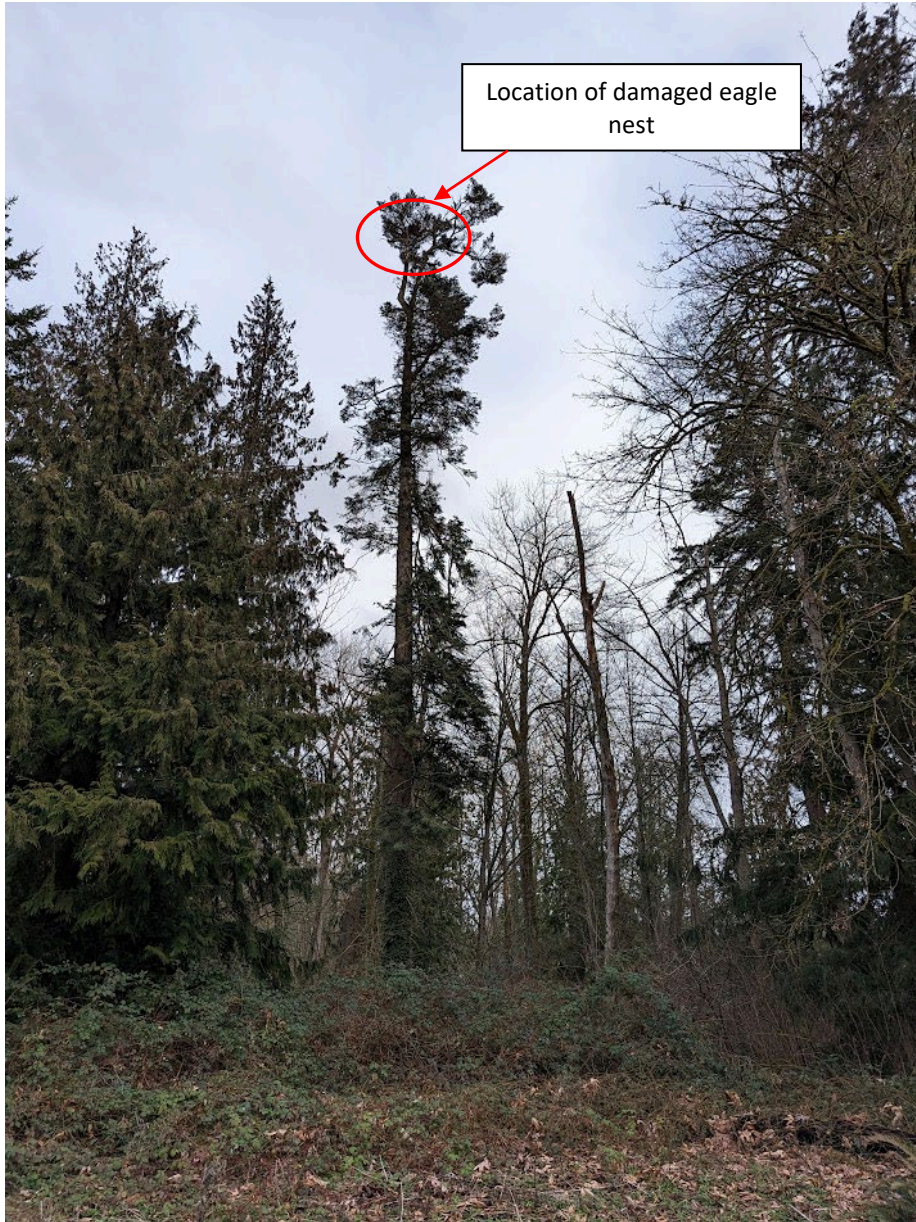
Photograph 2. Looking east towards adjacent parcel. Douglas Fir with double leader and damaged eagle nest is shown.

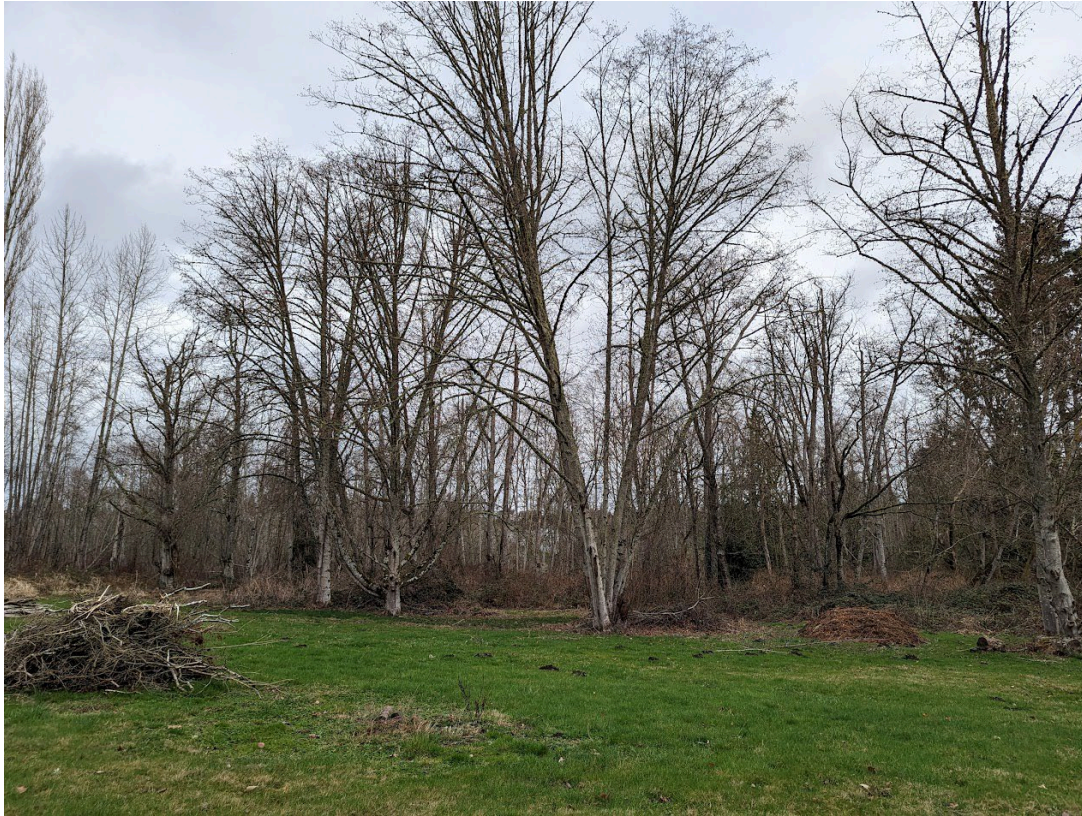
Photograph 3. Looking northeast towards the other terrestrial habitat within the adjacent parcel. No nests or bald eagle nest building activity was observed within this area.
