July 15, 2022
ES-5718.13

Earth Solutions NW LLC

**Subject: Infiltration Evaluation and
Winter Groundwater Monitoring
Montesa Plat
2703 - 156th St NE
Marysville, Washington**

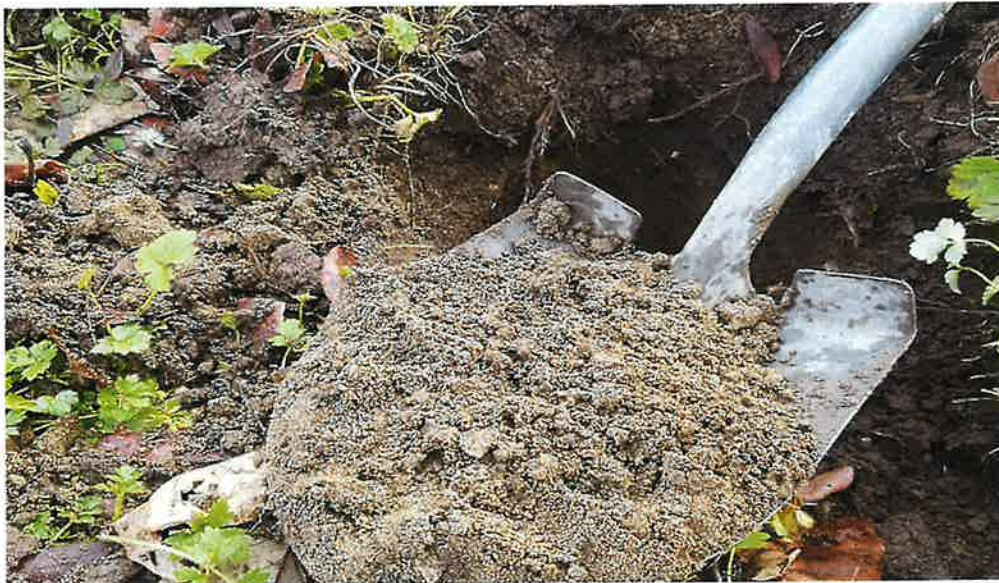
A constant and falling head small-scale pit test (PIT) was completed at test pit TP-102 at the time of our November 2021 investigation. The PIT was completed at a depth of roughly 2.5 feet below the existing ground surface elevation. The photo below depicts the general soil characteristic exposed at the test site (also see attached sieve data).

Marysville Sand Exposed At Test Location (Future Pond Area)

At the time of construction and related excavation activities for the proposed infiltration pond facility, the engineer (or his representative) should observe the pond excavation to confirm that Marysville Sand soils suitable for the design infiltration rate will be exposed throughout the entirety of the completed pond bottom. As necessary, supplement recommendations may be provided by the engineer to ensure the design rate is satisfied.

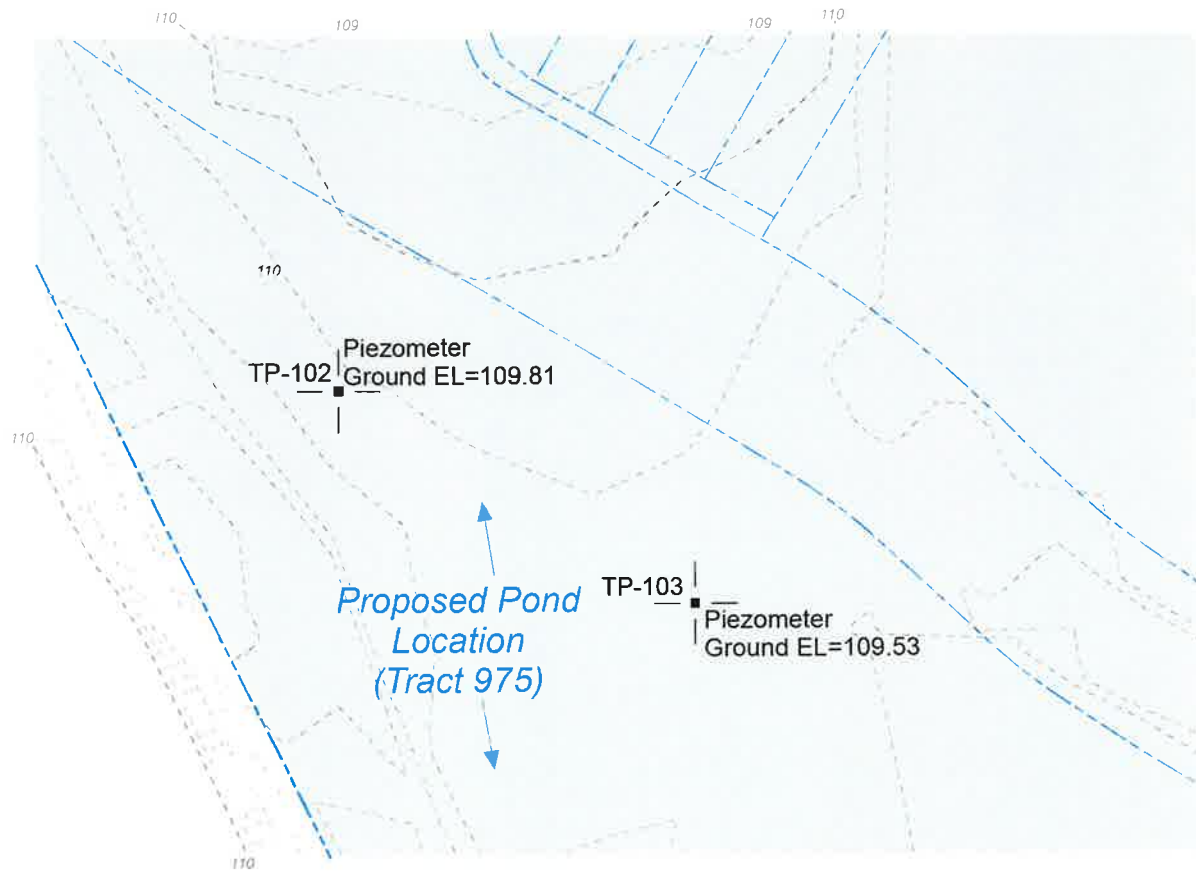
Earth Solutions NW LLC <small>Geotechnical Engineering, Construction Observation/Testing and Environmental Services</small>	
	Piezometer Location Plan Montesa Marysville, Washington	
Drwn. MRS	Date 07/14/2022	Proj. No. 5718.13
Checked RAC	Date July 2022	Plate 1

ESNW completed a seasonal groundwater monitoring program utilizing two monitoring wells that were installed in November 2021 at test pit locations TP-102 and TP-103. The attached Plate 1 depicts the approximate locations of the test pits and corresponding monitoring wells.

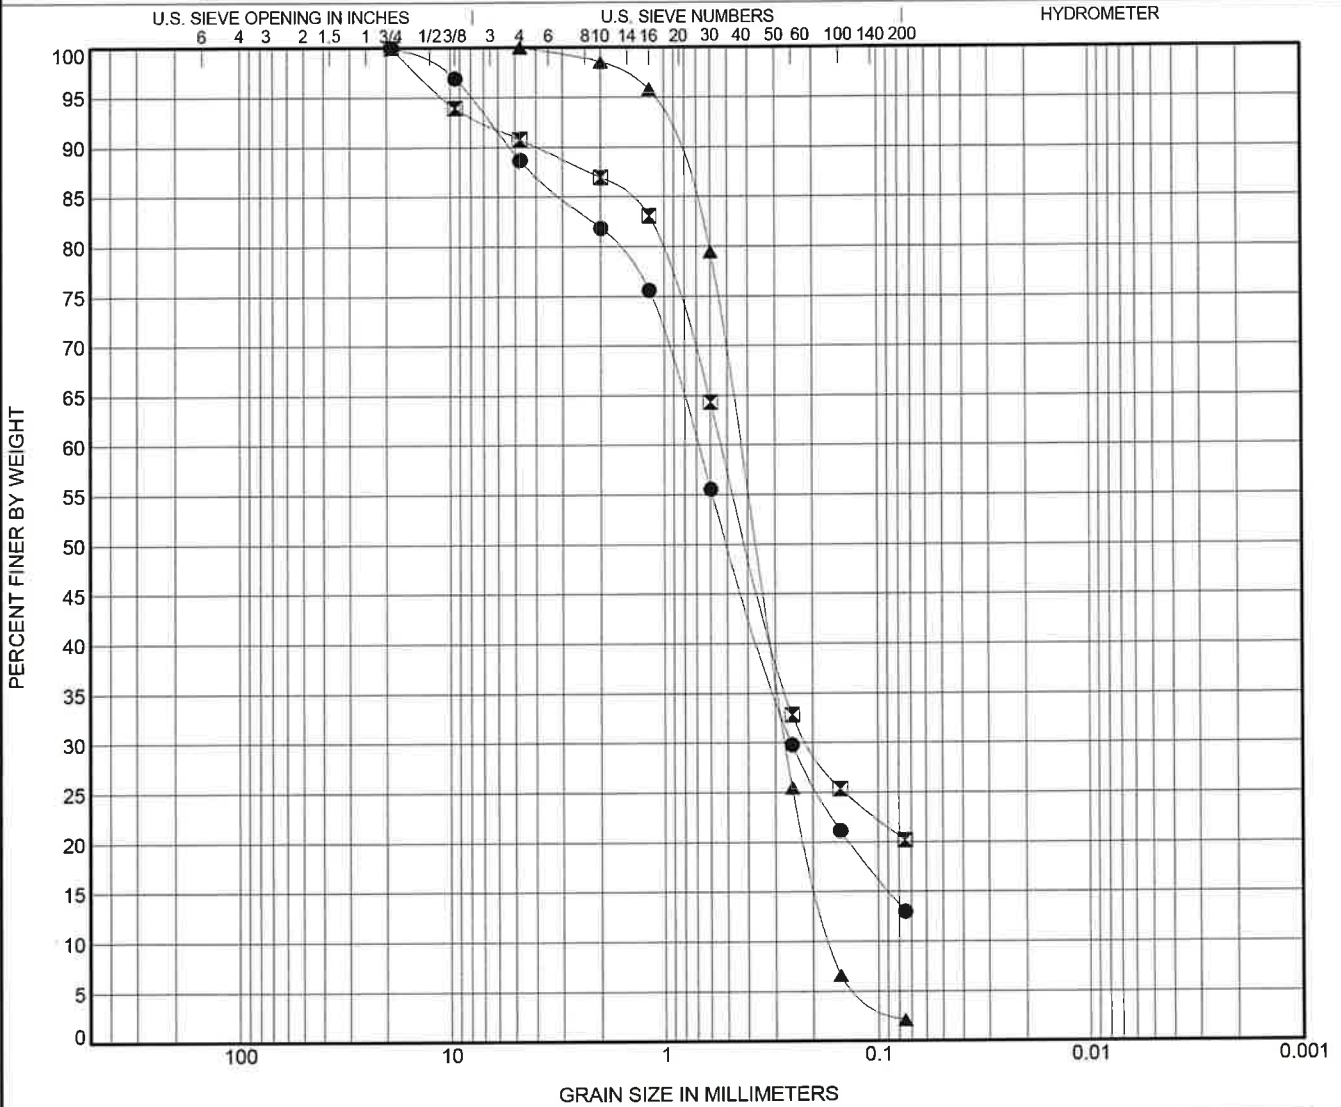
GRAIN SIZE DISTRIBUTION

Specimen Identification	Classification							Cc	Cu
● TP-102 2.50ft.	USDA: Brown Gravelly Loamy Coarse Sand. USCS: SM.								
☒ TP-103 3.00ft.	USDA: Gray Slightly Gravelly Loamy Coarse Sand. USCS: SM.								
▲ TP-104 2.50ft.	USDA: Brown Slightly Gravelly Sand. USCS: SP.							1.00	2.66
Specimen Identification	D100	D60	D30	D10	LL	PL	PI	%Silt	%Clay
● TP-102 2.5ft.	19	0.697	0.252					13.0	
☒ TP-103 3.0ft.	19	0.532	0.206					20.2	
▲ TP-104 2.5ft.	4.75	0.438	0.269	0.165				2.1
