Preliminary Stormwater Site Plan

White Barn on Lots 3 and 4

Barghausen Consulting Engineers, Inc.

Marysville, Washington

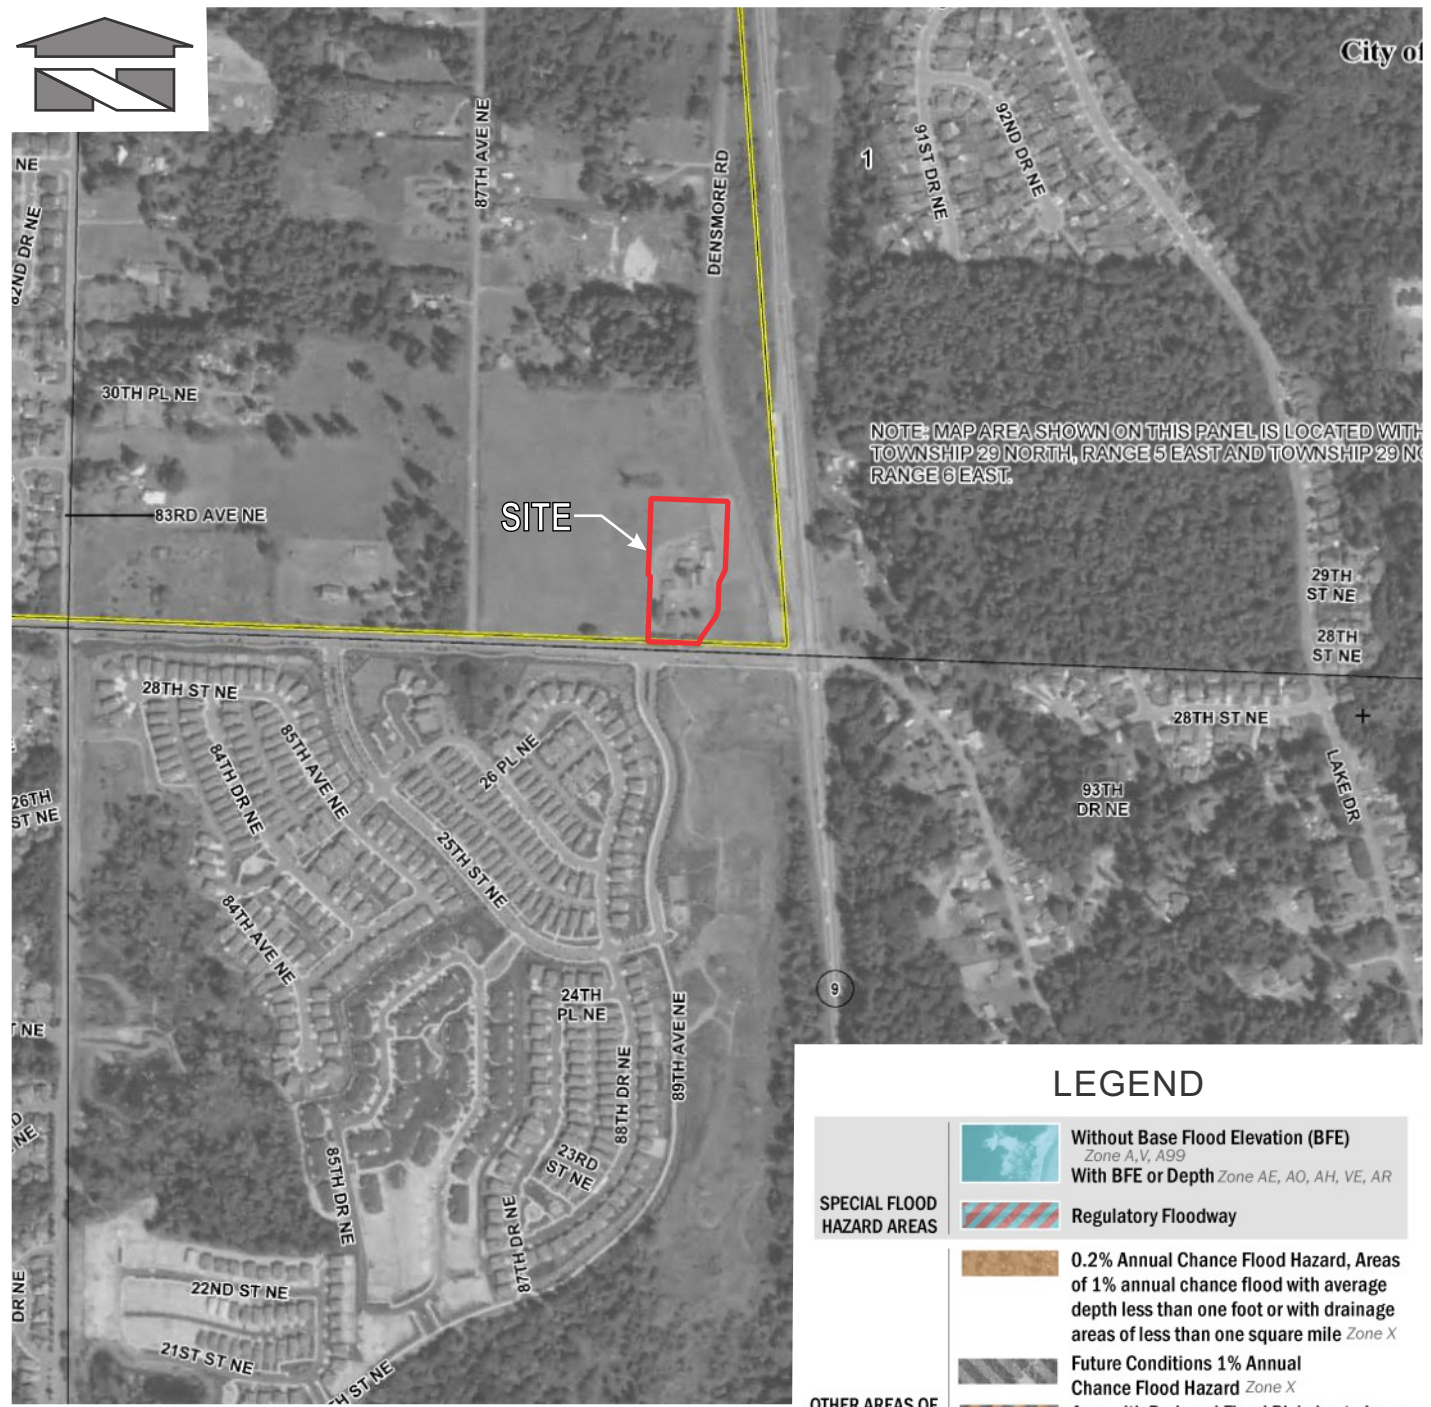
Figure 3.4 FEMA Map

The project site is located in Snohomish County in FEMA Flood Zone X, as shown in Figure 3.4. The existing site consists of rough grading activities, with topography slopes ranging from 2 to 7%, with 30% slopes along the east property boundary. Stormwater runoff currently flows north to south before entering the existing storm infrastructure within Soper Hill Road.

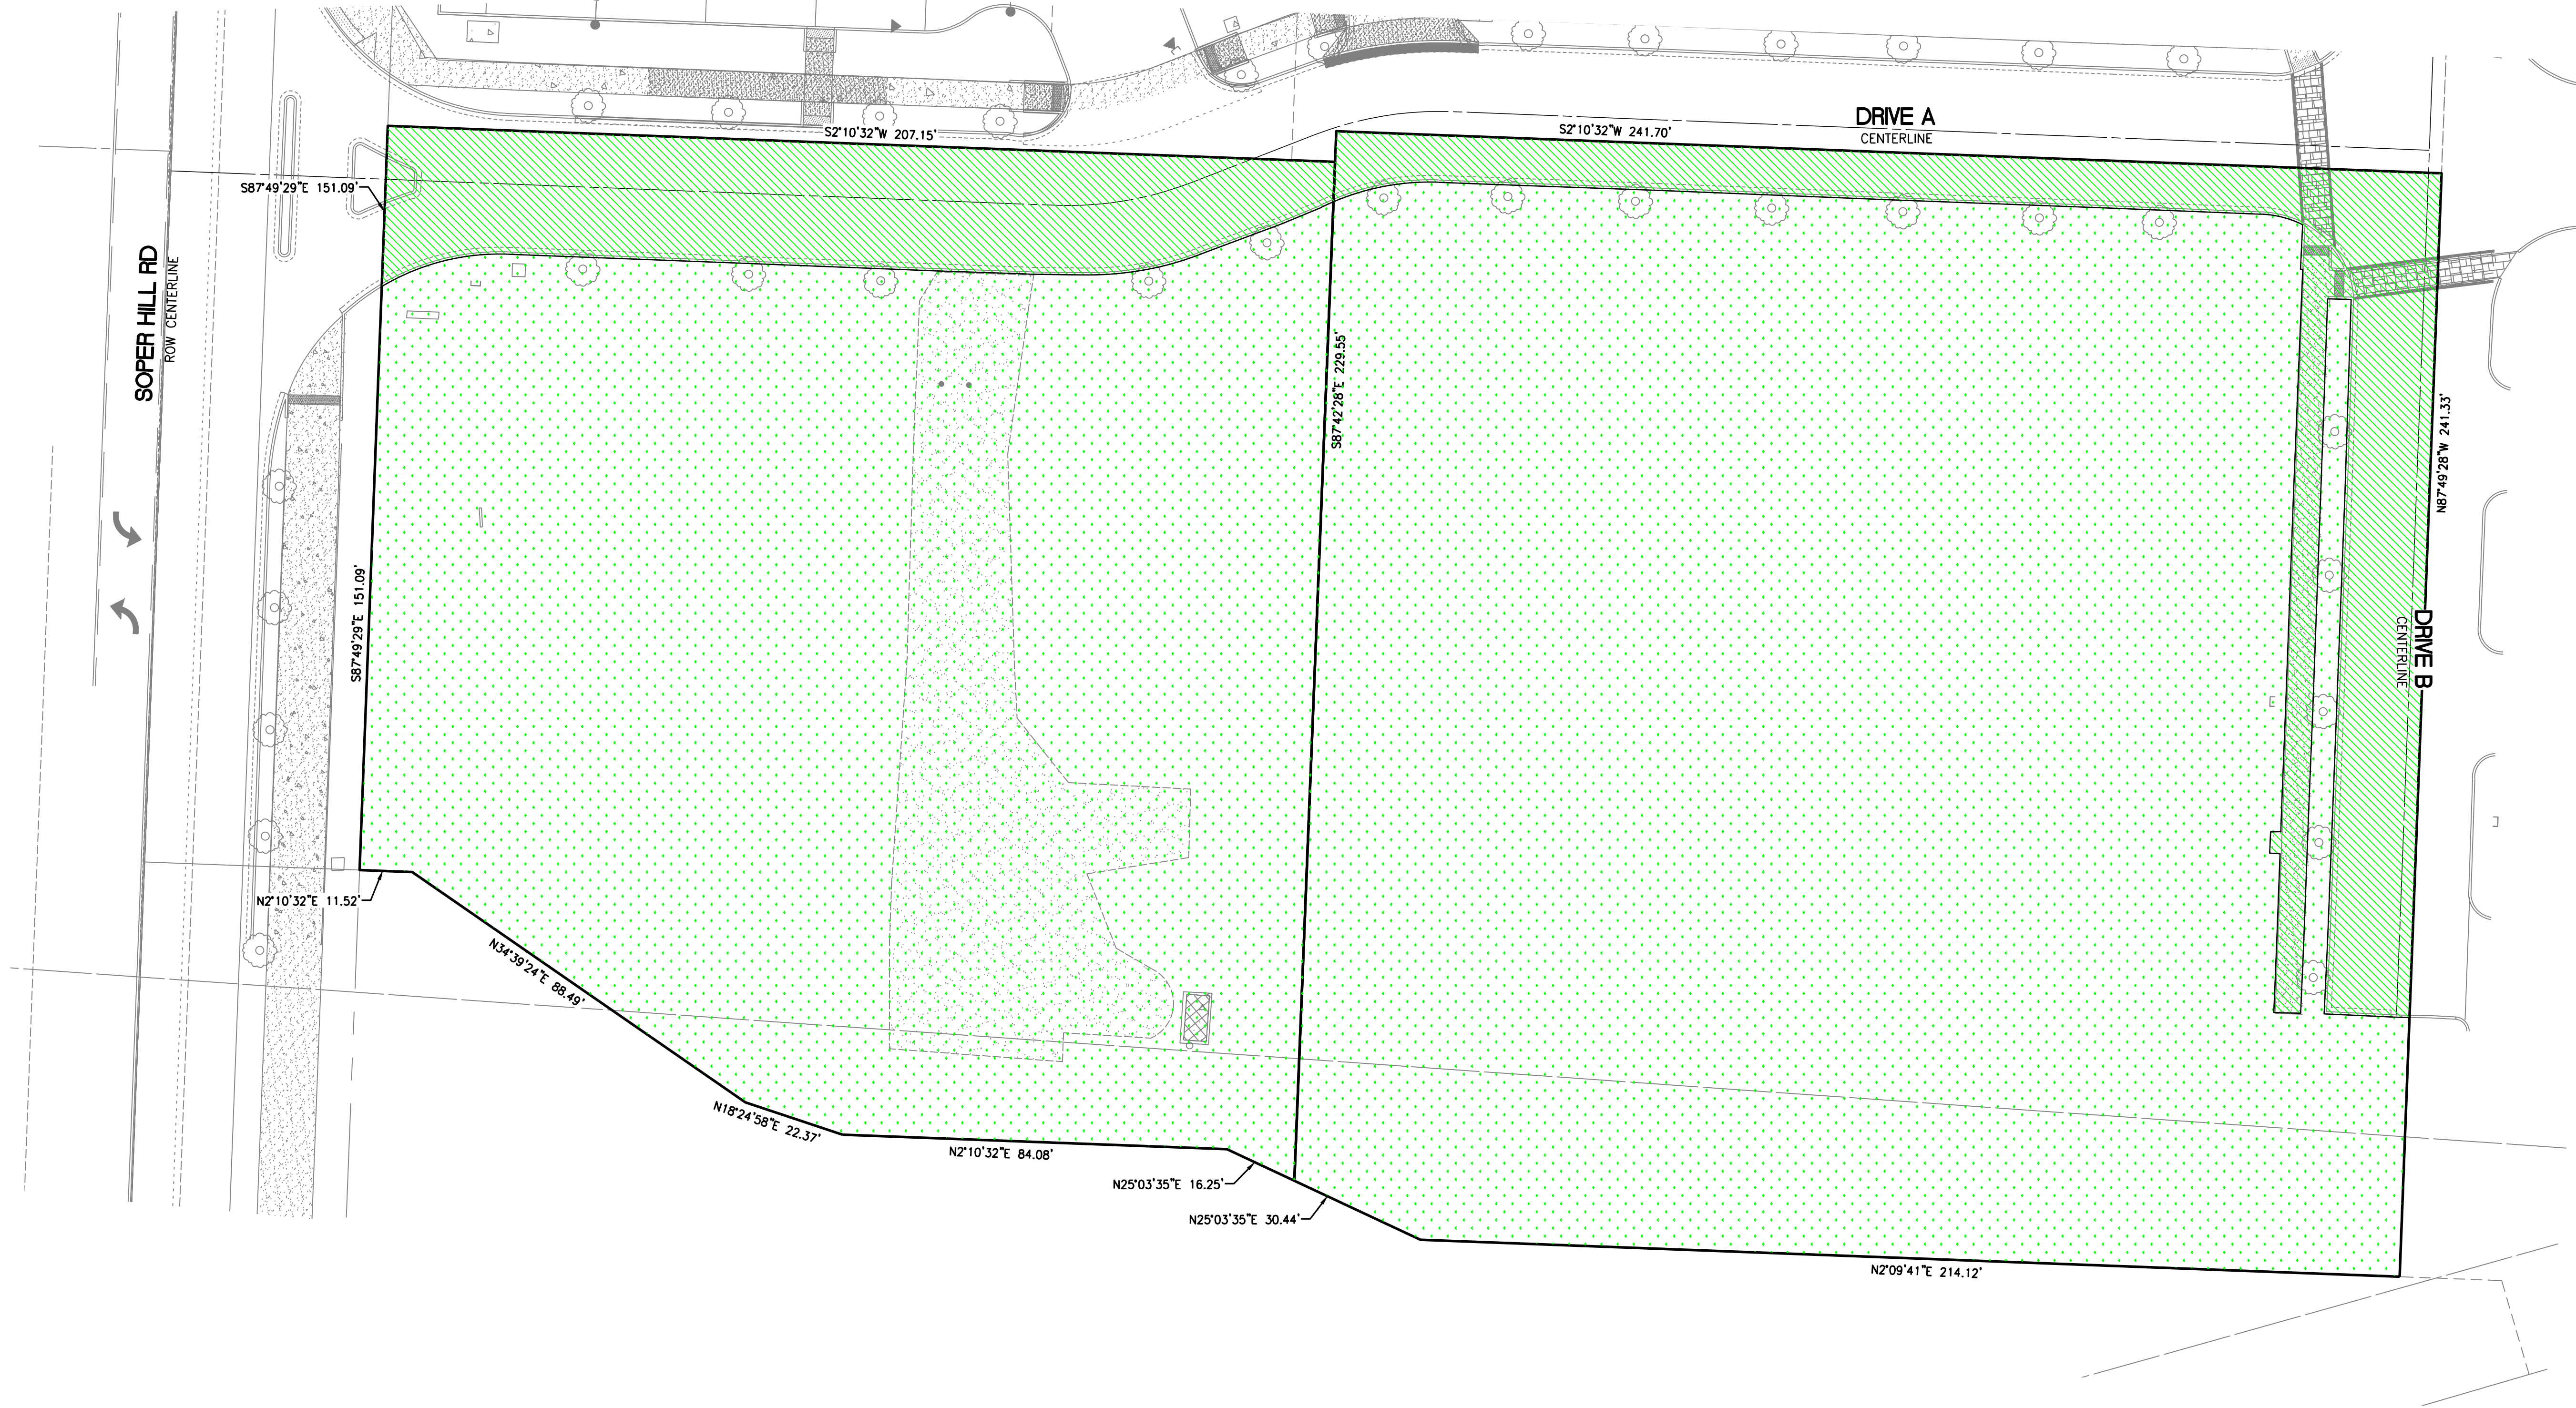
TOTAL AREA	100,156± SF (2.30 AC)

Title:
PRE-DEVELOPED BASIN MAP
FOR
BROWN BEAR MARYSVILLE

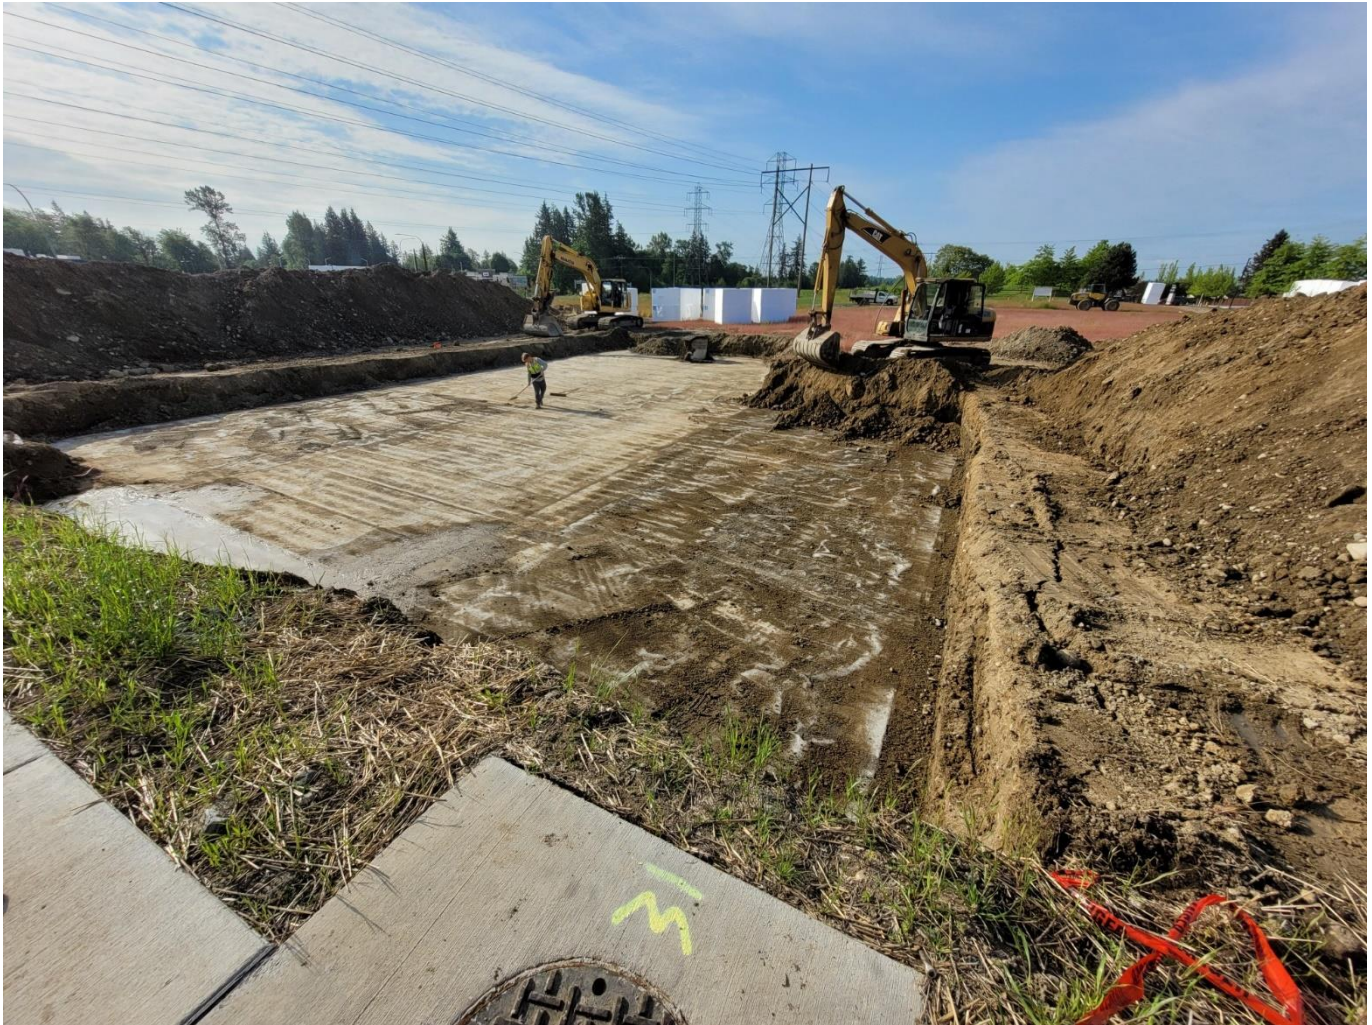
ESNW rep. observed the contractor begin removing previously installed soil from the vault lid on the north portion of the vault. ESNW rep. observed the contractor expose the vault lid and begin to install geofoam. See map below and photo on page 2. ESNW rep. will return for continued observations.

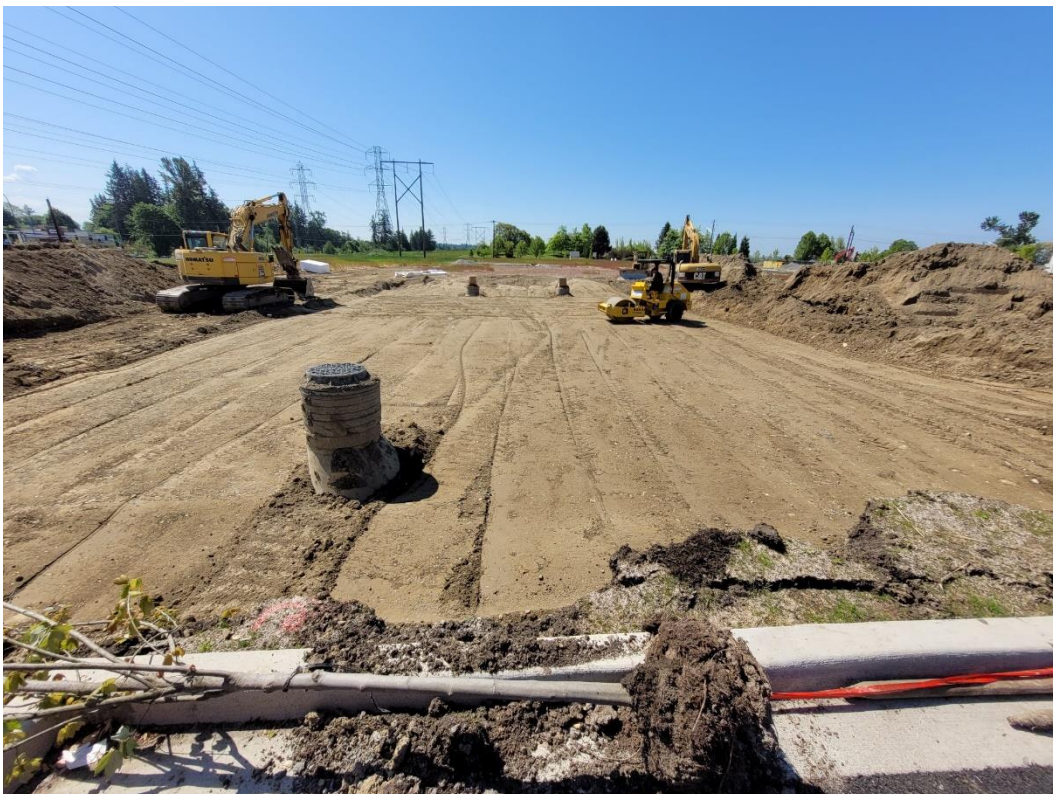
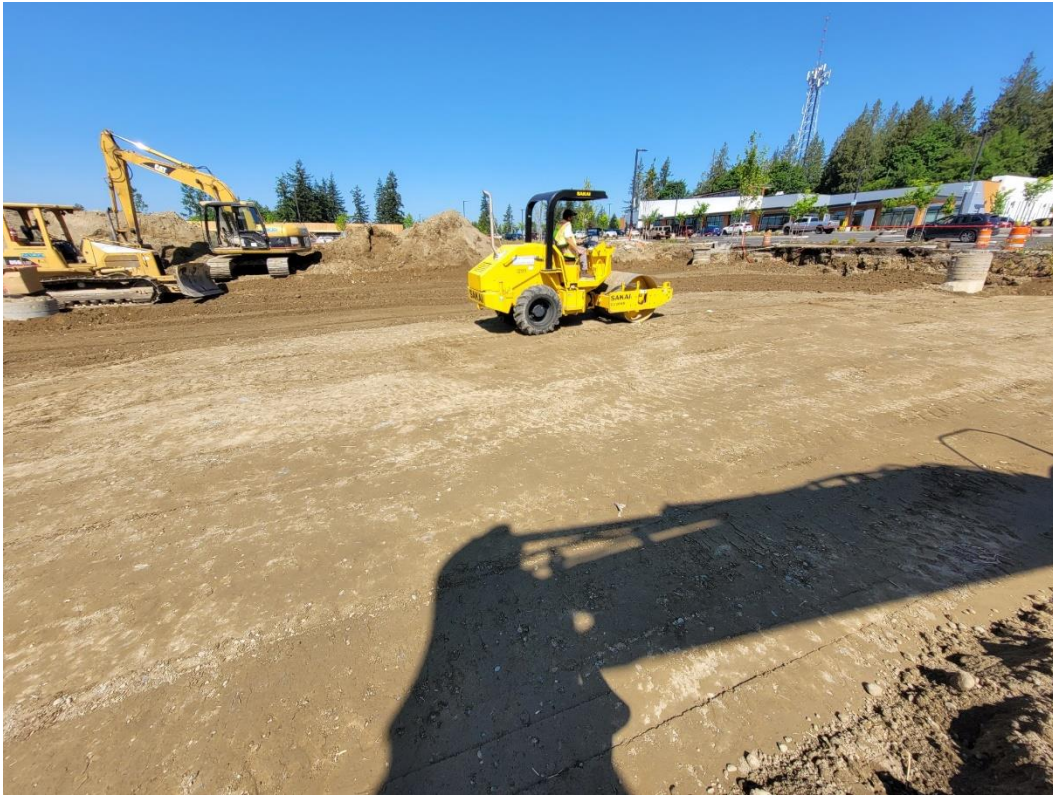
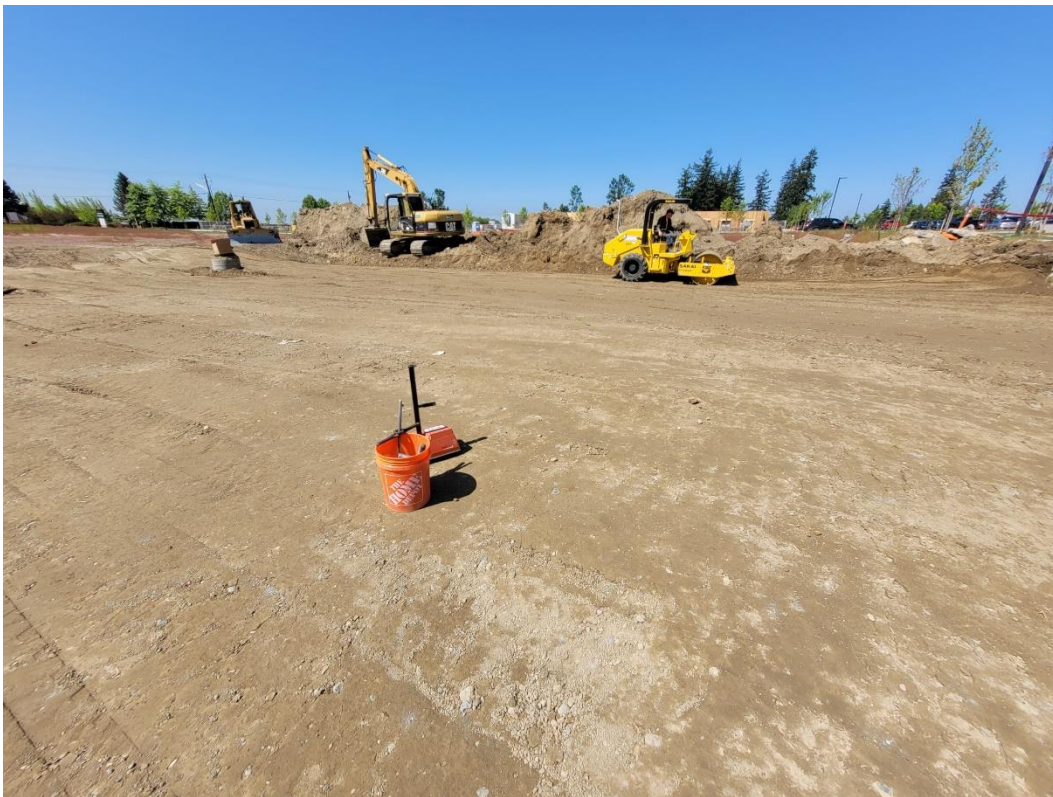
ESNW rep. observed the contractor grade out approx. 12-inch-max loose lifts of native soil along the vault lid. ESNW rep. observed the contractor compact each lift using a vibrating drum roller. See photos on pages 2 and 3. Adequate compaction of at least 95% of the modified proctor MDD was achieved at tested locations. See map on page 2 for approximate test locations.

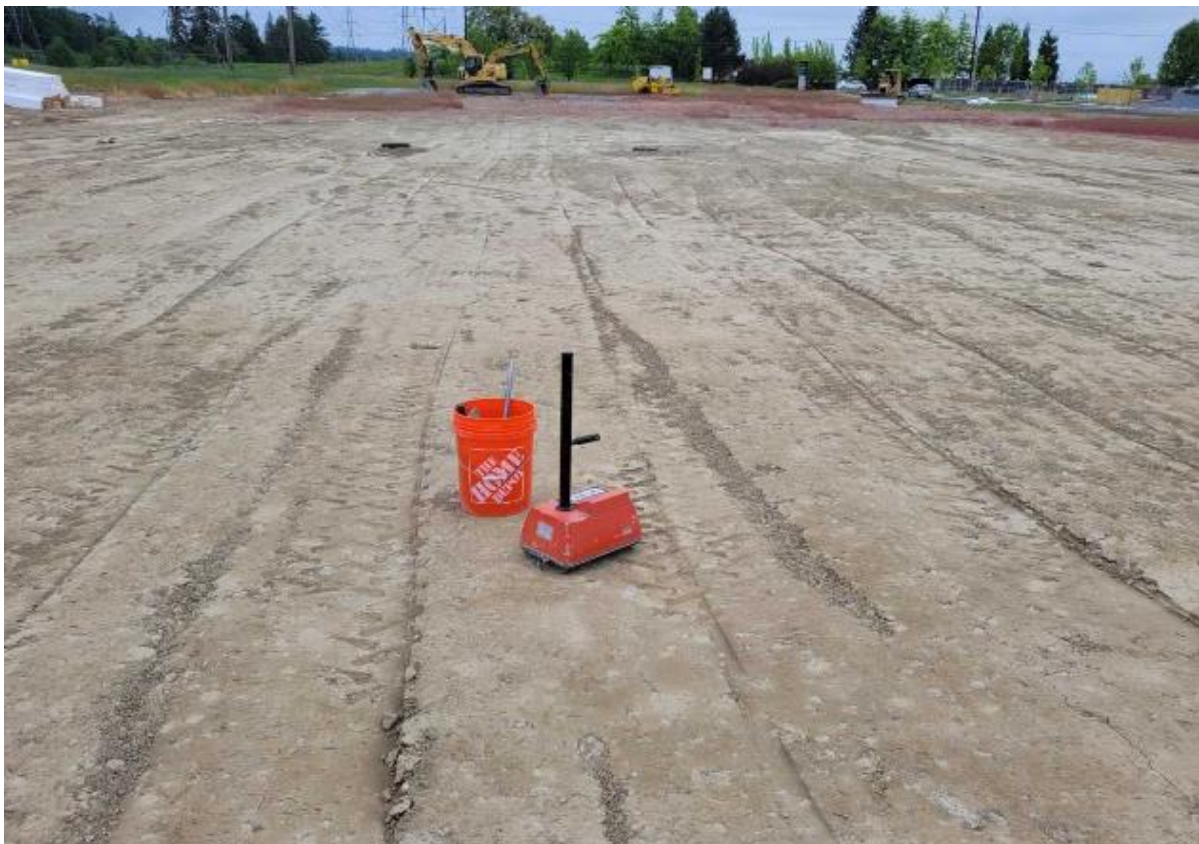
ESNW rep. observed the contractor grade out approx. 12-inch loose lifts of native soil along the vault lid. ESNW rep. observed the contractor compact each lift using a vibrating drum roller. Adequate compaction of at least 95% of the modified proctor was achieved at tested locations. See map for approximate test locations.

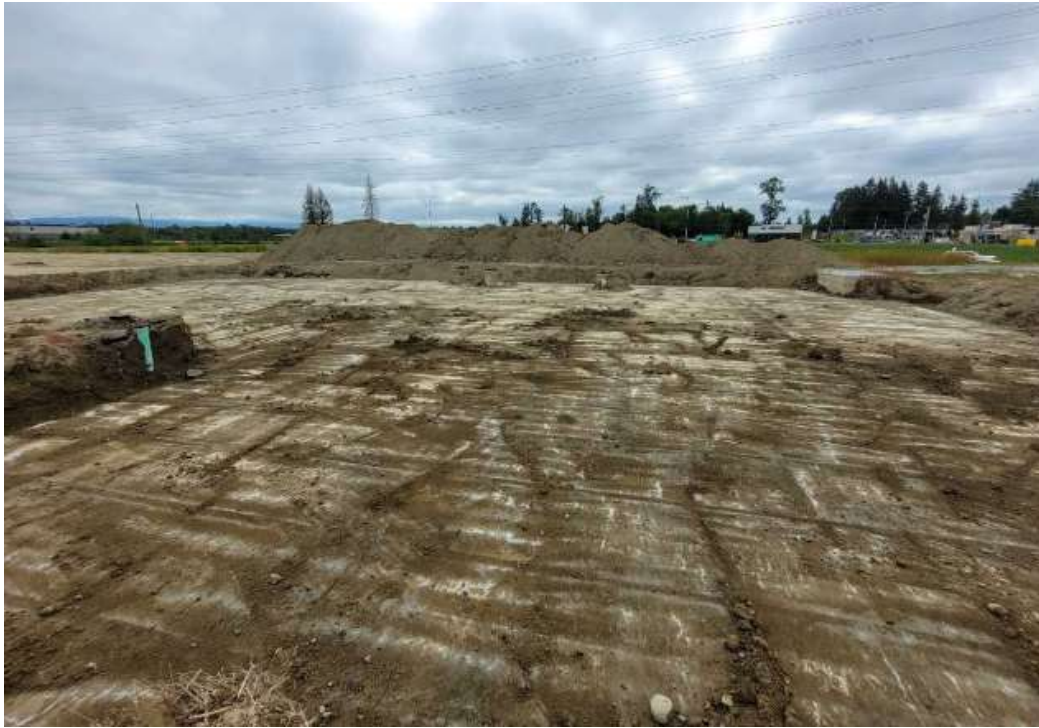
ESNW rep. observed the contractor excavate all of the soil from the top of the vault that was previously placed. ESNW rep. observed the soil to be suitable for grading out in lifts and compacting. ESNW rep. will return for soil compaction observations, as requested.

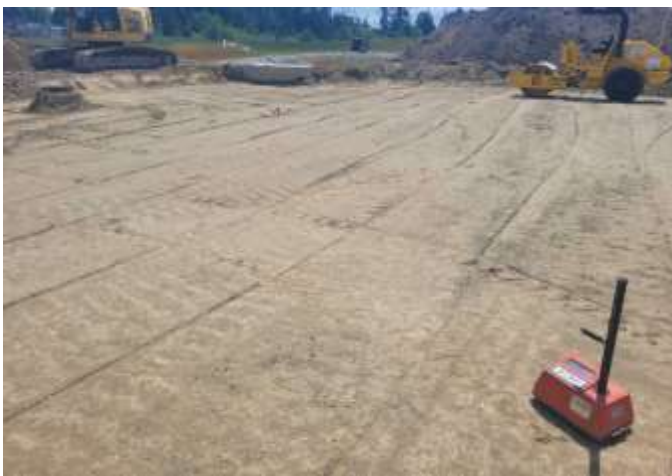
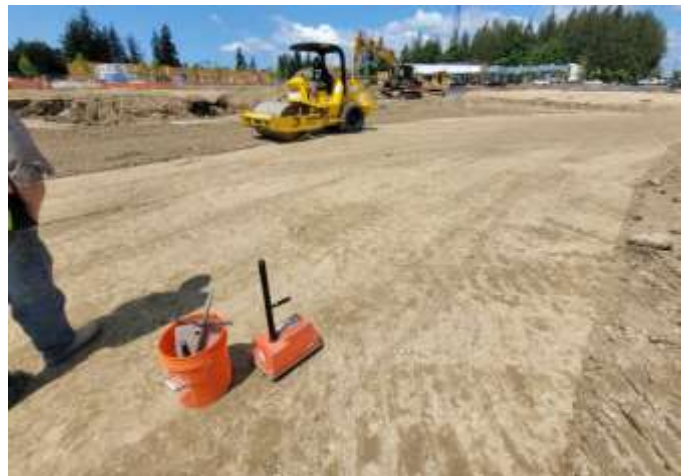
ESNW rep. observed the contractor grade out approx. 12-inch loose lifts of structural soil on the vault lid. ESNW rep. observed the contractor compact each lift using a large vibrating drum roller. Adequate compaction of at least 95% of the modified proctor MDD was achieved at tested locations. See map for approximate test locations.

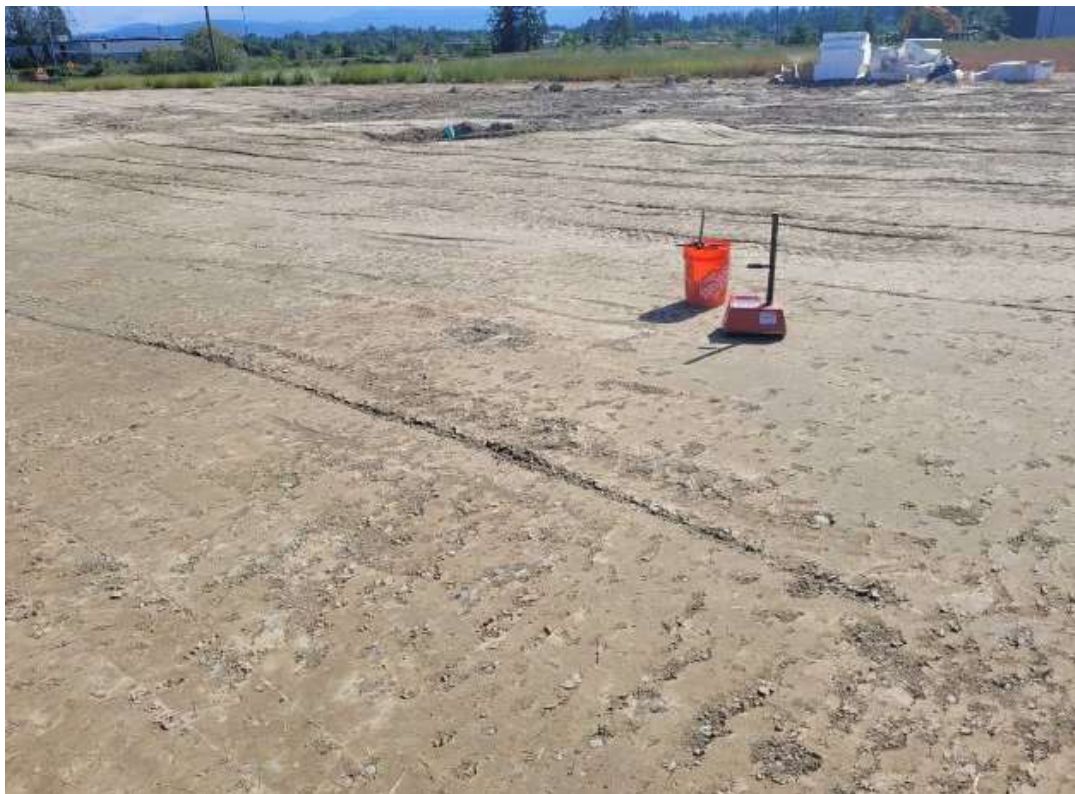
ESNW rep. observed the contractor grade out approx. 12-inch loose lifts of structural soil on the vault lid. ESNW rep. observed the contractor compact each lift using a large vibrating drum roller. Adequate compaction of at least 95% of the modified proctor MDD was achieved at tested locations. See map for approximate test locations.

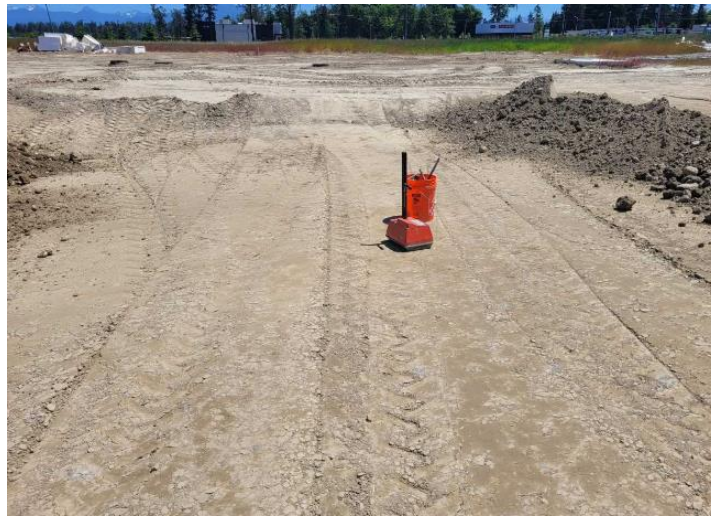
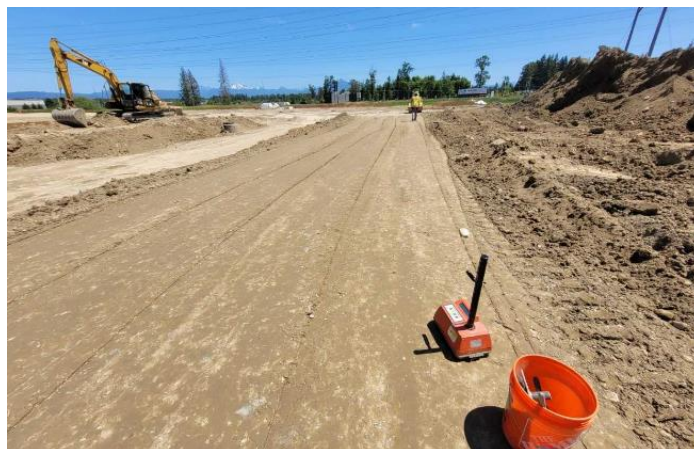
ESNW rep. observed the contractor grade out approx. 12-inch loose lifts of structural soil on the vault lid. ESNW rep. observed the contractor compact each lift using a large vibrating drum roller. Adequate compaction of at least 95% of the modified proctor MDD was achieved at tested locations. See map for approximate test locations.

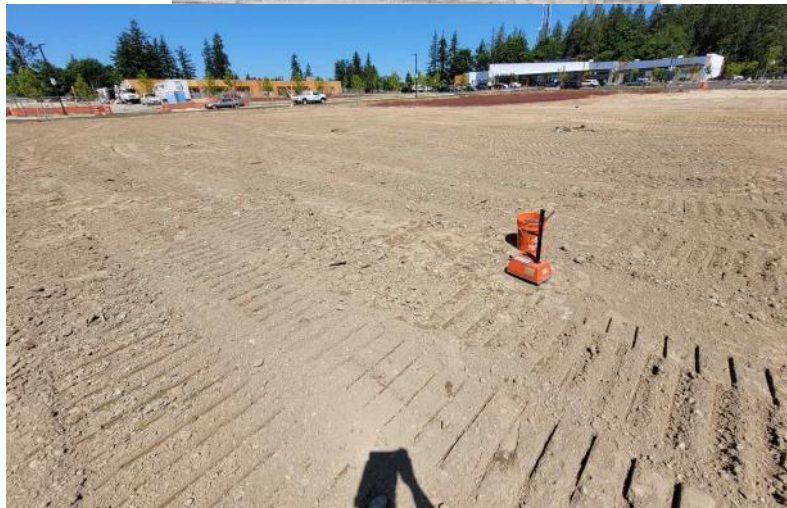
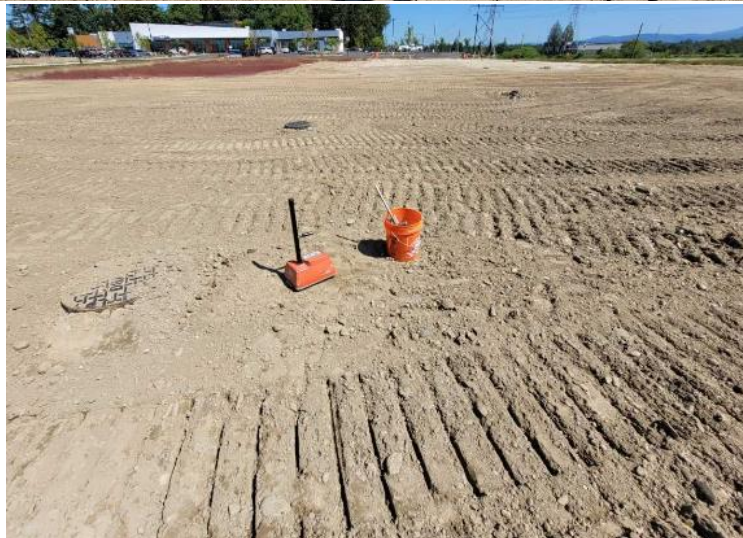
ESNW rep. observed the contractor grade out approx. 12-inch loose lifts of structural soil on the vault lid. ESNW rep. observed the contractor compact each lift using a large vibrating drum roller. Adequate compaction of at least 95% of the modified proctor MDD was achieved at tested locations. See map for approximate test locations.
