Geddes Marina Phase 2 Critical Areas Report and Mitigation Plan

> Prepared for City of Marysville

December 2021

Prepared by Parametrix

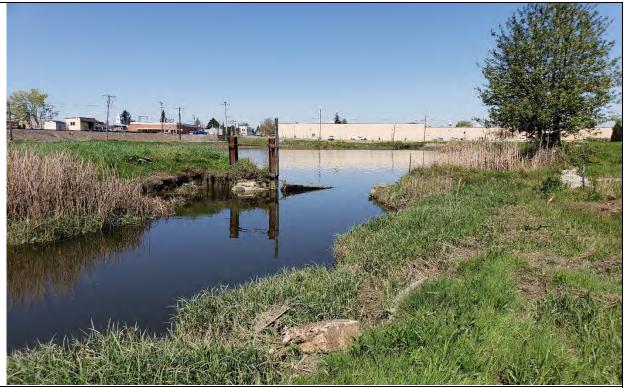
Photo 1: Lagoon (Wetland C) in background and outlet channel to Ebey slough at high tide. Location of weir is visible and is the break line between Wetland B and Wetland C (4/25/2018).

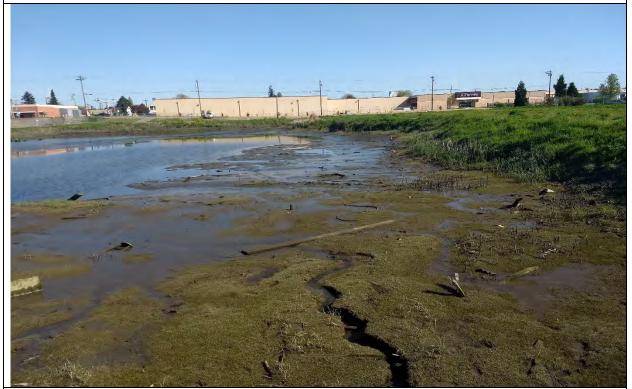
Photo 2: Lagoon (Wetland C) along perimeter of boat basin at low tide looking north toward 1st Street on Geddes Site (4/25/2018).

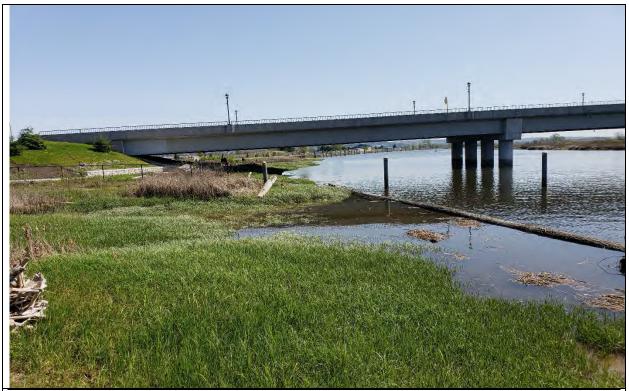
Photo 5: Ebey Slough shoreline and Wetland A east of Ebey waterfront Park's boat ramp looking toward SR 529 (4/25/2018).

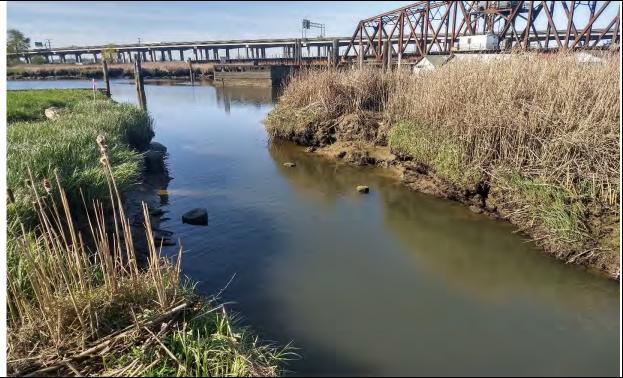
Photo 6: Outlet channel from Lagoon to Ebey Slough with Wetland B on either side of channel and extending to the right and left along Ebey Slough shoreline. Looking southwest toward BNSF & I-5. railroad and I-5.

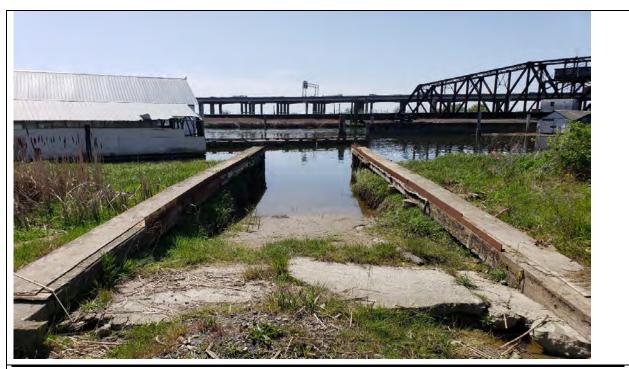
Photo 7. Old wood rail boat lift on Geddes Site in foreground extending into Ebey Slough with docks and boat houses in background. Approximate location of new non-motorized boat launch with Wetland B on either side (4/25/2018).

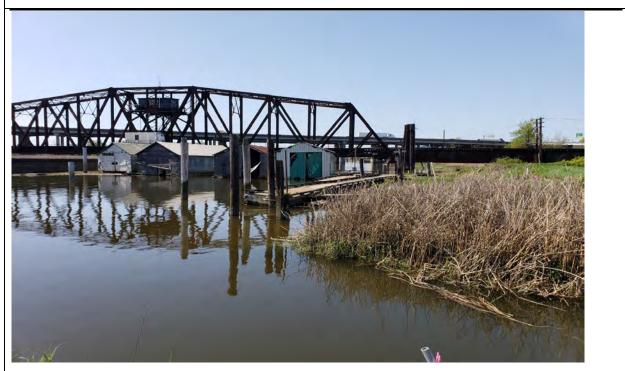
Photo 8: Wetland B to along shoreline. Looking west from boat basin outlet to Ebey Slough (4/25/2018). The boathouses and dock have since been removed (see Photo 16 and 17).

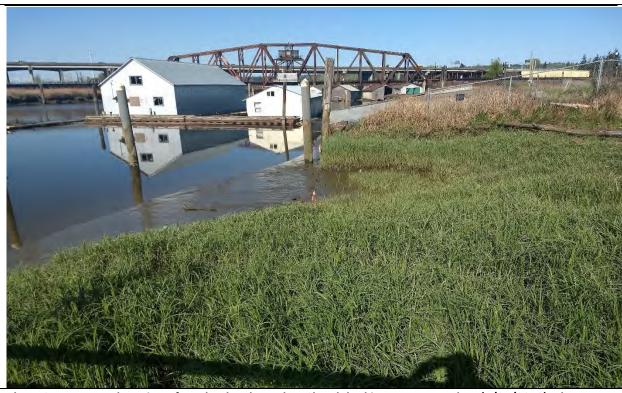
Photo 9: Unarmored portion of Wetland B along Ebey Slough looking west toward I-5 (4/25/2018). The boathouses and have since been removed. (see Photos 16 and 17).

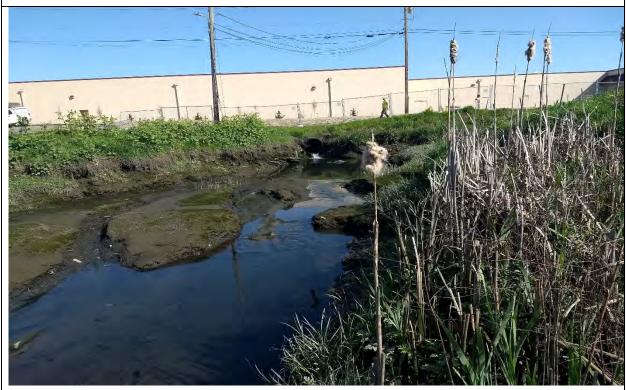
Photo 10: Looking north from edge of boat basin on Geddes Site towards the 36-inch culvert that discharges stormwater into lagoon from beneath 1st Street. Wetland C skirts the perimeter of the entire boat basin.

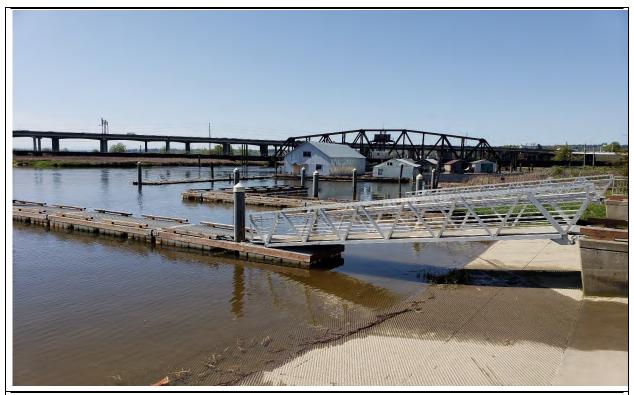
Photo 11. Existing motorized boat launch facilities at Ebey Waterfront Park (4/25/2018).

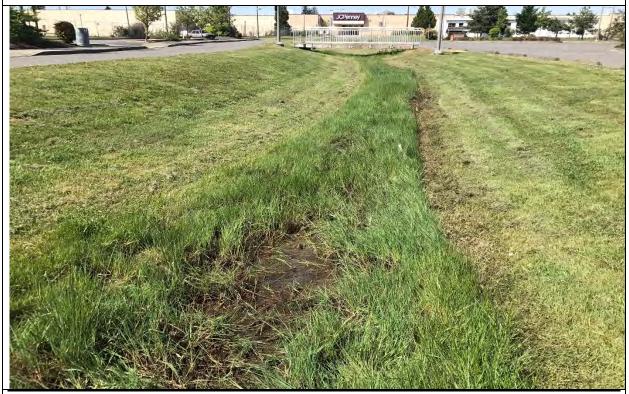
Photo 12: Constructed stormwater swale in parking area of Ebey Waterfront Park looking north toward park entrance and downtown commercial properties (4/25/2018).

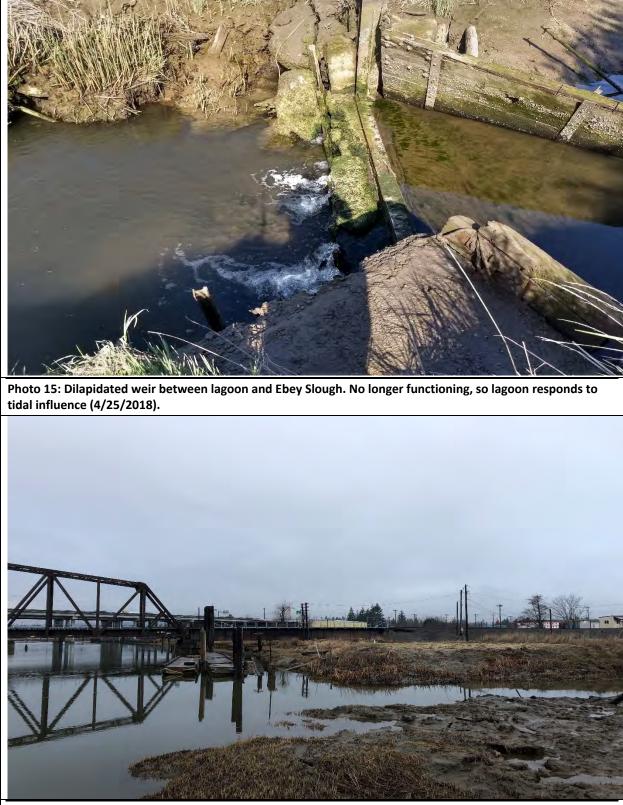
Photo 16: Remnant docks/floats/piles waterward of Geddes Site in Ebey Slough. All boat houses shown in prior pictures have been removed (3/13/2019).

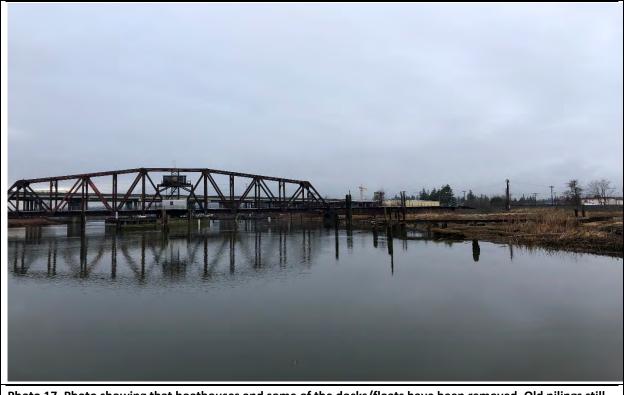
Photo 17. Photo showing that boathouses and some of the docks/floats have been removed. Old pilings still remain and will be removed as part of the expansion project (3/13/2019).

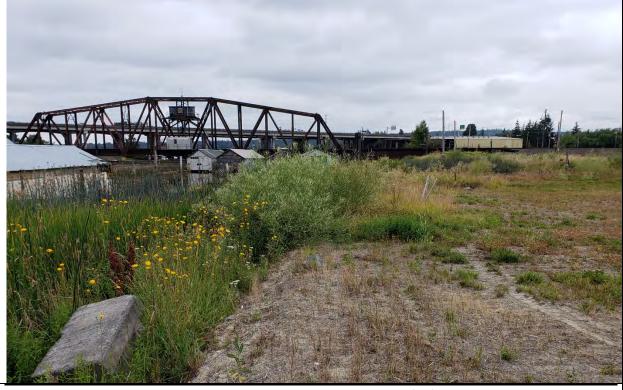
Photo 18: Weeds along waterward edge of Geddes Site in Ebey Slough (7/11/2018).
