**ARCHAEOLOGICAL SURVEY AND ASSESSMENT FOR THE PROPOSED GEDDES MARINA
REDEVELOPMENT, 1326 1ST STREET, MARYSVILLE, SNOHOMISH COUNTY, WASHINGTON**

CALDERA ARCHAEOLOGY TECHNICAL REPORT 1014A

MARCH 12, 2015

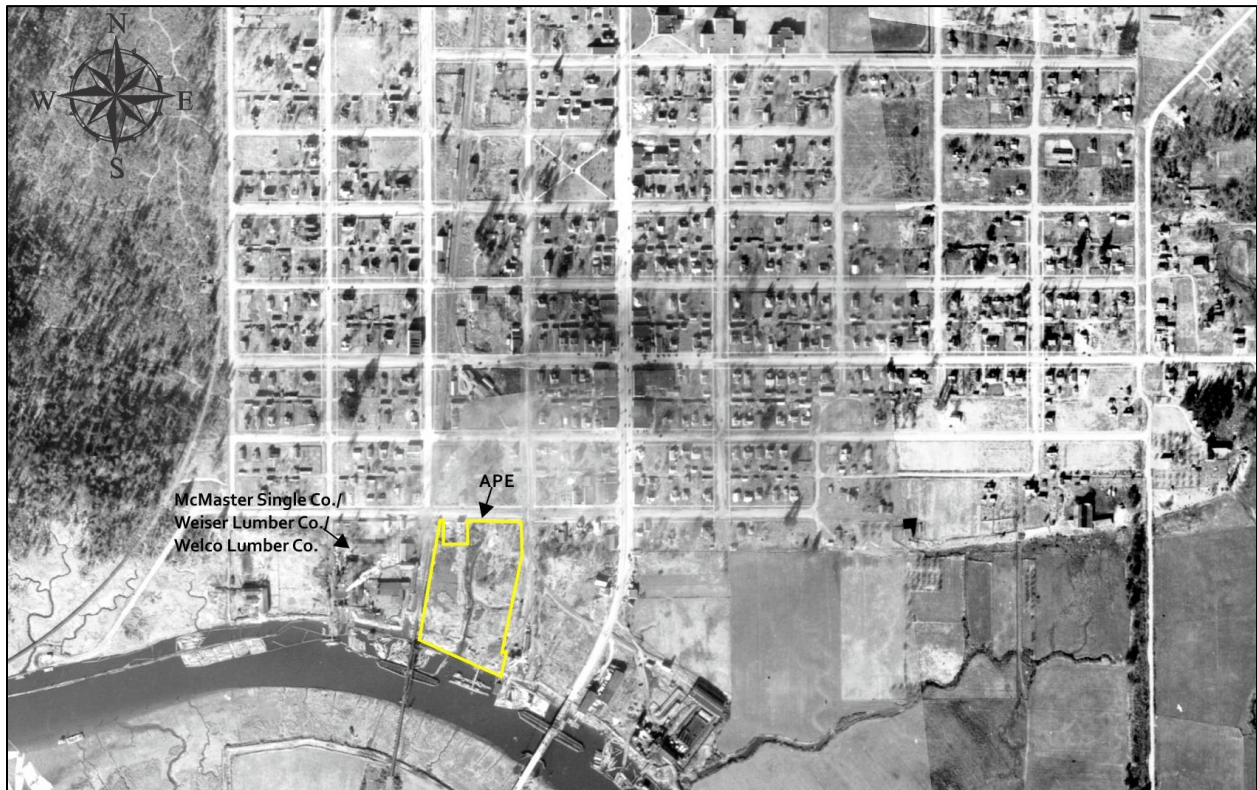
Ongoing and significant mill operations were located directly west of the current APE, on the opposite side of the railroad grade (Figure 4). In 1909, John McMaster purchased an existing mill on the property

Figure 4. Historic aerial photograph from 1938 depicting the APE and the prominent mill operations located directly to the west; accessed at Puget Sound River History Project (2015).

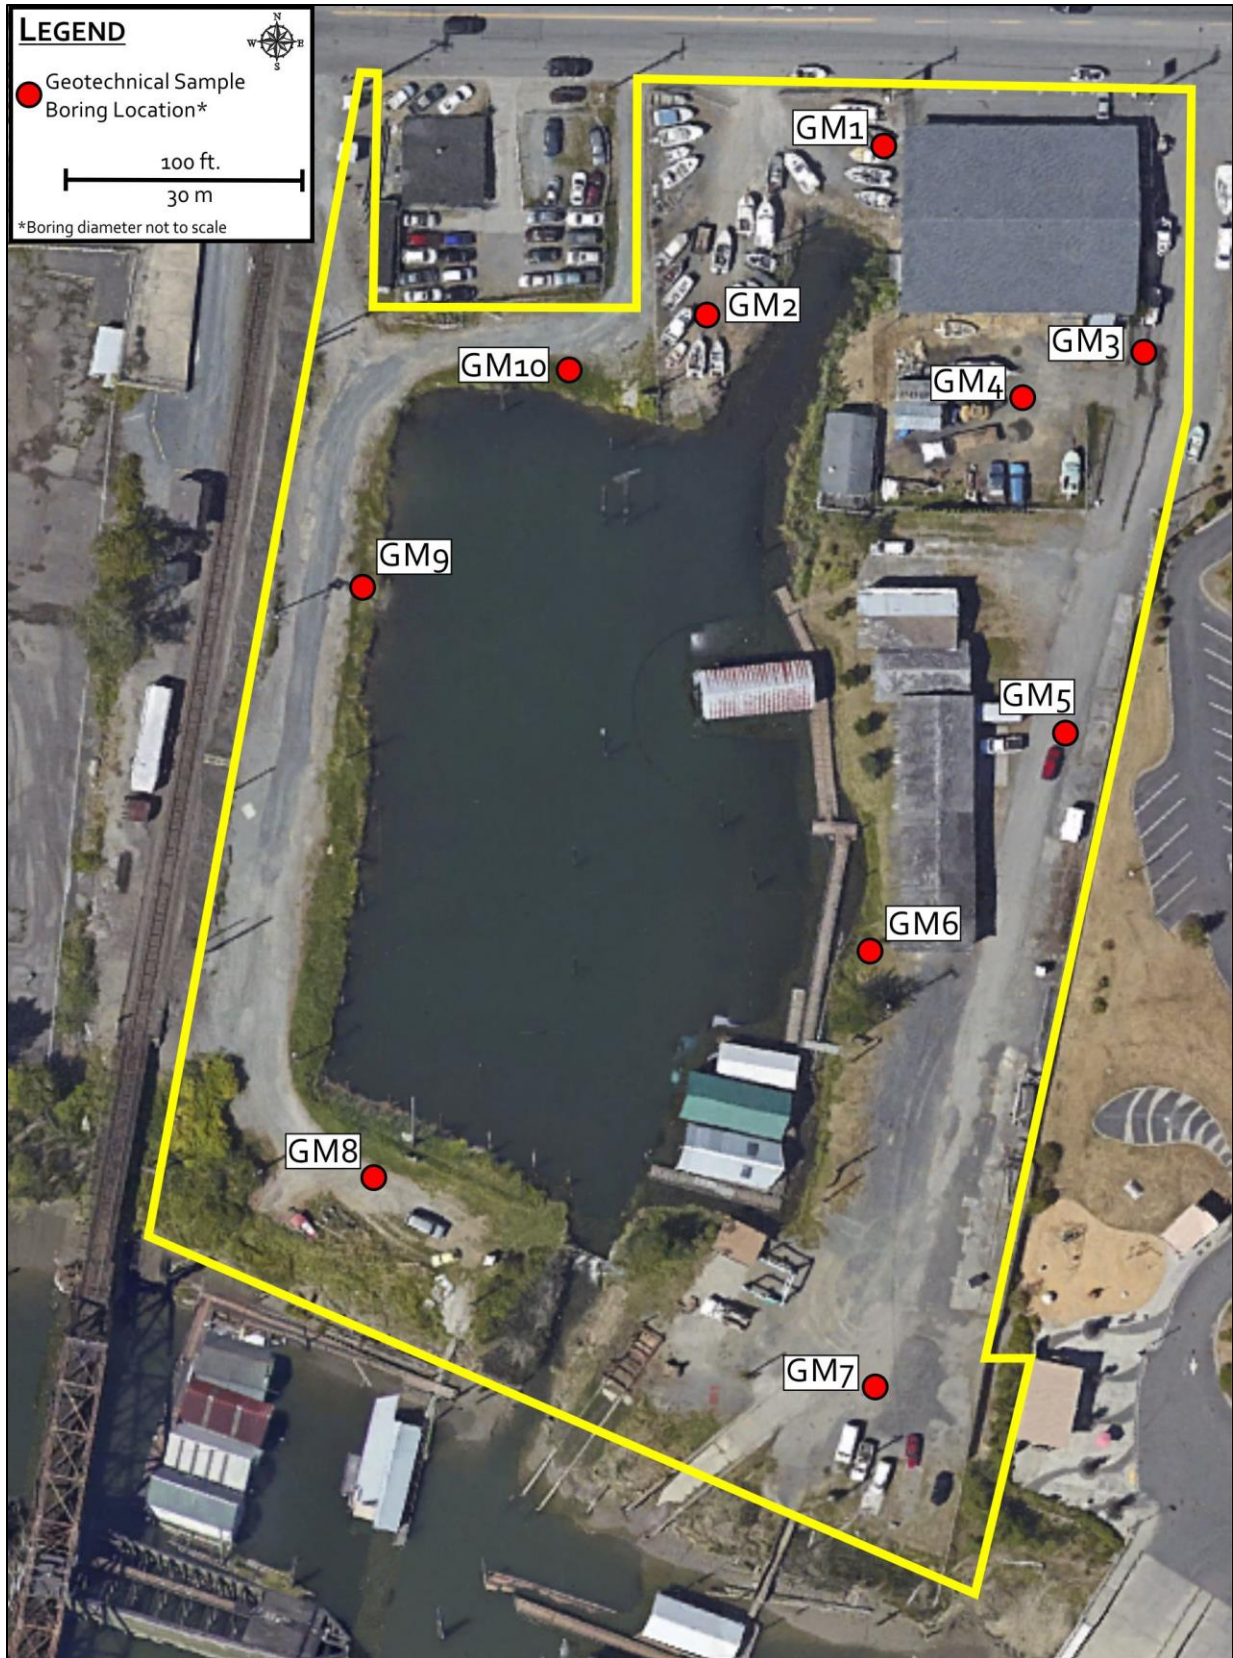
A total of 10 geotechnical sample borings were placed across the APE (Figure 8). Recovered geotechnical sample borings revealed a relatively consistent subsurface profile across the APE. Fill comprised of glacial loam and/or dredged estuarine/riverine sediments intermixed with varying amounts of natural wood/root/grass organic inclusions and/or industrial woodchips and sawdust extended to an approximate depth of 11-13 ft. (3.4-4 m) below the current surface across the APE. The fill overlies basal well-sorted riverine sand, silt and clay deposits (Figures 9-13). The observed depth of fill correlates well with an expected amount required to raise the landform up the meet the subaerially exposed 10 ft. elevation near 1st Street. The basal sediments encountered below the fill match the expected Puget silty clay loam soils that have been mapped within the APE by the Natural Resources Conservation Service.

Figure 8. Recent aerial photograph of the APE (yellow boundary) with geotechnical borings locations indicated; adapted from Google Maps.

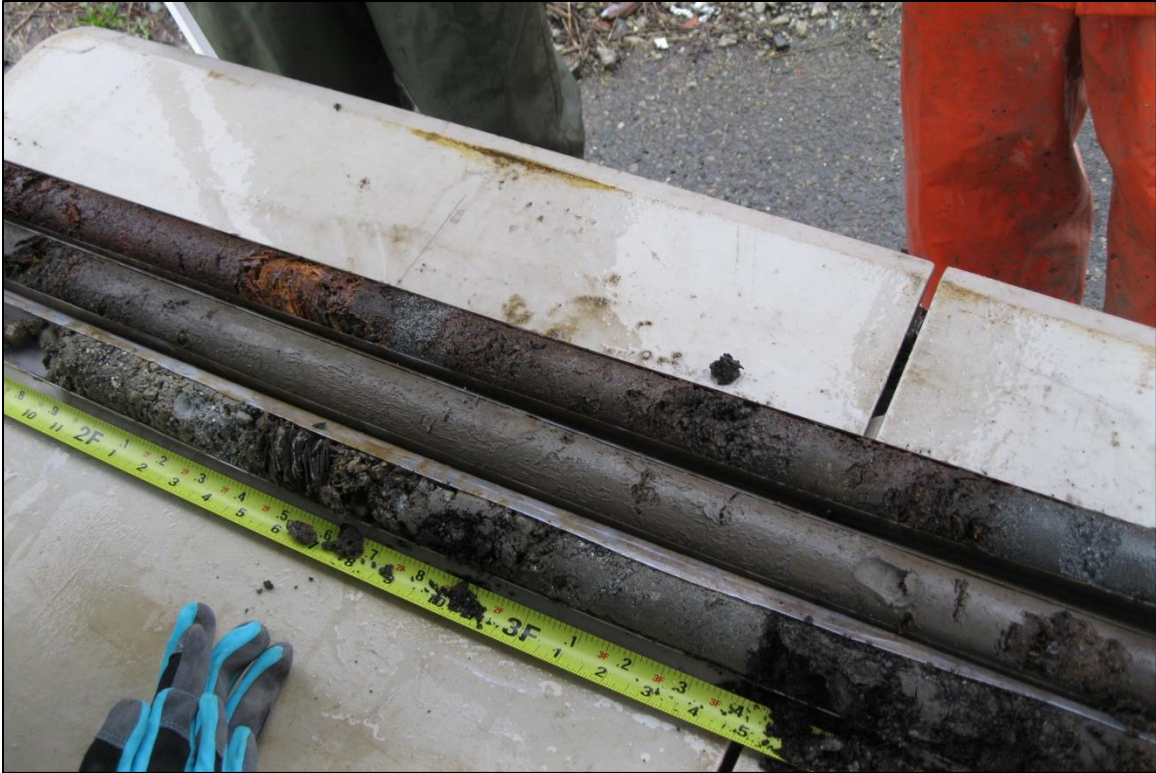
Figure 9. Photograph of sediments recovered within boring GM3; increasing depth left to right, bottom to top (each tube samples 5 ft.).

Detailed sediment observations within the geotechnical borings are presented in Appendix A.

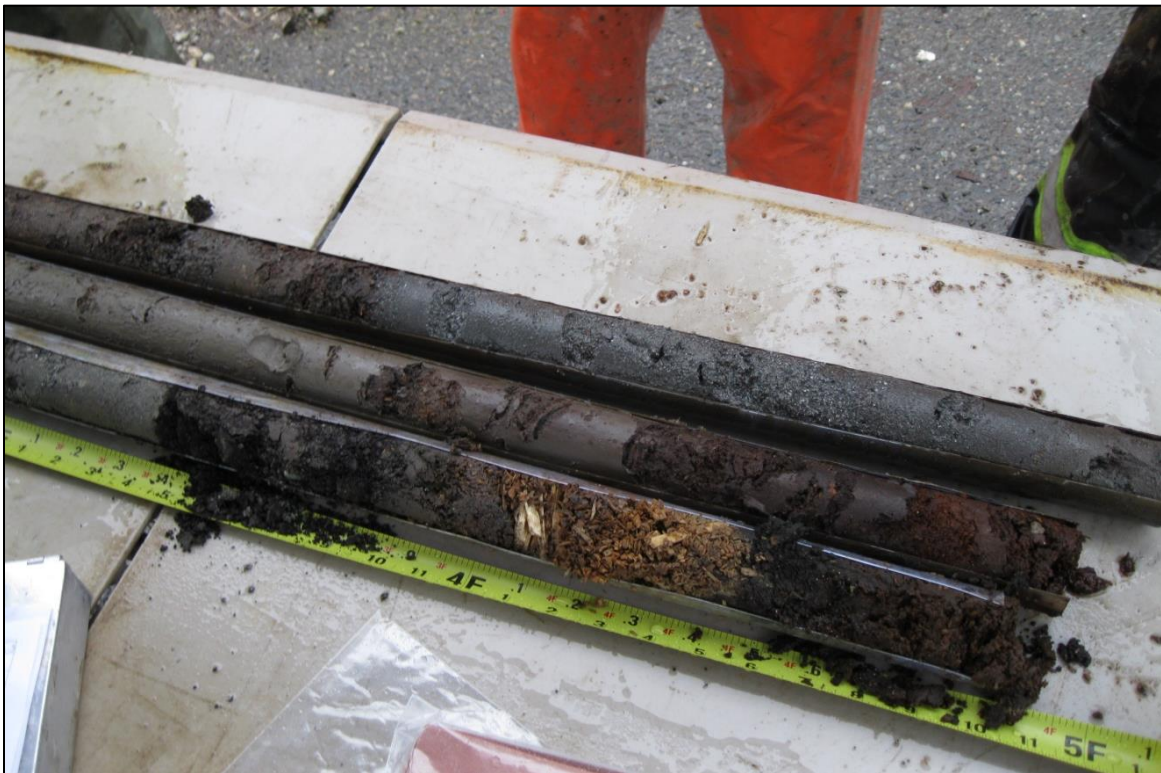
Figure 10. Photograph of sediments recovered within boring GM3; increasing depth left to right, bottom to top.

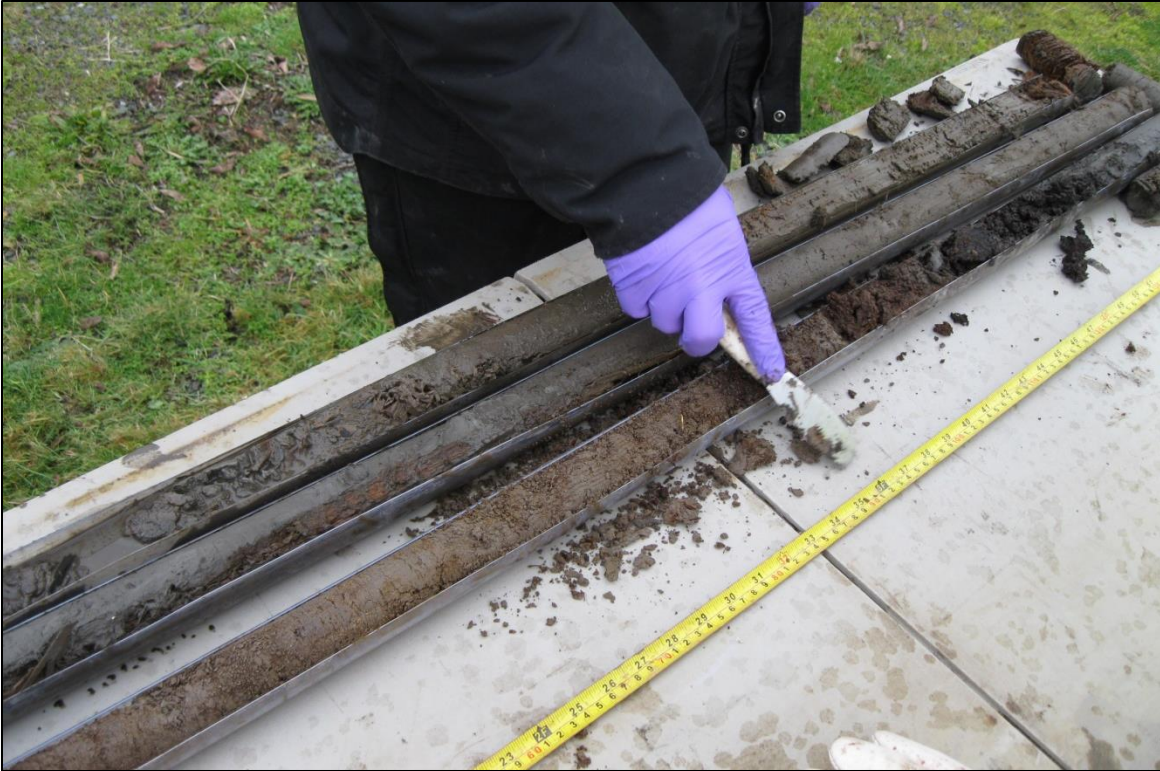
Figure 11. Photograph of sediments recovered within boring GM6; increasing depth left to right, bottom to top.

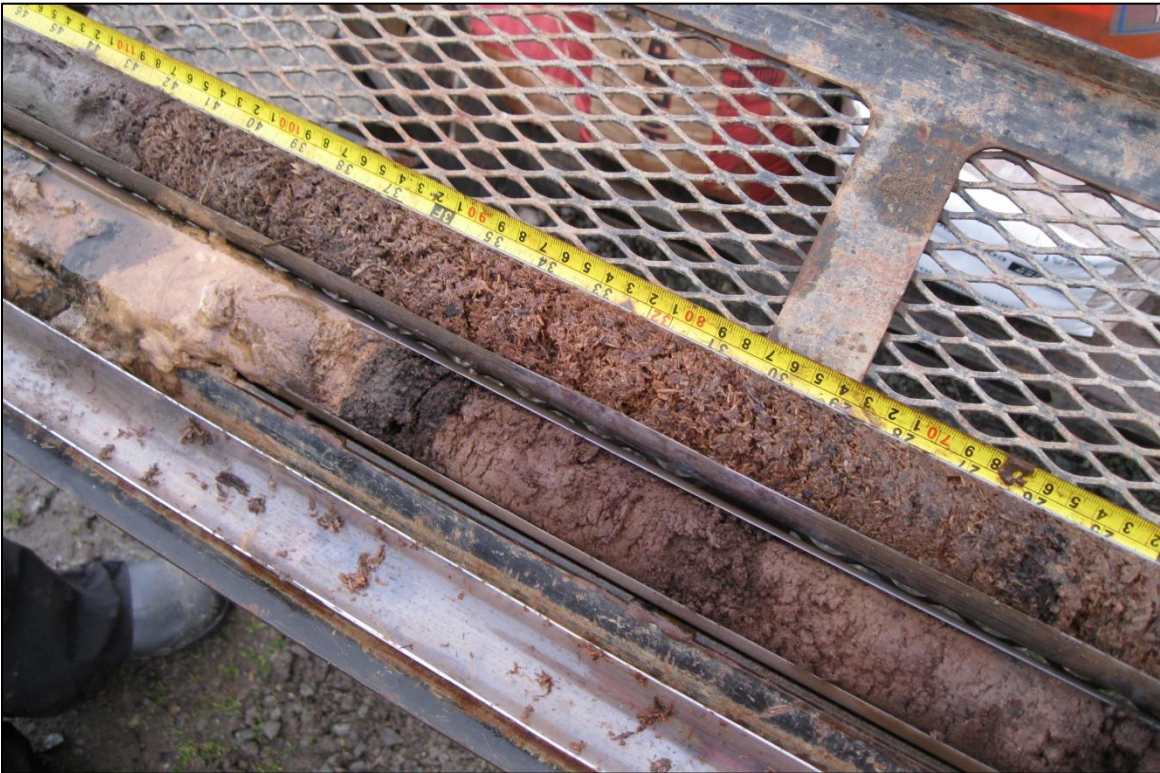
Figure 12. Photograph of sediments recovered within boring GM8 illustrating dominant woodchip/sawdust stratum encountered from 5-8 ft. (1.5-2.4 m) below surface.

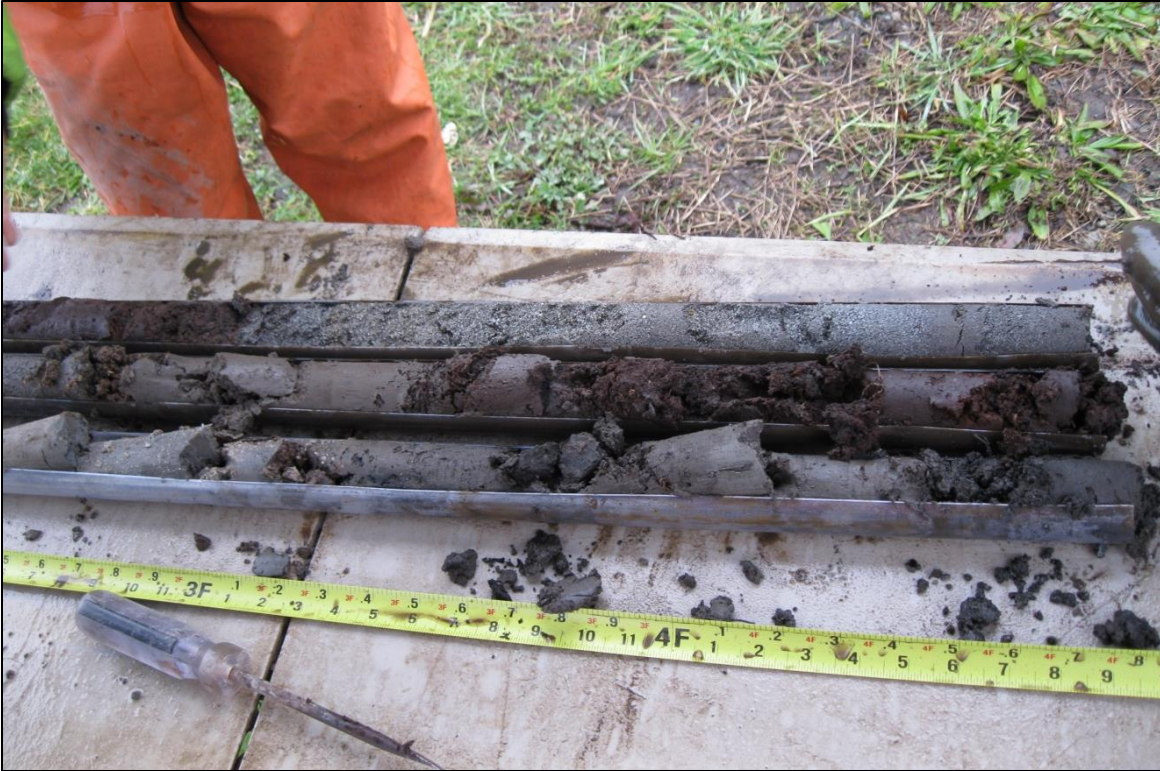
Figure 13. Photograph of sediments recovered within boring GM10; increasing depth left to right, bottom to top.

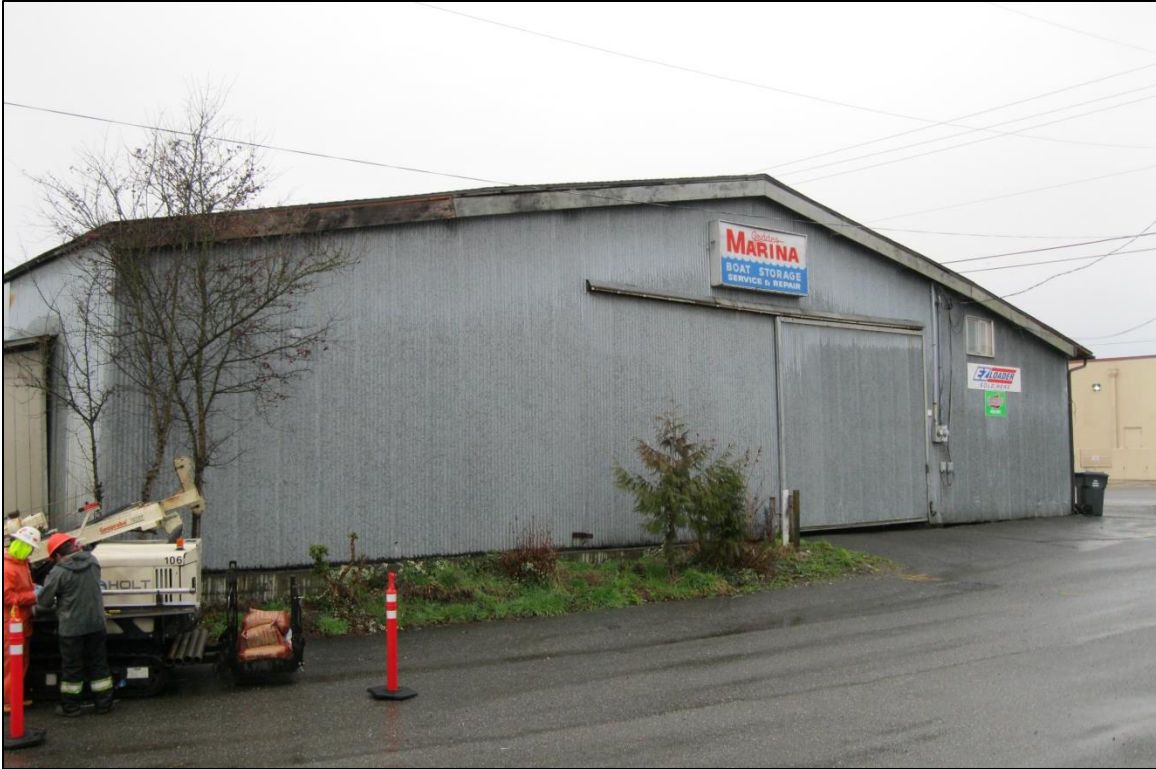
The 8000 square foot rectangular commercial building measures 100 ft. east to west and 80 ft. north to south. The south end of the building has an interior 2000 square foot loft. The siding is corrugated metal on all sides except the north, which is vertical plywood board and batten. The roof is low gable with asphalt shingles with a cornice wood fascia trim. The foundation is poured concrete at the eastern end and main portion of the building, with the southwest end being supported by marine pilings. All features of the building appear to be original, but changes to the building since 1965 are unknown (Figures 14 and 15).

Figure 14. Overview photograph of the east end of the Geddes Marine Service building.

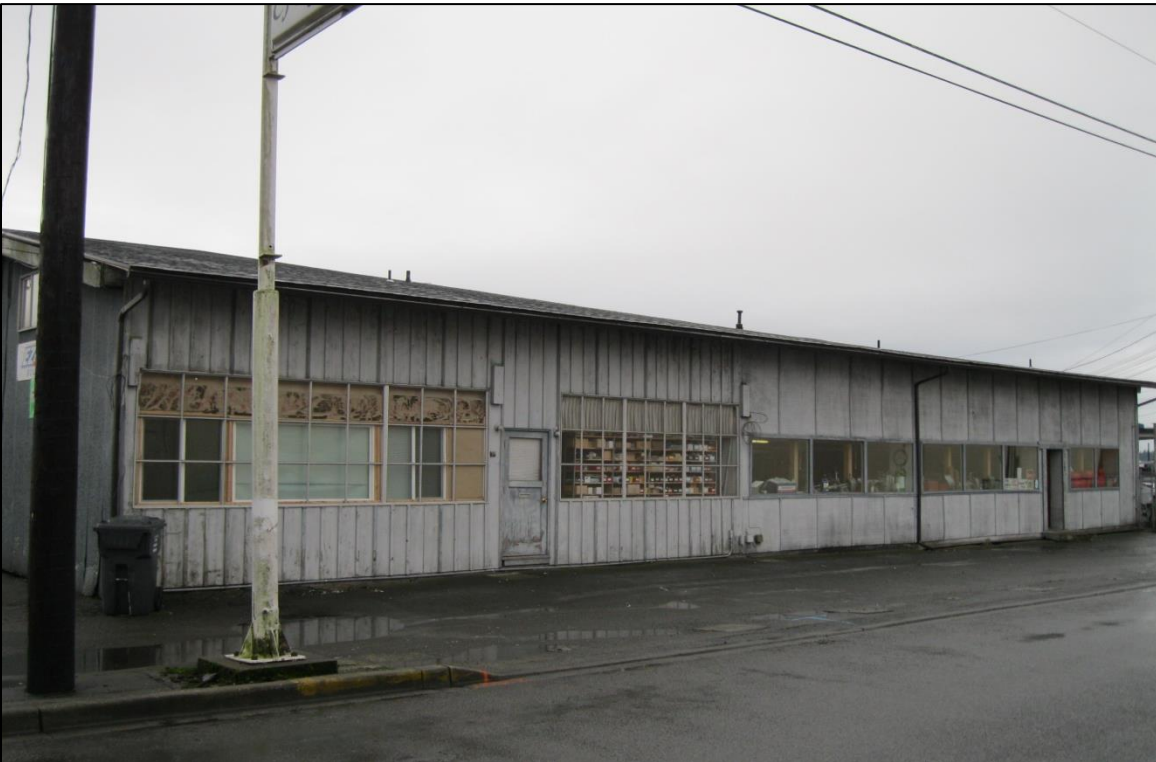
Figure 15. Overview photograph of the north side of the Geddes Marine Service building.

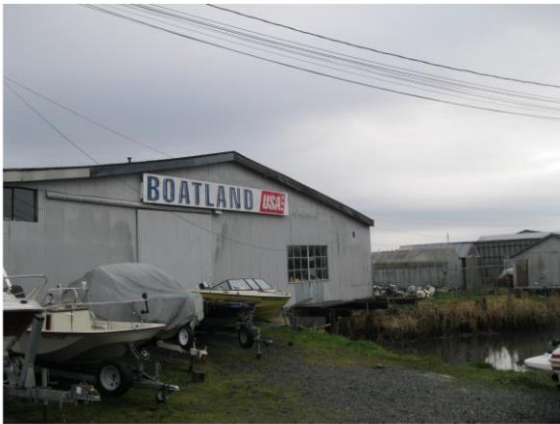
Southwest corner of building supported by pilings
2015
