**Cultural Resources Assessment for the
Geddes Marina Phase 2 Remediation Project,
Marysville, Snohomish County, Washington**

Prepared by
Robert Kopperl, Ph.D.

April 7, 2022

WillametteCRA Report No. 22-7
Seattle, Washington

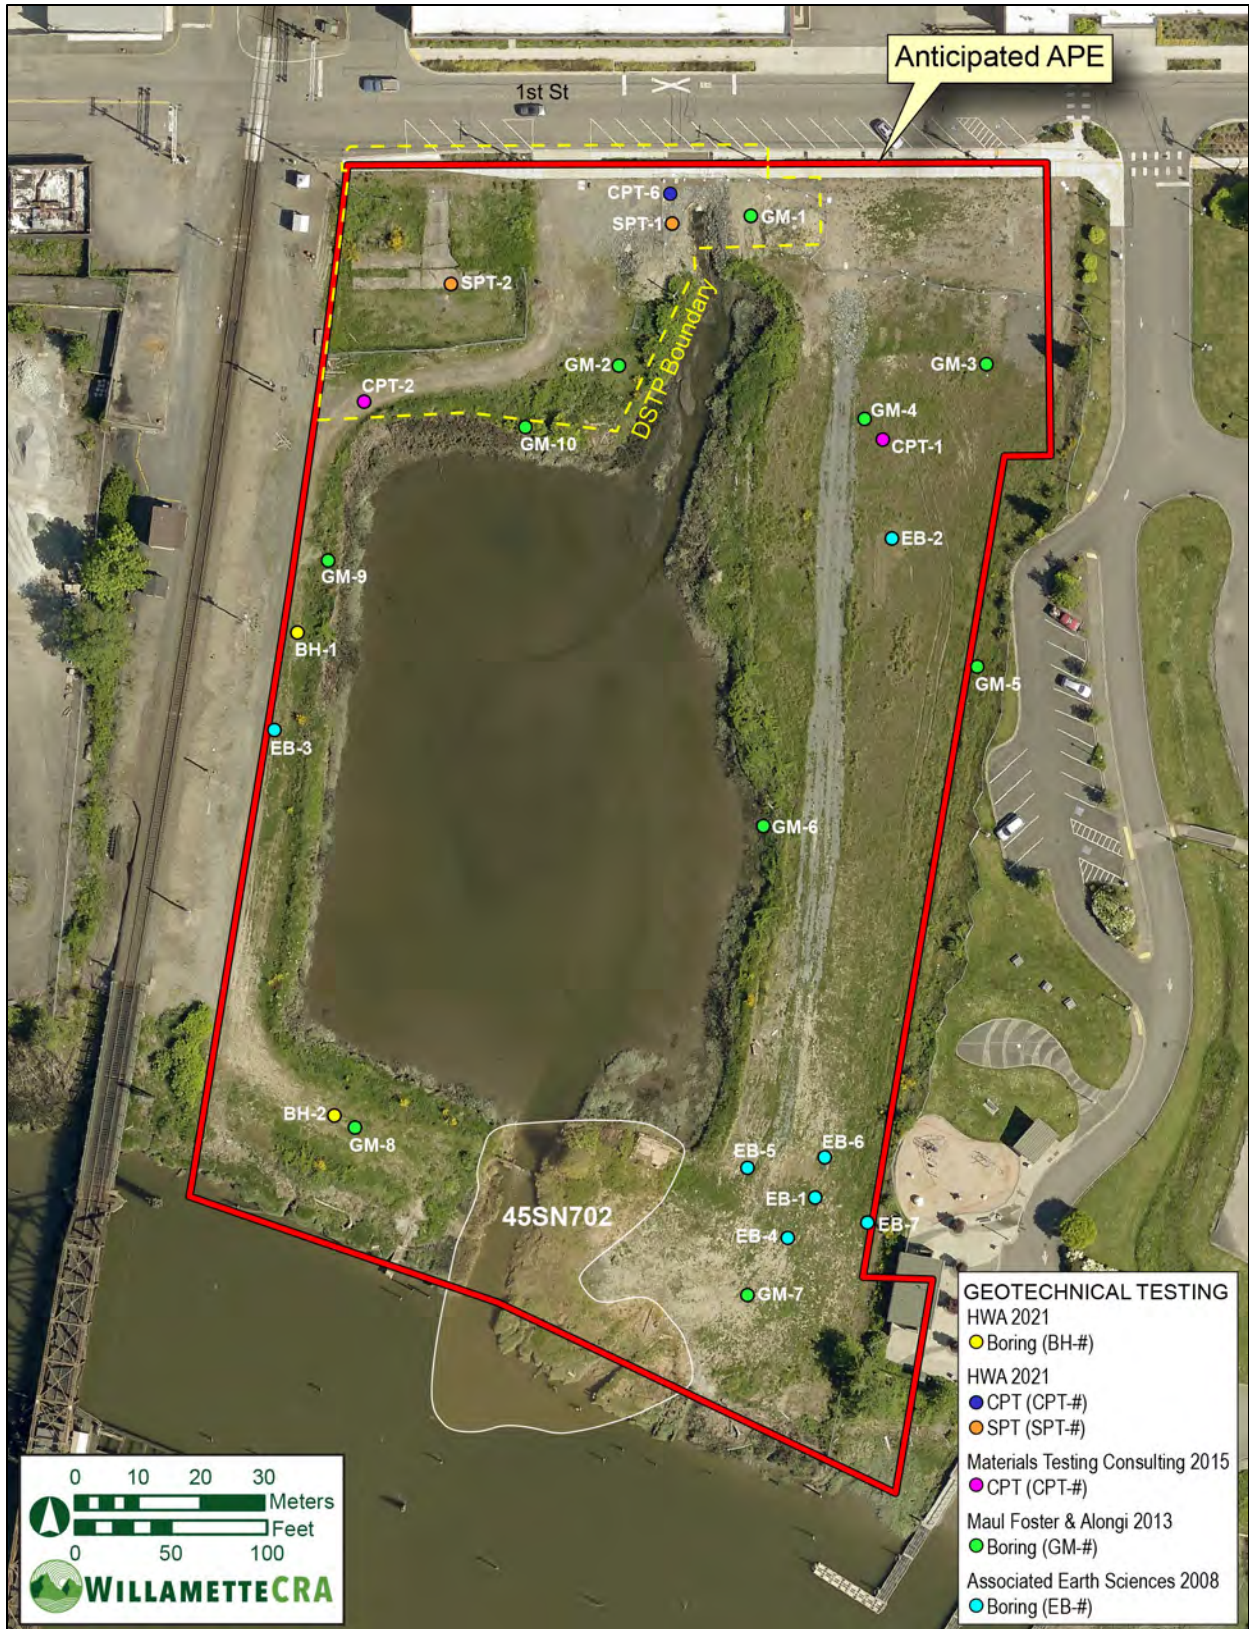
Figure 12. Aerial with APE, geotechnical borehole locations, and 45SN702 site boundary.

Site 45SN702 is composed of several surface features associated with the Geddes Marina, which operated at this location between the 1930s and 2010. The remains of other marina-related features surrounding the boat basin are visible on aerial photographs as recent as a few years old; However, they have been thoroughly removed as part of the remediation project. As noted above, the ramp, pier, and boathouse features extending south from the waterfront that were present up until recent years are a transitory, with materials and configurations that have changed over the past several decades. The features recorded as 45SN702 appear on an historic aerial photograph from 1961 that confirms their age and association with the marina going back at least 50 years. The boundary of the site encompasses these features, shown in Figure 12 above.

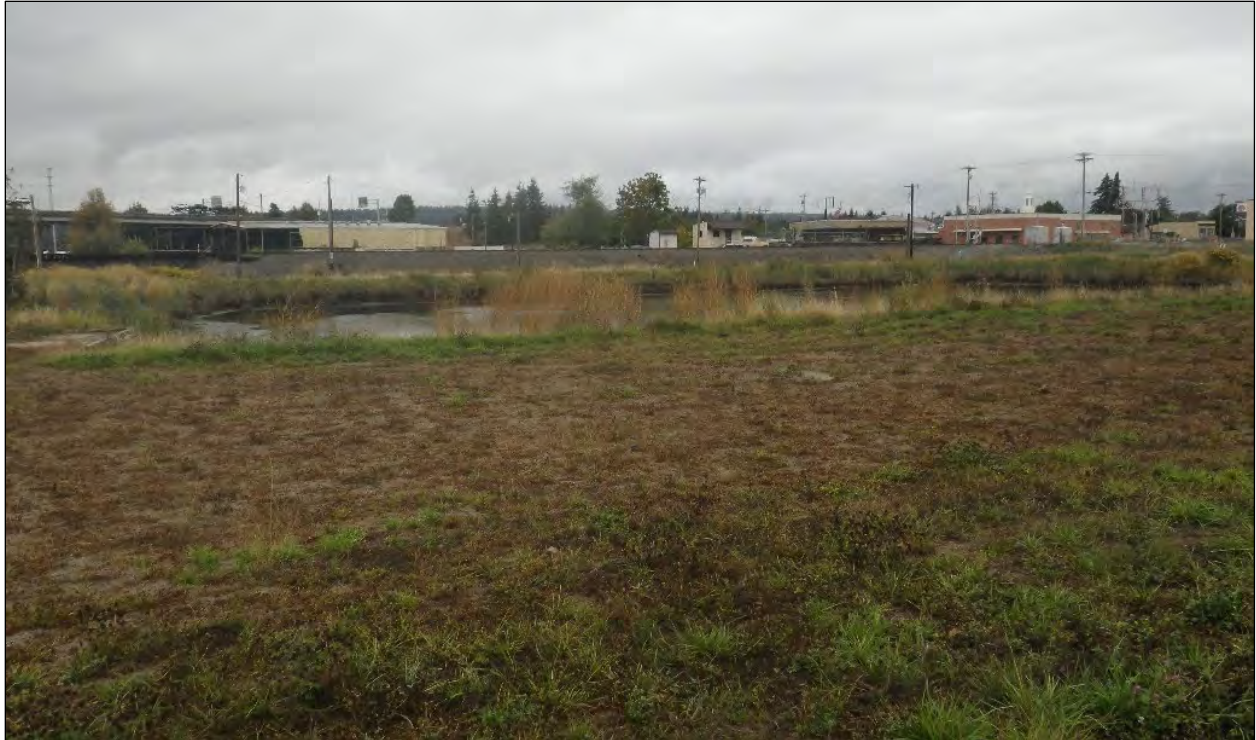
Figure 13. Overview of former marina property; boat basin in background. View to the west-northwest from the east edge of the marina property.

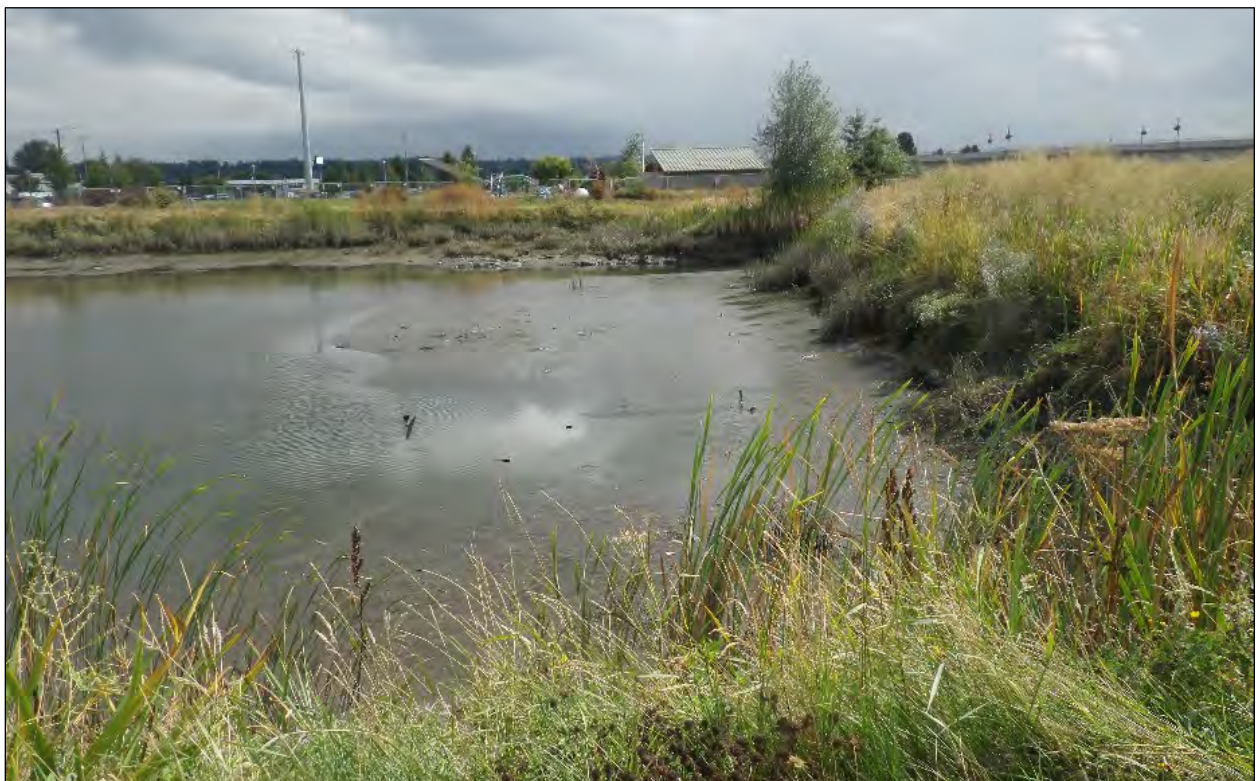
Figure 14. Overview of southern end of boat basin in former marina property, with existing park in background. View to the east from the southwest corner of the boat basin.

Pedestrian survey of the current APE (western half of the 2018 project survey area) involved parallel transects spaced about 5 meters apart around the perimeter of the roughly rectangular boat basin. More closely spaced transects covered the southern portion of the property and along the waterfront where some remnants of the former marina were observed and documented (see below). Most of the property has recently been capped with additional imported fill, hosting sparse vegetation except near the edge of the boat basin (Figure 13). The boat basin itself appears to have mostly been cleared of debris and any features of the former marina operation that are visible in historic aerial photographs, partially exposing at low tide a mudflat and very sparse non-diagnostic debris such as dimensional lumber (Figure 14 and Cover Photo).

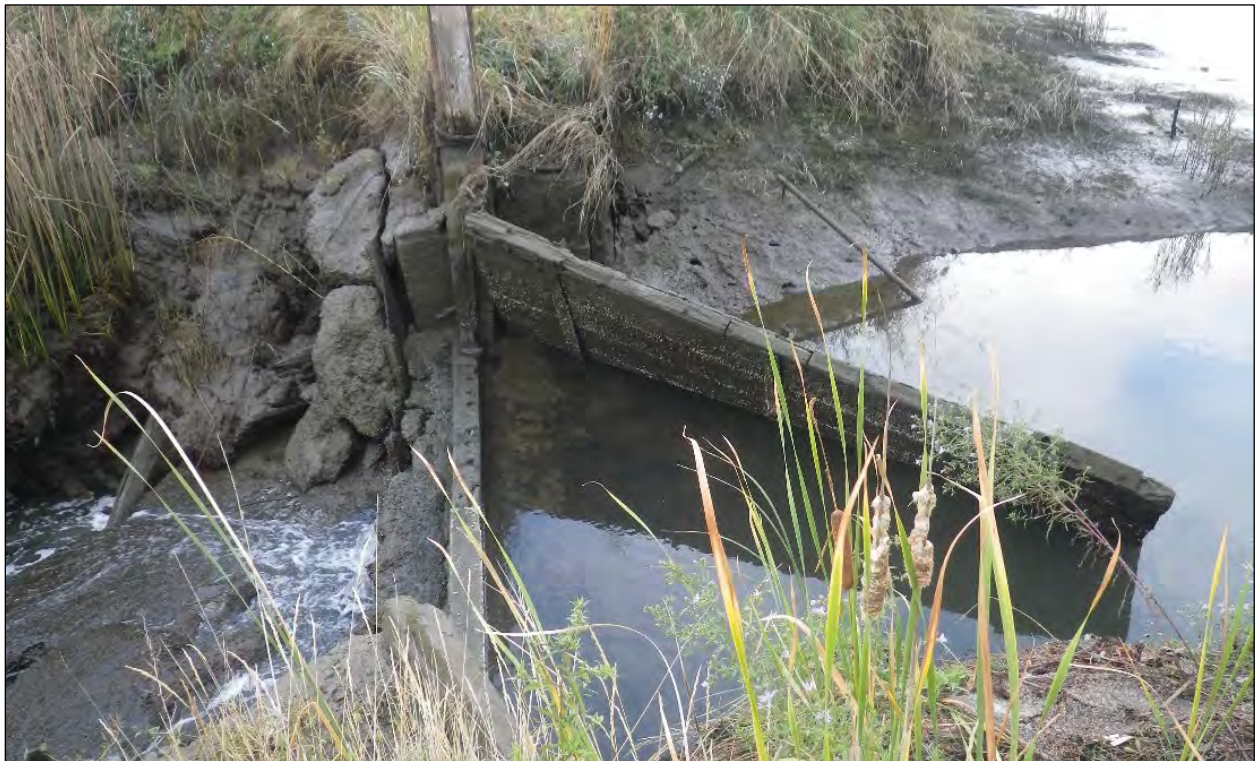
Figure 15. Weir feature. View to the west from the east side of inlet.

immediately south of the weir into the inlet. Between about 30 and 45 feet south of the weir within the inlet are four wood pilings, between about 1- to 1½-foot diameter in a roughly square arrangement (Figure 16). This weir, or at least a similar feature at the same location, is shown on aerial photographs as early as 1961, and some kind of barrier would presumably have been in place when the boat basin was created for the marina.

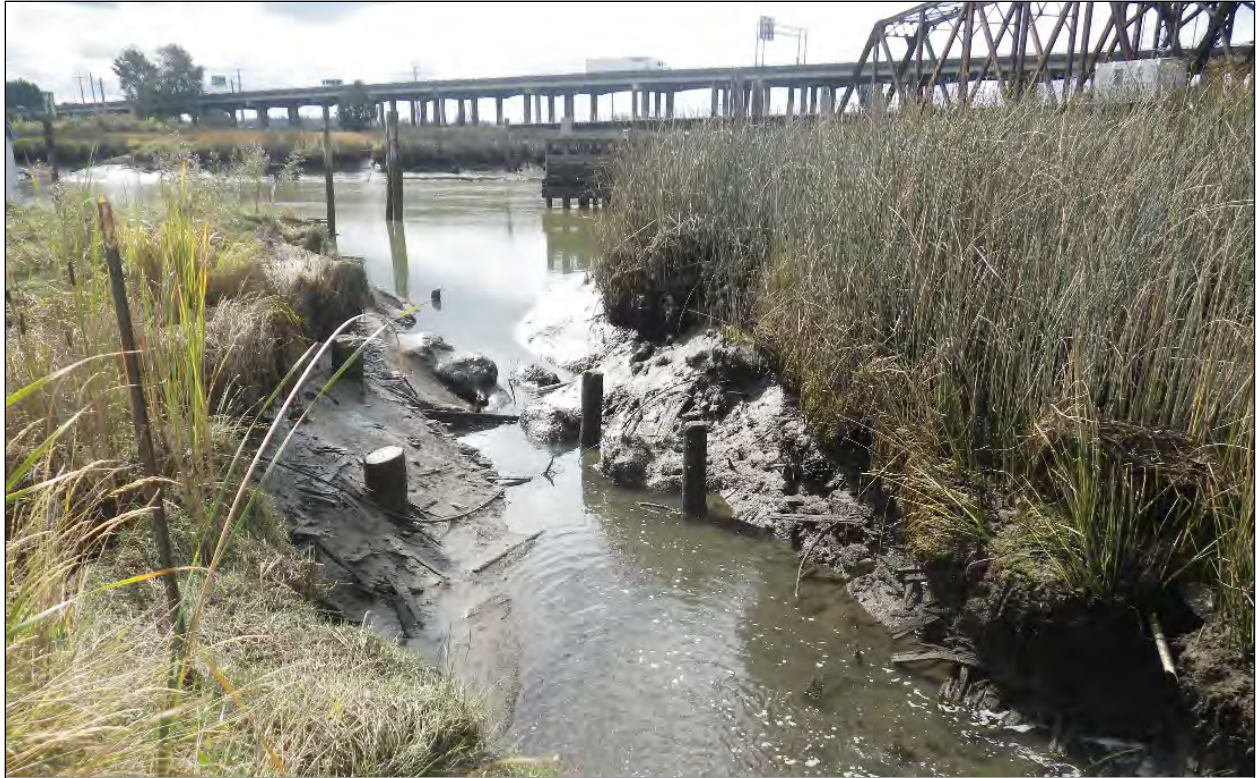
Figure 16. Piling configuration within inlet channel. View to the south from the east side of weir.

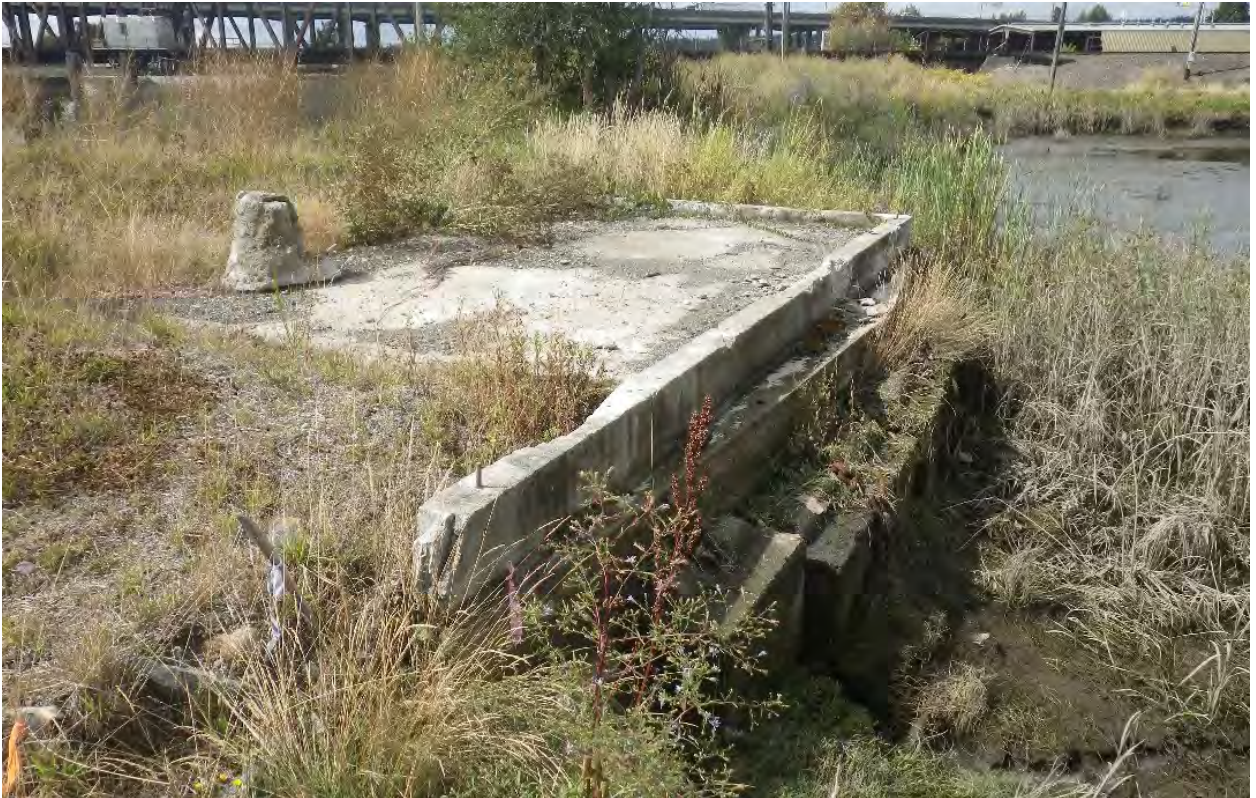
Figure 17. Concrete pad on east side of inlet. Site datum tree in background. View to the west.

A rectangular concrete pad was observed approximately 50 feet east of the weir, and 30 feet east of a deciduous tree that served as the site datum, above the southeast corner of the I boat basin. It is approximately 20 feet long northwest-southeast, and 12 feet long northeast-southwest (Figure 17). A roughly 3-inch tall, 6-inch wide rebar-reinforced lip is on the northwest and northeast sides of the pad and extends several feet to the southeast along the northeast side of the foundation. That side is visible in the embankment above the boat basin (about 4 feet in elevation below the surface of the pad) reinforced with several concrete slabs and wooden planks. A round concrete fragment, possibly a post foundation, had been placed on the south corner of the pad. A larger building is shown in this location on aerial photographs from 1961 onward; this may be the only structural component of the building left following demolition and removal of the marina facilities.

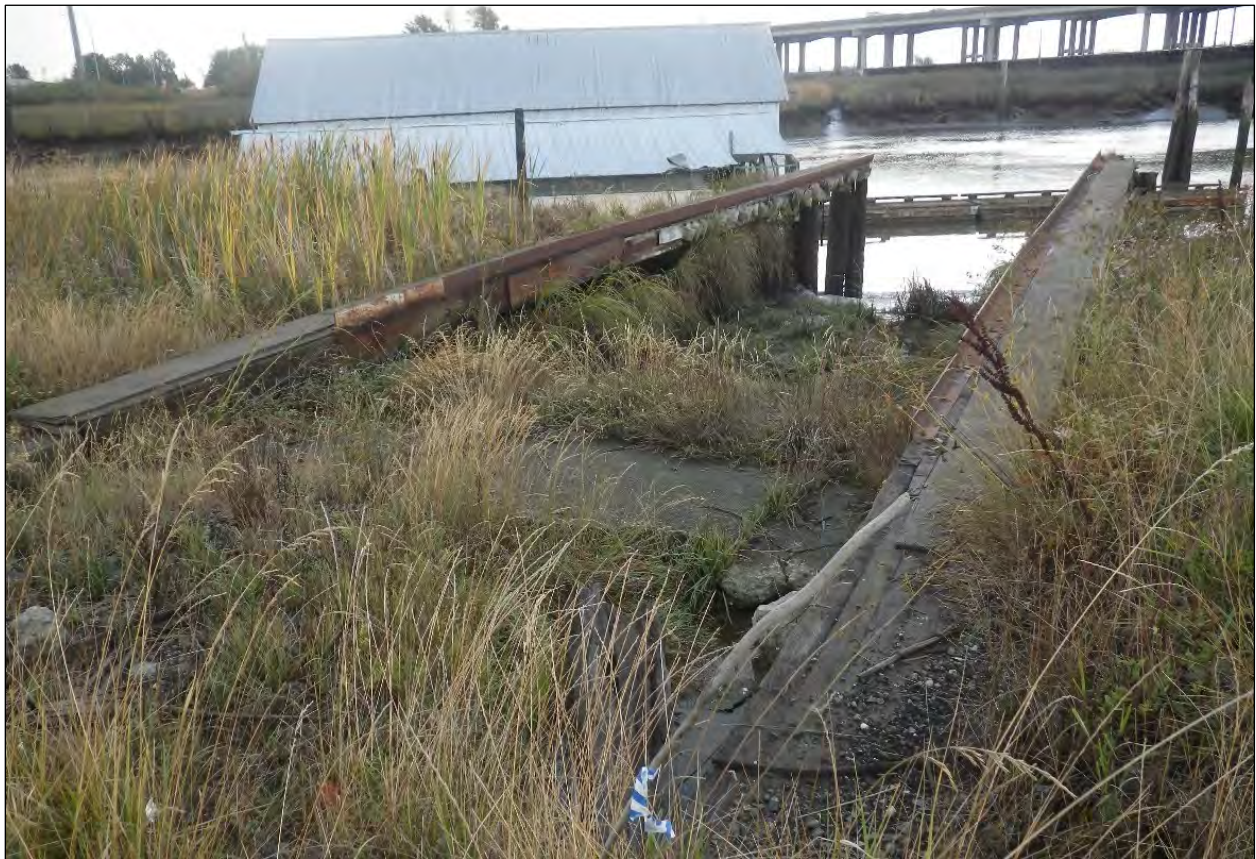
Figure 18. Boat Launch 1, extending over the Ebey Slough on pilings. View to the south.

Two boat launch features were observed on the east side of the inlet, descending from the surface overlooking the waterfront down towards the intertidal below. Both are visible on the 1961 aerial photograph, although little remains of either except the rails and concrete platforms near their inland ends. Boat Launch 1, as it is labeled on the sketch map, is composed of two rails that extend from a rectangular concrete platform out over the intertidal, both supported above the mudflat by several wooden pilings (Figure 18). The rails are about 60 feet long, spaced about 10 feet apart, and are made of metal-reinforced square wood beams. The inside of the rails at their southwest end, overhanging the intertidal, have relatively modern strips of canvas apparently used to secure cushions. Boat Launch 2, approximately 40 feet to the west and oriented slightly different, is generally constructed in a similar manner but several feet narrower between rails. In addition, Boat Launch 2 is in total approximately 100 feet long, with an extension of the rails continuing down to the intertidal with the southwest end submerged under water even at low tide (Figure 19). In addition, two wooden pilings were noted in the intertidal between the two boat launches, and two wooden pilings with a square wooden cross-beam were observed against the artificial embankment along the waterfront just east of Boat Launch 1 (Figure 20). The specific association between these pilings and the boat launches or other marina features is unknown and they are not discernable on historic aerial photographs, but they were recorded and included within the site boundary.

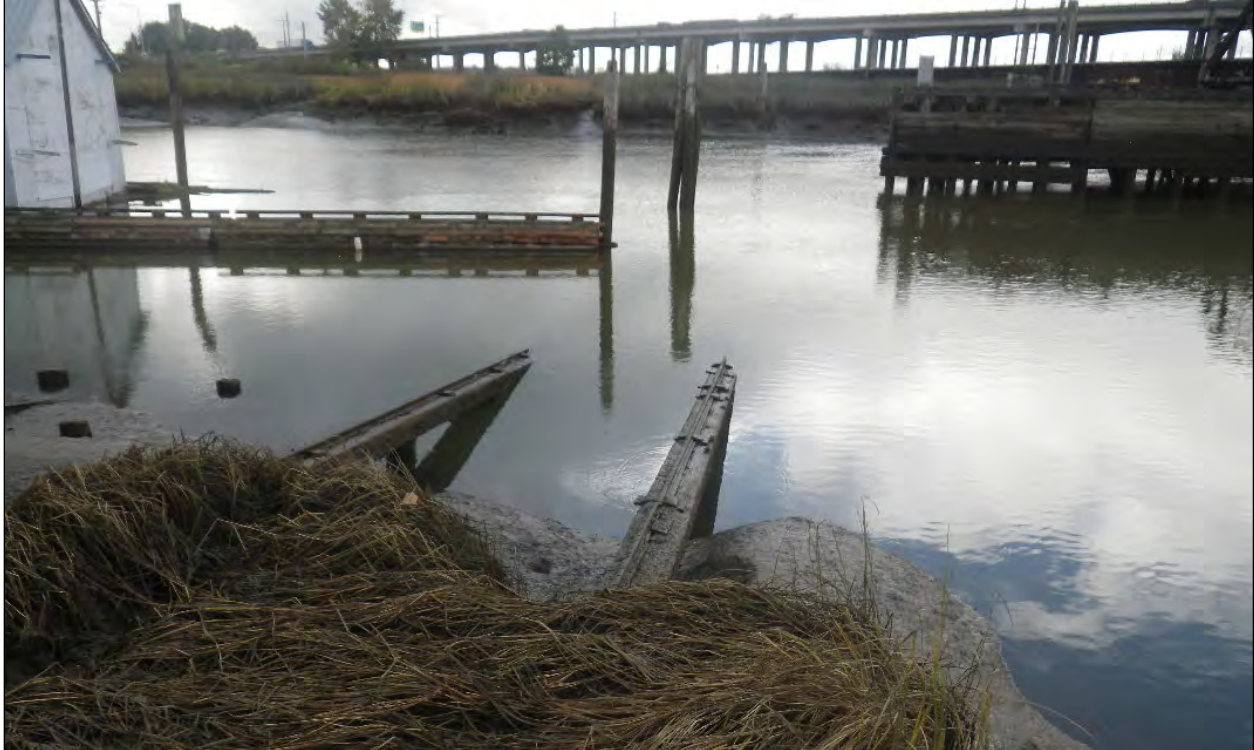
Figure 19. Southwest extension of Boat Launch 2, embedded in the Ebey Slough intertidal. View to the south.

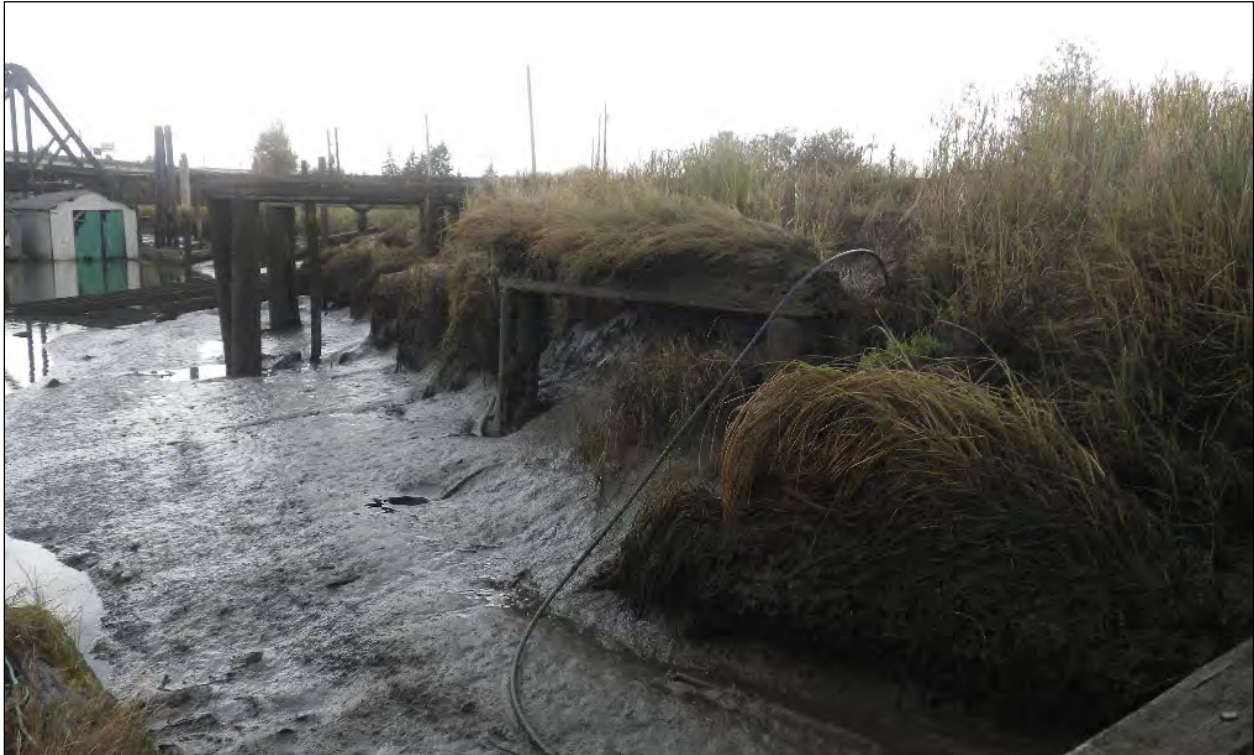
Figure 20. Two pilings and square cross-beam along embankment edge. Boat Launch 1 rails on pilings in background. View to the west-northwest.

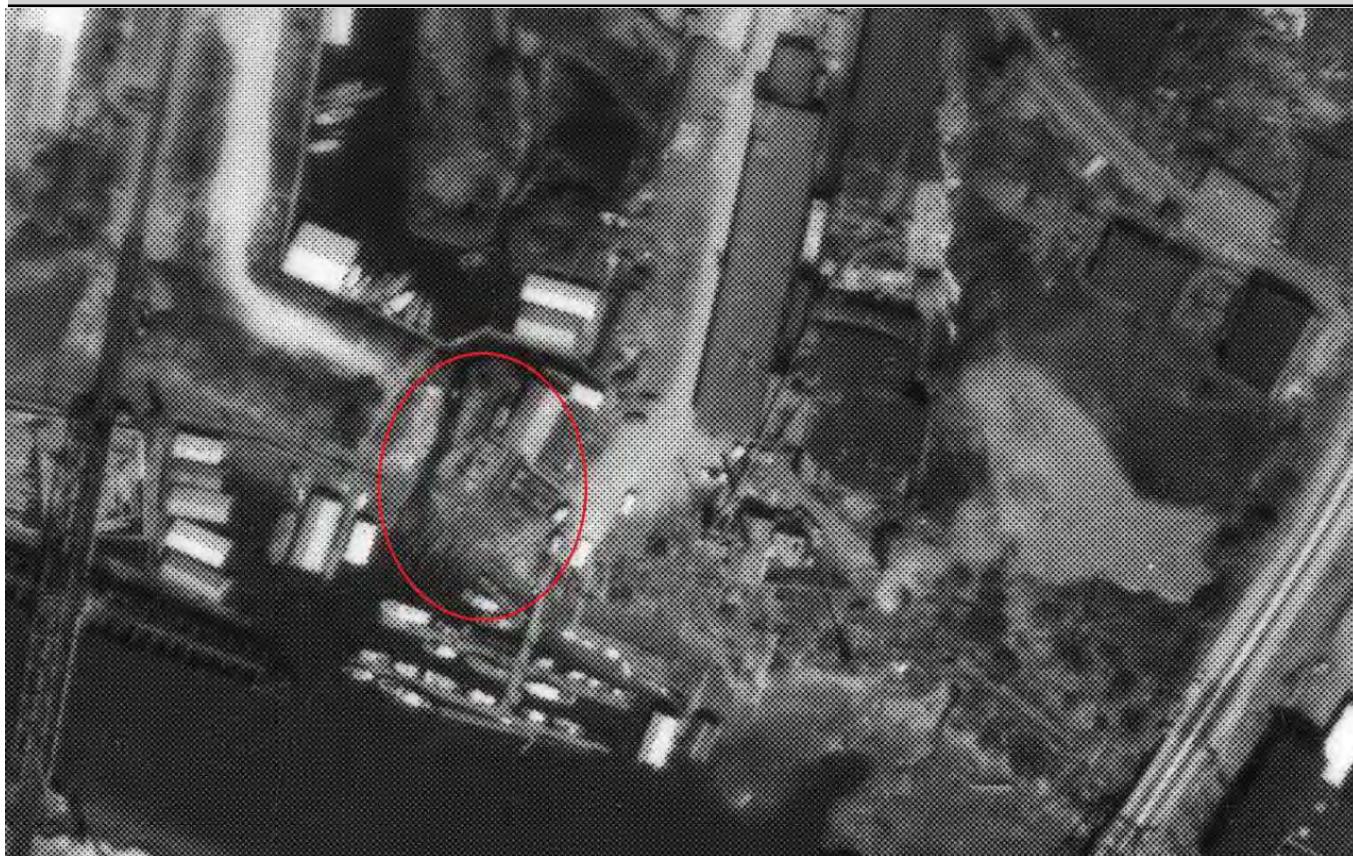
Photo ID 396873
Title 1961 Aerial
Year Taken 2018
Is Circa?
Notes Portion of 1961 aerial photograph (NW-61 A-94-11-35 8_11_61 1_400) showing vicinity of remnant historic marina features (red oval).
Type image/jpeg
Photo View
Source 9/17/2018 Inventory - Willamette Cultural Resources Associates, Ltd.
Copyright

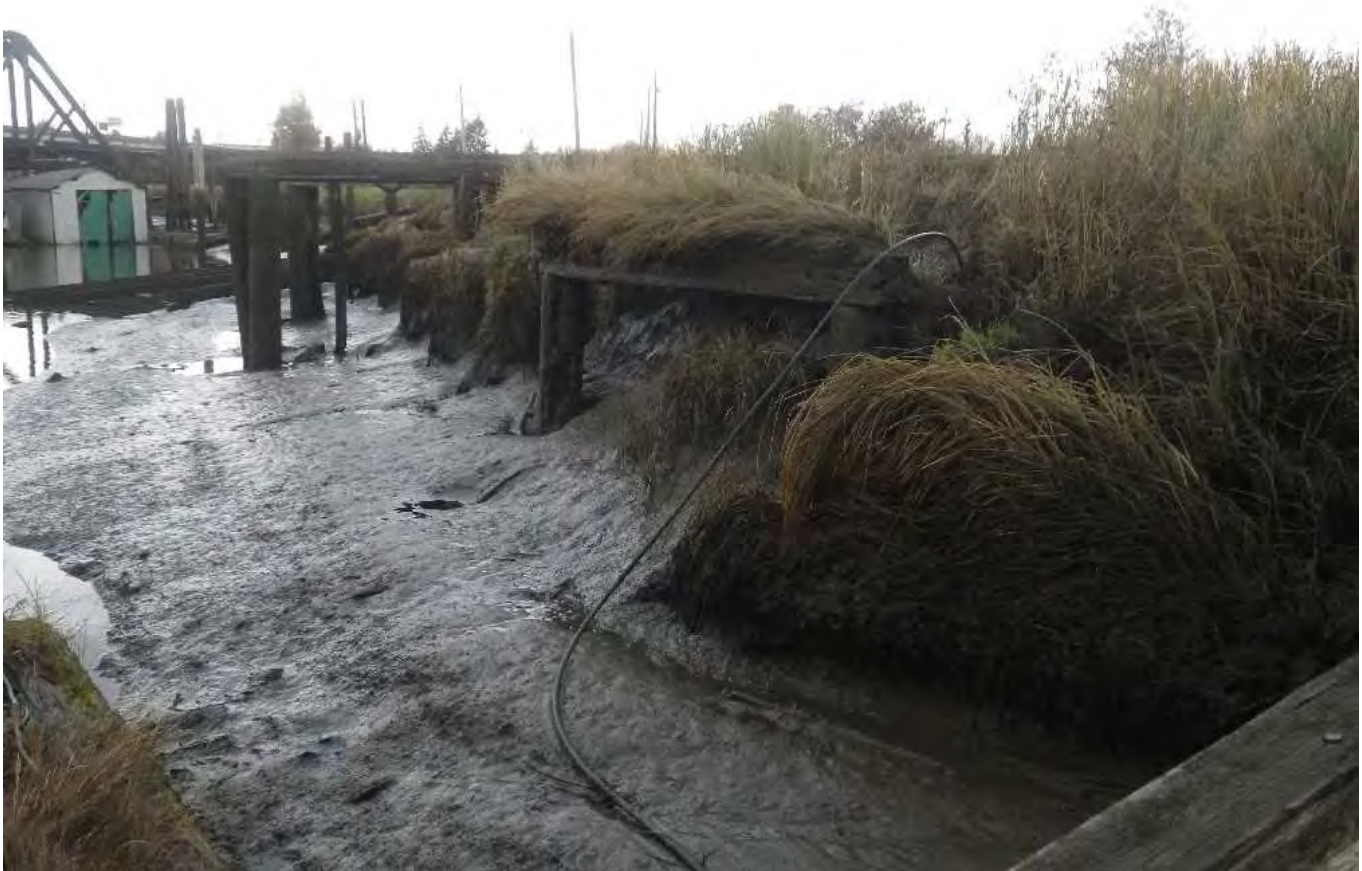
Photo ID 396855
Title Site Photo 6 More pilings
Year Taken 2018
Is Circa?
Notes Two pilings and square cross-beam along embankment edge. Boat Launch 1 rails on pilings in background. View to the west-northwest.
Type image/jpeg
Photo View
Source 9/17/2018 Inventory - Willamette Cultural Resources Associates, Ltd.
Copyright

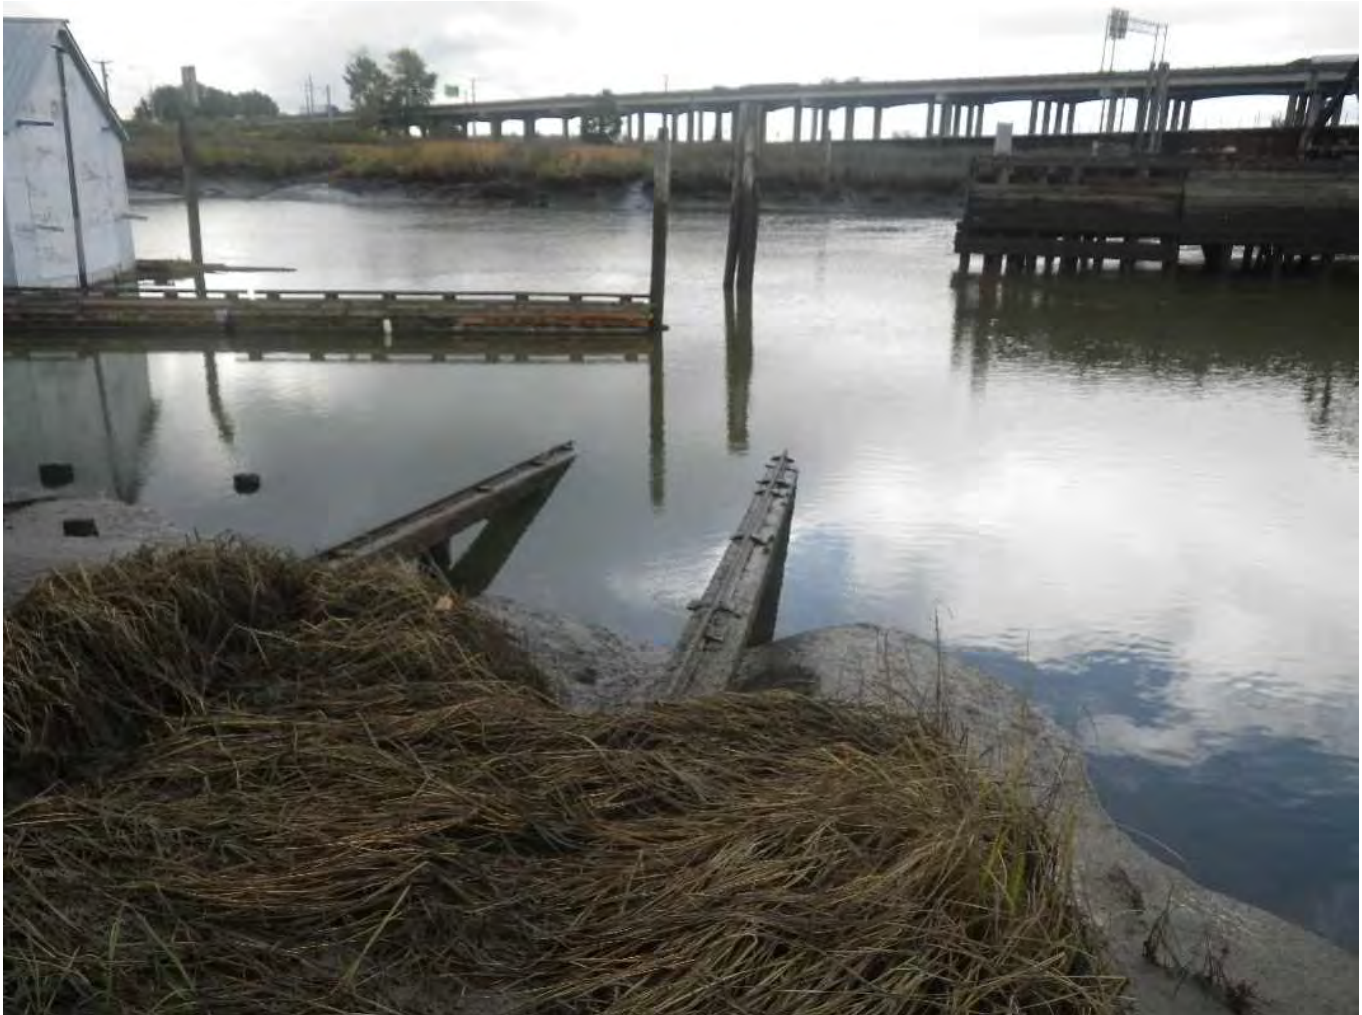
Photo ID 396854
Title Site Photo 5 Boat Launch 2
Year Taken 2018
Is Circa?
Notes Southwest extension of Boat Launch 2, embedded in the Ebey Slough intertidal. View to the south.
Type image/jpeg
Photo View
Source 9/17/2018 Inventory - Willamette Cultural Resources Associates, Ltd.
Copyright

feet to the west and oriented slightly different, is generally constructed in a similar manner but several feet narrower between rails. In addition, Boat Launch 2 is in total approximately 100 feet long, with an extension of the rails continuing down to the intertidal with the southwest end submerged under water even at low tide. In addition, two wooden pilings were noted in the intertidal between the two boat launches, and two wooden pilings with a square wooden cross-beam were observed against the artificial embankment along the waterfront just east of Boat Launch 1. The specific association between these pilings and the boat launches or other marina features is unknown and they are not discernable on historic aerial photographs, but they were recorded and included within the site boundary.

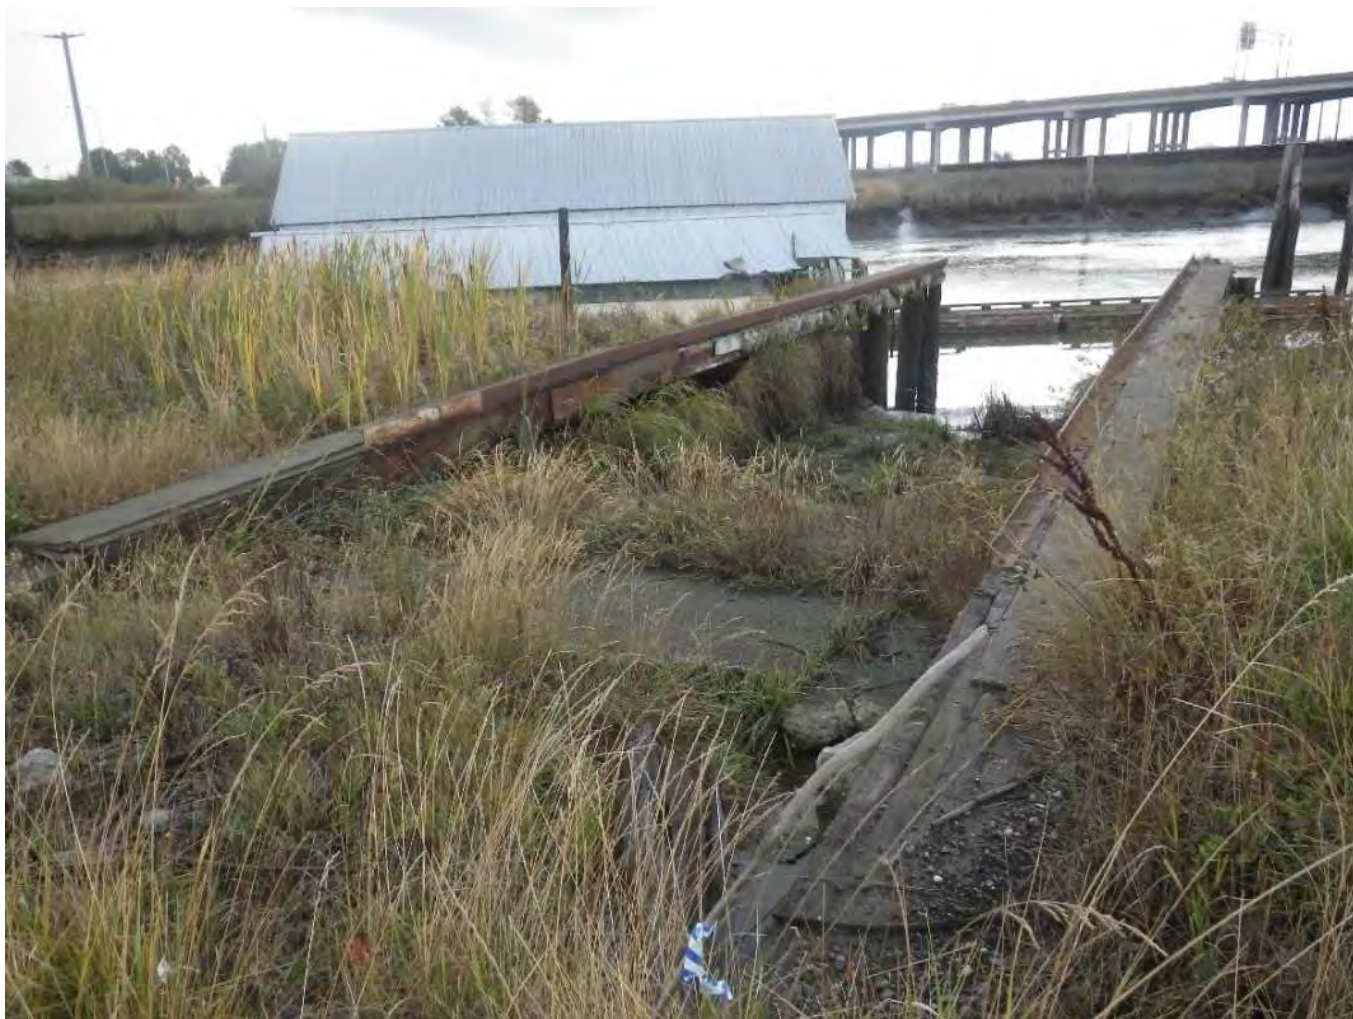
Photo ID 396853
Title Site Photo 4 Boat Launch 1
Year Taken 2018
Is Circa?
Notes Boat Launch 1, extending over the Ebey Slough intertidal on pilings. View to the south.
Type image/jpeg
Photo View
Source 9/17/2018 Inventory - Willamette Cultural Resources Associates, Ltd.
Copyright

Two boat launch features were observed on the east side of the inlet, descending from the surface overlooking the waterfront down towards the southwest to the intertidal below. Both are visible on the 1961 aerial photograph, although little remains of either except the rails and concrete platforms near their inland ends. Boat Launch 1, as it is labeled on the sketch map, is composed of two rails that extend from a rectangular concrete platform out over the intertidal, both supported above the mudflat by several wooden pilings. The rails are about 60 feet long, spaced about 10 feet apart, and are made of metal-reinforced square wood beams. The inside of the rails at their southwest end, overhanging the intertidal, have relatively modern strips of canvas apparently used to secure cushions. Boat Launch 2, approximately 40

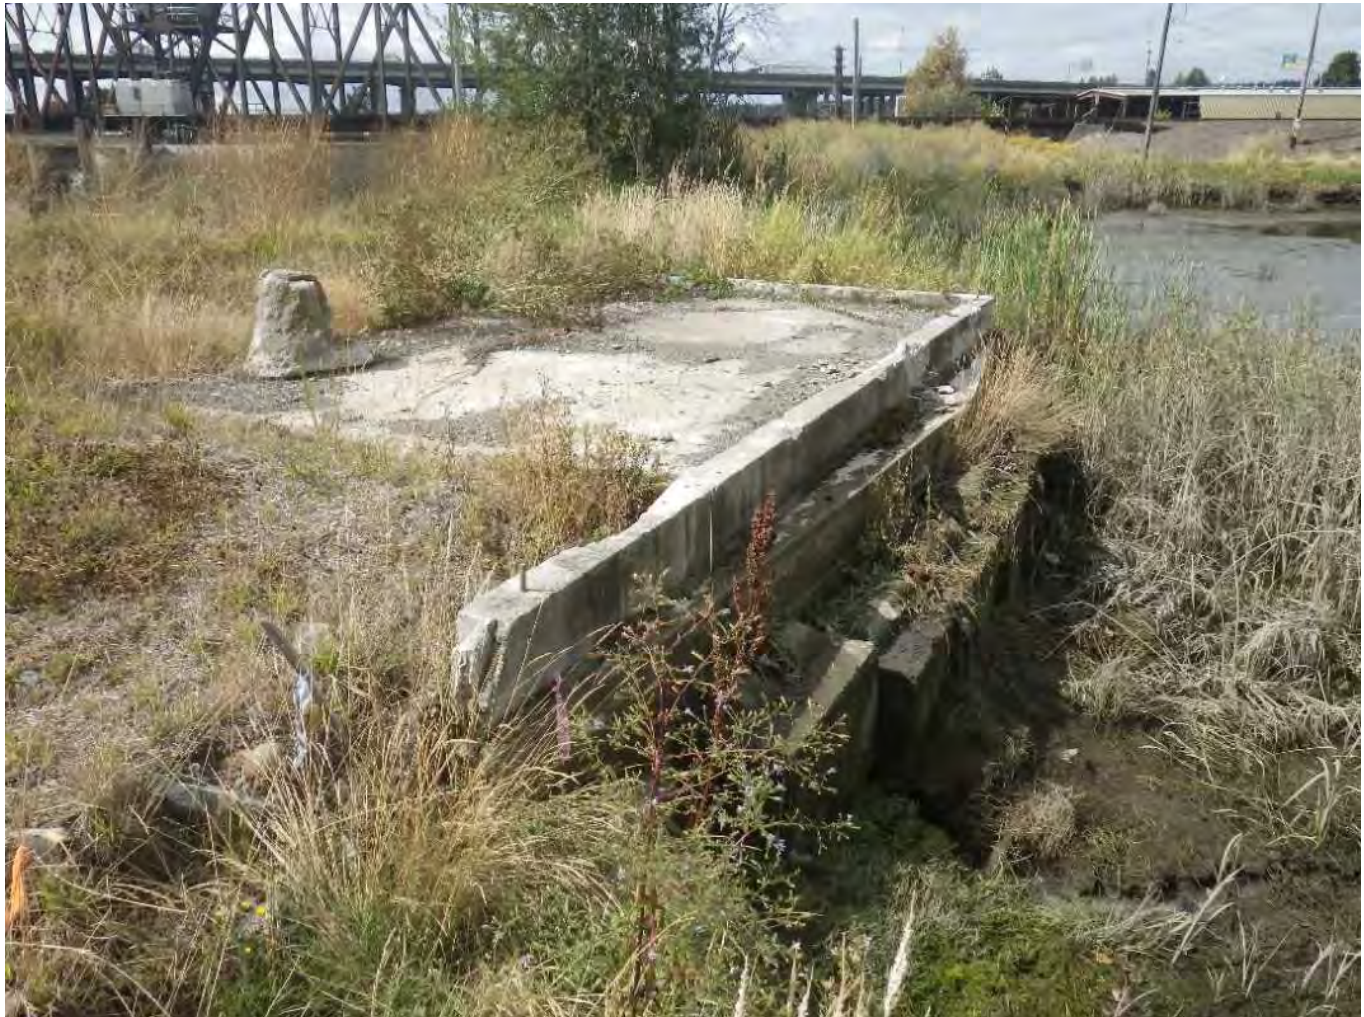
Photo ID 396852
Title Site Photo 3 Concrete Pad
Year Taken 2018
Is Circa?
Notes Concrete pad on east side of inlet and dam. Site datum tree in background. View to the west.
Type image/jpeg
Photo View
Source 9/17/2018 Inventory - Willamette Cultural Resources Associates, Ltd.
Copyright

A rectangular concrete pad was observed approximately 50 feet east of the dam, and 30 feet east of a deciduous tree that served as the site datum, above the southeast corner of the lagoon. It is approximately 20 feet long northwest-southeast, and 12 feet long northeast-southwest. A roughly 3-inch tall, 6-inch wide rebar-reinforced lip is on the northwest and northeast sides of the pad and extends several feet to the southeast along the northeast side of the foundation. That side is visible in the embankment above the lagoon (about 4 feet in elevation below the surface of the pad) reinforced with several concrete slabs and wooden planks. A round concrete fragment, possibly a post foundation, had been placed on the south corner of the pad. A larger building is shown in this location on aerial photographs from 1961 onward; this may be the only structural component of the building left following demolition and removal of the marina facilities.

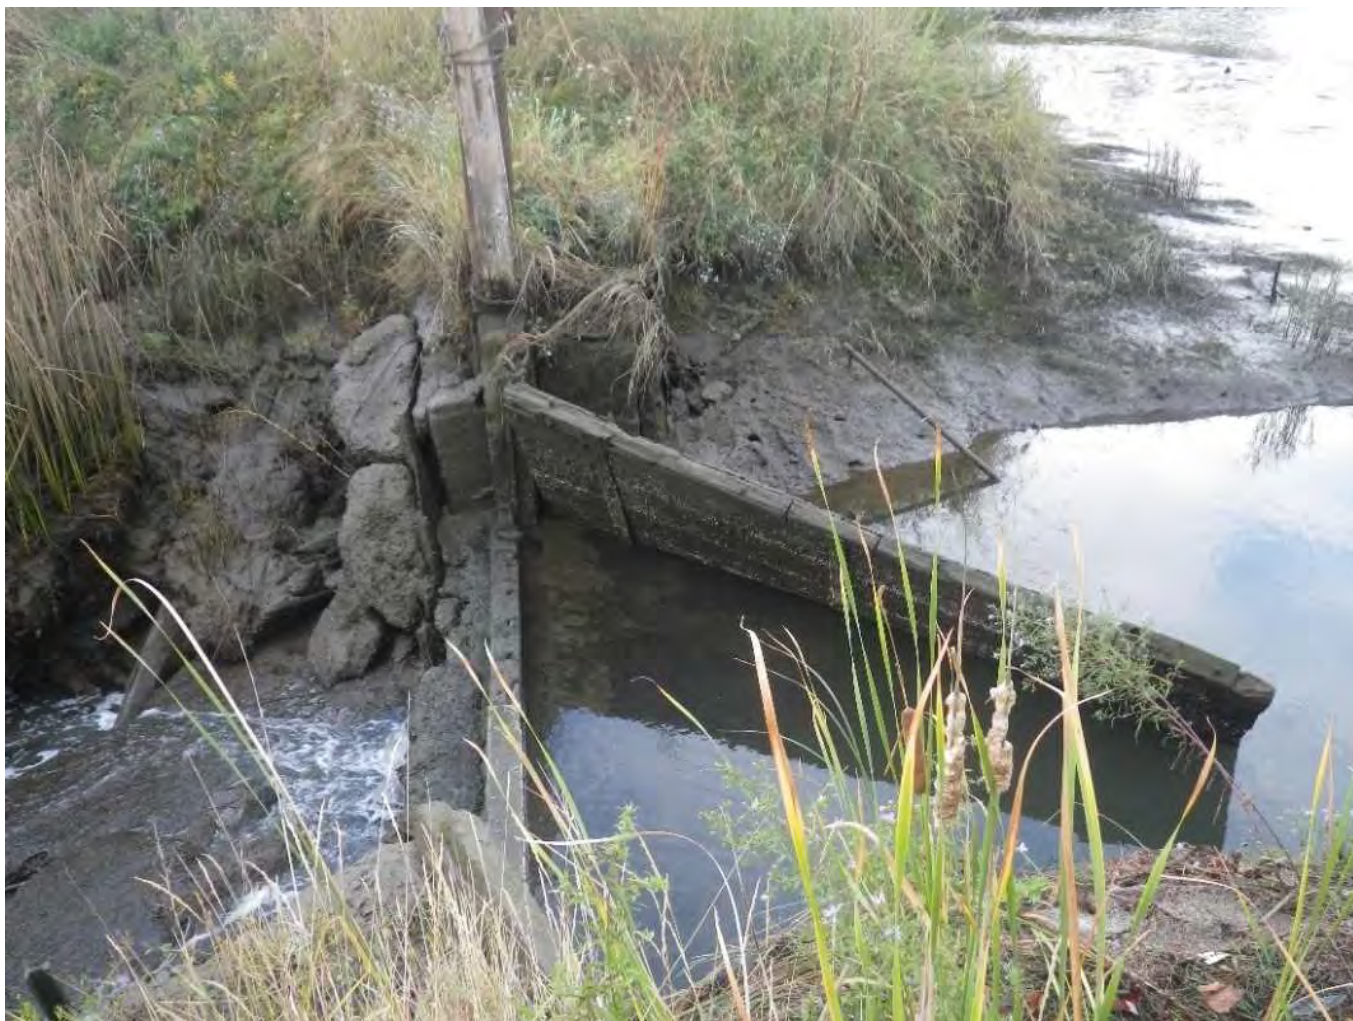
Photo ID 396850
Title Site Photo 1 Dam
Year Taken 2018
Is Circa?
Notes Dam feature. View to the west from the east side of inlet.
Type image/jpeg
Photo View West
Source 9/17/2018 Inventory - Willamette Cultural Resources Associates, Ltd.
Copyright

The historic features recorded as part of the archaeological site include a small dam structure and several pilings within the lagoon inlet, a small rectangular concrete pad that served as a foundation for a larger structure no longer present, two boat-launch features that extend south into the intertidal, and a few piling features also in the intertidal nearby.
