FINAL FOCUSED SITE ASSESSMENT WORK PLAN

FORMER GEDDES MARINA PROPERTY
MARYSVILLE, WASHINGTON

Prepared for
CITY OF MARYSVILLE
MARYSVILLE, WASHINGTON
December 16, 2014
Project No. 0689.01.03

Prepared by
Maul Foster & Alongi, Inc.
1329 N State Street, Suite 301, Bellingham WA 98225

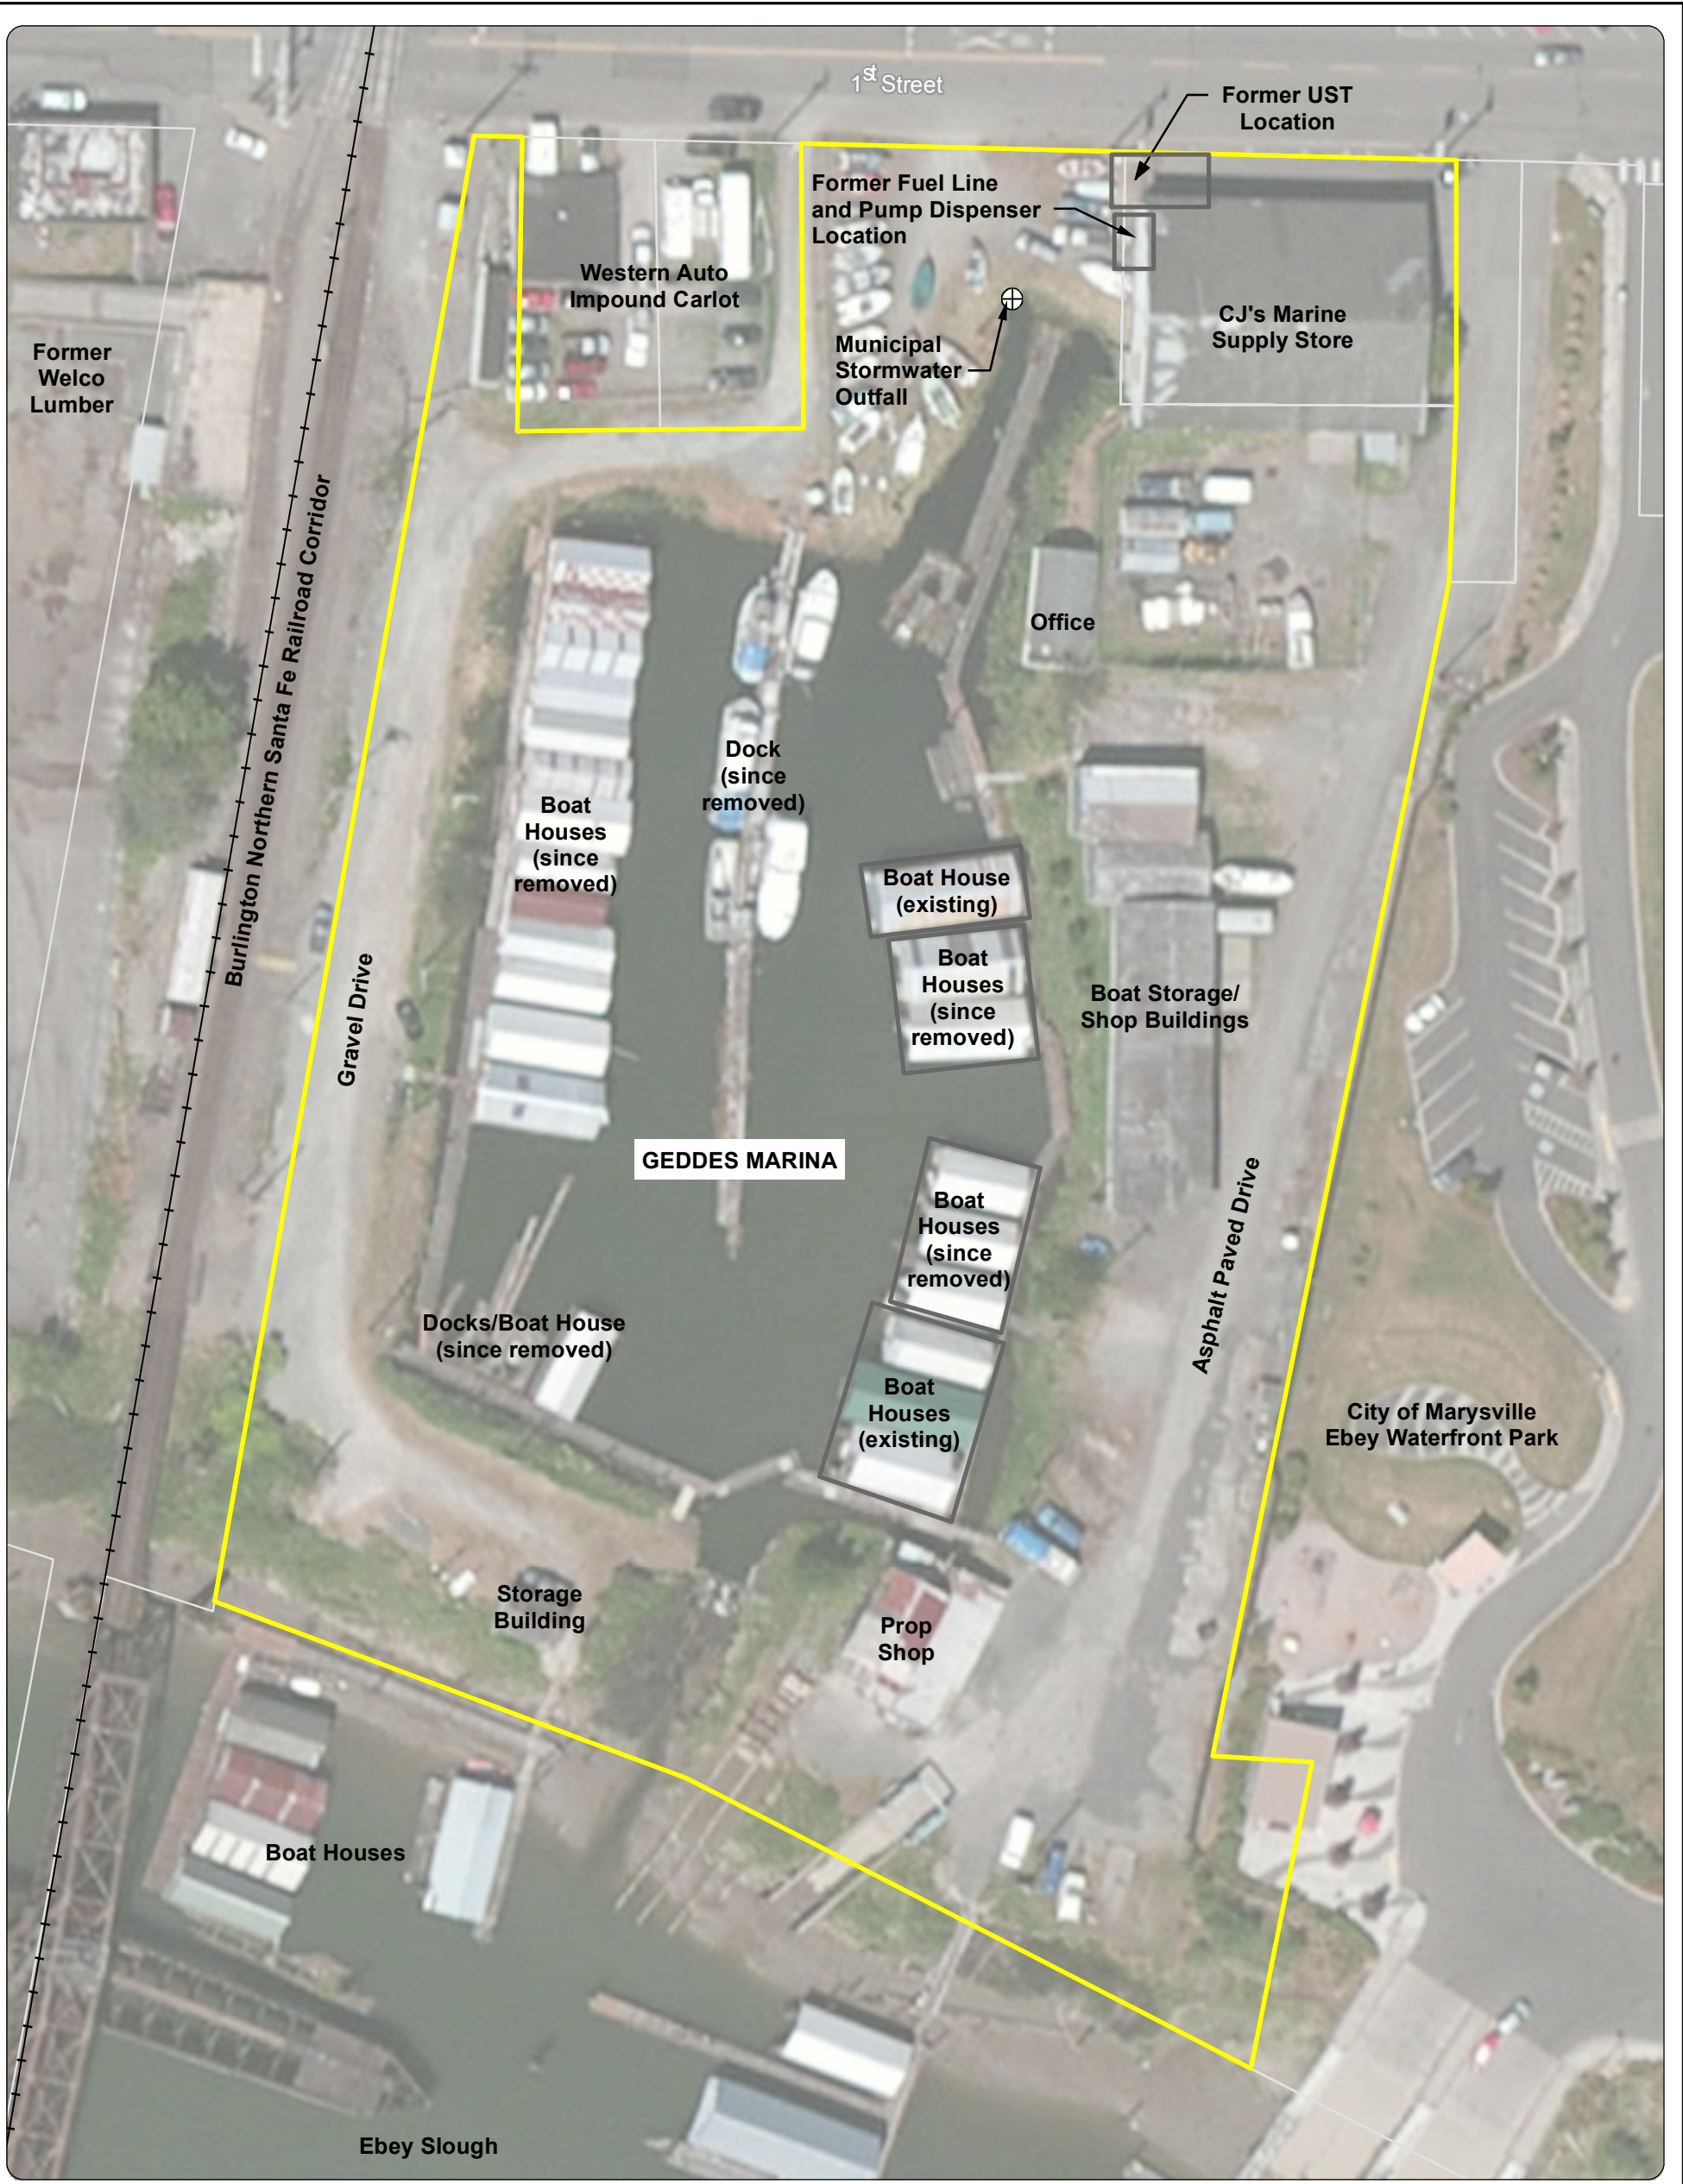
The Property currently contains several warehouses, upland and in-water boat shelters, marine repair facilities, and a marine supply store along the northeast and east boundaries of the lagoon (Figure 2). A boat launch and several in-water boat shelters are located along the southern edge of the Property in Ebey Slough. Minor vegetation is present around the lagoon and Ebey Slough, with partially paved surfaces and gravel dominating the ground surface along the boundaries of the Property.

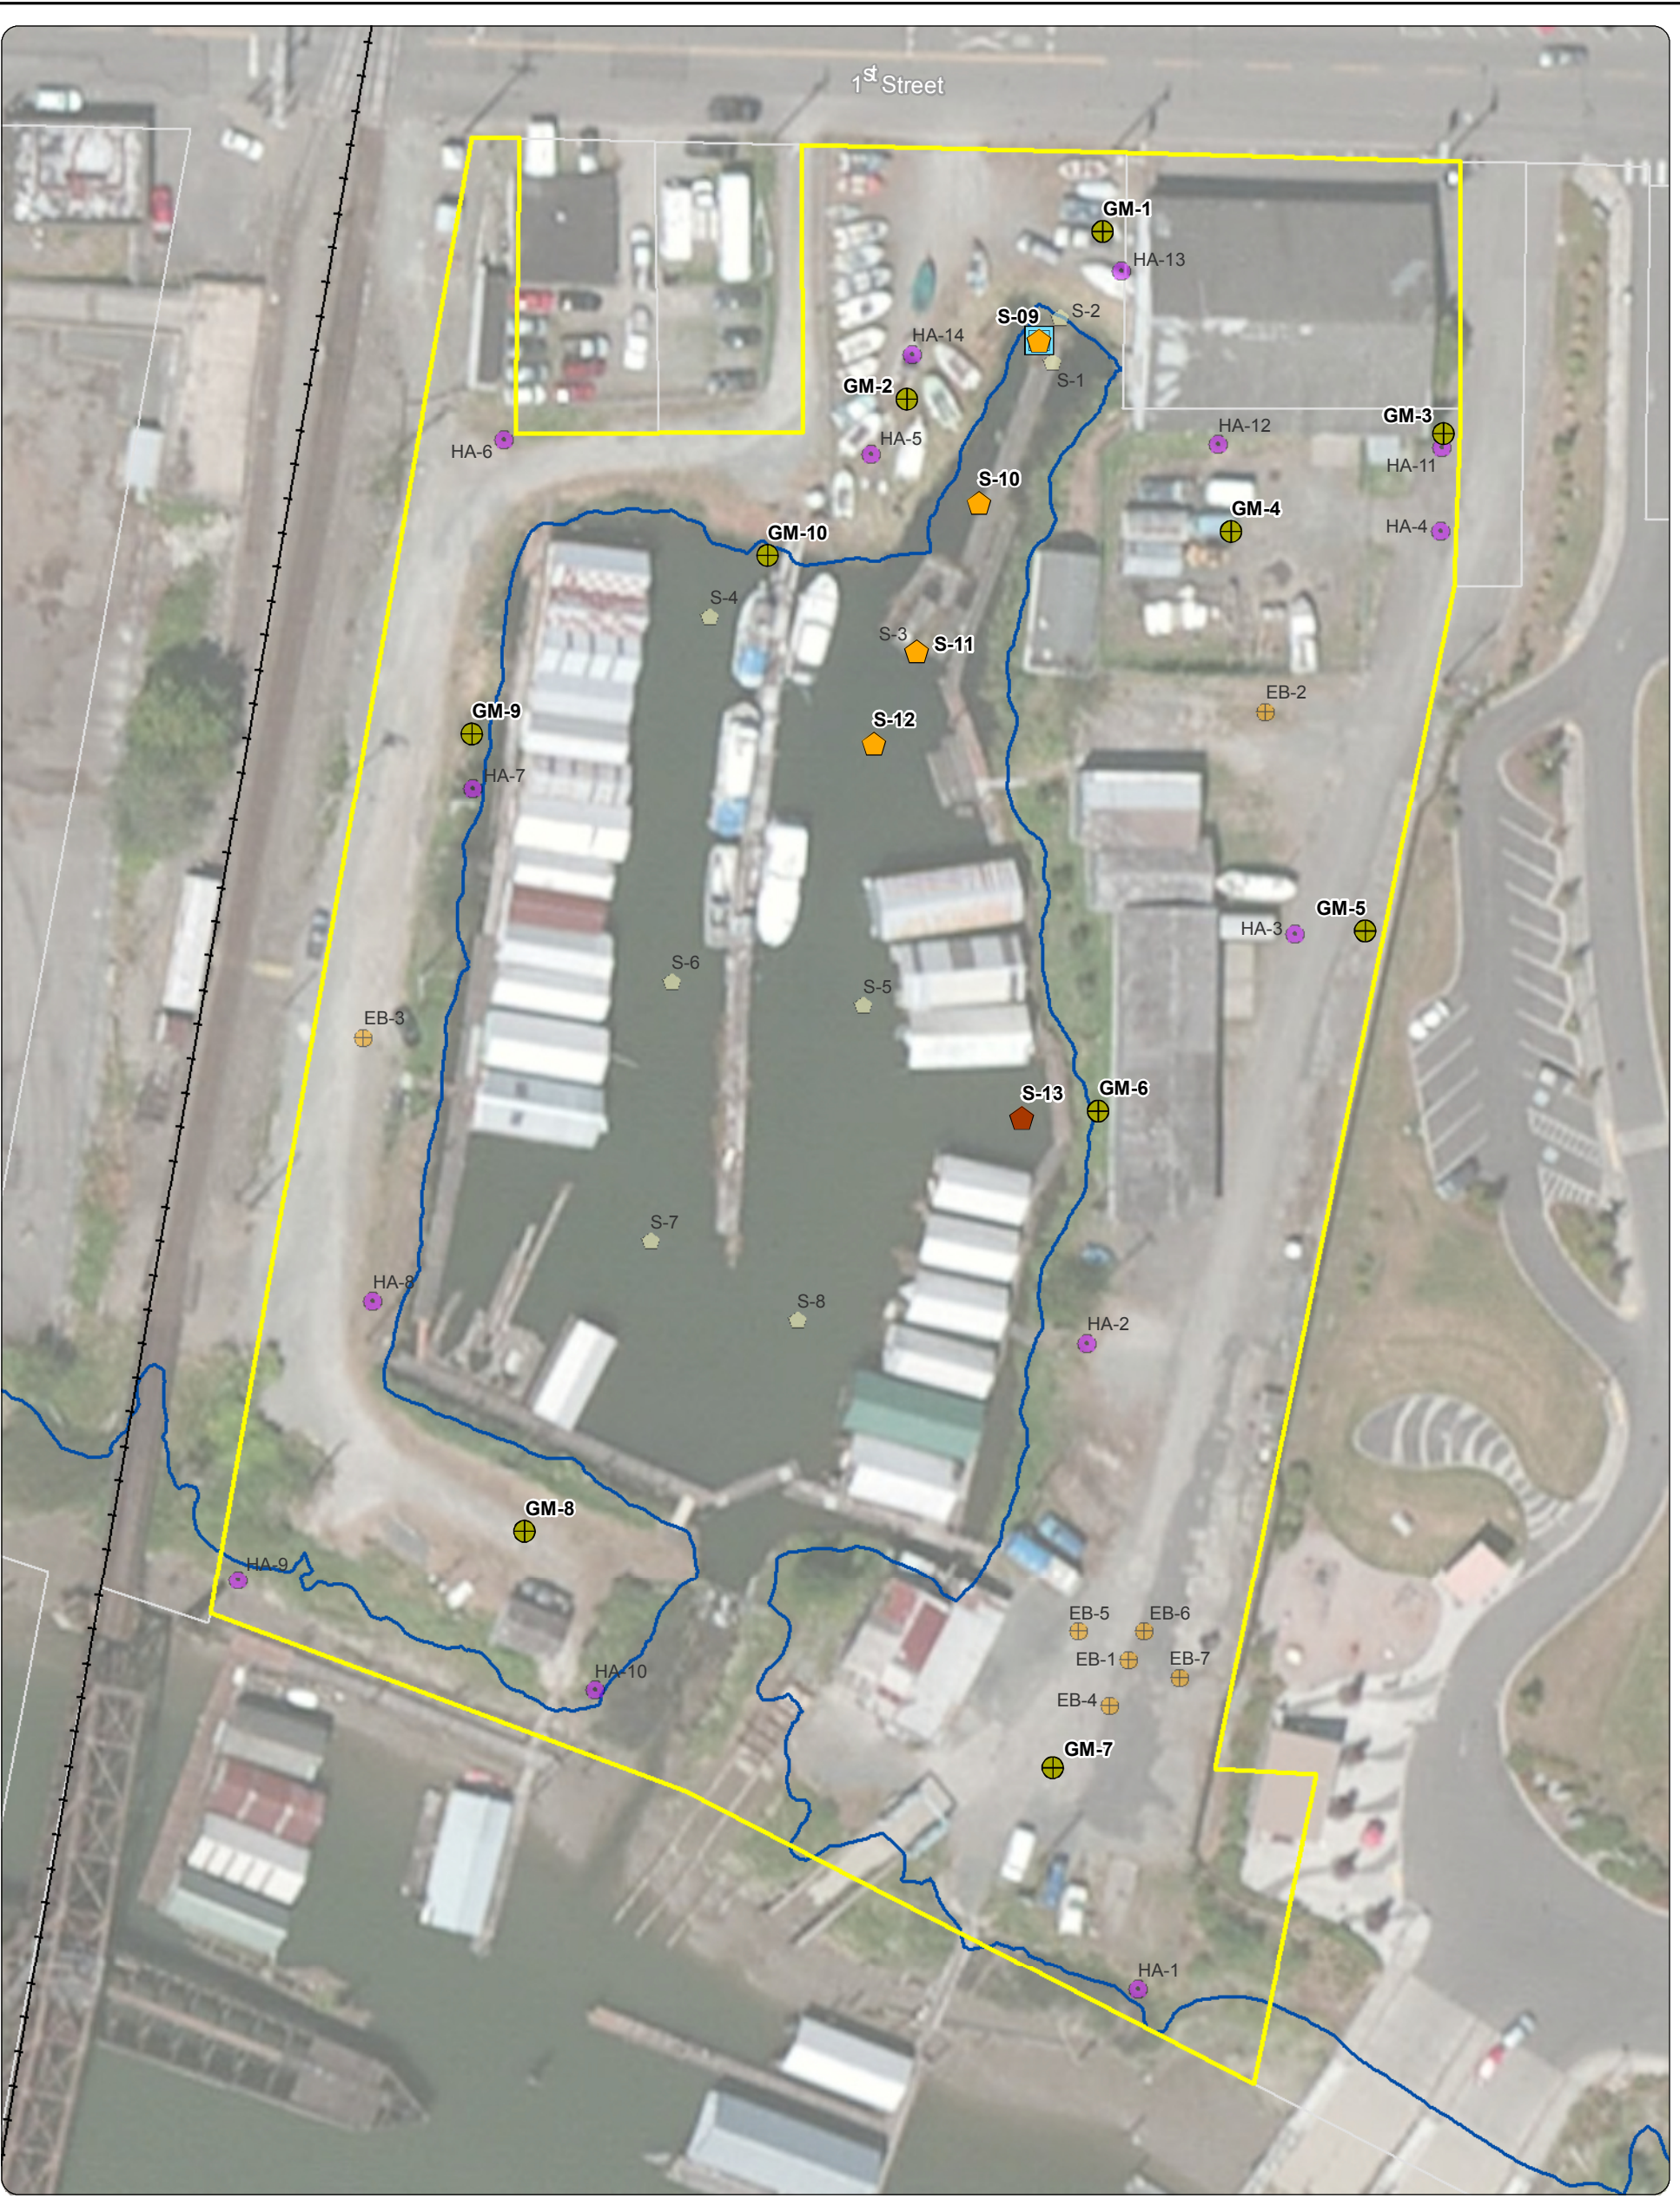
To evaluate the potential for biodegradation processes at the Property, selected groundwater samples from GM-1 and GM-7 (see attached table and Figure 4) will also be analyzed for the following geochemical parameters to prescreen for the presence of electron acceptors:

- Area adjacent to and inferred downgradient generally to the south (southeast and southwest) of the former UST at the northeast area of the Property.
- Areas throughout the Property associated with the boat parts and outboard repair shop (northeast area of the Property), boat shop (east side of Property), and prop shop (southeast area of the Property).

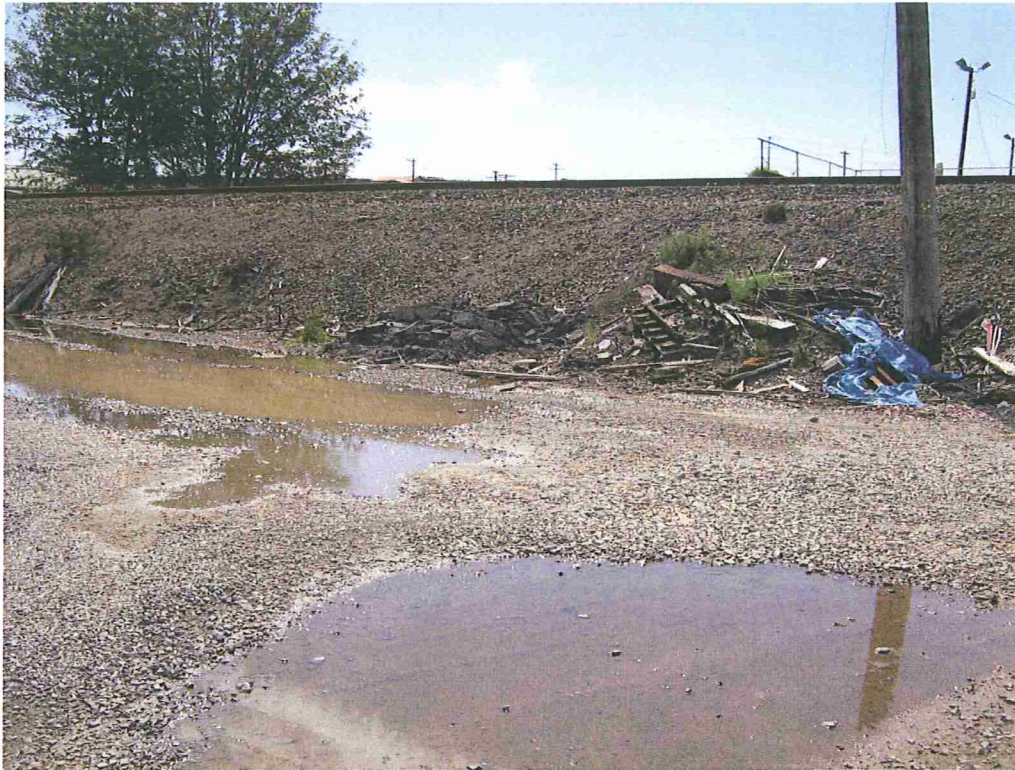
Photograph of debris piles observed on along the western boundary of the subject property.
Viewing to the west.

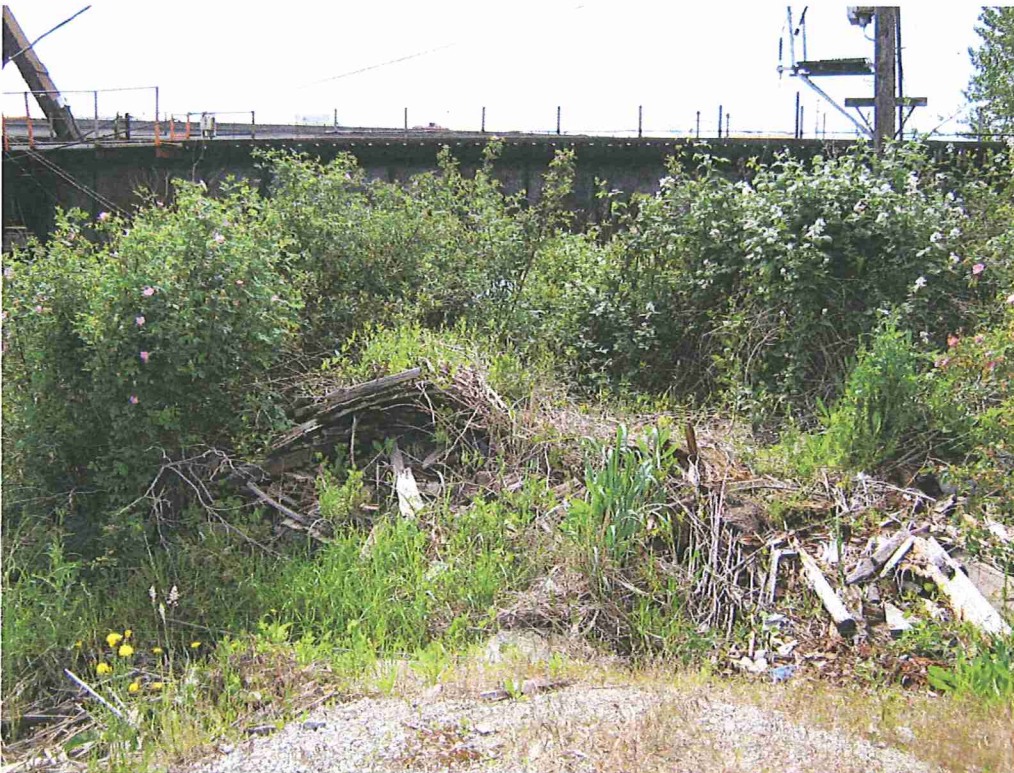
Photograph of a building materials debris pile located on the northwestern portion of the
subject property. Viewing to the southwest.

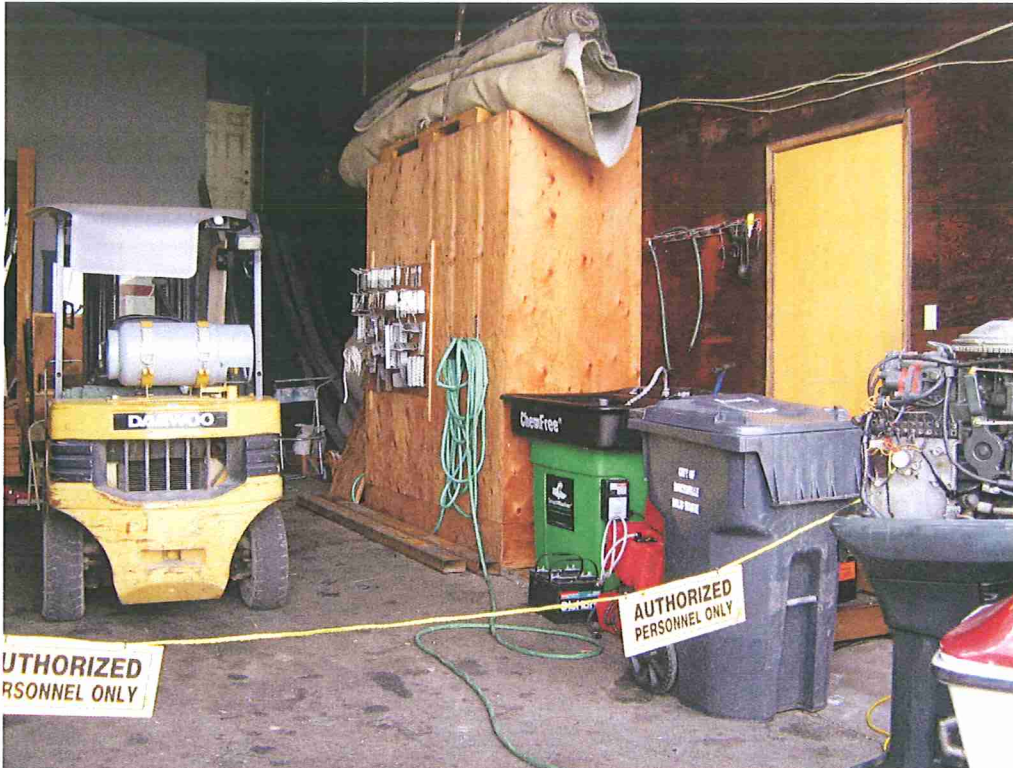
Photograph of the interior of the shop portion of the boat store, note minor staining across concrete floor. Viewing to the northwest.

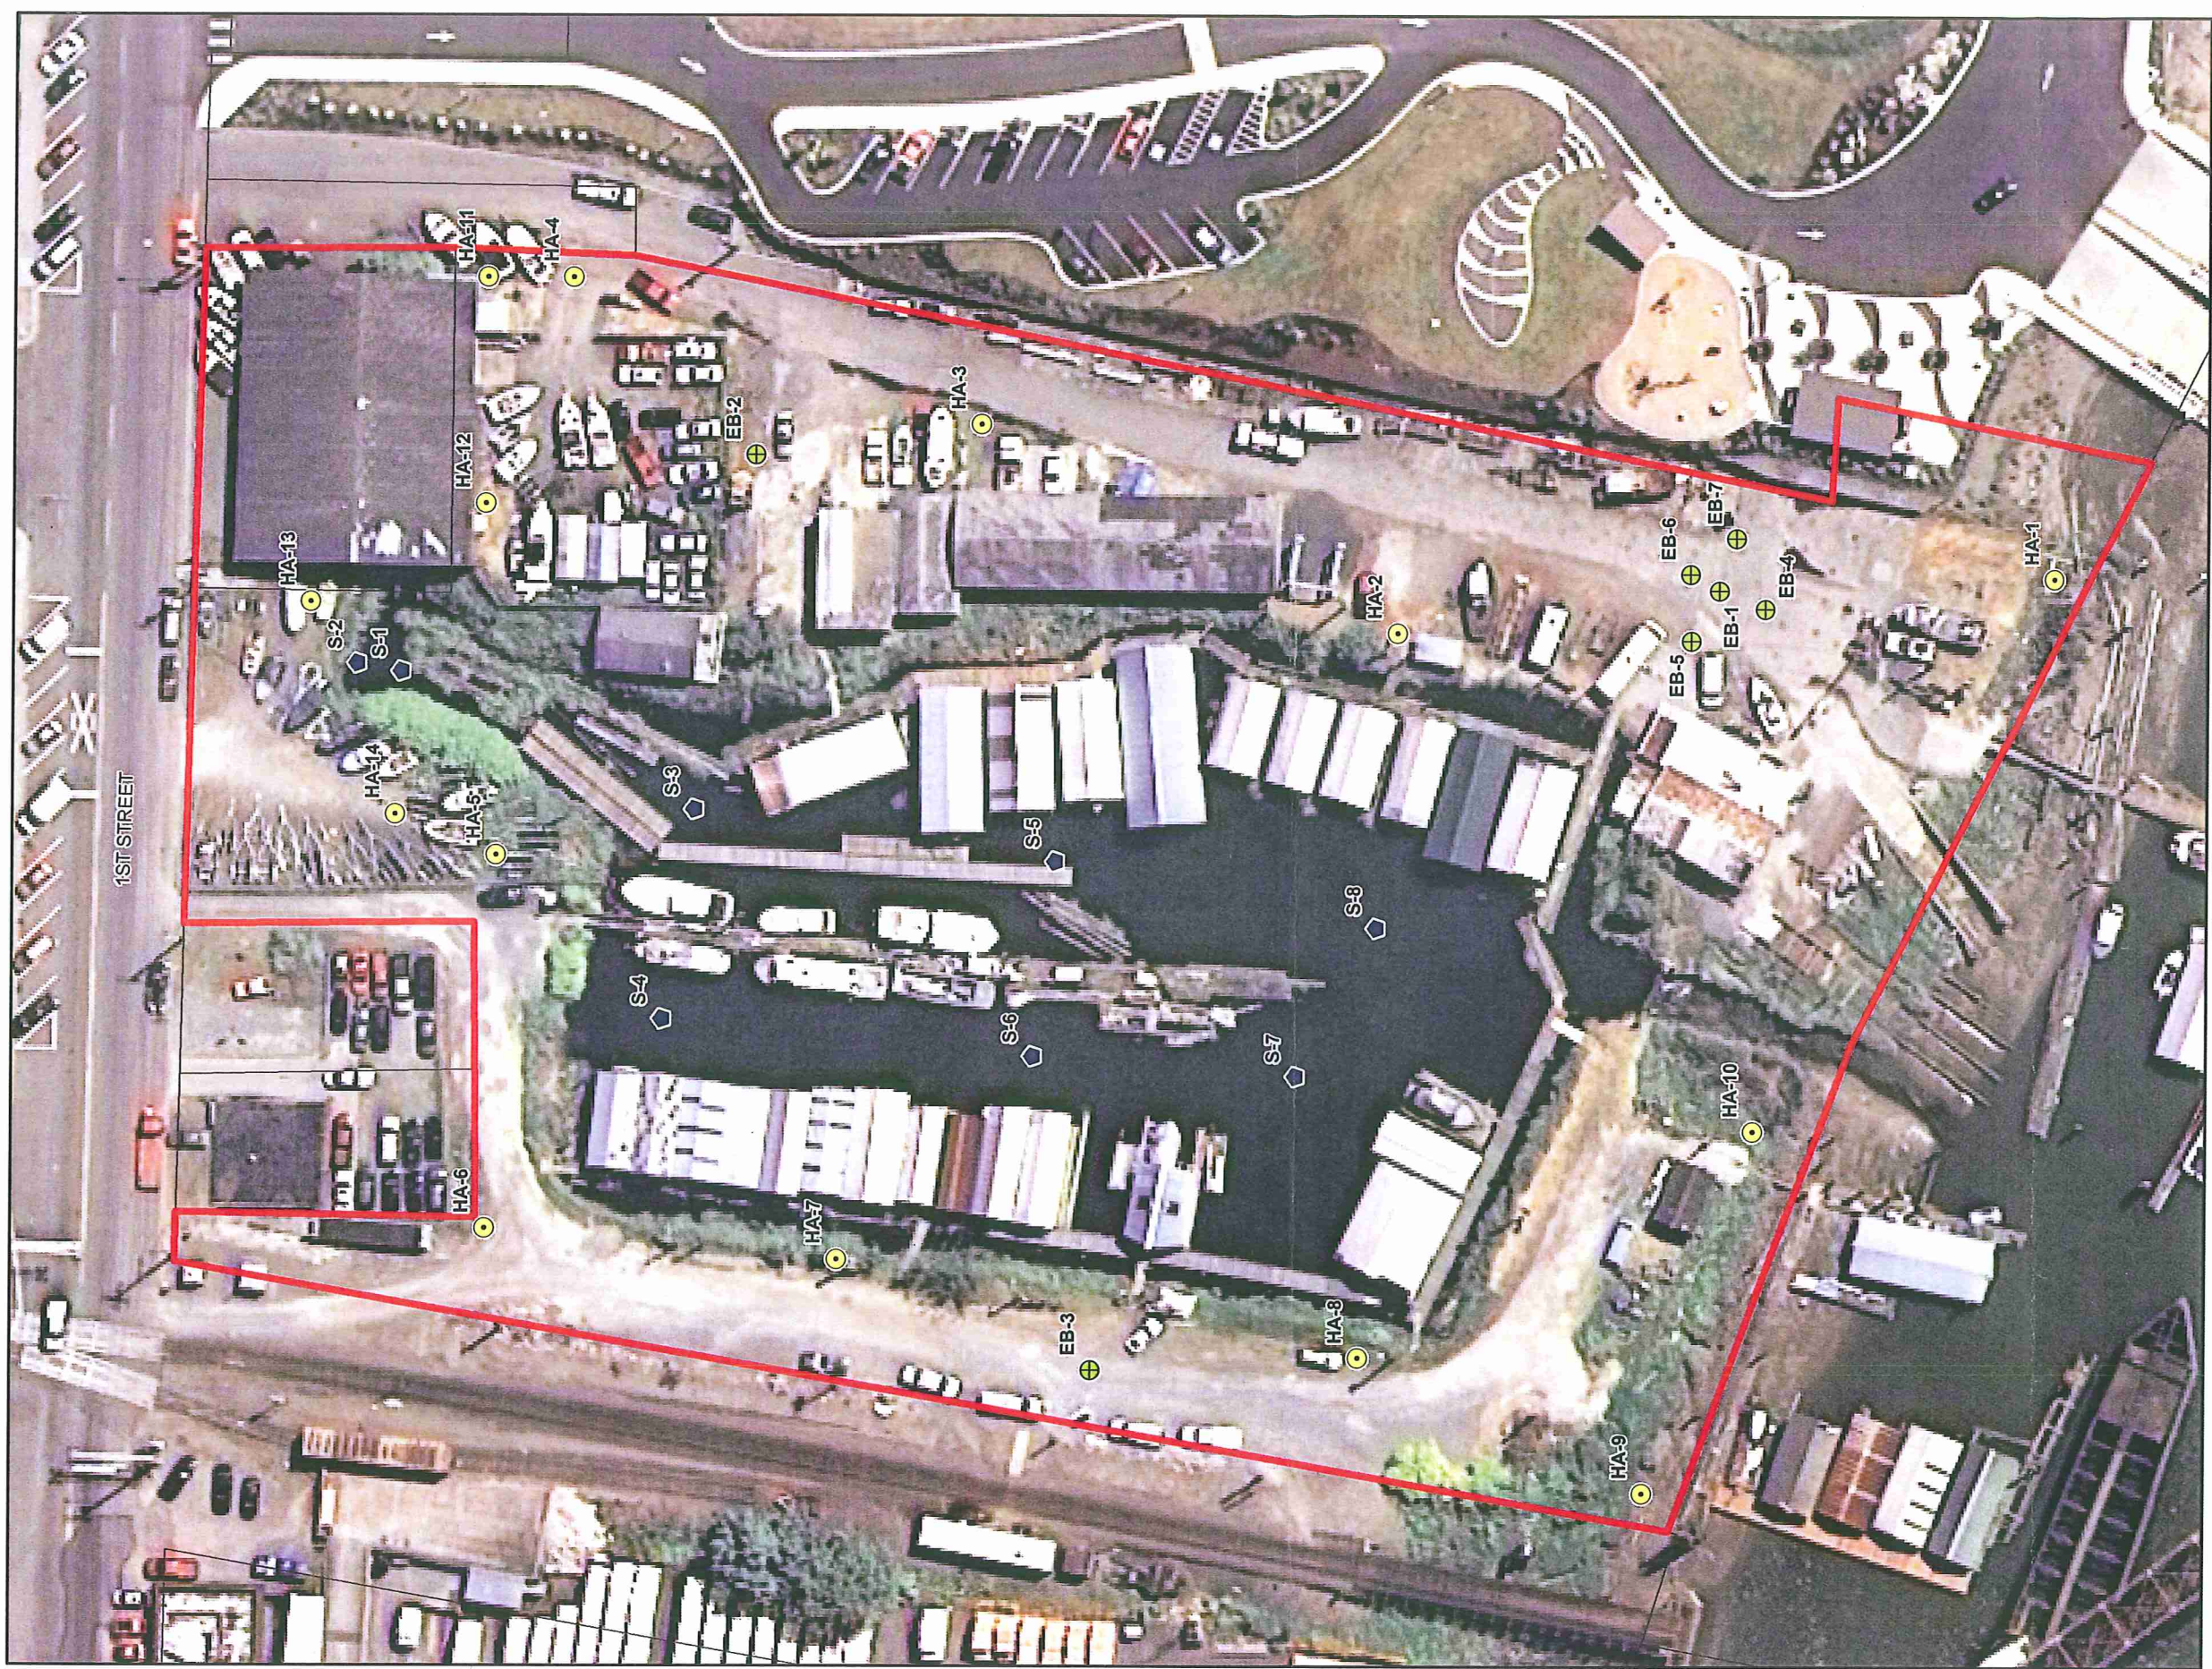
- ⊕ Exploration Boring
- Hand Auger Exploration
- ⬠ Sediment_Samples
- Approximate Subject Property Boundary

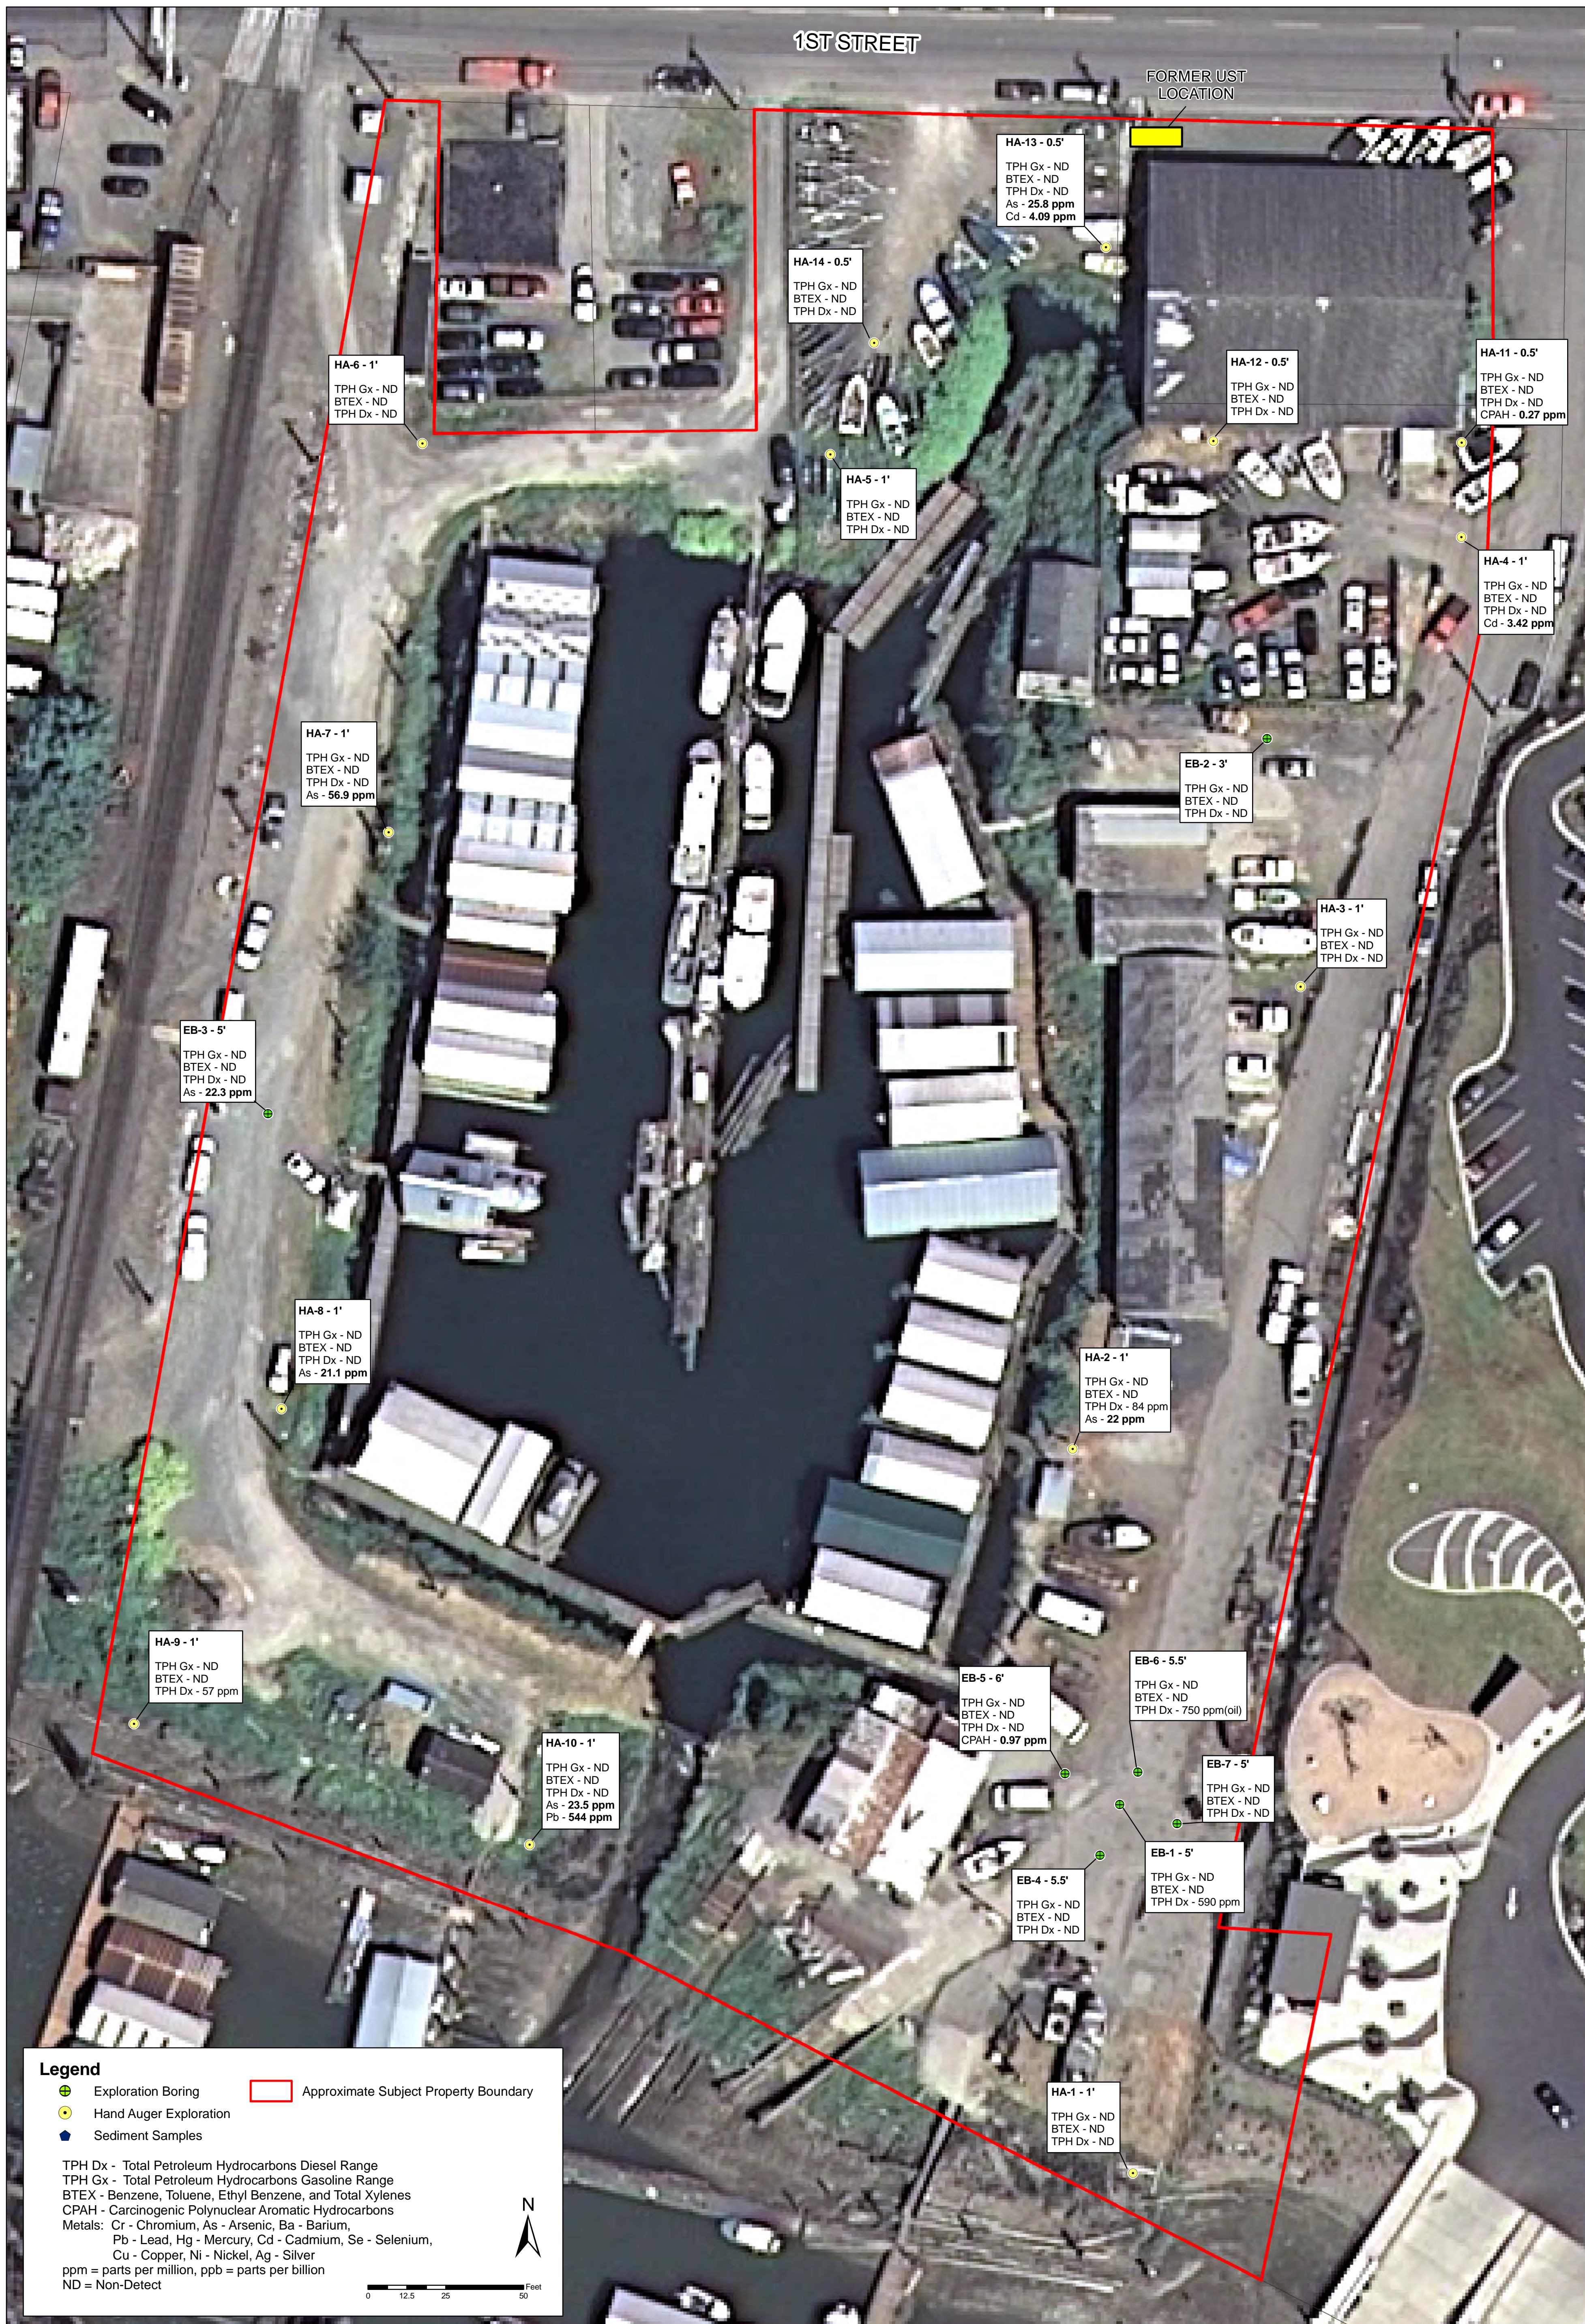
PLATE 1
ANALYTICAL TEST RESULTS - TERRESTRIAL SOIL
GEDDES MARINA
MARYSVILLE, WASHINGTON

PROJECT NO.: K0080118A
 DATE: 11/08
 CHECKED BY: MSA
 DRAWN BY: MSA
 SHEET: 1 of 3
