TECHNICAL MEMO 2005M-1

RE: Cultural Resources Assessment for the Northsound Corporate Park Project,
Marysville, Snohomish County, Washington

**Cultural Resources Assessment for the
Northsound Corporate Park Project,
Marysville, Snohomish County, Washington**

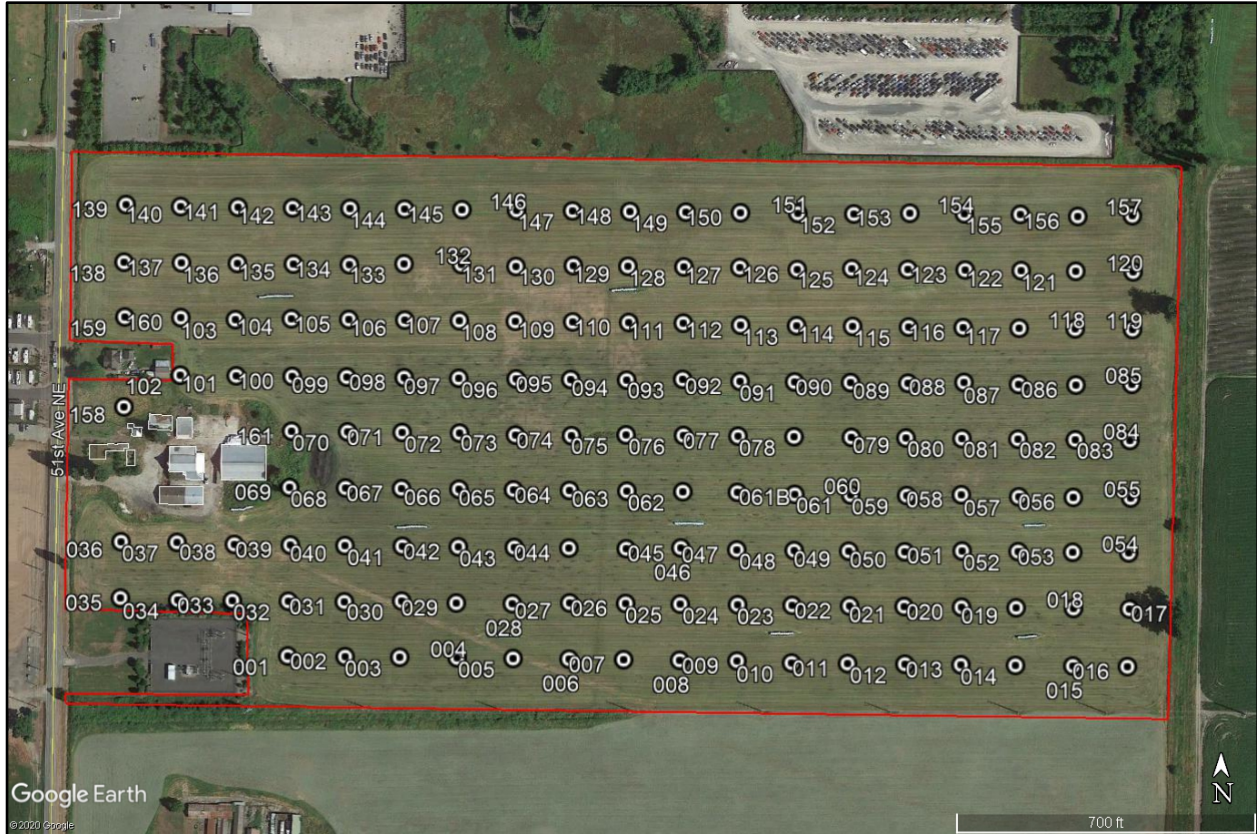
Subsurface investigations included the completion of 162 probes set in a 40 meter by 40 meter grid (Figure 8; Attachment B). A typical soil profile consisted of approximately 30 cm (1 foot) topsoil above weathered glacial sediment (oxidized coarse grained sand to fine grained sandy silts and clays) above unweathered glacial sediments (coarse to very coarse grained gravelly sand). Variations of this included topsoil above alluvium (sand to silty sand gradually grading to coarser sands) or disturbed subsoils associated with French drains installed north to south throughout the project. French drains were typically 80 to 90 centimeters below the ground surface. Eight probes, all located on the western quarter of the project, contained modern or non-diagnostic materials such as brown bottle glass shards or orange twine within 40 cm of the ground surface. A single utility was noted in Probe 38 approximately 60 cm below the surface. Additionally, the topsoil typically has an abrupt boundary with subsoils, often with an intermediate layer of mixed topsoil and glacial sediments, even above obvious disturbances such as French drainage trenches. This suggests the topsoil has been actively managed through agriculture and is likely heavily disturbed.

Figure 8. Satellite image of project location annotated with project boundaries (red) and probe locations.

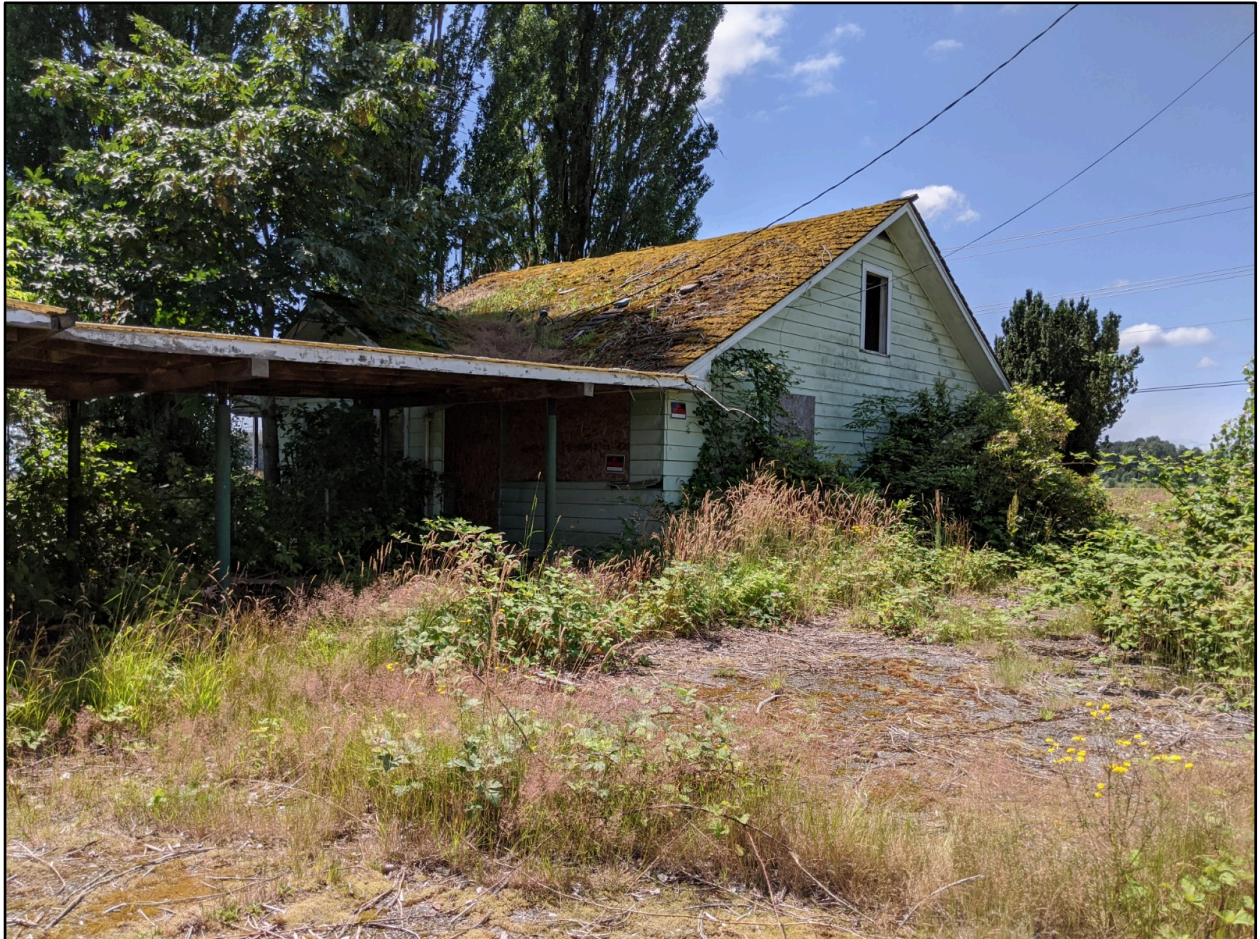
DAHP Property #228837: The house at 16329 51st Avenue NE is a 1.5 story single-family dwelling which was constructed in 1948 (Figure 9). The structure has a rectangular footprint of 30 feet by 38 feet with a total floorplan of 1,852 square feet. The house was built on a poured concrete foundation. The cladding is comprised of manufactured and insulated clapboard siding. The roof is generally a moderate sloped side gable with returns and plain boxed cornices. A front

gable is located on the north end of the west face and a closed porch with a side entrance is covered by a smaller front gable on the south end of the east face. The roof is covered in cedar shingles. The roofline is edged in aluminum gutters.

Figure 9. 1948 house (DAHP Property #228837) at 16329 51st Avenue NE. Image of north and east elevations, view to the southwest.

An undated image provided by the Snohomish County Assessor listing showed the front door under the western gable. The doorway and western face are currently obscured by large, dense bushes and other vegetation. The rear door, located within the closed porch, has been boarded up with plywood, obscuring any original details. The fenestrations, when visible, are generally broken with few glass panes left. Remaining materials indicate the fenestrations were originally steel framed with molded trim surrounds and lugsills. Those with intact sashes indicate the fenestrations were likely hung with two sashes.

DAHP Property #228837: The house is in poor condition with diminished integrity of feeling, materials, setting. Background research could not identify a direct association with significant persons or events. The structure, though the construction made use of more modern materials, has elements of Minimal Traditional style that were common to the time period. The structure is recommended not eligible for listing on the NRHP or WHR.

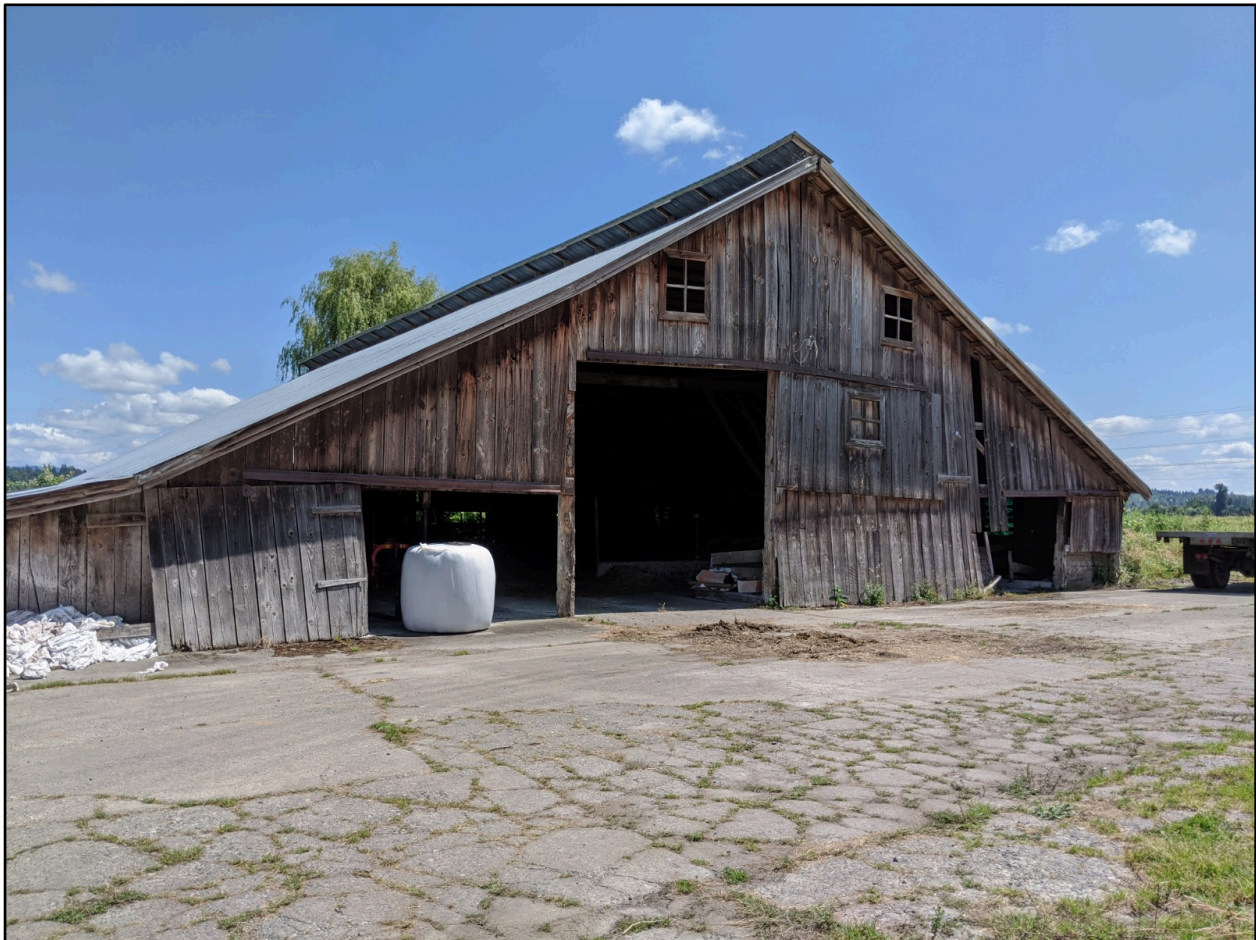
DAHP Property #722499: Barn 1 is a farm structure located on the eastern edge of the farming complex at 16329 51st Avenue (Figure 10). It is of an unknown construction date. The barn was originally built of pole and timber frame construction in a Dutch barn style. Observed remnants of the foundation indicate the structure was originally placed on a timber base. The barn is clad in vertical plank siding. The roof is covered in ribbed metal sheeting, with an under layer of wood shingles present on the south face. The structure is vented through the use of overlapping, open rooflines at the gable apex, with the opening facing to the north. Doors were placed on the east and west faces of the barn, under the gables and consisted of a central extra wide hung, sliding door with smaller hung, sliding doors at the north and south ends. The western central door was a two-story, square, sliding, hung door that provided entrance north of center. The top half of the door, with a central square window, is all that remains of the original door. It is currently held open by boards nailed to the façade. Additionally, the northern doors of the east and west faces have been removed and the southern doors appear to be damaged or removed. Two square, four pane fenestrations were placed on the eastern and western faces, at second story height.

Figure 10. Barn 1 (DAHP Property #722499) at 16329 51st Avenue NE. Image of western elevation, view to the southeast.

A concrete floor was poured after construction, as evident by the way the remaining external pole posts are surrounded but not set in the concrete. It is also evident through the central raised cement pad which is surrounded by large supporting posts which have been cut off approximately 6-8 feet from the ground and propped on metal rods.

DAHP Property #722499: The construction date of the barn is unknown. However, the structure and associated farm complex were present on a 1954 historic aerial image (NETR 2020). A 1943 topographic map also recorded a structure in the complex vicinity, which may have represented a house or farm complex (USGS 1943). This, along with the developed state of the farm complex as of 1954, indicate the structure is likely circa 1940-50. The barn is currently used for machine storage. The barn is in fair condition with the greatest damage evident on the eastern face, which is made inaccessible by vegetation. The addition of the cement pad and associated improvements, the replaced roofing materials, and the general disrepair of the barn has diminished the integrity of feeling, design, materials, and workmanship. Background research could not identify a direct association with an historic person or event. The structure is recommended not eligible for listing on the NRHP or WHR.

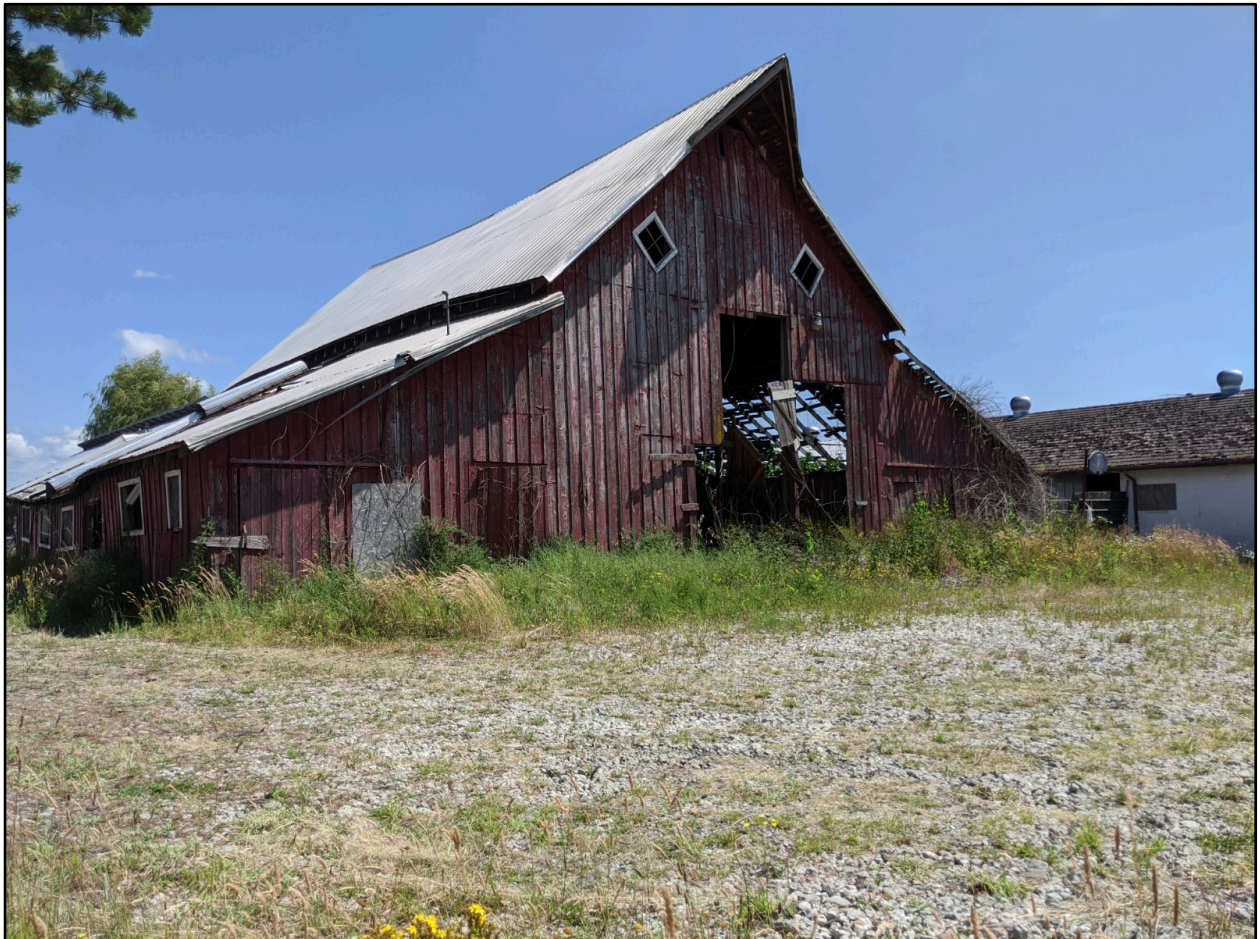
DAHP Property #722500: Barn 2 is a farm structure located at the center of the farming complex at 16329 51st Avenue (Figure 11). It is of an unknown construction date. The barn was originally built of pole and timber frame construction in a western monitor style. A later lean-to extension on the eastern face gives it a partial appearance of a gable on hip style construction. The foundation appears to be made of a timber base, however, the surrounding concrete pad obscures the foundation and limits verification. The barn is clad in board and batten siding and the roof is covered in ribbed metal sheeting. Standard sized wooden shingles can be seen below the metal sheeting on the original barn structure, and missing sheets reveal mounting planks set between the shingles and the sheets. Long wooden shingles are visible below the sheeting on the eastern wing addition. The roof ends in open rafters. The roof of the southern wing and the eastern lean-to are in poor condition with a high degree of collapse observed.

Figure 11. Barn 2 (DAHP Property #722500) at 16329 51st Avenue NE. Image of west and north elevations, view to the southeast.

The barn is accessed through several doors on the western face, as well as a set of doors on the southeast and northeast corners of the eastern lean-to. The western face of the structure has been cut in several locations for the addition of many doors, which include: vertical hinged doors; horizontal hinged doors; hung, sliding doors; and nested doors. Many of the larger doors are damaged or missing. Fenestrations on the structure vary depending on elevation. Two diamond shaped windows were placed at the third-story height of the western face, with square windows placed at the equivalent height on the eastern face. Several fenestrations were placed at the ground-floor level along the north, east, and southern faces. These are generally in poor condition with remaining windows suggesting a standardized four-pane, two sash style with plain trim on the original north and south faces, and varied single sash windows with plain trim on the eastern addition.

DAHP Property #722500: The construction date of the barn is unknown. However, the structure and associated farm complex were present on a 1954 historic aerial image (NETR 2020). A 1943 topographic map also recorded a structure in the complex vicinity, which may have represented a house or farm complex (USGS 1943). This, along with the developed state of the farm complex as of 1954, indicate the structure is likely circa 1940-50. The barn is in poor condition with many aspects of the structure missing or in disrepair. The structure has also been altered heavily through the addition of the eastern wing and the varied doors and access points cut into the western face. The barn has diminished integrity of feeling, design, materials, and workmanship. The addition of the dairy facility and loading ramp have diminished the integrity of setting. Background research could not identify a direct association with an historic person or event. The structure is recommended not eligible for listing on the NRHP or WHR.

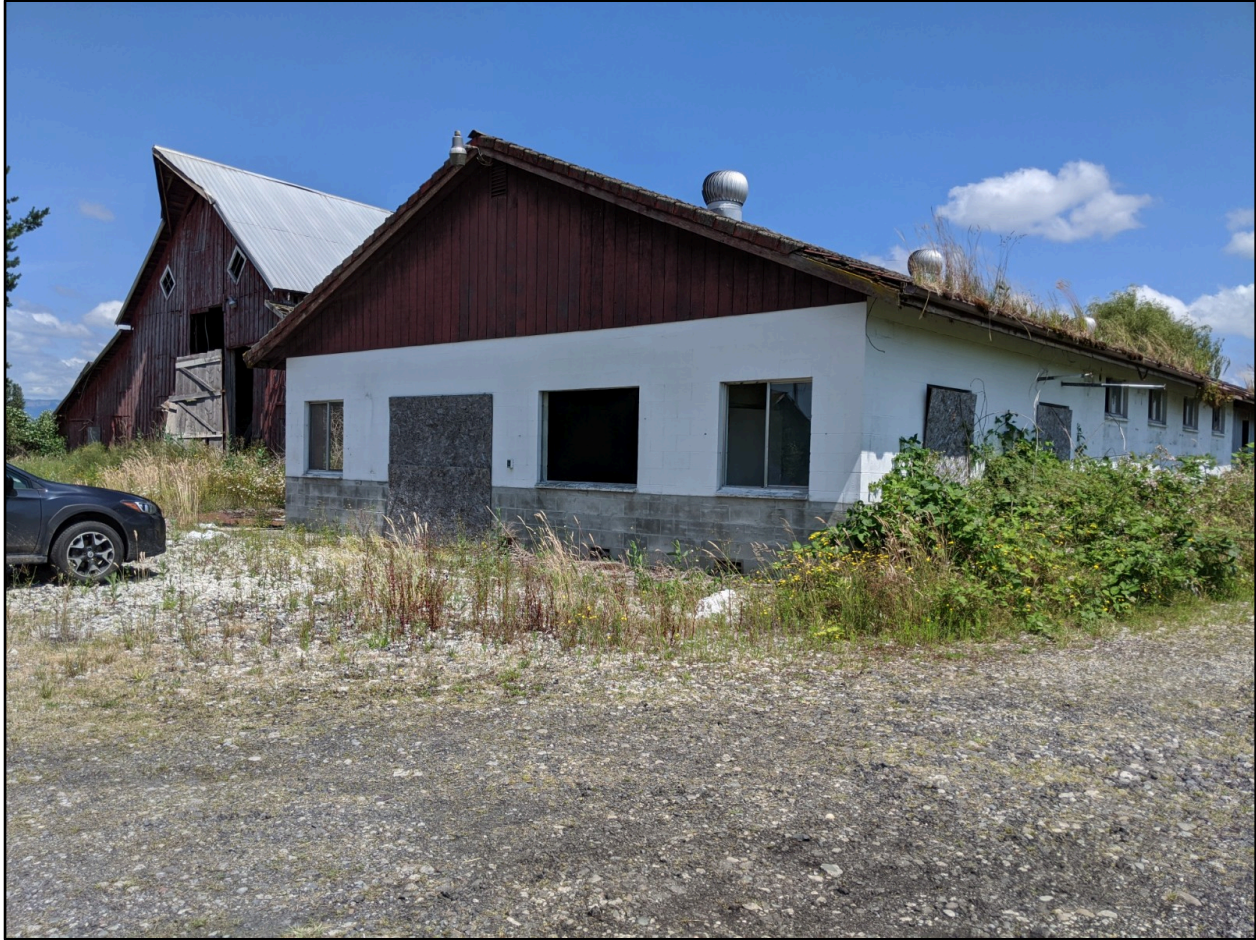
DAHP Property #722501: Outbuilding 1 is constructed on the south side of the farming complex at 16329 51st Avenue NE (Figure 12). Historic aerial images indicate the structure was built between 1969 and 1980. The structure is built on a poured concrete slab with the western half built at grade and the eastern half poured sloping up to the center. The western two thirds of the building are built of concrete blocks while the eastern third is built of modern plank construction. The roof is made of a front-gable design with the western cement block section covered in stylized, manufactured shingles, possibly ceramic in nature, and the eastern plank-framed section covered in ribbed metal sheeting. Three turbine ventilators are situated along the apex of the roof at evenly spaced intervals. The southern and northern walls of the eastern portion of the building are clad in ribbed metal and plastic corrugated sheets, with the eastern wall left open. The apex of the western wall, above the cement block construction, is clad in panel siding.

Figure 12. Outbuilding 1 (DAHP Property #722501) at 16329 51st Avenue NE. Image of west and south elevations, view to the northeast.

The western exterior door was boarded up at the time of investigation, though the metal interior door suggests most entries may also have been made of metal. Fenestration built into the cement walls were sliding, two-sash windows in metal frames of varying sized depending on the interior room. Larger windows were used for offices while transom style windows were used in the milking parlor.

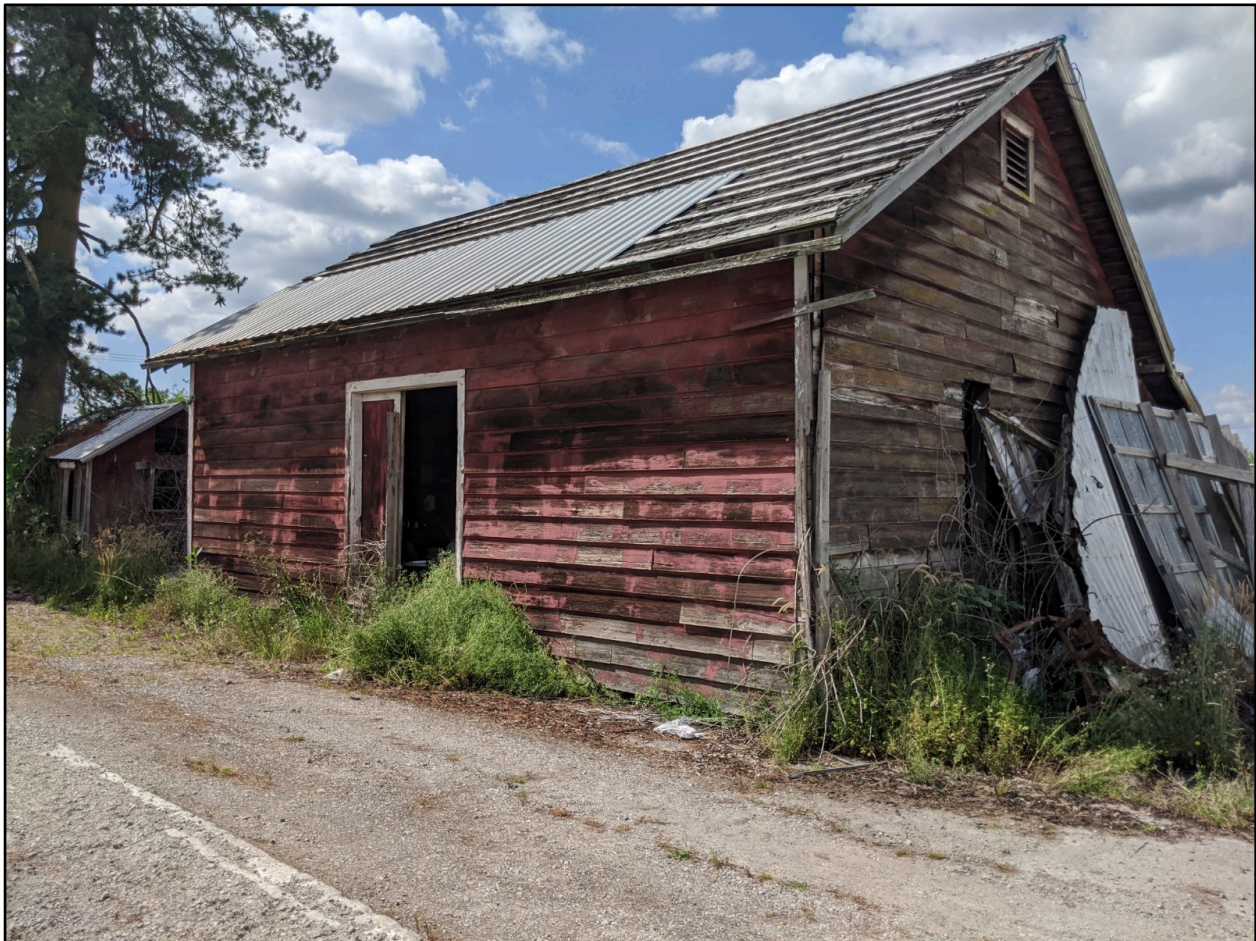
DAHP Property #722502: Outbuilding 2 is a multi-purpose structure located north of the center of the farming complex at 16329 51st Avenue NE (Figure 13). The building has a generally rectangular footprint and appears to have been constructed in three phases: a main gable roofed structure as the southern half; a moderate lean-to roofed central addition; and a shallow lean-to roofed northern addition. The main body of the structure and central lean-to

addition appeared on a 1954 historic aerial image and may be contemporaneous with other construction on the property circa 1940-50. The main body of the building is rectangular and was constructed on post and pier foundation. The plank framed structure has an open interior. The exterior appears to have double thick siding with a shiplap base and clapboard covering. Some clapboard siding is missing. It is covered in a side gable roof with layered roofing materials. The likely-original wooden shingles form a base layer with horizontal planks lain at regular intervals to support the ribbed metal sheeting. Some metal roofing sheets are missing. The roof terminates in open rafters and a wooden gutter on the south face. The structure is accessed through the main entrance on the south face and has a cut out entrance on the east face, an added flap door on the west face, and vents placed at the each apex of the gable roof. The main door is an internally hung, sliding wooden door with a plain trim surround. Knob and tube electrical materials are still visible on the structure, as well as a large glass insulator at the eastern apex of the roof. A two-direction flood light, though missing bulbs, is located at the southwest corner.

Figure 13. Outbuilding 2 (DAHP Property 722502) at 16329 51st Avenue NE. Image of south and east elevation, view to the northwest.

The central addition is evident in the angle of the roofline (a northern projecting moderate lean-to style) and its juncture with the main structure. The addition is clad in vertical plank siding and is accessed externally through a hung, sliding door on the western face. No internal door was noted in the main structure. The third addition is a shallow lean-to projecting from the northern

DAHP Property #722502: The construction date of this outbuilding is unknown. Given historic aerial images available beginning in 1954, it is surmised the original building was likely contemporaneous with other noted construction on the property, circa 1940-50. Both the main section and central addition were visible on the 1954 historical aerial image. The northern addition was present by 1990, however, aerial images taken between 1954 and 1990 were grainy or of low-quality and fine details, such as the presence of the lean-to, could not be distinguished (NETR 2020). Outbuilding 2 has been altered since the original construction with two northern additions, cuts to the eastern and western faces, and new roofing materials. It has diminished integrity of feeling, design, and workmanship. Background research could not identify a direct association with an historic person or event. In addition the structure is not likely to hold as-of yet unknown details concerning construction and outbuilding uses of the time period and is recommended not eligible for listing on the NRHP or WHR.

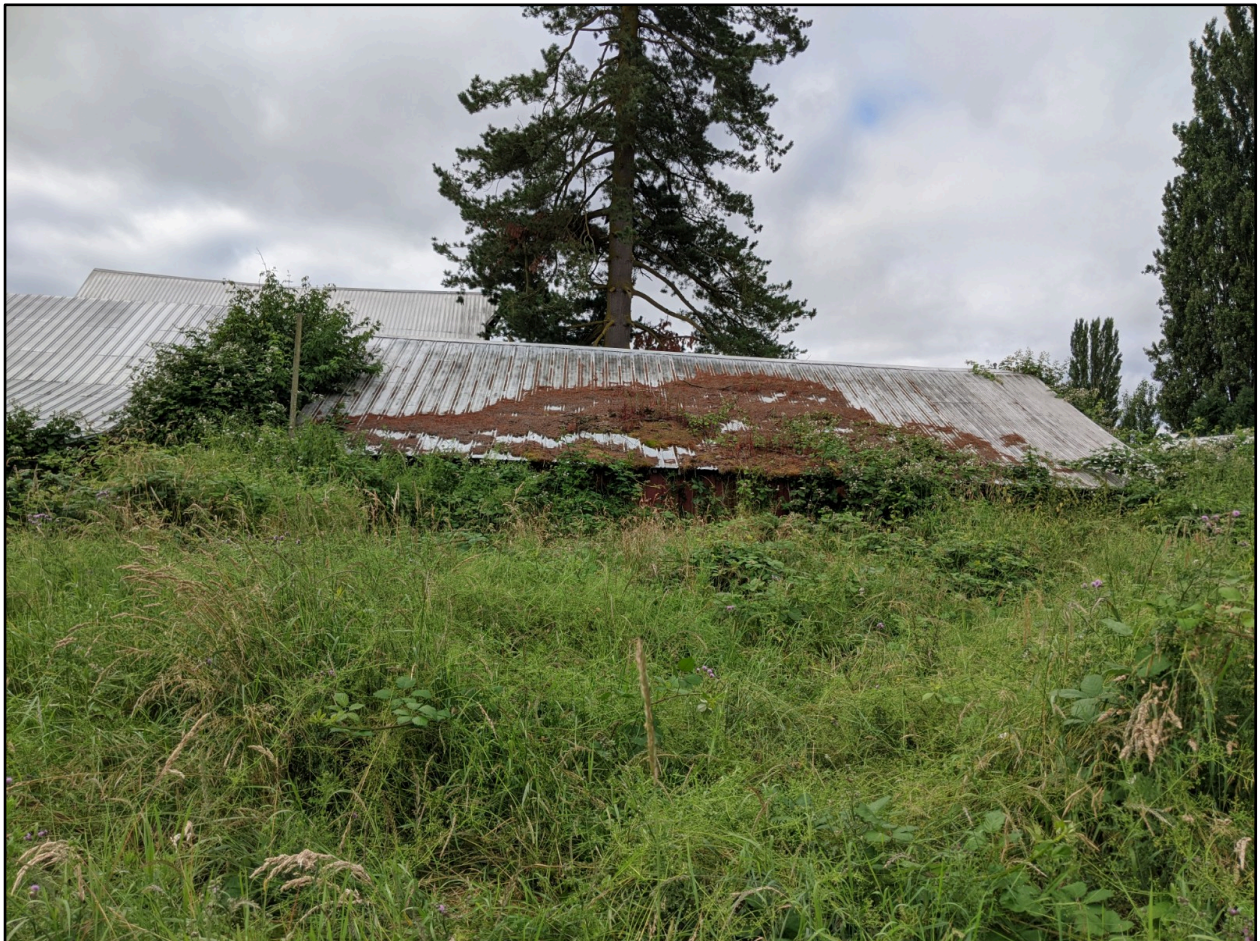
DAHP Property #722503: Outbuilding 3 is a structure of indeterminate use located at the northwest edge of the farming complex at 16329 51st Avenue NE (Figure 14). The structure is of rectangular footprint with a gable roof. The roof is covered in ribbed metal sheeting and the structure is clad in board and batten siding.

Figure 14. Outbuilding 3 (DAHP Property # 722503) at 16329 51st Avenue NE. Image of north elevation, view to the south. Trees or tall brush to left divide Outbuildings 3 and 2 (DAHP Property # 722502).

DAHP Property #722503: This outbuilding was generally obscured by vegetation to the point where investigators could not gain access. As the structure could not be accessed directly, a proper investigation could not be carried out. Given the extent of vegetation surrounding the structure, it is likely it has not been used in some time and is likely in disrepair. The associated shed is small and of an unknown construction date. In addition the structures are not likely to hold as-of yet unknown details concerning construction and outbuilding uses of the time period and are recommended not eligible for listing on the NRHP or WHR.

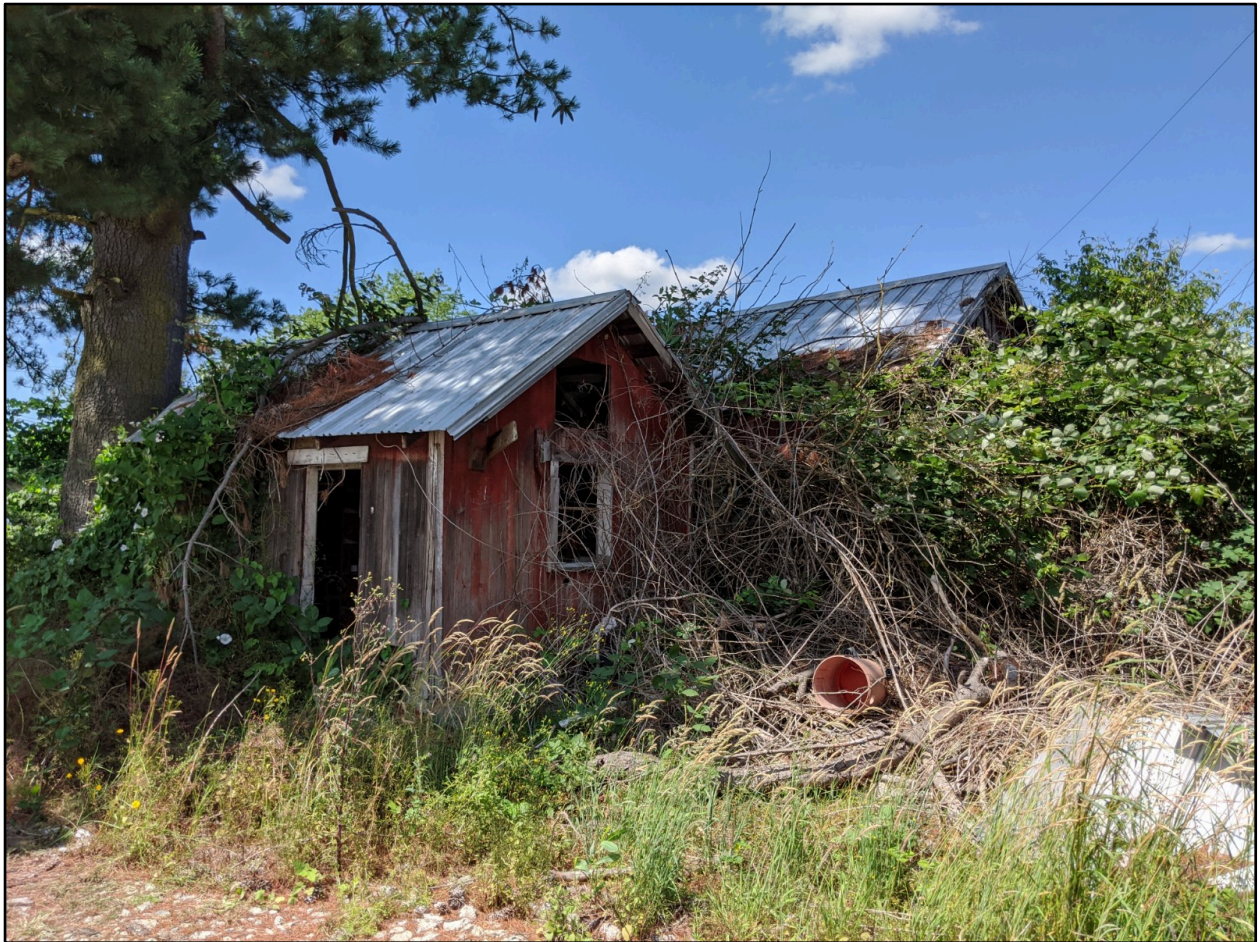
A small shed to the south of outbuilding 3 contained several shelves and may have been a tool or paint shed (Figure 15). The small shed is covered by a side gable with ribbed metal sheeting and is accessed by a door-frame opening on the south face. A hung, two-sash window with plain trim

is located on the eastern face, but lacks glass. A loft may have been accessed by a square opening above the fenestration.

Figure 15. Shed and Outbuilding 3 (DAHP Property #722503) at 16329 51st Avenue NE. Image of south and east elevations of shed (foreground) and southeast corner of Outbuilding 3 (background), view to the northwest.

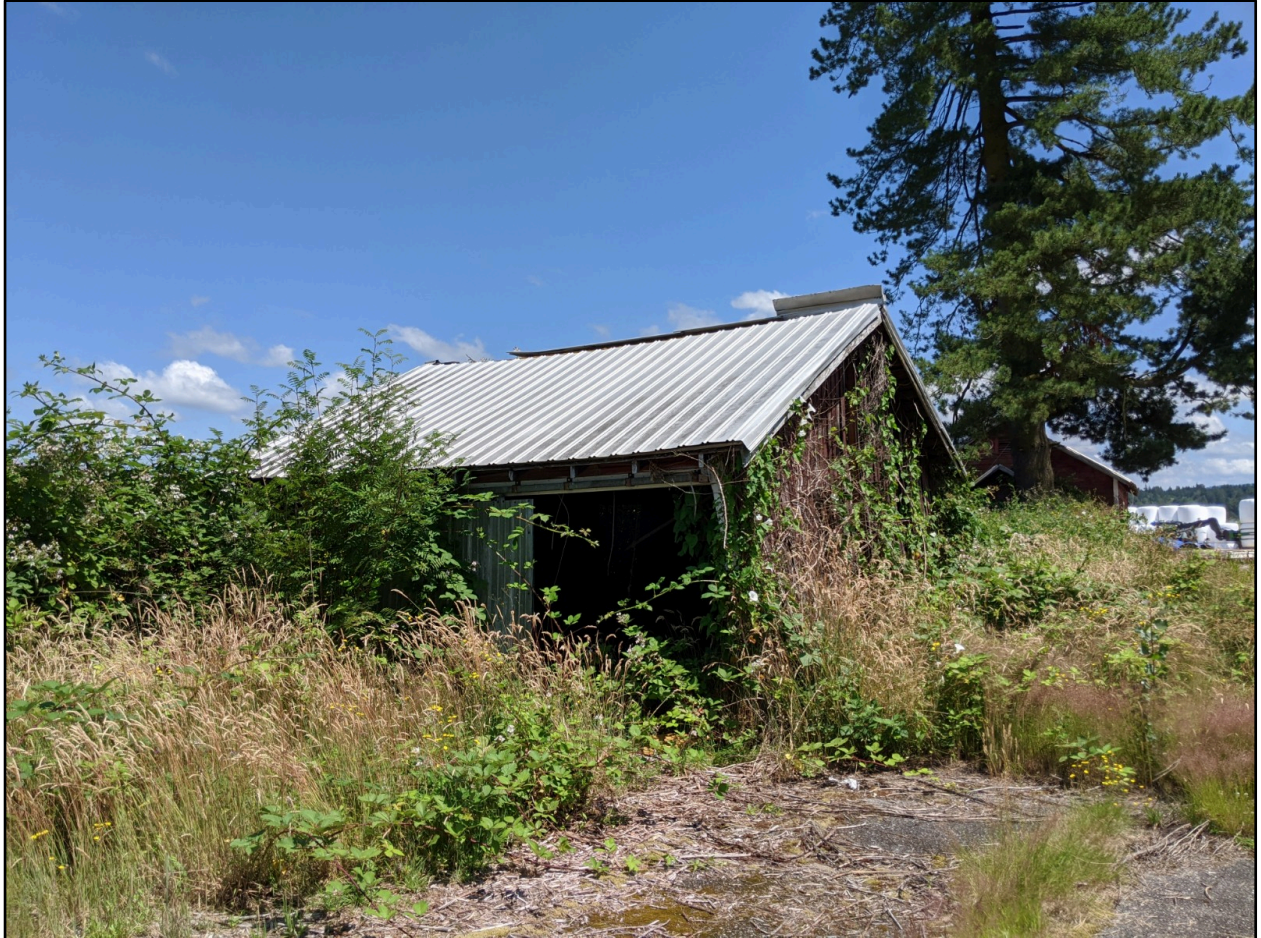
DAHP Property #722504: This small garage-like structure is located at the northwest corner of the farming complex at 16329 51st Avenue (Figure 16). The rectangular structure has a side gable roof covered in ribbed metal sheeting. The cladding is made of reverse-style board and batten siding. A wide, hung, sliding door covered in corrugated metal sheeting provides entrance on the western, street facing side. A single wide swinging door located on the north end of the eastern face provides a secondary exit. Two holes in the northern wall suggest the fenestrations may have been located there.

Figure 16. Garage-like structure at 16329 51st Avenue NE. Image of west and south elevations, view to the east northeast.

DAHP Property #722504: The construction date of the garage is unknown. However, the structure and associated farm complex were present on a 1954 historic aerial image (NETR 2020). A 1943 topographic map also recorded a structure in the vicinity, which may have been a house or farm complex (USGS 1943). This, along with the developed state of the farm complex as of 1954, indicate the structure is likely circa 1940-50. The integrity of materials and workmanship has diminished through the re-roofing of the structure and damages to the walls. Background research could not identify a direct association with an historic person or event. In addition the structure is not likely to hold as-of yet unknown details concerning construction and outbuilding uses of the time period and is recommended not eligible for listing on the NRHP or WHR.

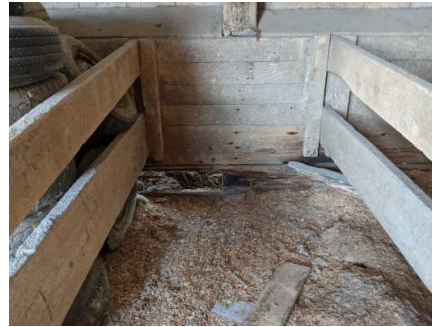
north elevation, internal, close up of foundation and stall addition

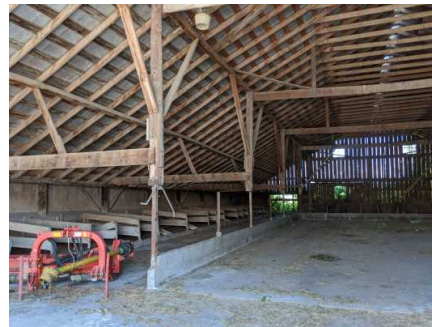
north and east elevation, internal, altered floor and construction

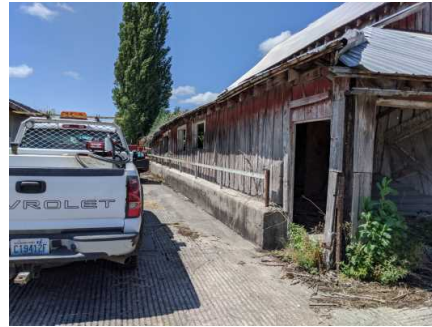
cement loading ramp, south elevation of Barn 2

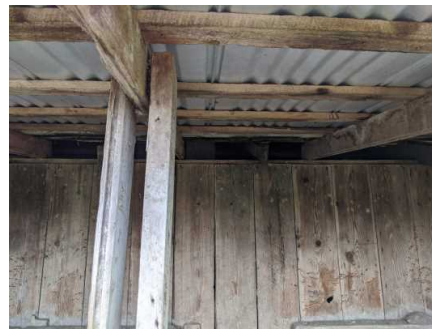
underside of roof, juncture of central and northern additions
