### TECHNICAL MEMO 2005M-1

RE: Cultural Resources Assessment for the Northsound Corporate Park Project,  
Marysville, Snohomish County, Washington

Title of Report: Cultural Resources Assessment for the Northsound Corporate Park Project, Marysville, Snohomish County, Washington

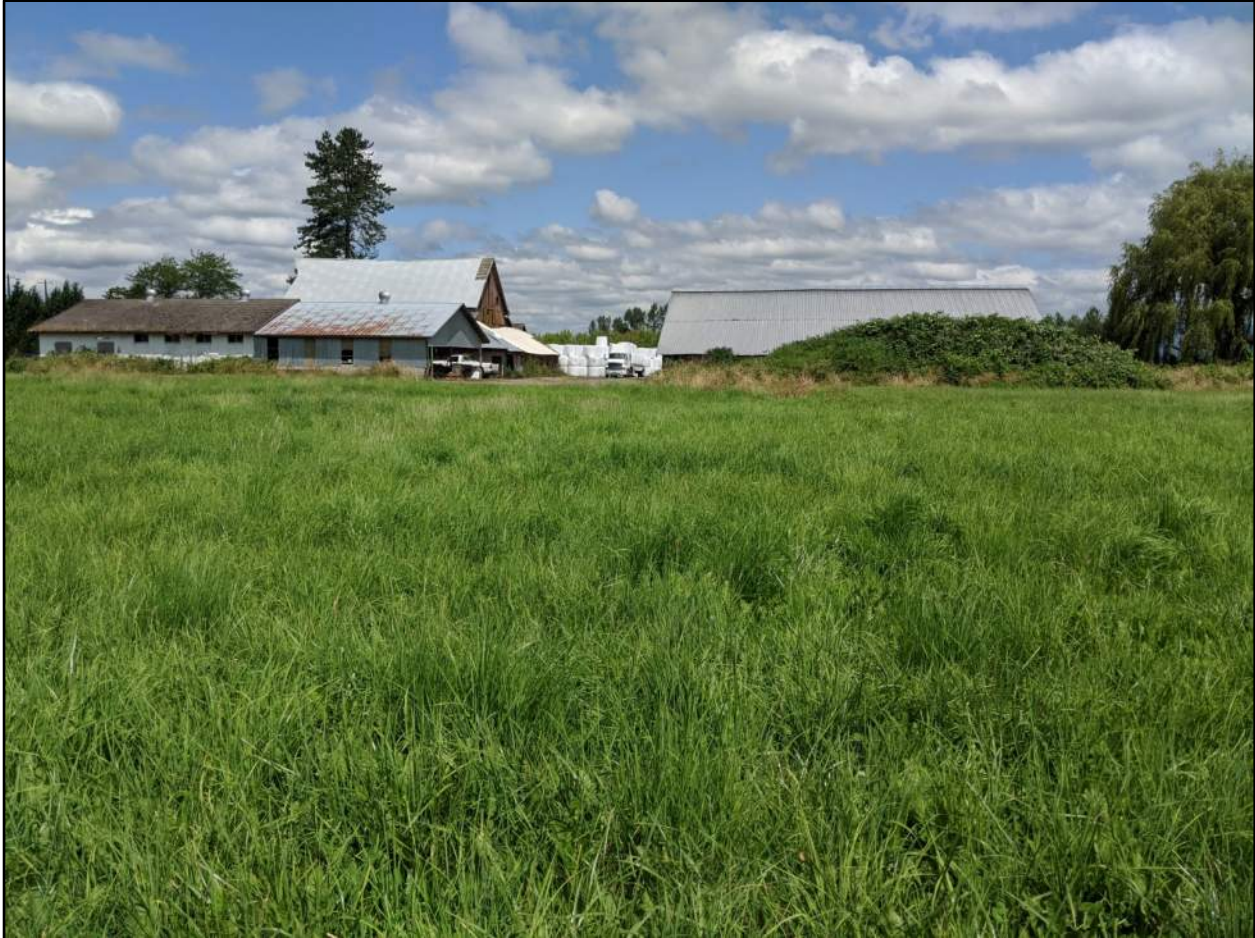
Figure 7. Overview of farm complex structures Barns 1 and 2 and Outbuilding 1. View to the north, taken from Probe 33.

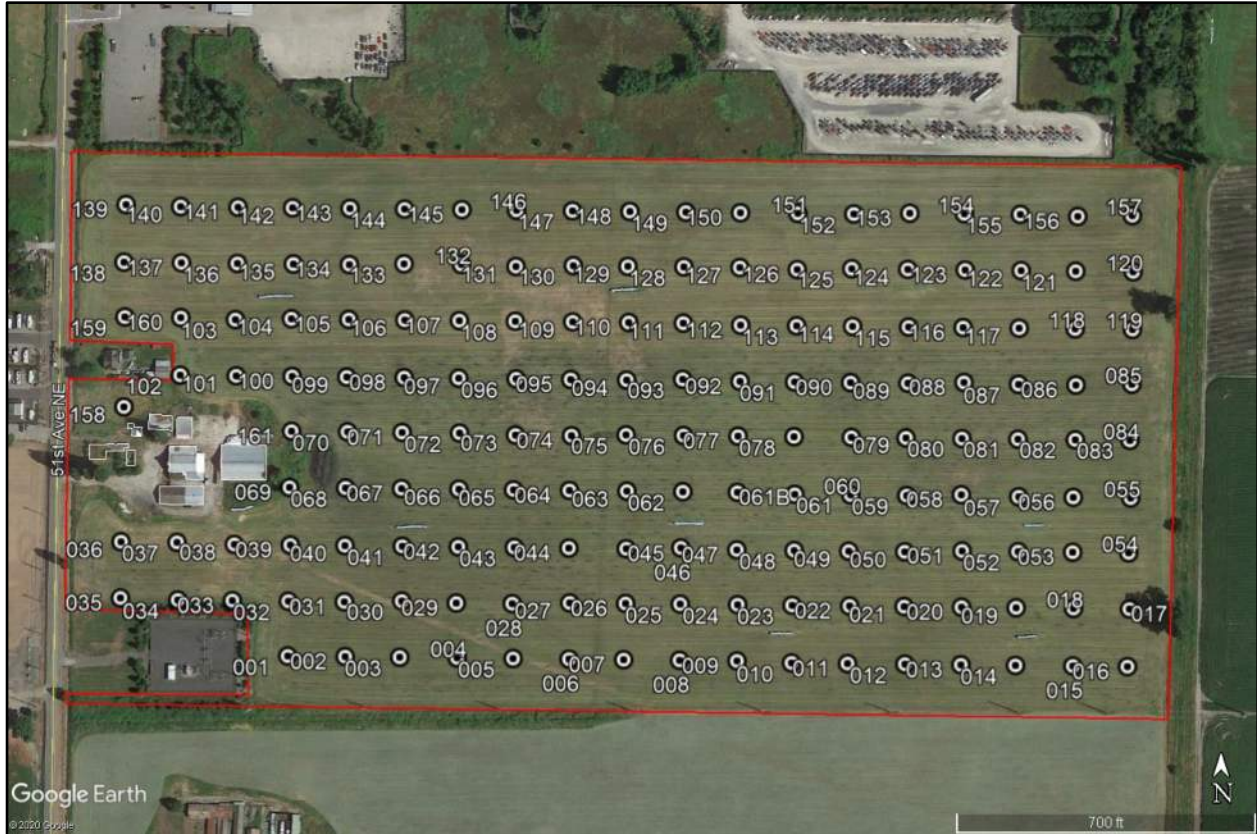
Subsurface investigations included the completion of 162 probes set in a 40 meter by 40 meter grid (Figure 8; Attachment B). A typical soil profile consisted of approximately 30 cm (1 foot) topsoil above weathered glacial sediment (oxidized coarse grained sand to fine grained sandy silts and clays) above unweathered glacial sediments (coarse to very coarse grained gravelly sand). Variations of this included topsoil above alluvium (sand to silty sand gradually grading to coarser sands) or disturbed subsoils associated with French drains installed north to south throughout the project. French drains were typically 80 to 90 centimeters below the ground surface. Eight probes, all located on the western quarter of the project, contained modern or non-diagnostic materials such as brown bottle glass shards or orange twine within 40 cm of the ground surface. A single utility was noted in Probe 38 approximately 60 cm below the surface. Additionally, the topsoil typically has an abrupt boundary with subsoils, often with an intermediate layer of mixed topsoil and glacial sediments, even above obvious disturbances such as French drainage trenches. This suggests the topsoil has been actively managed through agriculture and is likely heavily disturbed.

Figure 8. Satellite image of project location annotated with project boundaries (red) and probe locations.

All probes were negative for archaeological deposits. No intact historic or precontact archaeological materials or buried anthropogenic surfaces were identified during the course of this survey. Probes were backfilled following documentation.

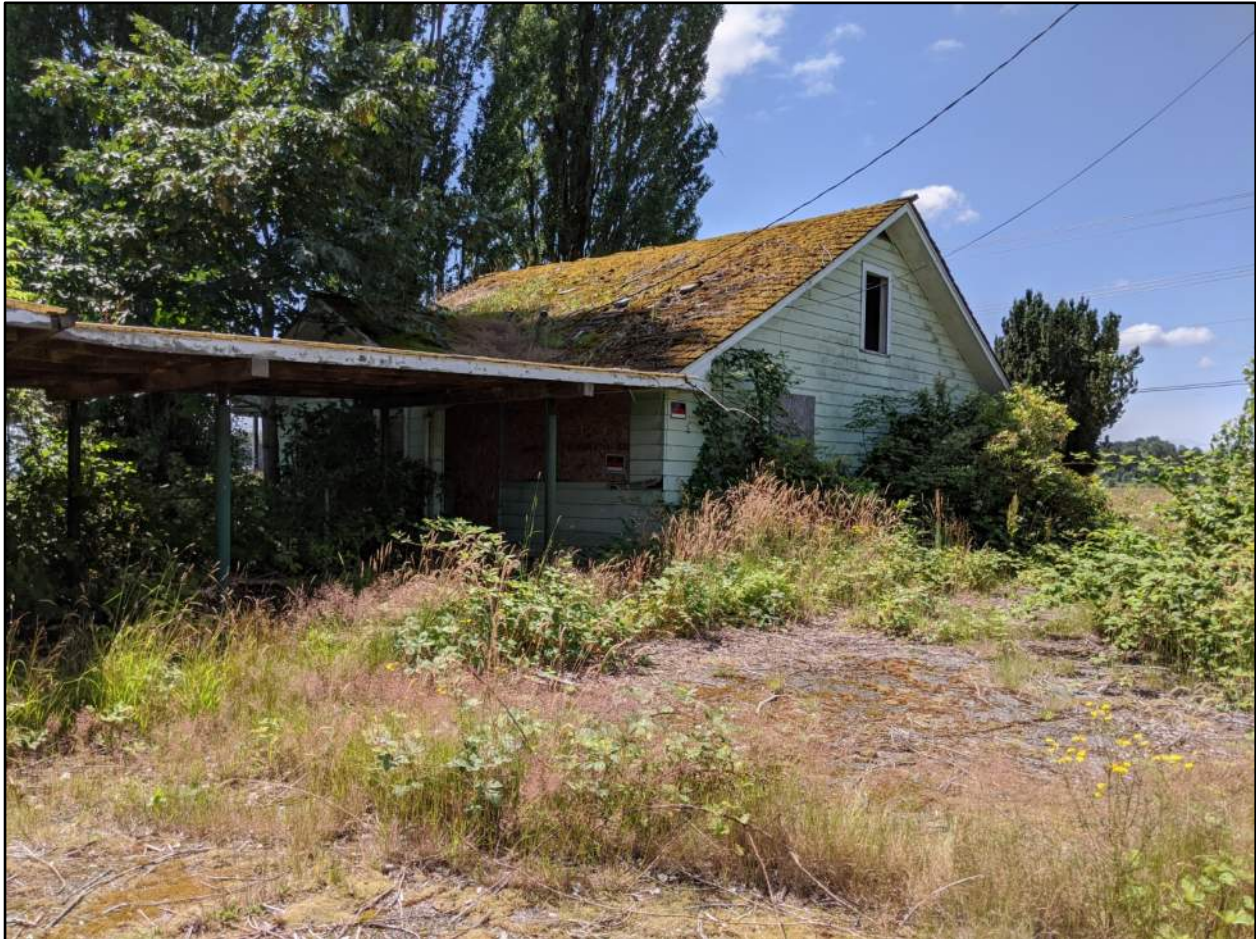
*DAHP Property #228837:* The house at 16329 51<sup>st</sup> Avenue NE is a 1.5 story single-family dwelling which was constructed in 1948 (Figure 9). The structure has a rectangular footprint of 30 feet by 38 feet with a total floorplan of 1,852 square feet. The house was built on a poured concrete foundation. The cladding is comprised of manufactured and insulated clapboard siding. The roof is generally a moderate sloped side gable with returns and plain boxed cornices. A front

gable is located on the north end of the west face and a closed porch with a side entrance is covered by a smaller front gable on the south end of the east face. The roof is covered in cedar shingles. The roofline is edged in aluminum gutters.

Figure 9. 1948 house (DAHP Property #228837) at 16329 51st Avenue NE. Image of north and east elevations, view to the southwest.

An undated image provided by the Snohomish County Assessor listing showed the front door under the western gable. The doorway and western face are currently obscured by large, dense bushes and other vegetation. The rear door, located within the closed porch, has been boarded up with plywood, obscuring any original details. The fenestrations, when visible, are generally broken with few glass panes left. Remaining materials indicate the fenestrations were originally steel framed with molded trim surrounds and lugsills. Those with intact sashes indicate the fenestrations were likely hung with two sashes.

*DAHP Property #228837:* The house is in poor condition with diminished integrity of feeling, materials, setting. Background research could not identify a direct association with significant persons or events. The structure, though the construction made use of more modern materials, has elements of Minimal Traditional style that were common to the time period. The structure is recommended not eligible for listing on the NRHP or WHR.

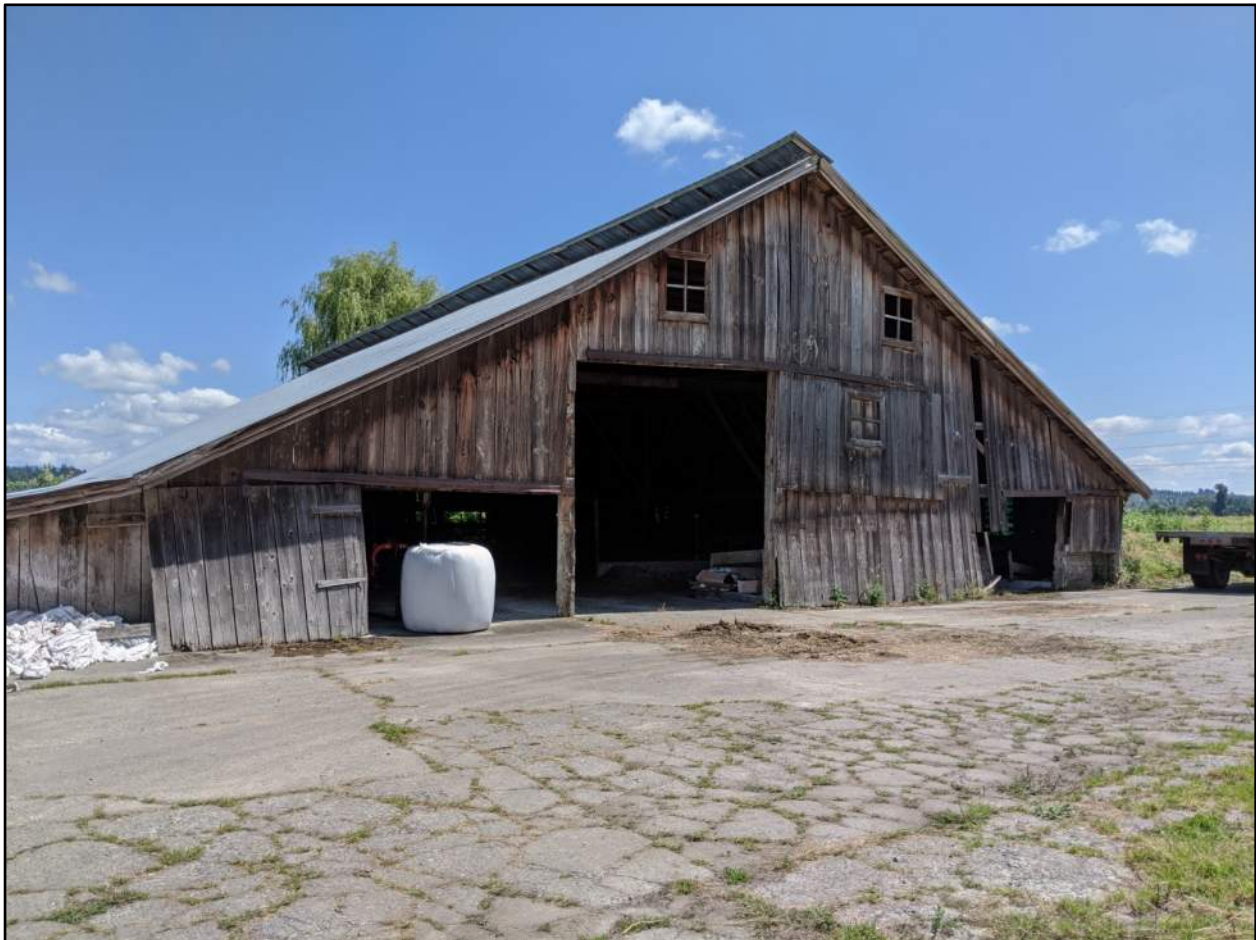
*DAHP Property #722499:* Barn 1 is a farm structure located on the eastern edge of the farming complex at 16329 51<sup>st</sup> Avenue (Figure 10). It is of an unknown construction date. The barn was originally built of pole and timber frame construction in a Dutch barn style. Observed remnants of the foundation indicate the structure was originally placed on a timber base. The barn is clad in vertical plank siding. The roof is covered in ribbed metal sheeting, with an under layer of wood shingles present on the south face. The structure is vented through the use of overlapping, open rooflines at the gable apex, with the opening facing to the north. Doors were placed on the east and west faces of the barn, under the gables and consisted of a central extra wide hung, sliding door with smaller hung, sliding doors at the north and south ends. The western central door was a two-story, square, sliding, hung door that provided entrance north of center. The top half of the door, with a central square window, is all that remains of the original door. It is currently held open by boards nailed to the façade. Additionally, the northern doors of the east and west faces have been removed and the southern doors appear to be damaged or removed. Two square, four pane fenestrations were placed on the eastern and western faces, at second story height.

Figure 10. Barn 1 (DAHP Property #722499) at 16329 51<sup>st</sup> Avenue NE. Image of western elevation, view to the southeast.

A concrete floor was poured after construction, as evident by the way the remaining external pole posts are surrounded but not set in the concrete. It is also evident through the central raised cement pad which is surrounded by large supporting posts which have been cut off approximately 6-8 feet from the ground and propped on metal rods.

*DAHP Property #722499:* The construction date of the barn is unknown. However, the structure and associated farm complex were present on a 1954 historic aerial image (NETR 2020). A 1943 topographic map also recorded a structure in the complex vicinity, which may have represented a house or farm complex (USGS 1943). This, along with the developed state of the farm complex as of 1954, indicate the structure is likely circa 1940-50. The barn is currently used for machine storage. The barn is in fair condition with the greatest damage evident on the eastern face, which is made inaccessible by vegetation. The addition of the cement pad and associated improvements, the replaced roofing materials, and the general disrepair of the barn has diminished the integrity of feeling, design, materials, and workmanship. Background research could not identify a direct association with an historic person or event. The structure is recommended not eligible for listing on the NRHP or WHR.

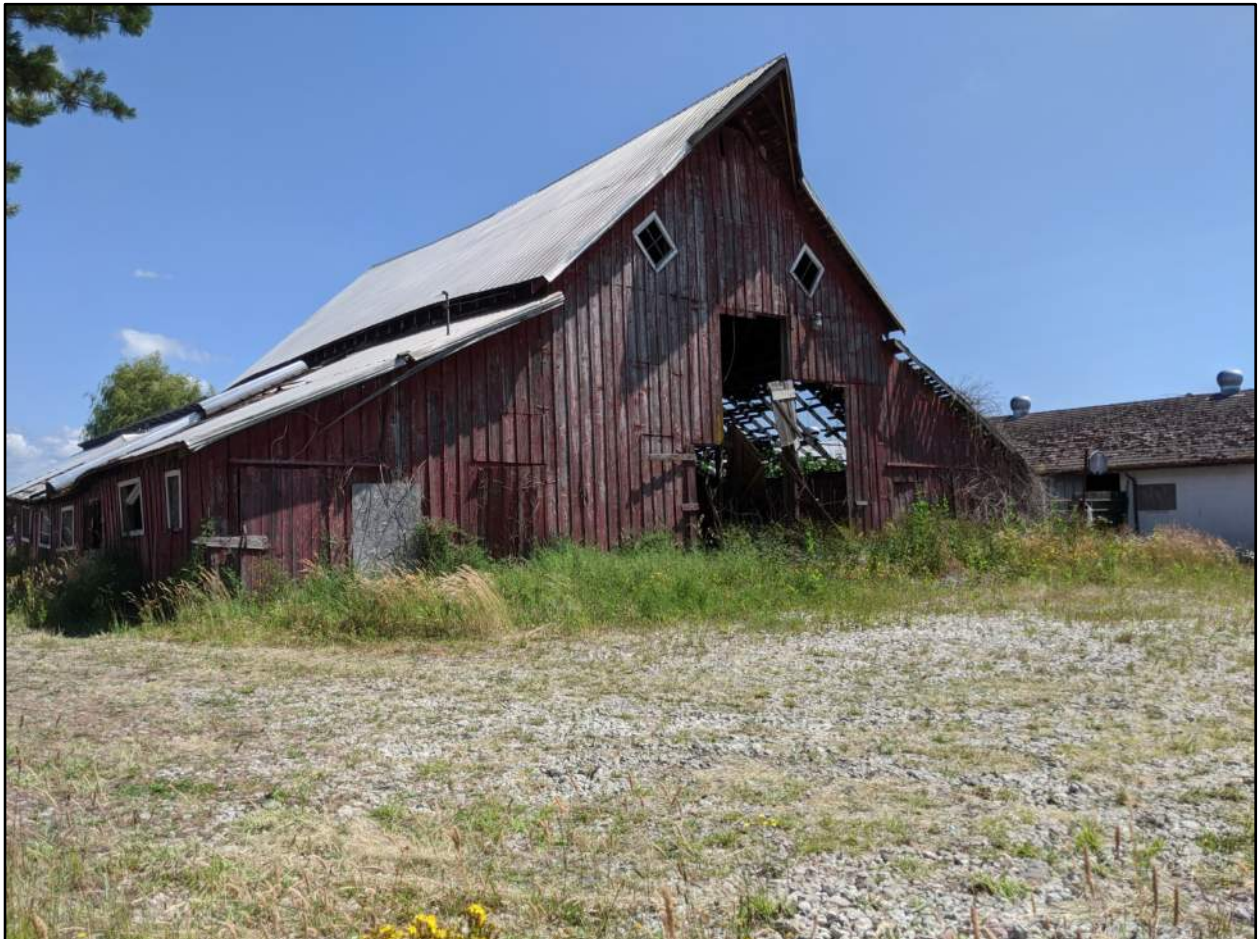
*DAHP Property #722500:* Barn 2 is a farm structure located at the center of the farming complex at 16329 51<sup>st</sup> Avenue (Figure 11). It is of an unknown construction date. The barn was originally built of pole and timber frame construction in a western monitor style. A later lean-to extension on the eastern face gives it a partial appearance of a gable on hip style construction. The foundation appears to be made of a timber base, however, the surrounding concrete pad obscures the foundation and limits verification. The barn is clad in board and batten siding and the roof is covered in ribbed metal sheeting. Standard sized wooden shingles can be seen below the metal sheeting on the original barn structure, and missing sheets reveal mounting planks set between the shingles and the sheets. Long wooden shingles are visible below the sheeting on the eastern wing addition. The roof ends in open rafters. The roof of the southern wing and the eastern lean-to are in poor condition with a high degree of collapse observed.

Figure 11. Barn 2 (DAHP Property #722500) at 16329 51st Avenue NE. Image of west and north elevations, view to the southeast.

The barn is accessed through several doors on the western face, as well as a set of doors on the southeast and northeast corners of the eastern lean-to. The western face of the structure has been cut in several locations for the addition of many doors, which include: vertical hinged doors; horizontal hinged doors; hung, sliding doors; and nested doors. Many of the larger doors are damaged or missing. Fenestrations on the structure vary depending on elevation. Two diamond shaped windows were placed at the third-story height of the western face, with square windows placed at the equivalent height on the eastern face. Several fenestrations were placed at the ground-floor level along the north, east, and southern faces. These are generally in poor condition with remaining windows suggesting a standardized four-pane, two sash style with plain trim on the original north and south faces, and varied single sash windows with plain trim on the eastern addition.

Additionally, a dairy facility was constructed to the south of the barn between 1969 and 1980. A cement livestock loading ramp was added in the space in between and abutting the southern face of the barn as part of the construction.

*DAHP Property #722500:* The construction date of the barn is unknown. However, the structure and associated farm complex were present on a 1954 historic aerial image (NETR 2020). A 1943 topographic map also recorded a structure in the complex vicinity, which may have represented a house or farm complex (USGS 1943). This, along with the developed state of the farm complex as of 1954, indicate the structure is likely circa 1940-50. The barn is in poor condition with many aspects of the structure missing or in disrepair. The structure has also been altered heavily through the addition of the eastern wing and the varied doors and access points cut into the western face. The barn has diminished integrity of feeling, design, materials, and workmanship. The addition of the dairy facility and loading ramp have diminished the integrity of setting. Background research could not identify a direct association with an historic person or event. The structure is recommended not eligible for listing on the NRHP or WHR.

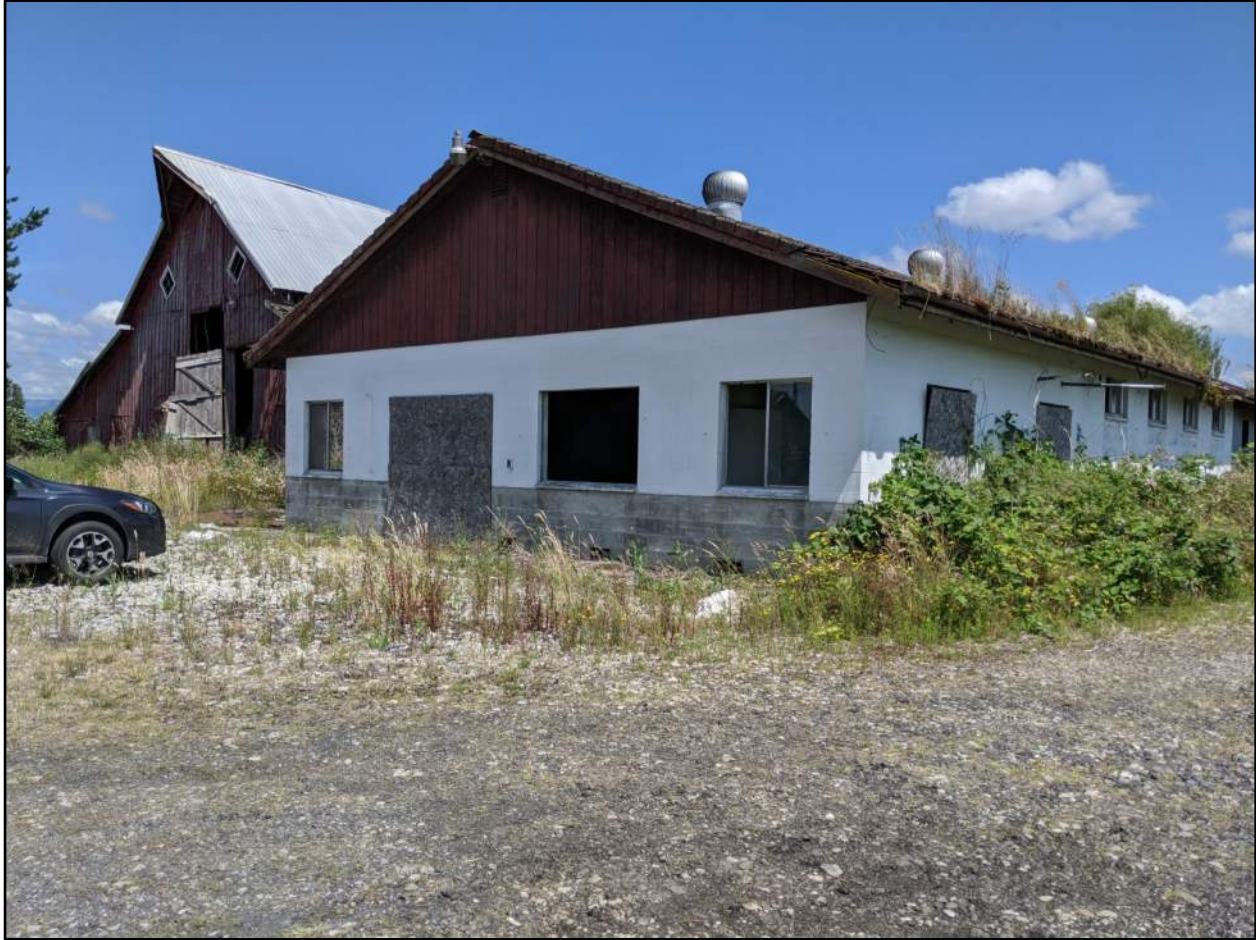
*DAHP Property #722501:* Outbuilding 1 is constructed on the south side of the farming complex at 16329 51<sup>st</sup> Avenue NE (Figure 12). Historic aerial images indicate the structure was built between 1969 and 1980. The structure is built on a poured concrete slab with the western half built at grade and the eastern half poured sloping up to the center. The western two thirds of the building are built of concrete blocks while the eastern third is built of modern plank construction. The roof is made of a front-gable design with the western cement block section covered in stylized, manufactured shingles, possibly ceramic in nature, and the eastern plank-framed section covered in ribbed metal sheeting. Three turbine ventilators are situated along the apex of the roof at evenly spaced intervals. The southern and northern walls of the eastern portion of the building are clad in ribbed metal and plastic corrugated sheets, with the eastern wall left open. The apex of the western wall, above the cement block construction, is clad in panel siding.

Figure 12. Outbuilding 1 (DAHP Property #722501) at 16329 51st Avenue NE. Image of west and south elevations, view to the northeast.

The western exterior door was boarded up at the time of investigation, though the metal interior door suggests most entries may also have been made of metal. Fenestration built into the cement walls were sliding, two-sash windows in metal frames of varying sized depending on the interior room. Larger windows were used for offices while transom style windows were used in the milking parlor.

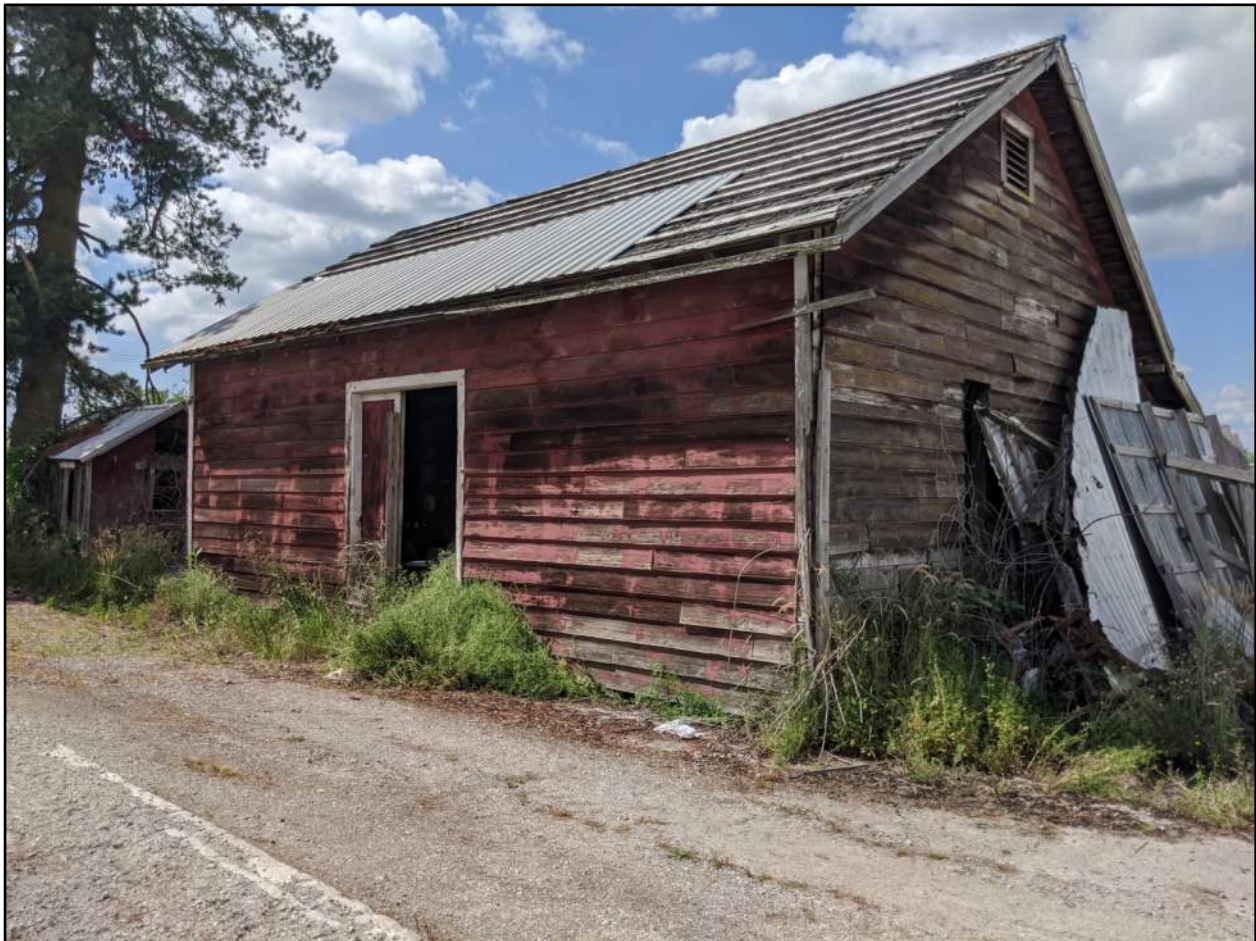
*DAHP Property #722502:* Outbuilding 2 is a multi-purpose structure located north of the center of the farming complex at 16329 51<sup>st</sup> Avenue NE (Figure 13). The building has a generally rectangular footprint and appears to have been constructed in three phases: a main gable roofed structure as the southern half; a moderate lean-to roofed central addition; and a shallow lean-to roofed northern addition. The main body of the structure and central lean-to

addition appeared on a 1954 historic aerial image and may be contemporaneous with other construction on the property circa 1940-50. The main body of the building is rectangular and was constructed on post and pier foundation. The plank framed structure has an open interior. The exterior appears to have double thick siding with a shiplap base and clapboard covering. Some clapboard siding is missing. It is covered in a side gable roof with layered roofing materials. The likely-original wooden shingles form a base layer with horizontal planks lain at regular intervals to support the ribbed metal sheeting. Some metal roofing sheets are missing. The roof terminates in open rafters and a wooden gutter on the south face. The structure is accessed through the main entrance on the south face and has a cut out entrance on the east face, an added flap door on the west face, and vents placed at the each apex of the gable roof. The main door is an internally hung, sliding wooden door with a plain trim surround. Knob and tube electrical materials are still visible on the structure, as well as a large glass insulator at the eastern apex of the roof. A two-direction flood light, though missing bulbs, is located at the southwest corner.

Figure 13. Outbuilding 2 (DAHP Property 722502) at 16329 51st Avenue NE. Image of south and east elevation, view to the northwest.

The central addition is evident in the angle of the roofline (a northern projecting moderate lean-to style) and its juncture with the main structure. The addition is clad in vertical plank siding and is accessed externally through a hung, sliding door on the western face. No internal door was noted in the main structure. The third addition is a shallow lean-to projecting from the northern

*DAHP Property #722502:* The construction date of this outbuilding is unknown. Given historic aerial images available beginning in 1954, it is surmised the original building was likely contemporaneous with other noted construction on the property, circa 1940-50. Both the main section and central addition were visible on the 1954 historical aerial image. The northern addition was present by 1990, however, aerial images taken between 1954 and 1990 were grainy or of low-quality and fine details, such as the presence of the lean-to, could not be distinguished (NETR 2020). Outbuilding 2 has been altered since the original construction with two northern additions, cuts to the eastern and western faces, and new roofing materials. It has diminished integrity of feeling, design, and workmanship. Background research could not identify a direct association with an historic person or event. In addition the structure is not likely to hold as-of yet unknown details concerning construction and outbuilding uses of the time period and is recommended not eligible for listing on the NRHP or WHR.

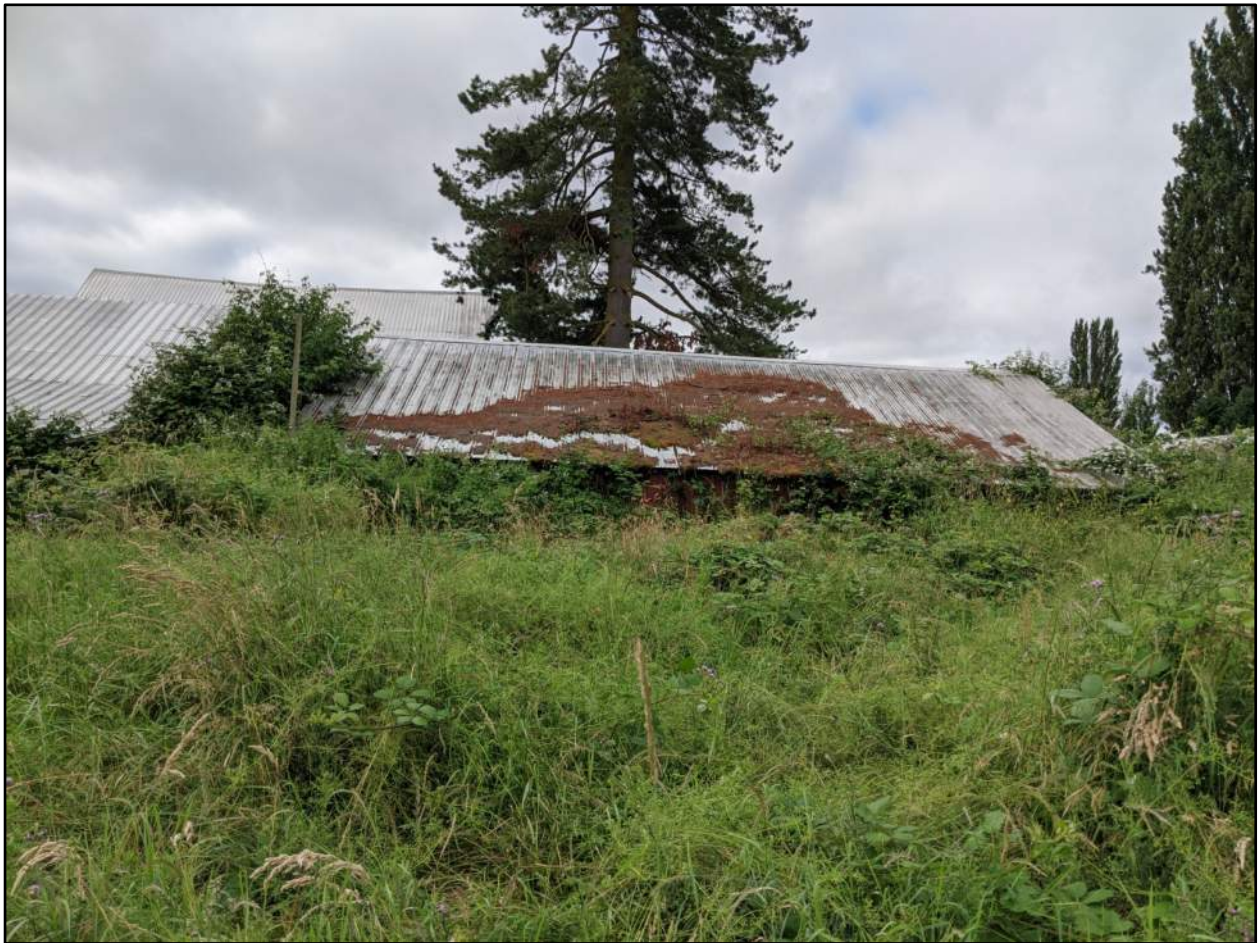
*DAHP Property #722503:* Outbuilding 3 is a structure of indeterminate use located at the northwest edge of the farming complex at 16329 51<sup>st</sup> Avenue NE (Figure 14). The structure is of rectangular footprint with a gable roof. The roof is covered in ribbed metal sheeting and the structure is clad in board and batten siding.

Figure 14. Outbuilding 3 (DAHP Property # 722503) at 16329 51st Avenue NE. Image of north elevation, view to the south. Trees or tall brush to left divide Outbuildings 3 and 2 (DAHP Property # 722502).

*DAHP Property #722503:* This outbuilding was generally obscured by vegetation to the point where investigators could not gain access. As the structure could not be accessed directly, a proper investigation could not be carried out. Given the extent of vegetation surrounding the structure, it is likely it has not been used in some time and is likely in disrepair. The associated shed is small and of an unknown construction date. In addition the structures are not likely to hold as-of yet unknown details concerning construction and outbuilding uses of the time period and are recommended not eligible for listing on the NRHP or WHR.

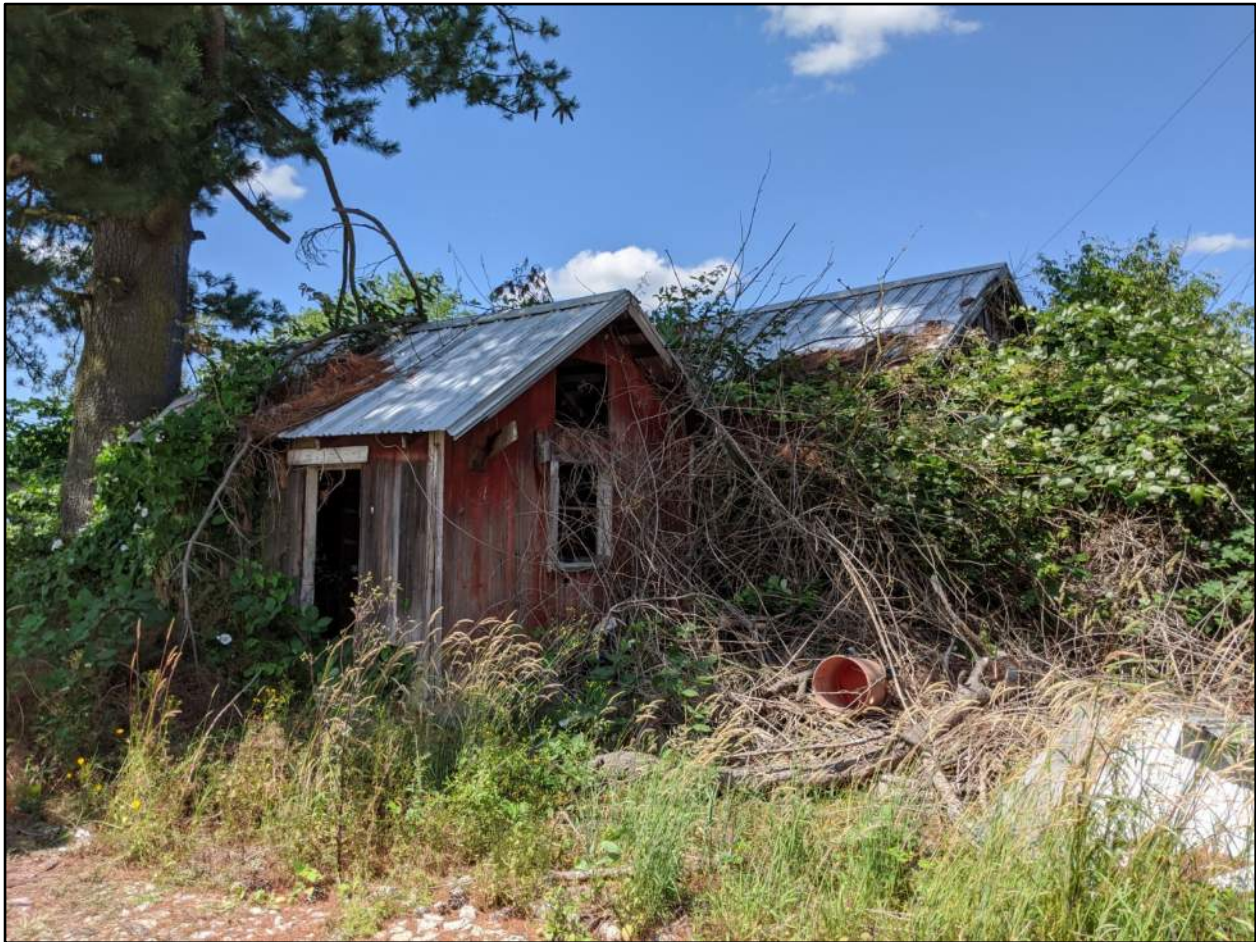
A small shed to the south of outbuilding 3 contained several shelves and may have been a tool or paint shed (Figure 15). The small shed is covered by a side gable with ribbed metal sheeting and is accessed by a door-frame opening on the south face. A hung, two-sash window with plain trim

is located on the eastern face, but lacks glass. A loft may have been accessed by a square opening above the fenestration.

Figure 15. Shed and Outbuilding 3 (DAHP Property #722503) at 16329 51st Avenue NE. Image of south and east elevations of shed (foreground) and southeast corner of Outbuilding 3 (background), view to the northwest.

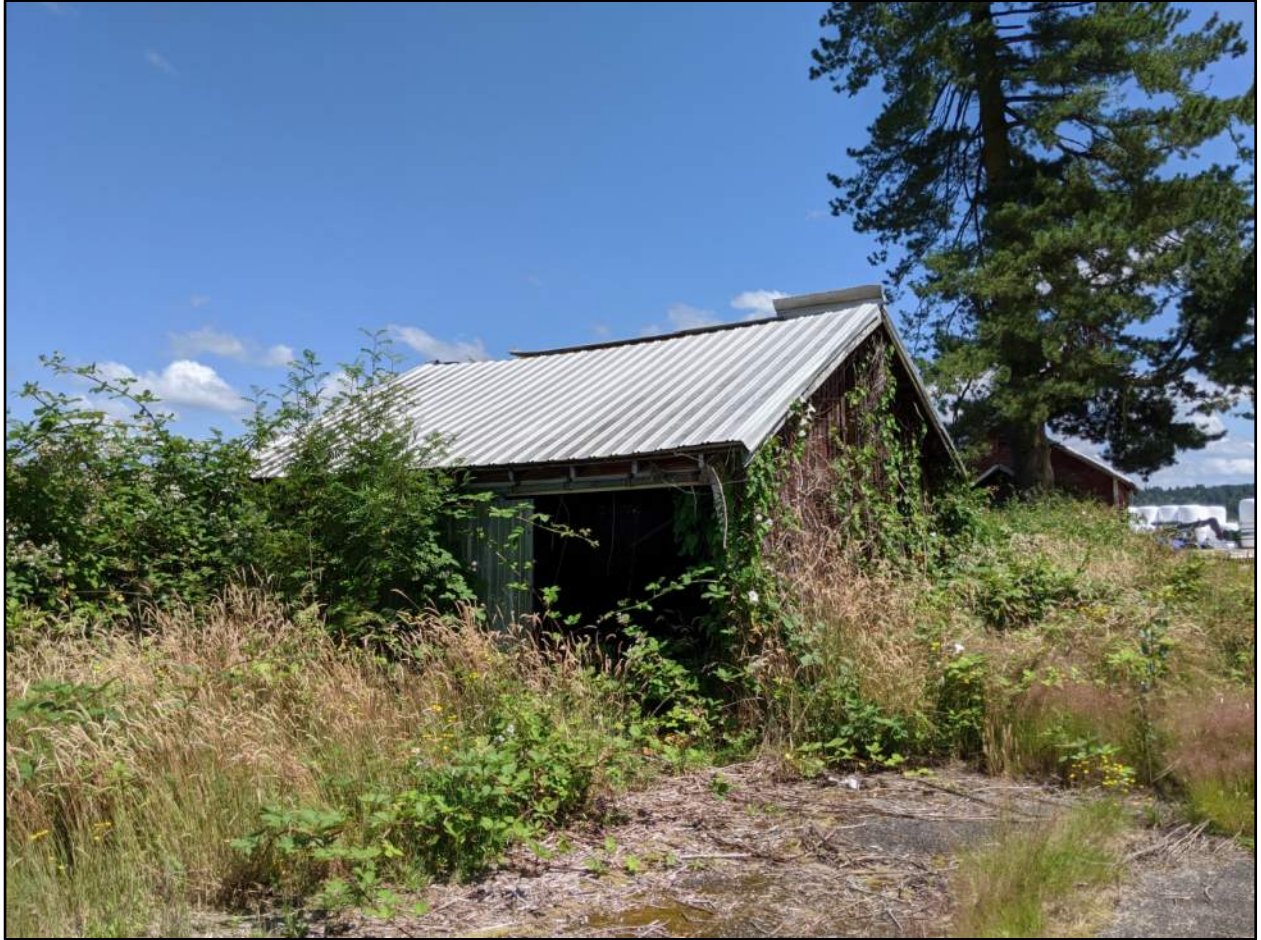
*DAHP Property #722504:* This small garage-like structure is located at the northwest corner of the farming complex at 16329 51<sup>st</sup> Avenue (Figure 16). The rectangular structure has a side gable roof covered in ribbed metal sheeting. The cladding is made of reverse-style board and batten siding. A wide, hung, sliding door covered in corrugated metal sheeting provides entrance on the western, street facing side. A single wide swinging door located on the north end of the eastern face provides a secondary exit. Two holes in the northern wall suggest the fenestrations may have been located there.

Figure 16. Garage-like structure at 16329 51st Avenue NE. Image of west and south elevations, view to the east northeast.

*DAHP Property #722504:* The construction date of the garage is unknown. However, the structure and associated farm complex were present on a 1954 historic aerial image (NETR 2020). A 1943 topographic map also recorded a structure in the vicinity, which may have been a house or farm complex (USGS 1943). This, along with the developed state of the farm complex as of 1954, indicate the structure is likely circa 1940-50. The integrity of materials and workmanship has diminished through the re-roofing of the structure and damages to the walls. Background research could not identify a direct association with an historic person or event. In addition the structure is not likely to hold as-of yet unknown details concerning construction and outbuilding uses of the time period and is recommended not eligible for listing on the NRHP or WHR.

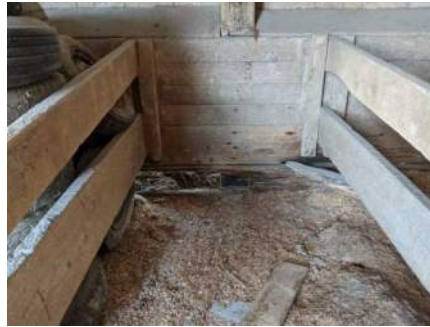
north elevation, internal, close up of foundation and stall addition

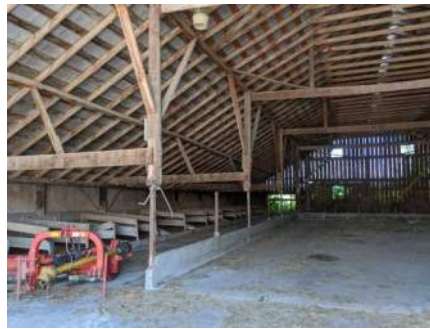
north and east elevation, internal, altered floor and construction

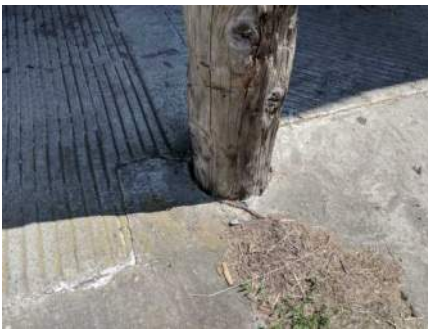
west elevation, close up of post

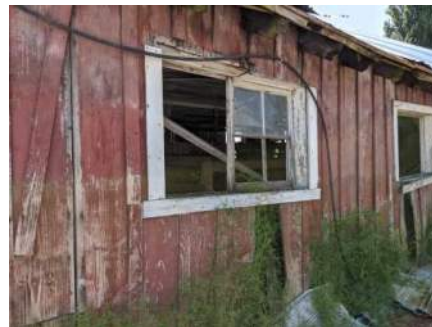
north elevation, close up of fenestration

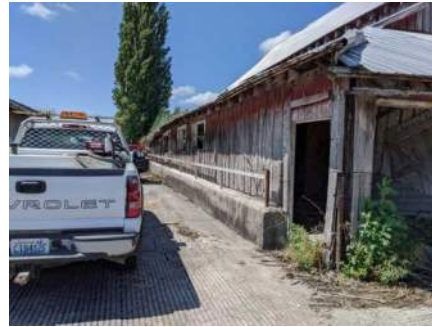
cement loading ramp, south elevation of Barn 2

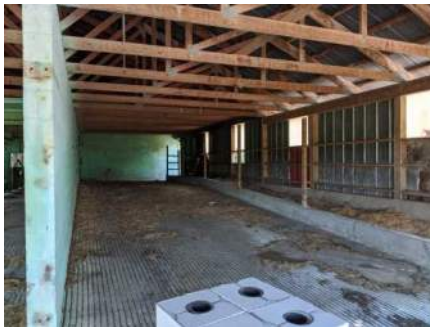
Livestock ramp, internal room

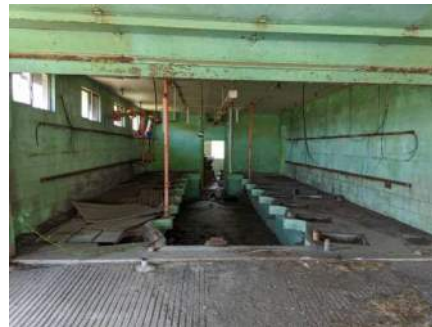
milking parlor

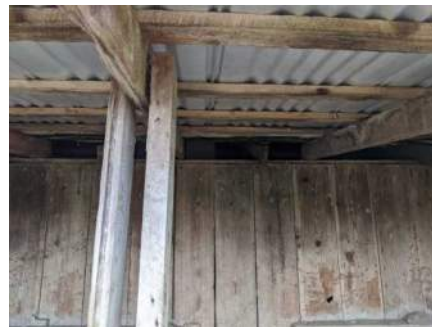
underside of roof, juncture of central and northern additions
