Sewall Wetland Consulting, Inc.

RE: Critical Area Report – Parcels #31053300205300 & 200 City of Marysville, Washington SWC Job #21-180

This report describes our observations of any jurisdictional wetlands, streams and buffers on consisting of Parcels #31053300205300 & 200, located at 15223 Smokey Point Boulevard, in the City of Marysville, Washington.

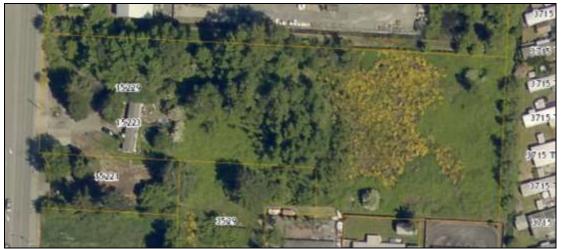
The site consists of an undeveloped, cleared property along the east side of Smokey Point Boulevard. A home was located on the site as recently as 2012, but does not appear in the 2015 aerial photographs of the site so it was removed between 2012 and 2015.

Above: 2012 Aerial photograph of the site with a structure on the western side of the site.

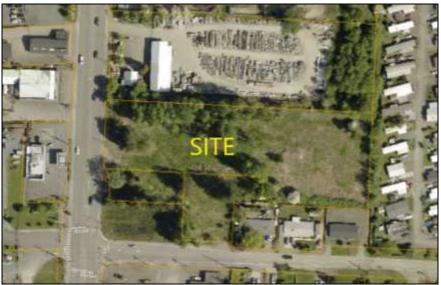
Above: 2020 aerial photograph of the site, note structure removed.

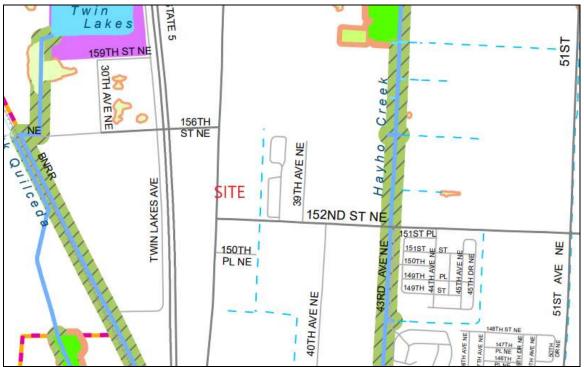
The City of Marysville has both a Critical Areas and Stream Classification website that would pertain to the site. Both maps depict the ditch along the eastern side of the site as "Not Regulated"

Above: City of Marysville Critical areas mapping.

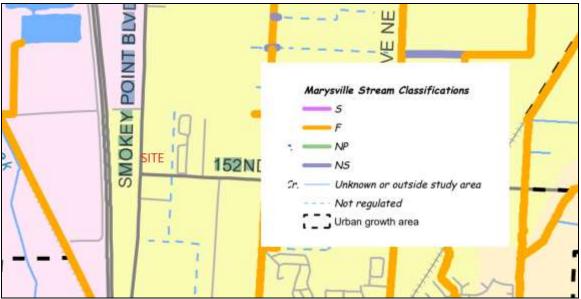
Above: City of Marysville Stream Classification mapping.

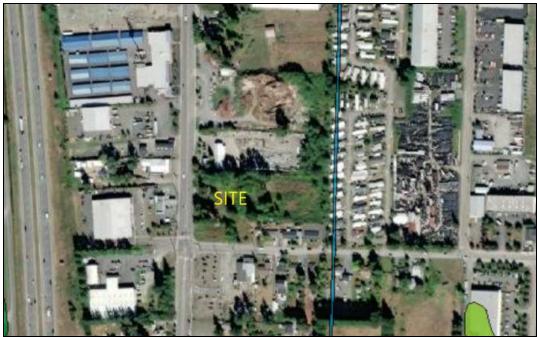
The NWI map depicts no wetlands on the site. A linear water body (ditch) is located east of the site as shown on the other inventories.

Above: NWI map of the area of the site

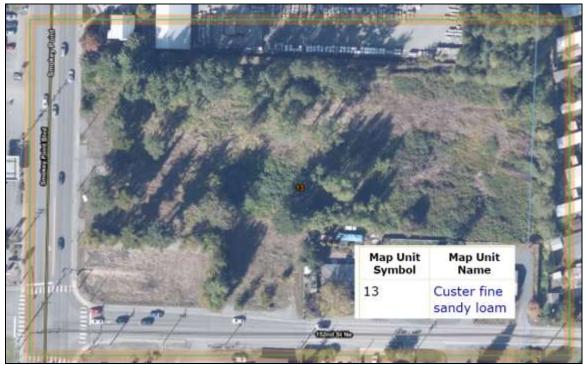
According to the NRCS Soil Mapper website, the site is mapped entirely as Custer Fine Sandy Loam. This soil series considered a "hydric" soils according to the publication *Hydric Soils of the United States* (USDA NTCHS Pub No.1491, 1991).

Above: NRCS soil map of the site.

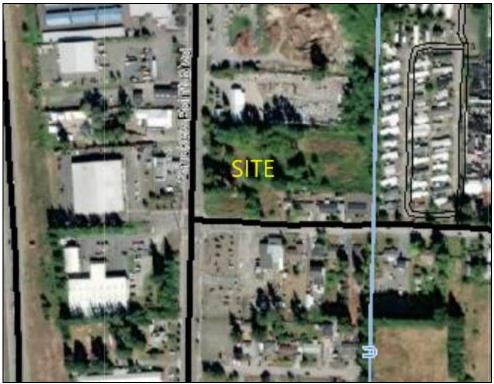
The Washington Department of Natural Resources Fpars stream type mapping website depicts the ditch along the eastern side of the site as "unclassified".

Above: WDNR Fpars stream mapping for the area of the site.

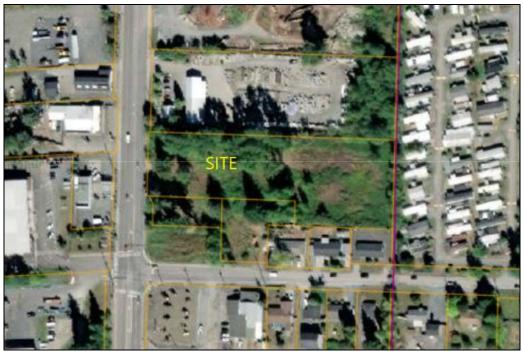
According to the WDFW Priority Habitats mapping website, a ditch is located along the eastern side of the site.

Above: WDFW Priority Habitats mapping of site.
