GEOTECHNICAL ENGINEERING REPORT
City of Marysville State Avenue
Corridor Widening Project
MARYSVILLE, WASHINGTON

City of Marysville State Avenue Corridor Widening Project
Marysville, Washington

Geotechnical Engineering Report

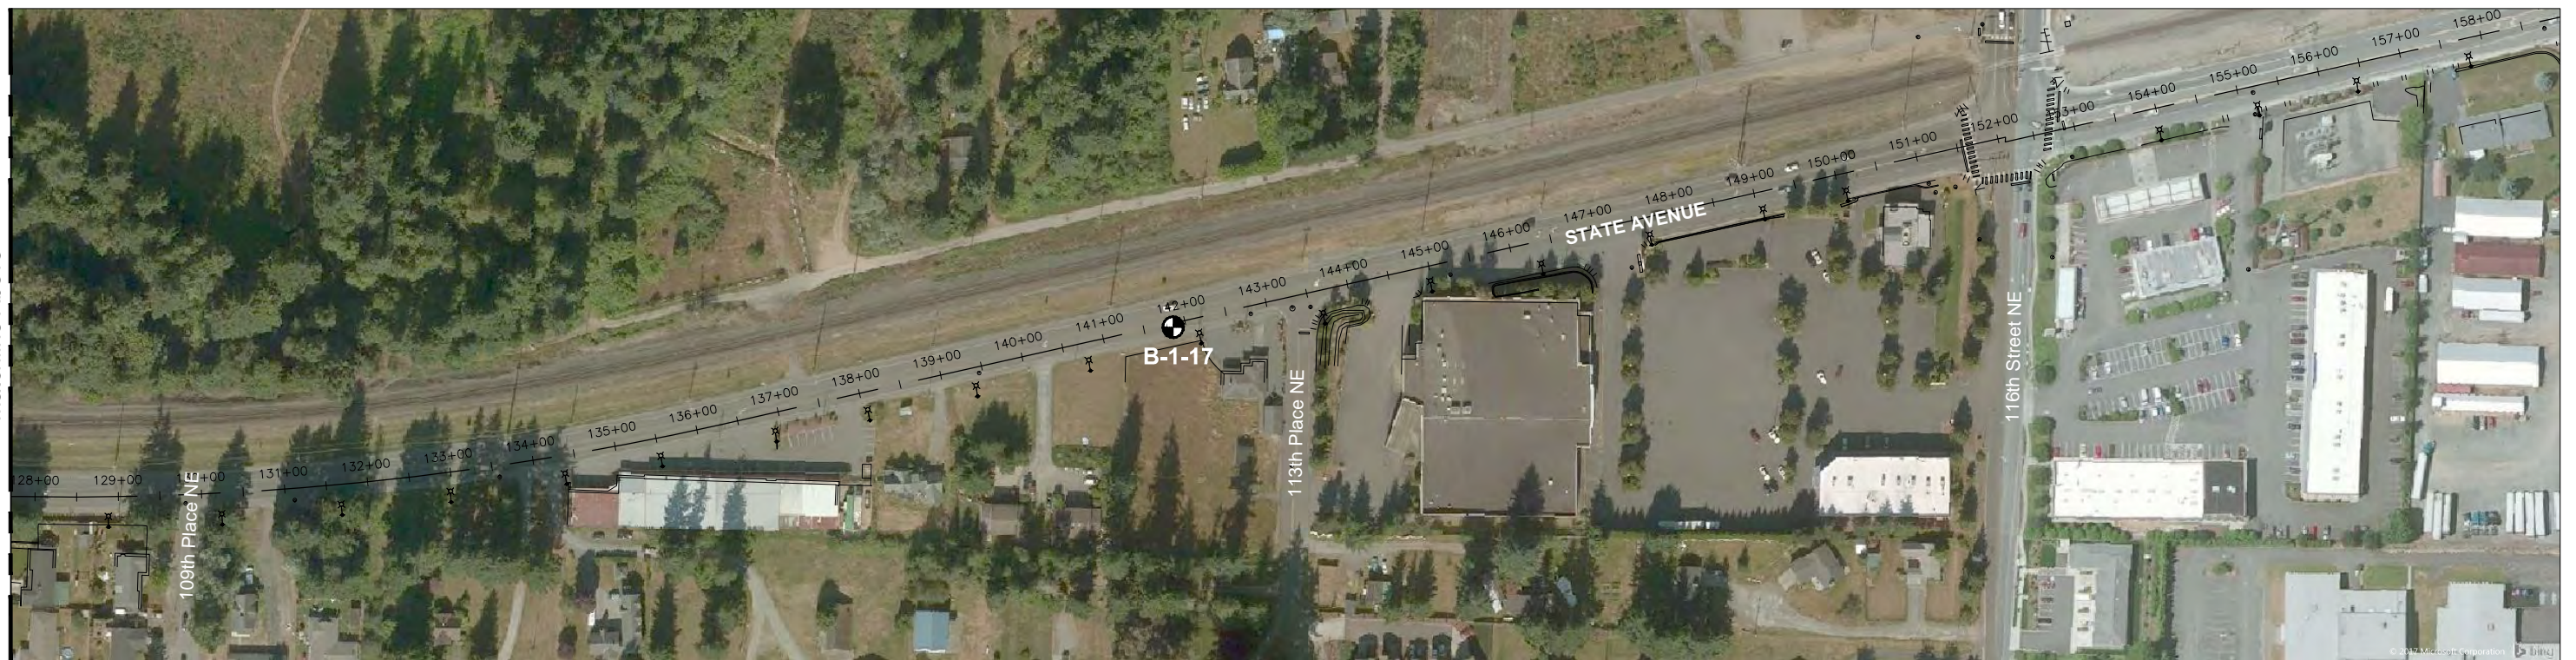
Matchline Below

Figure adapted from file XRef_COM_StateAve-RD.dwg dated 07/06/2016, 17010-SV-BS.dwg received 07/14/2017, and Cross_Sections-60_Percent.dwg, ILLUMINATION XREF.dwg, and ROADWAY LAYOUT XREF.dwg, received 03-19-2018, and XP-ALIGN.dwg, XP-BRIDGE.dwg, XP-RET WALL KEY PLAN.dwg, and XP-ROADWAY.dwg, received 08-23-2018. Aerial imagery provided by Bing! used in accordance with Microsoft Corporation Product Print Rights.
