CULTURAL RESOURCES ASSESSMENT FOR THE
CITY OF MARYSVILLE STATE AVENUE WIDENING PROJECT,
SNOHOMISH COUNTY, WASHINGTON

SWCA Project No. 42694
SWCA Report No. 17-562

CULTURAL RESOURCES ASSESSMENT FOR THE CITY OF MARYSVILLE STATE AVENUE WIDENING PROJECT

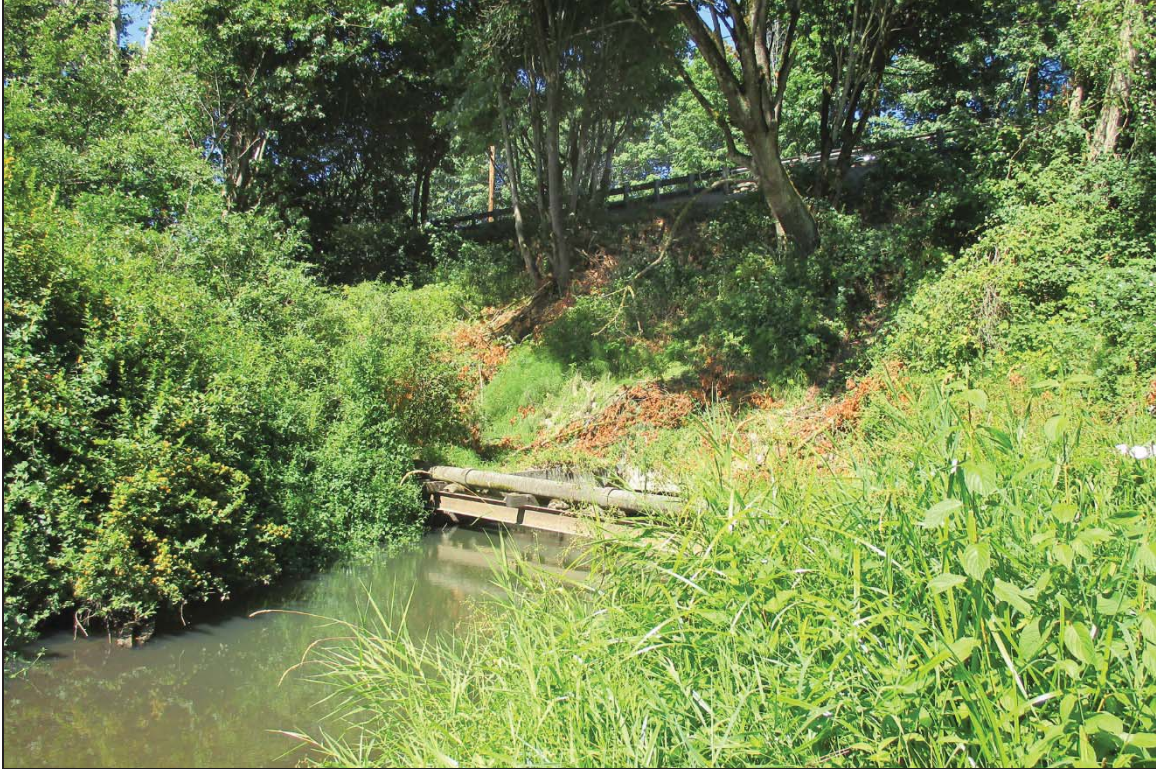
Figure 8. Existing retaining walls and utilities at the bottom of the Quilceda Creek ravine on the west side of State Avenue, view northeast.

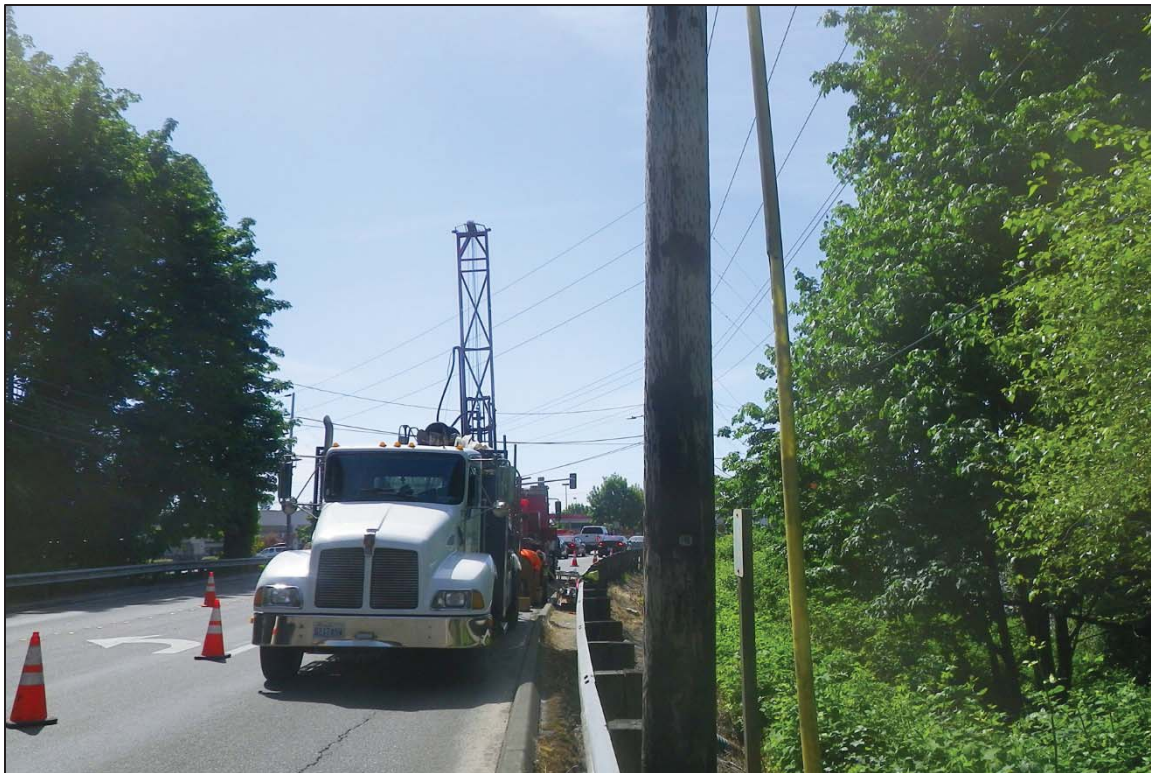
Nine geotechnical borings were drilled along the length of the project by geotechnical engineers. SWCA archaeologically monitored drilling of one boring, B-9-17, in the State Avenue road prism at the Quilceda Creek crossing (Figure 12). Four strata were encountered in B-9-17: from top to bottom, historical period fill, Holocene-aged alluvium, Pleistocene-aged glaciolacustrine or glaciomarine deposits, and Pleistocene-aged glacial outwash.

Figure 12. Borehole drilling at where State Avenue crosses over Quilceda Creek, view south.

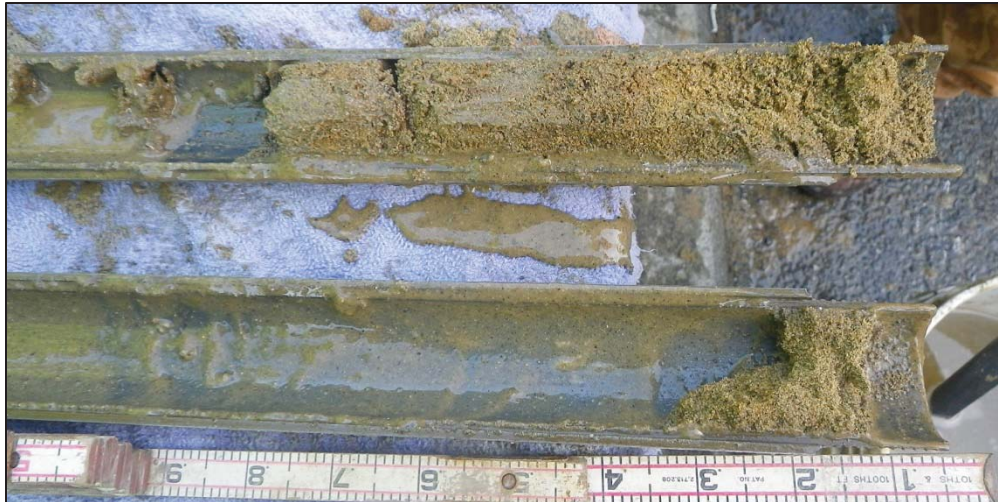
Fill consisting of gray to brown, occasionally gravelly, sometimes silty, fine to coarse sand was encountered in B-9-17 between 0 and 12.2 mbs (0 and 40 fbs) (Figure 13). Bluish gray, fine to medium sandy, silty fill was encountered at the base of the road base fill between 12.2 and 12.3 mbs (40 and 40.5 fbs) in B-9-17. No cultural materials were observed in the relatively massive fill stratum at the Quilceda Creek crossing.

Figure 13. Example of the fill sands observed in B-9-17 at 15 to 16 fbs, top is left.

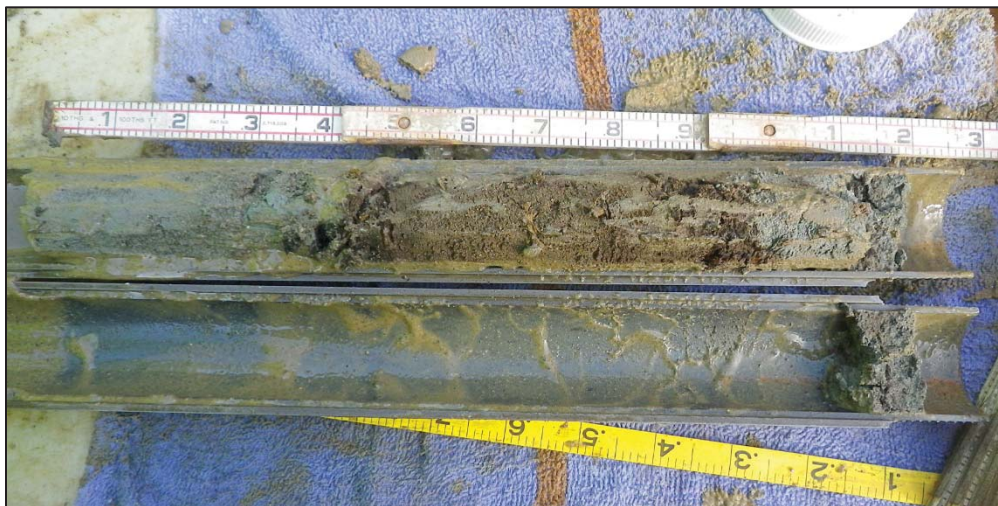
Figure 14. Holocene-aged buried surface at the base of the fill in a sample collected from 40 to 41.5 fbs in B-9-17; top is left.

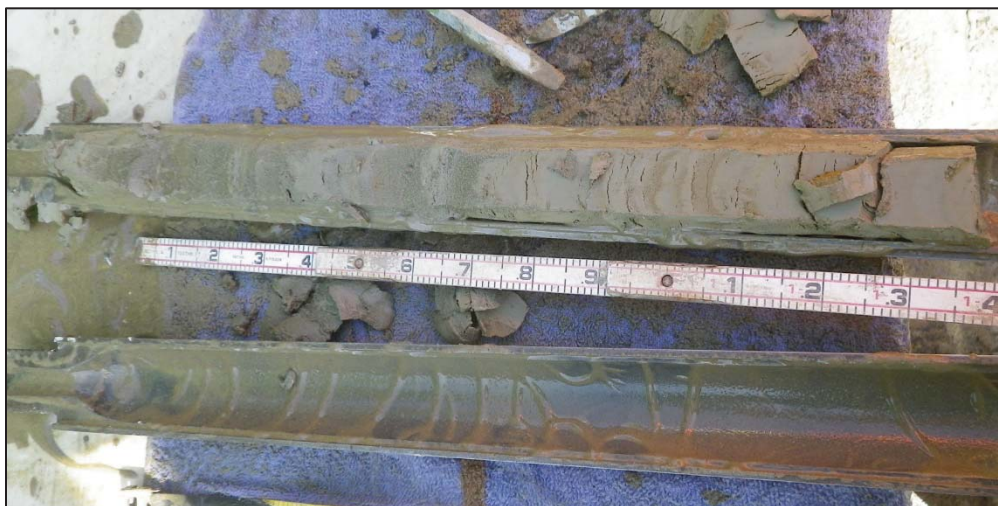
Figure 15. Surface of the glacial deposits from 55 to 56.5 fbs in B-9-17; top is left.

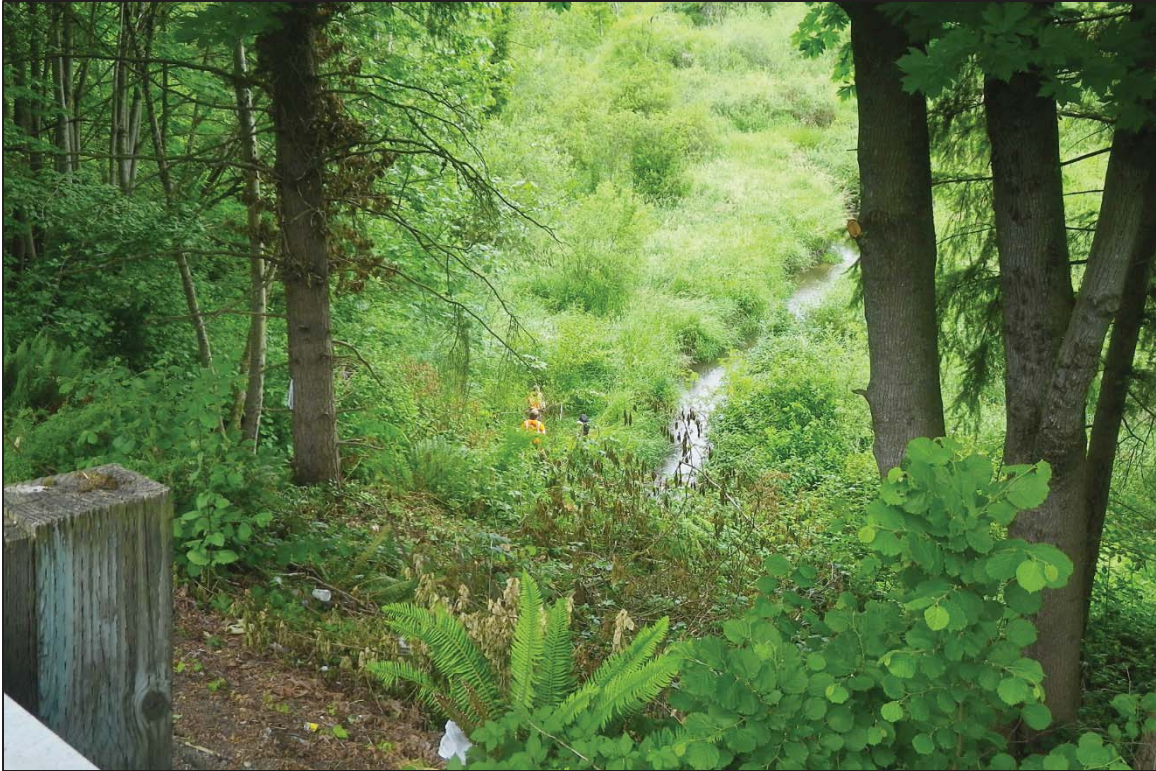
After borehole monitoring, SWCA monitored the excavation of two hand augers, HA-1 and HA-2, that were excavated at the base of the road prism within the Quilceda Creek ravine and floodplain (Figures 16 and 17). Holocene-aged creek alluvium consisting mainly of silty sand deposits, which is similar to the Holocene-aged deposits identified at 12.3 mbs (40.5 fbs) in B-9-17, was present from 0 to 4.6 mbs (0 to 15 fbs) in HA-1 and HA-2 (Figure 18). The upper 1.5 m (5 feet) of silty, sandy alluvium at HA-1 is disturbed. Gray sand with a few pebbles and branch wood fragments was encountered below the disturbed alluvium in HA-1. At HA-2, recent flood deposits and

Figure 16. Overview of HA-1 location and excavation, looking east from State Avenue down the road prism at Quilceda Creek.

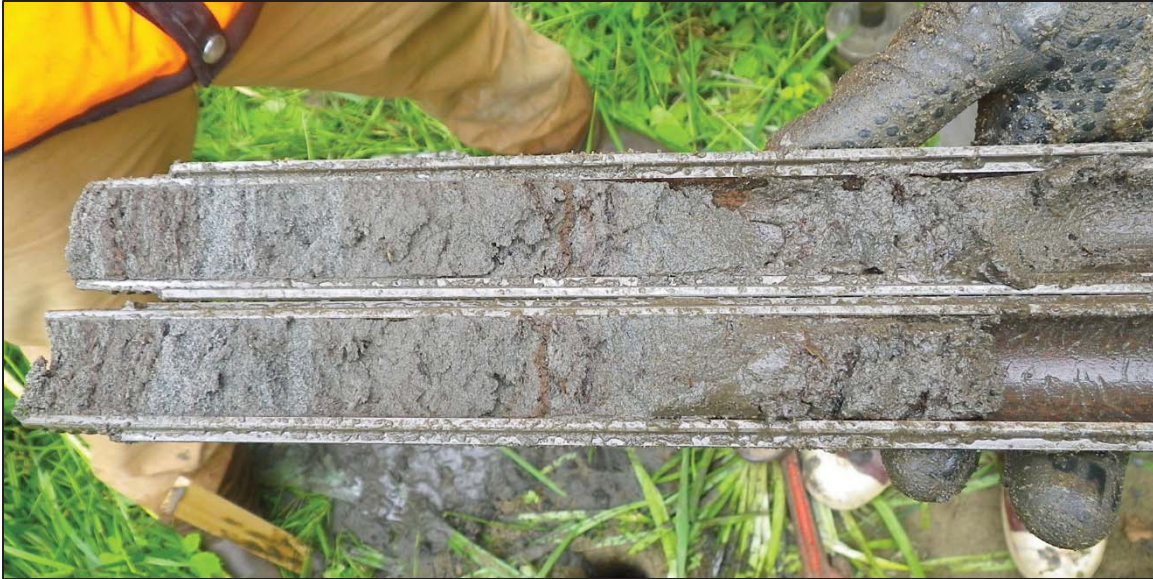
Figure 18. Holocene-aged creek alluvium from 7.5 to 8.3 fbs in HA-2; top is right.

wetland soils were observed at the surface, extending to about 1.2 mbs (4 fbs). Organic-rich to peaty beds of silt and sand were encountered between 1.2 and 4.6 mbs (4 and 15 fbs) in HA-2. The loose and wet sands sloughed out of the auger and samplers below 2 mbs (6.5 fbs), especially on the east side of the State Avenue, so characterization of the more deeply buried alluvium was difficult. Still, the presence of peat and organic-rich beds of silt suggests buried surfaces are present throughout the alluvium on the Quilceda Creek floodplain. No cultural materials were observed in the geotechnical hand auger samples.

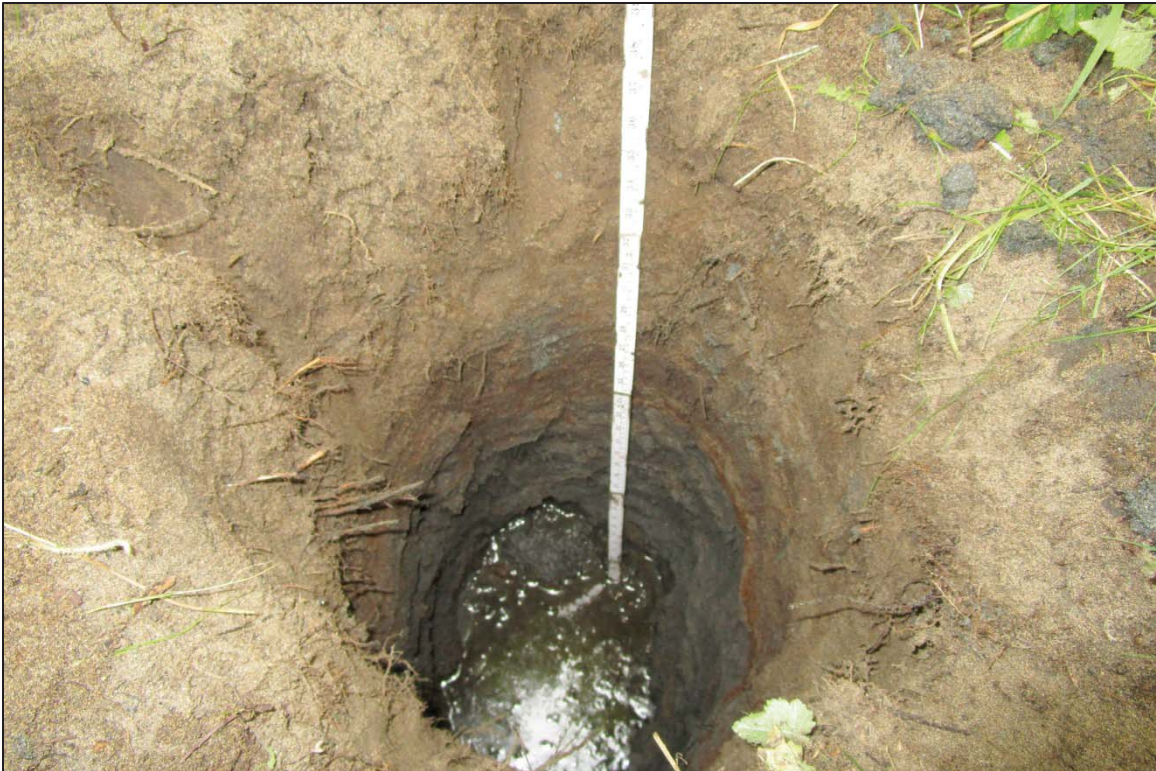
Figure 20. Creek deposits in SP 8, shown excavated from 0 to 102 cmbs.

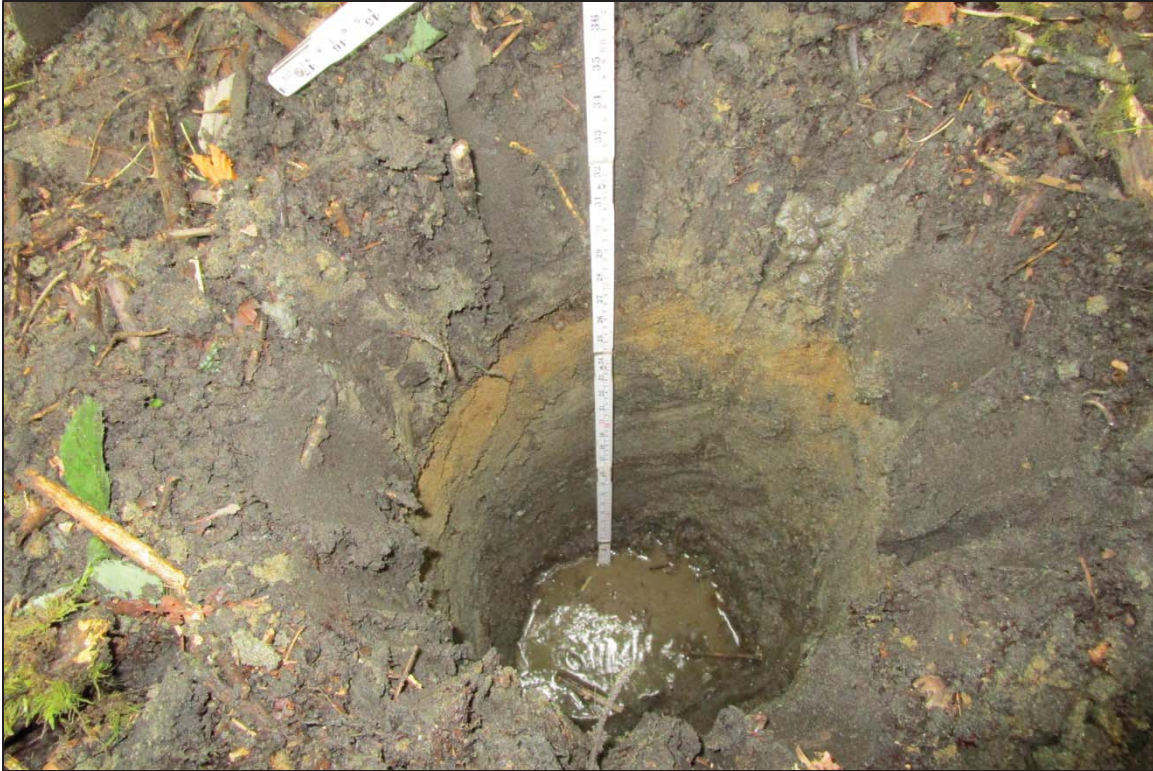
Results of shovel probing at the Quilceda Creek crossing were similar to the results of hand augering. Disturbed wetland soils formed in creek alluvium and a limited amount of imported fill were encountered to depths reaching between 41 and 76 cmbs (1.3 and 2.5 fbs) closest to State Avenue. Where present, the fill contains modern debris, including asphalt in SP 4 at 43 cmbs (1.4 fbs), plastic in SP 5 at 20 to 60 cmbs (8 inches below the surface [inbs] to 2 fbs), glass fragments in SP 9 from 0 to 40 cmbs (1.3 fbs), and metal and glass fragments in SP 10 from 20 to 75 cmbs (8 inbs to 2.5 fbs). However, most of the shovel probes that were excavated in the ravine bottom contained an undisturbed A-B-C soil profile developed in wetland alluvium overlying bedded undisturbed alluvium at depth (Figure 20). In general, the intact alluvial soils are composed of silty sand with scattered pebbles and naturally occurring wood fragments. A well-developed soil A horizon was present across the ground surface, but buried surfaces were not prevalent within the alluvium at depth around Quilceda Creek. Buried surfaces were observed where imported fill was placed in the ravine, for example at SP 4, essentially burying the historical floodplain surface (Figure 21).

Figure 21. Creek deposits in SP 4, shown excavated from 0 to 89 cmbs.

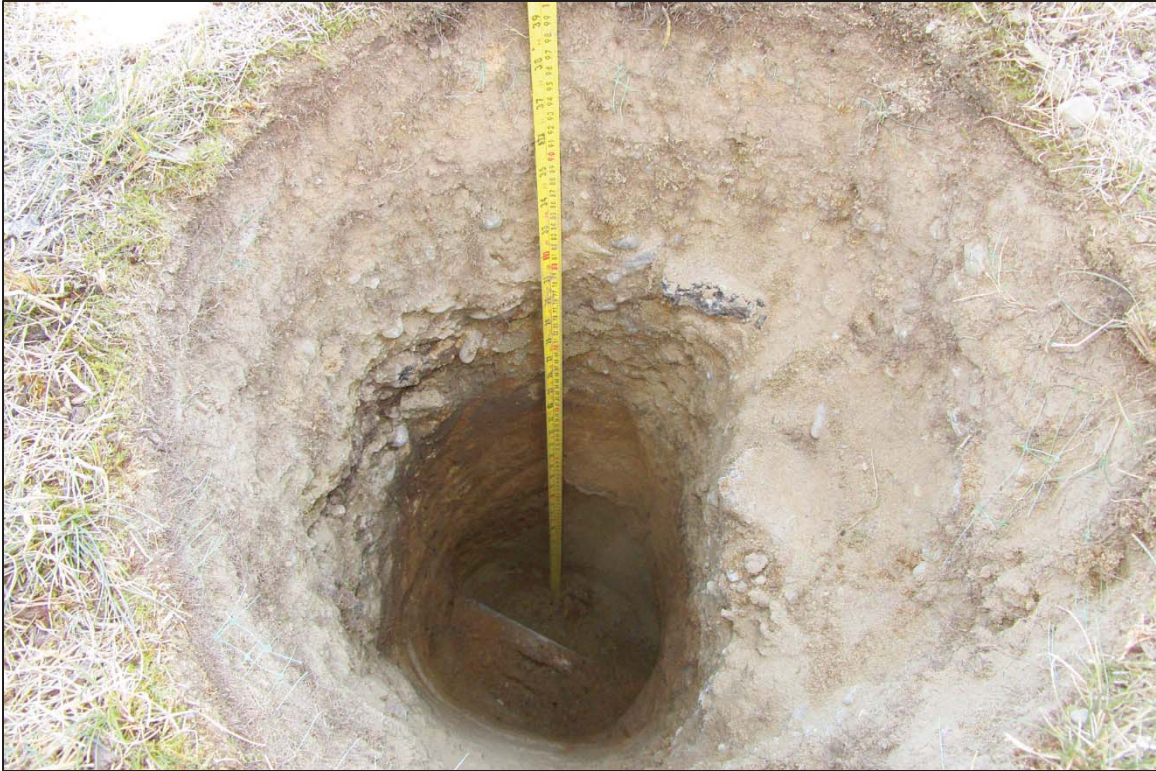
Figure 22. Stratigraphy in SP 27, shown excavated from 0 to 100 cmbs.

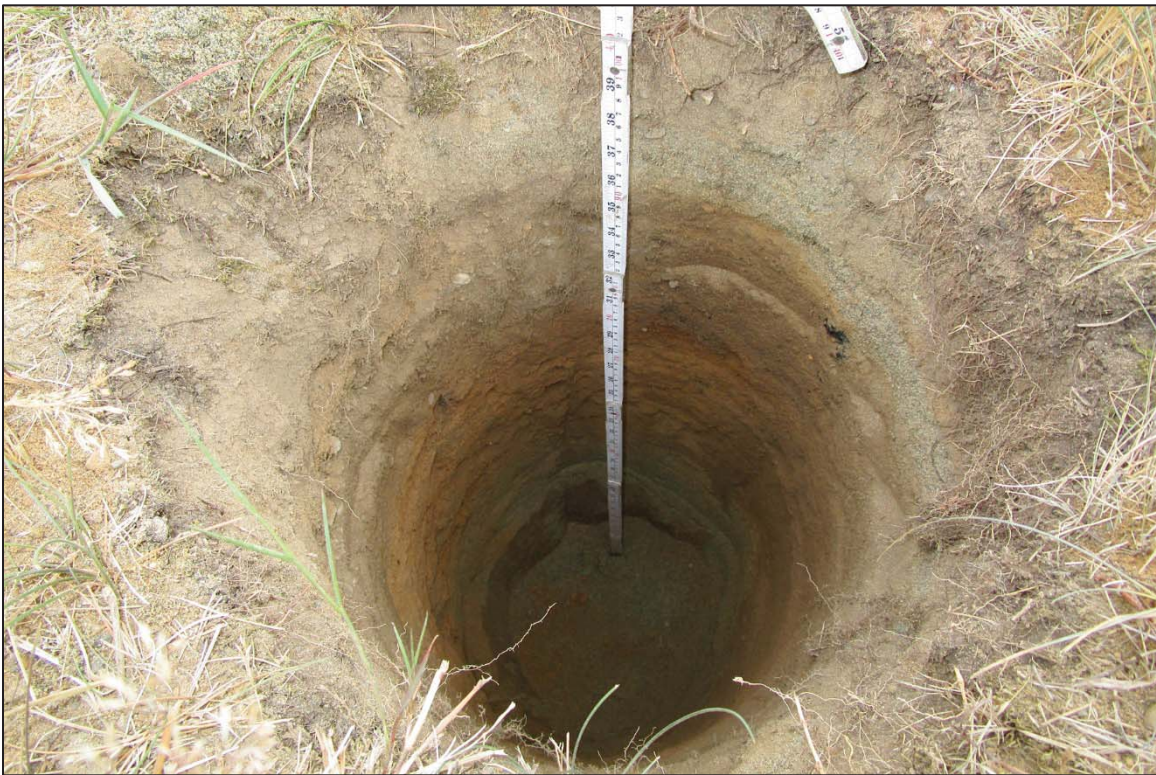
Disturbed soils that originally formed in glacial outwash were encountered in the probes excavated on the upland surrounding the Quilceda Creek ravine. A silty soil A horizon formed in disturbed sediment mixed with road and utility fill typically extends to between 22 and 82 cmbs (9 inbs and 2.6 fbs). Fill is particularly thick at the south end of the project area. The fill and disturbed soil at the surface across the glacial upland contains glass fragments in SP 12 from 0 to 20 cmbs (0 to 8 inbs), in SP 18 from 0 to 40 cmbs (0 to 1.3 fbs), in SP 19 from 40 to 70 cmbs (1.3 to 2.3 fbs), in SP 20 from 0 to 10 cmbs (0 to 4 inbs), in SP 24 from 50 to 70 cmbs (1.6 to 2.3 fbs), and in SP 27 from 40 to 60 cmbs (1.3 to 2 fbs). Asphalt was also encountered in SP 24 at 74 cmbs (2.4 fbs) and in SP 27 from 25 to 30 cmbs (10 to 12 inbs) above a pipe at around 75 cmbs (2.5 fbs) (Figure 22). A sandier, reddish to yellowish brown B horizon that is typical of glacial deposits in the region extends up to 80 cmbs (2.6 fbs) where it is undisturbed, overlying a grayish brown to gray, sandy C horizon that often contains a few pebbles (Figures 23 and 24).

Figure 23. Stratigraphy in SP 13, shown excavated from 0 to 104 cmbs.

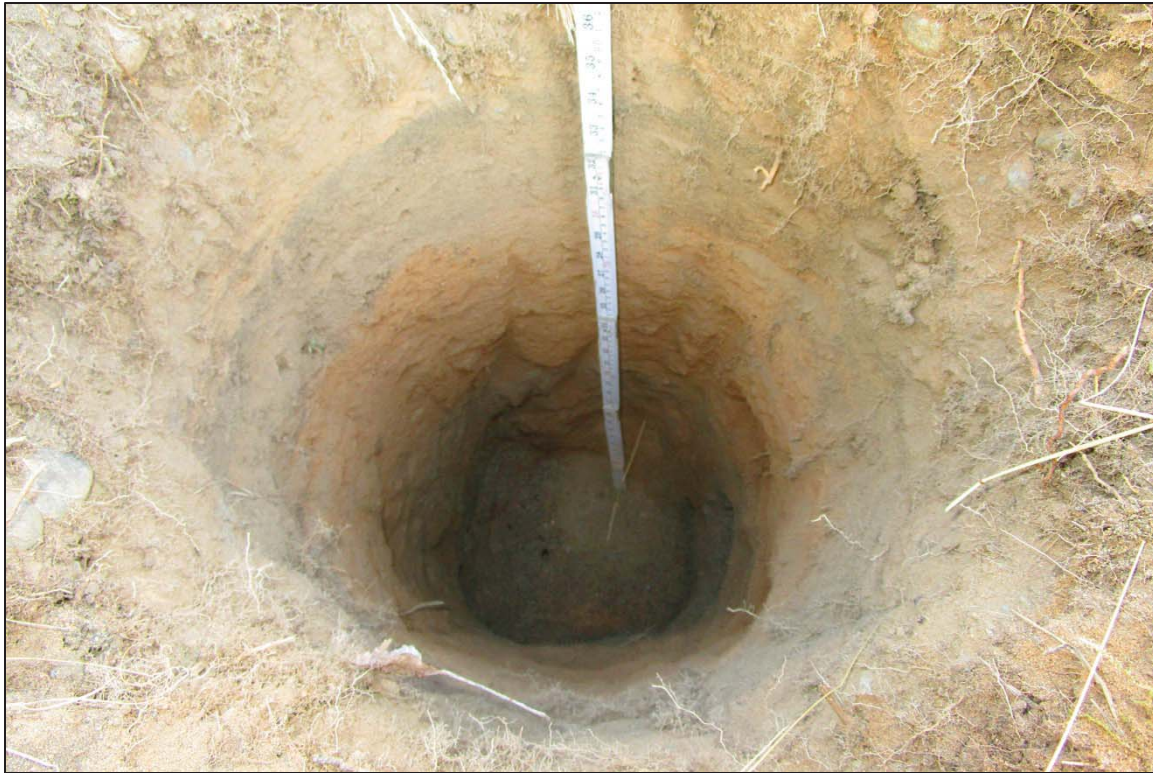
Figure 24. Stratigraphy in SP 16, shown excavated from 0 to 103 cmbs.

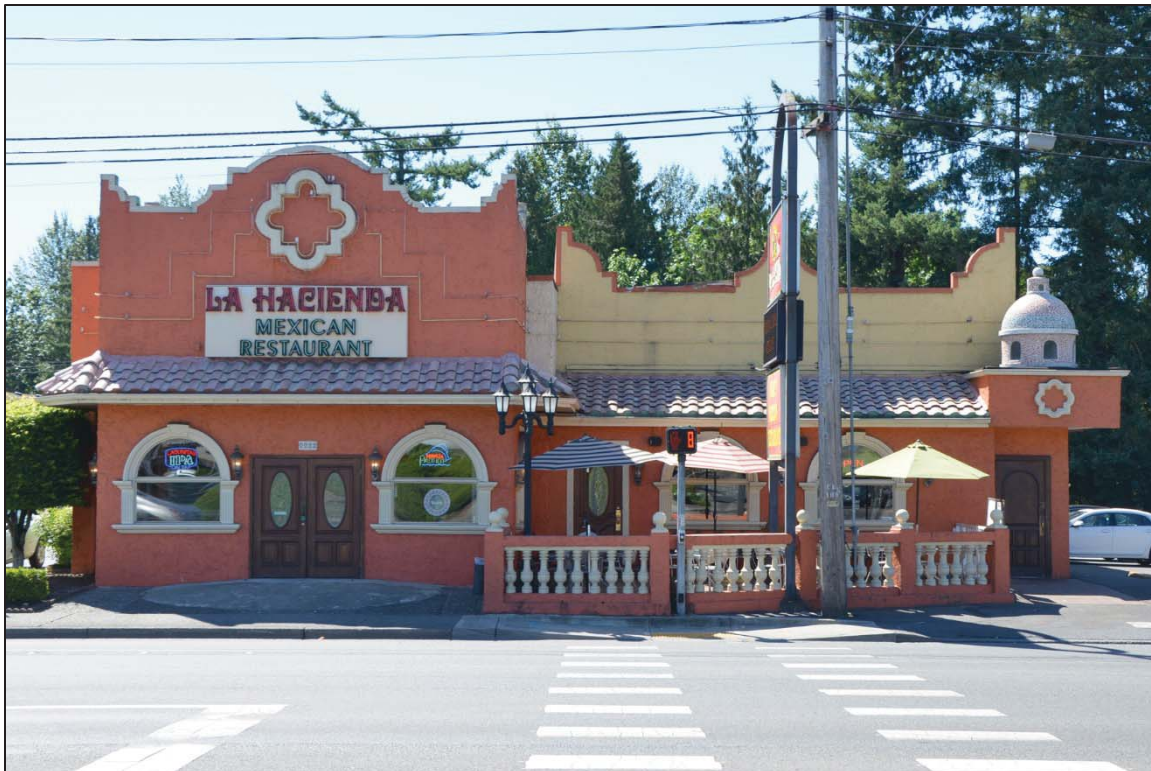
This single-story commercial building has an irregular footprint due to the construction of numerous additions and has a tall false-front Spanish Colonial Revival parapet that continues the exterior wall plane above a pent roof clad with curved clay tiles (Figure 25). The main roof is a cross-hipped form, and the exterior walls are clad with stucco. The interior is lit with large arched windows with a divided arched light over a rectangular lower pane. The window frame is designed to appear like stone. The building stands in the middle of a large parking lot, and utility areas for the building extend to the rear (west) side.

Figure 25. La Hacienda Mexican Restaurant (STA-17-01), showing numerous additions and exterior alterations; view to the west.

This building was constructed in 1928. It is unclear if this building was constructed as a house or a commercial building, but by the mid-twentieth century it housed the White Swan Café. Over the next 70 years, a variety of additions occurred. An addition was completed to the rear of the main building in 1930, and several major additions were built between 1974 and 1976, corresponding to the time the building housed the El Toro Restaurant. Another major remodel occurred in 1997 when the restaurant became La Hacienda. The original building is completely enveloped with additions, and no historic material on the exterior is extant (Snohomish County Assessor 1928–1998). Due to numerous alterations, this building has lost its integrity of design, materials, and workmanship and is recommended not eligible for the NRHP.

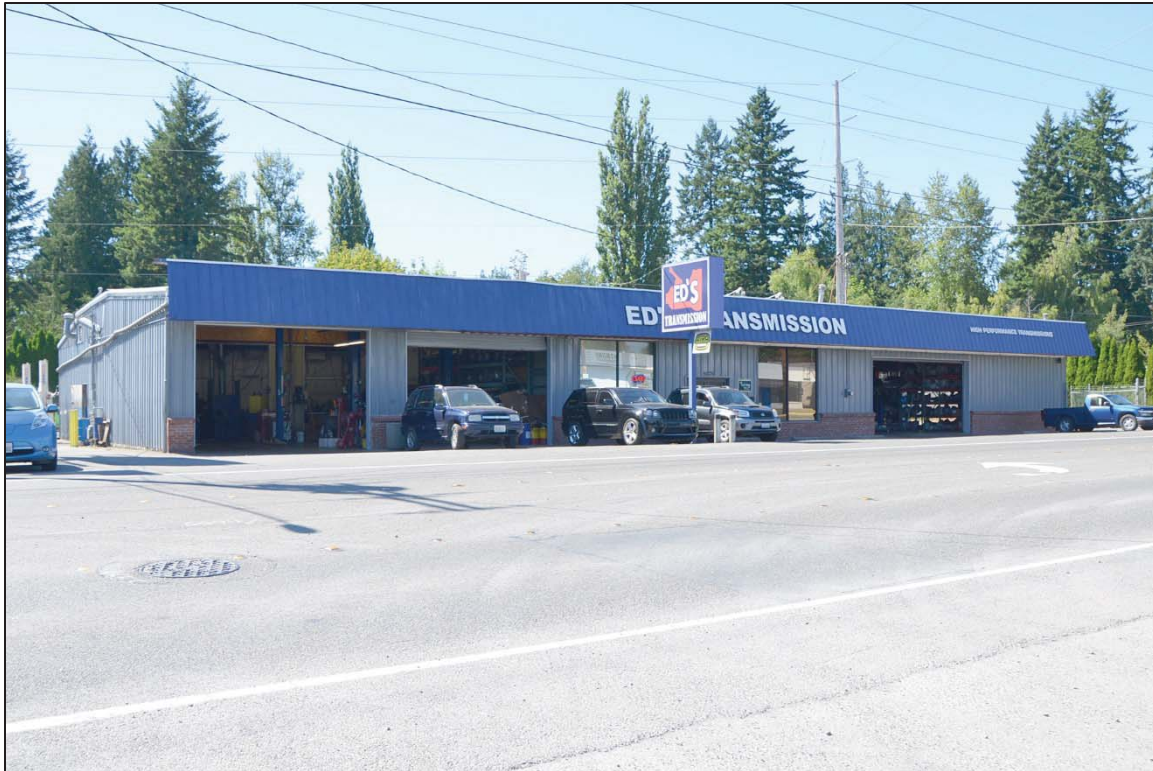
This automobile service garage was built in 1969 by Ralph Seauhier to house T&W Auto Parts. The building at the time of construction was a prefabricated metal two-bay garage. These bays now form the south end of the building, which was expanded to the north in 1977 with construction of an office and auto parts store. A third service bay was added to the north side of the building in 1980 (Snohomish County Assessor 1969–2000). This building lacks integrity of design, workmanship, and materials due to the construction of these additions and is recommended not eligible for the NRHP.

Figure 26. Ed's Transmission (STA-17-02), view to the west. The original section of the building consists of the two service bays on the south end of the building (left side of photograph).

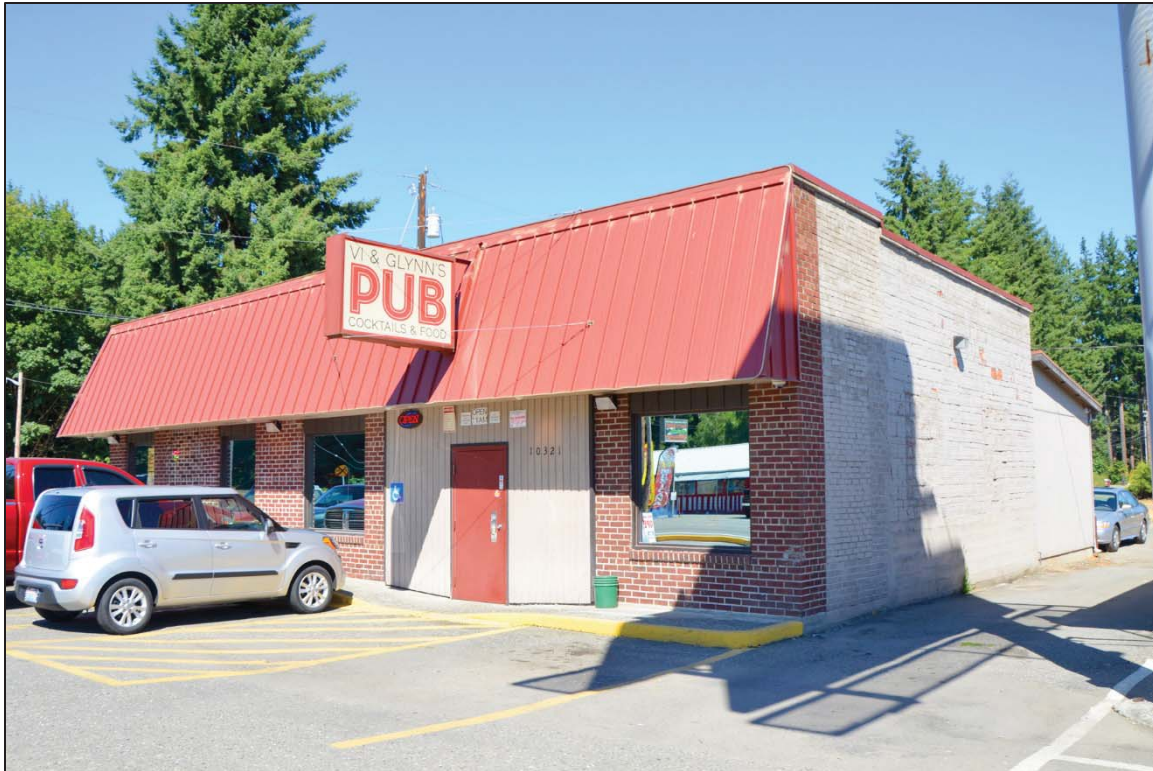
This single-story building stands on a poured concrete foundation and is built with hollow tile bricks and capped with a flat roof (Figure 28). The front (west) side of the building is clad in brick constructed with a common bond. Four large fixed windows light the interior, and a metal main entrance door with a slightly protruding plywood (T1-11) surround is located under a business sign extending from the mansard canopy. A small shed-roofed addition extends to the east from the rear of the building, and a fenced, partially covered patio area has been added to the rear (northeast corner) of the building.

The building appears to have been designed to contain two businesses, with two doors on the main façade with flanking windows. The door in the north half of the façade has been removed and the original four-over-two sash have been replaced with fixed windows. The main door has been replaced and a T1-11 surround has been added to the façade around the front door. A mansard canopy added ca. 1977 extends across the full width of the main façade; this was first clad in wood shingles, but these have since been replaced with standing seam metal roofing material. Shorter windows on the side of the building are covered with wood. These alterations have caused loss of integrity of design, materials and workmanship; this building is therefore recommended not eligible for the NRHP.

Figure 28. Vi and Glynn's Pub (STA-17-04), view to the northeast. Note alterations to entrance and addition of mansard canopy.

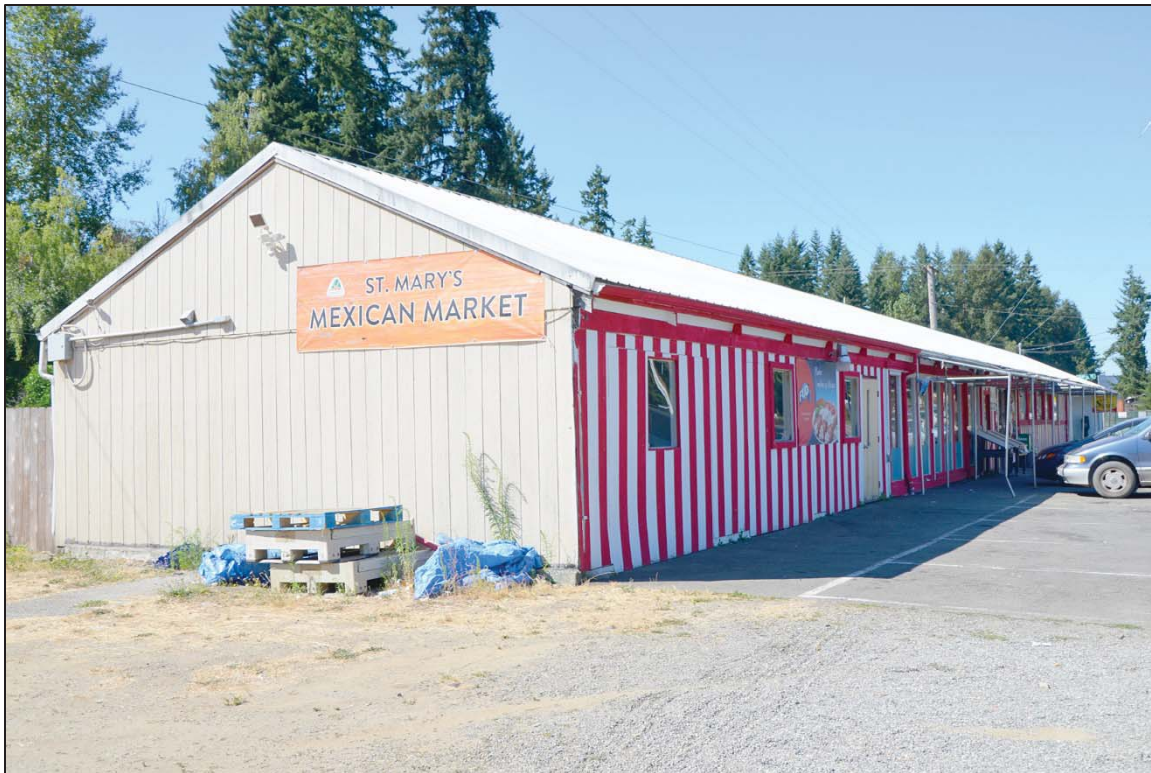
This building was constructed in 1951 as Del's Garden Center, containing two greenhouse spaces and an office. Property records indicate that a new greenhouse was built in 1974, but it is unclear if this is the extant building. Building sketches on property records indicate that the greenhouse was 216 feet long, approximately 50 feet longer than the building that currently stands in this location. This property was owned by Delmer C. Brown until 1997, when it was acquired by Colleen Young. The building currently houses St. Mary's Mexican Market. Extensive exterior alterations have taken place since 1974, including recladding the entire exterior with opaque material to convert the greenhouse into a store. These alterations have caused loss of integrity of design, materials, workmanship and association. This building is recommended not eligible for the NRHP.

Figure 29. St. Mary's Mexican Market (STA-17-05), view to the northwest; note the addition of opaque cladding materials to convert greenhouse into a market.

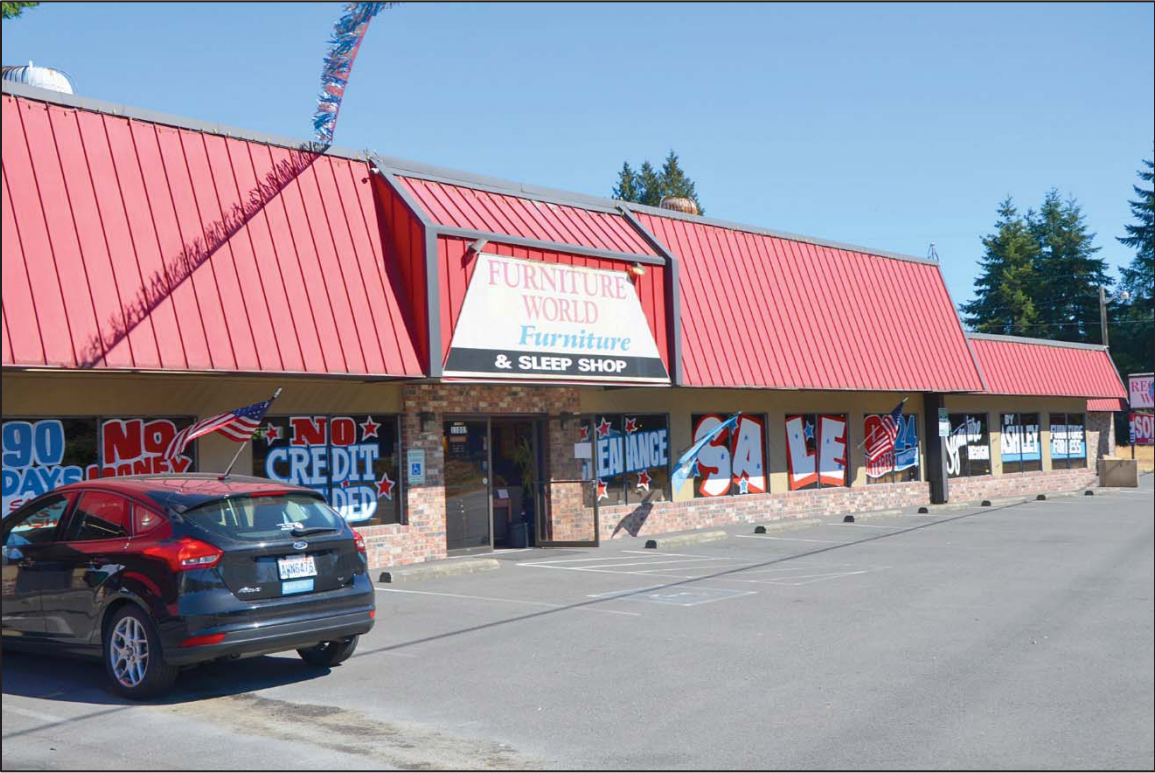
This sprawling, single-story commercial building is clad with brick veneer and diagonal wood siding, and is capped with a large mansard roof that is clad with standing-seam metal roofing material (Figure 31). The north half of the building lacks windows and appears to be used as a warehouse; a loading dock is located on the west wall of this section. The store is located in the southern part of the building, which is lit with fixed windows and is accessed by glass double doors. A slightly shorter addition on the southern end of the building is set back from the main façade and extends the store space.

Figure 31. Furniture World (STA-17-07), south section of the building, view to the southeast.

This building was constructed in 1961 and served as a boat shop, then a warehouse for carpets. In 1979, brick veneer and a wood-shingled mansard roof were added to the building, dramatically altering its appearance. The building has housed a furniture store since the 1970s. This building has undergone several alterations that have caused loss of integrity of design, materials, and workmanship. It is therefore recommended not eligible for the NRHP.

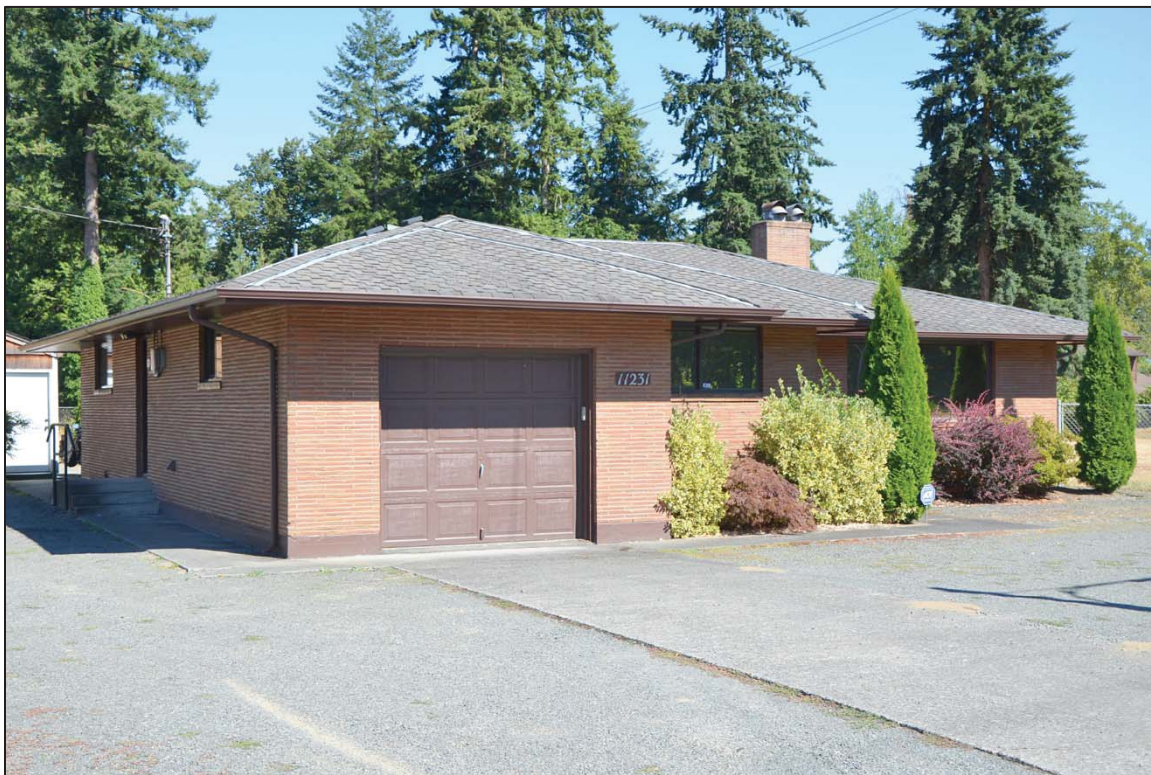
This house, built in 1955, is a typical small early post-war ranch, featuring a classic form and materials such as Roman brick. Although this building appears to retain its integrity, it is one of many similar buildings constructed in Marysville and Snohomish County in the 1950s and lacks individual significance: it is not the work of a master, is not associated with a significant individual, and it does not illustrate distinctive characteristics of a type, period, or method of construction. This house is therefore recommended not eligible for the NRHP.

Figure 32. Chad Wolfe House (STA-17-08), view to the southeast.
