June 7, 2018

**Re: Additional Cultural Resources Assessment for the City of Marysville State Avenue Widening Project, Snohomish County, Washington**

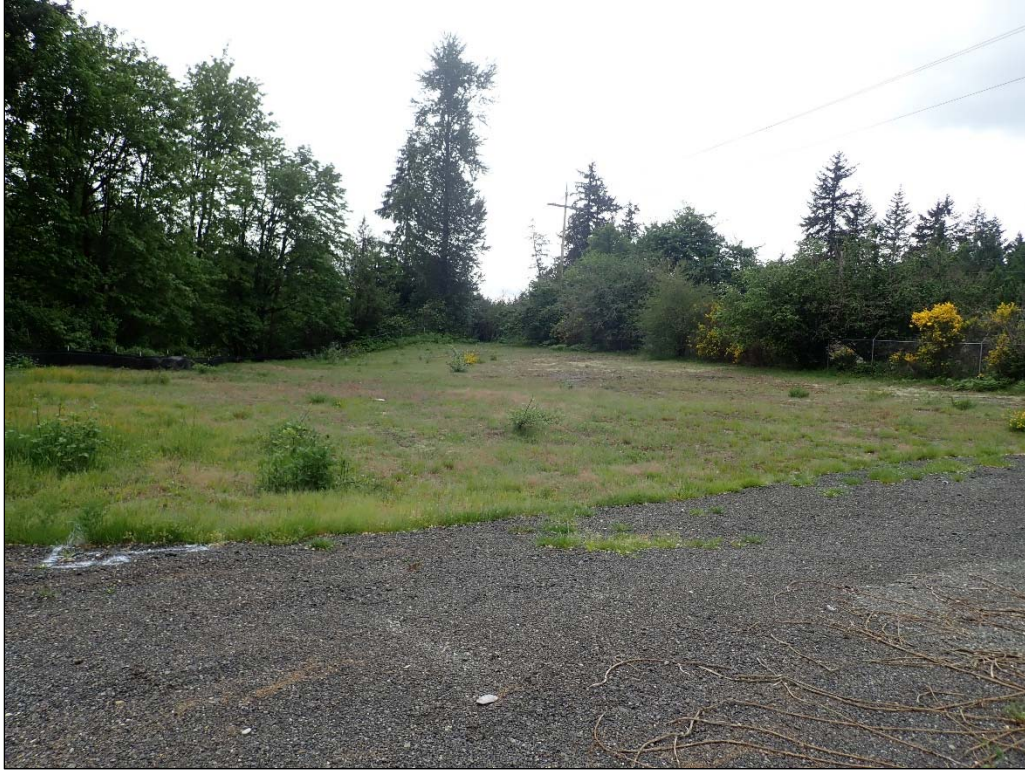
**Photo 1. Overview of the project area. facing south.**

The pedestrian survey was conducted while setting transect lines for the STPs and while recording STPs on the global positioning system (GPS) unit. Visibility was fair due to the limited ground vegetation. Vegetation consisted of limited amounts of short grasses for the majority of the project area (Photo 1). There were taller and denser grasses in the southern portion of the project area. There is a water well located in the middle of the project area. Observations during the surface survey included a substantial amount of modern debris consisting of fragments of various types of glass, rubber, and modern nuts and bolts. No archaeological resources were observed on the surface.

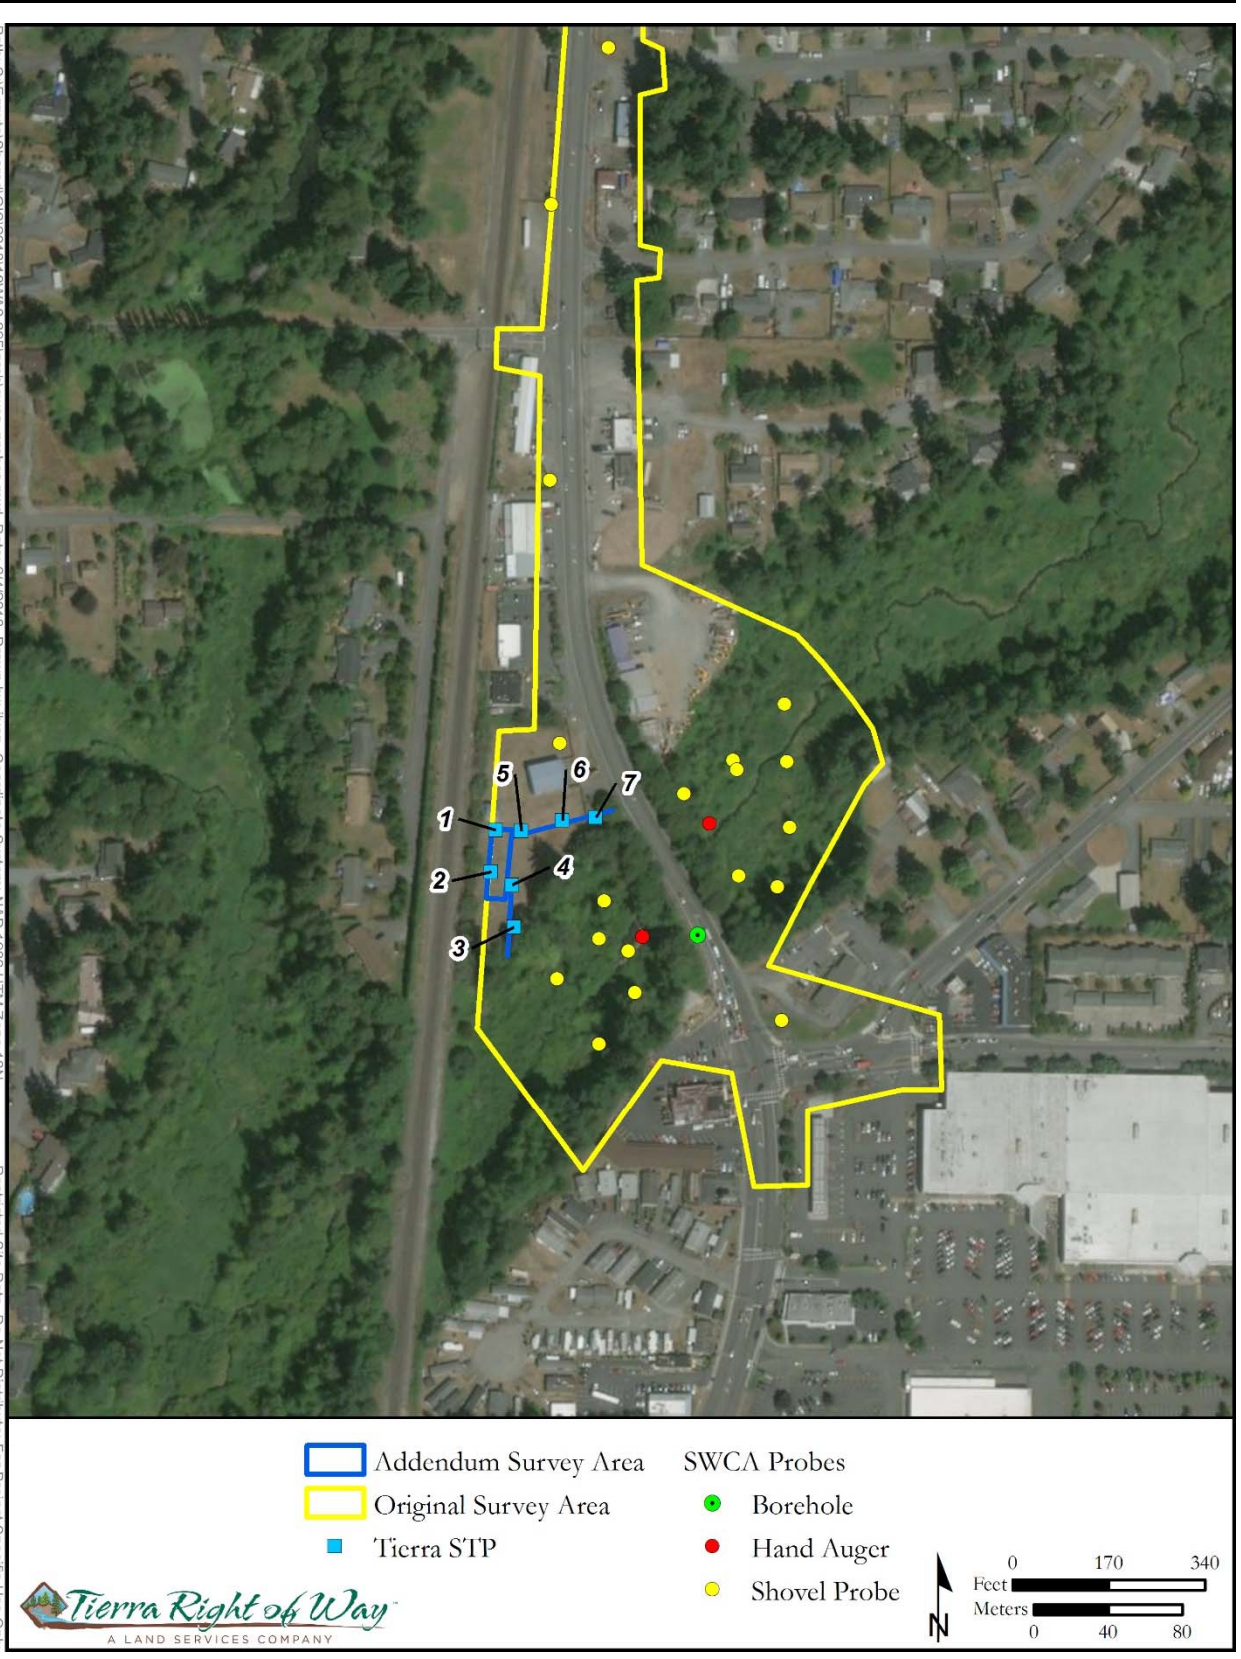
Figure 3. Results of Tierra's shovel testing.

Subsurface testing consisted a total of seven STPs to an average depth of 1.0 m (3.3 feet) (Figure 3). These STPs were set at intervals of 20 m (66 feet) apart within the project area. The results of the subsurface investigations identified nine types of soil matrices (Table 2). Matrices A, G, and L were identified as possible disturbed native soil or imported fill. Matrices B through F and H are fairly consistent with the Ragnar fine sandy loam series. Subsurface investigations show there have been multiple events of sediment disturbance within the project area to at least 40 cm (16 inches) below the surface.

Six of the seven STPs were negative for cultural material. The results of the STPs are presented in Table 3. STP three resulted in three pieces of non-diagnostic historic glass fragments at 40 cm (16 inches) below the surface. The cultural material was observed in disturbed native soil or imported fill (Photos 2–4).
