# Geotechnical Report

## Kostenick Property

Marysville, Washington

RN File No. 3395-004A • May 5, 2021

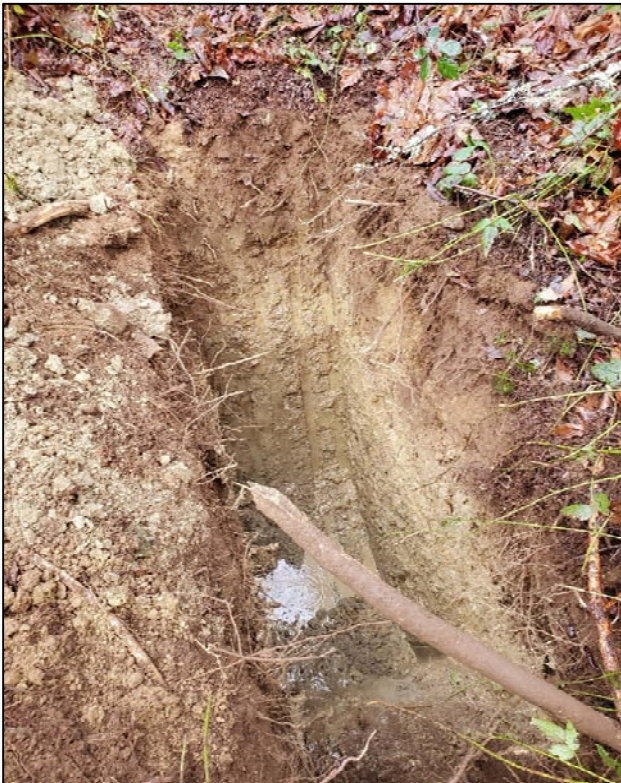
<b>ROBINSON</b> NOBLE  Kostenick Property 3395-004A <b>Figure 4</b>
--	---

Depth (ft.)	Soil Description	USC	View of Test Pit 1
0.0 - 1.2	Dark brown organic silt with roots (loose, moist) <b>(Duff)</b>	OL

1.2 - 2.0	Brown sandy silt with gravel trace roots and cobbles (medium dense, moist)	ML	
2.0 - 3.5	Rust stained brownish-gray sandy silt to silty fine to coarse sand with gravel and cobbles (medium dense, moist to wet)	ML/SM	
3.5 - 7.0	Brownish-gray weakly cemented sandy silt to silty fine to coarse sand with gravel and cobbles (dense to very dense, moist)	ML/SM

The subsurface conditions at the site are briefly described below, based upon our completed field explorations of soils and review of geologic maps for the site. For a more detailed description of the soils encountered, review the Test Pit Logs in Figures 4 through 10.

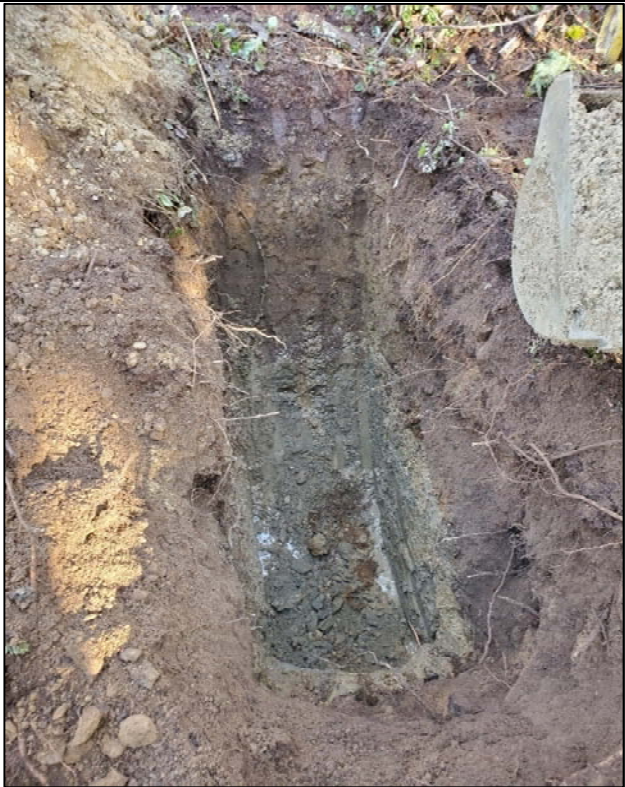
<b>ROBINSON</b> NOBLE  Kostenick Property 3395-004A <b>Figure 5</b>
--	---

Depth (ft.)	Soil Description	USC	View of Test Pit 2
0.0 - 0.8	Dark brown sandy silt with organics, wood and roots (loose, moist) <b>(Duff)</b>	ML

0.8 - 2.5	Brown sandy silt with gravel trace roots and cobbles (medium dense, moist to wet)	ML	
2.5 - 4.0	Rust stained brownish-gray sandy silt to silty fine to coarse sand with gravel and cobbles, banded rust mottling (medium dense to dense, moist to wet)	ML/SM	
4.0 - 5.5	Brownish-gray weakly cemented sandy silt to silty fine to coarse sand with gravel and cobbles (dense to very dense, moist)	ML/SM

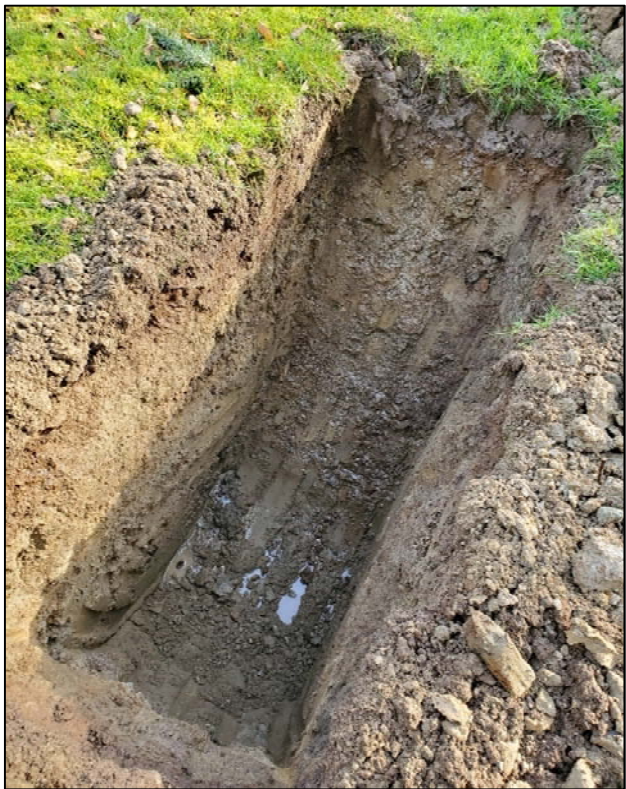
<b>ROBINSON</b> NOBLE  Kostenick Property 3395-004A <b>Figure 6</b>
--	---

Depth (ft.)	Soil Description	USC	View of Test Pit 3
0.0 - 0.5	Grayish-brown silty sand with trace gravel and roots (loose, wet) <b>(Fill)</b>	SM

0.5 - 1.0	Brown sandy silt with gravel trace roots and cobbles (loose, moist to wet)	ML	
1.0 - 4.0	Rust mottled brownish-gray sandy silt to fine to coarse sand with gravel (medium dense to dense, moist to wet)	ML/SM	
4.0 - 5.0	Brownish-gray weakly cemented sandy silt to silty fine to coarse sand with gravel and cobbles (dense to very dense, moist)	ML/SM

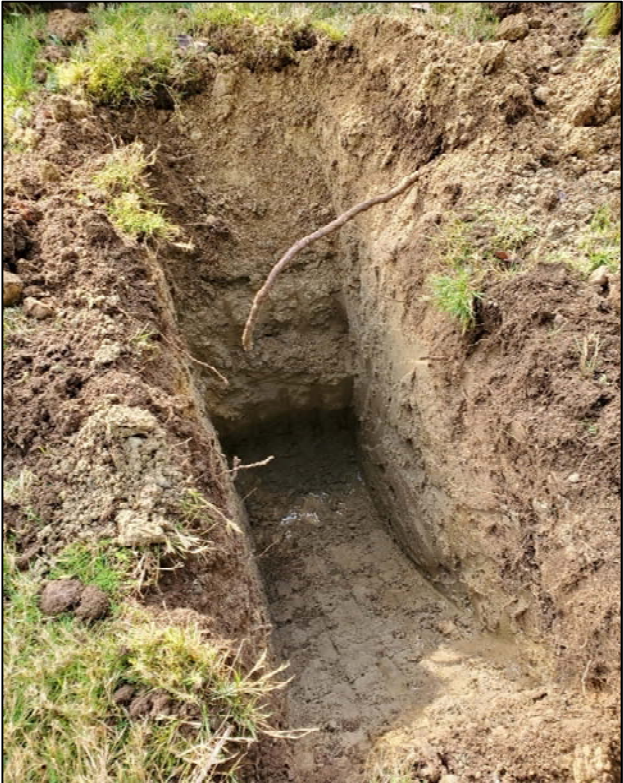
**Figure 7**

Depth (ft.)	Soil Description	USC	View of Test Pit 4
0.0 - 0.7	Dark brown sandy silt with roots and gravel (loose, moist) ( <b>Topsoil</b> )	ML

0.7 - 2.0	Brown sandy silt trace roots, gravel and cobbles (loose, moist to wet)	ML	
2.0 - 3.5	Rust stained brownish-gray silty fine sand with gravel and cobbles (medium dense, moist)	SM	
3.5 - 7.0	Brownish-gray layered fine to medium sand with silt, silty sand, and sandy silt trace gravel (dense, moist to wet)	SM/ML/ SP-SM

We noted the soils adjacent to the pond appeared to be sandier and may represent advance outwash soils. These soils were found to be wet at depths near pond-level in Test Pit 4 and Test Pit 6. If these soils are advance outwash and extend laterally underneath the till encountered elsewhere on site, then it is possible the pond level is associated with a regional water table in the permeable advance outwash. Further explorations would be necessary to determine whether the sandy soils are in fact advance outwash.

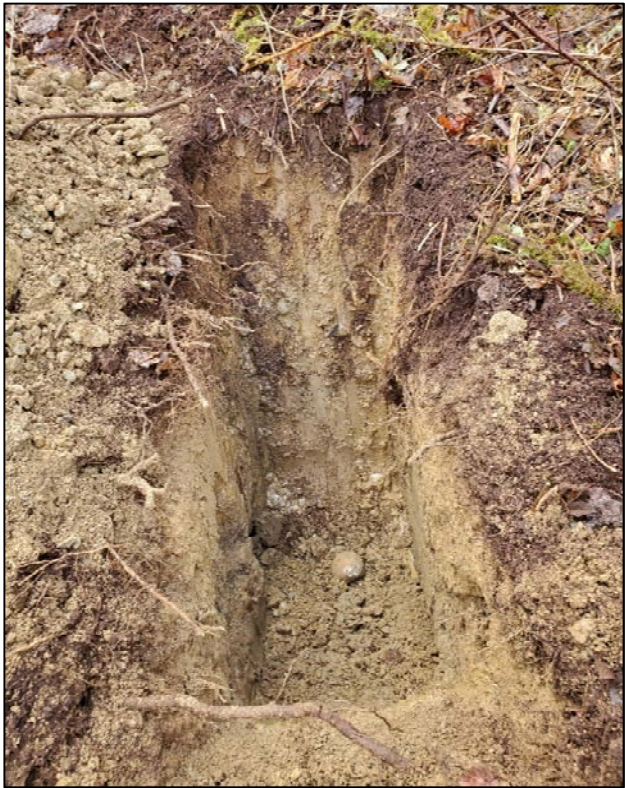
<b>ROBINSON</b> NOBLE
	Kostenick Property 3395-004A <b>Figure 8</b>

Depth (ft.)	Soil Description	USC	View of Test Pit 5
0.0 - 0.5	Dark brown sandy silt with organics, wood and roots (loose, moist) <b>(Duff)</b>	ML

0.5 - 2.0	Brown sandy silt with gravel trace roots and cobbles (medium dense, moist to wet)	ML	
2.0 - 3.0	Lightly rust mottled brownish-gray sandy silt to silty fine to coarse sand with gravel and cobbles (medium dense to dense, moist)	ML/SM	
3.0 - 5.5	Brownish-gray weakly cemented sandy silt to silty fine to coarse sand with gravel and cobbles (dense to very dense, moist)	ML/SM

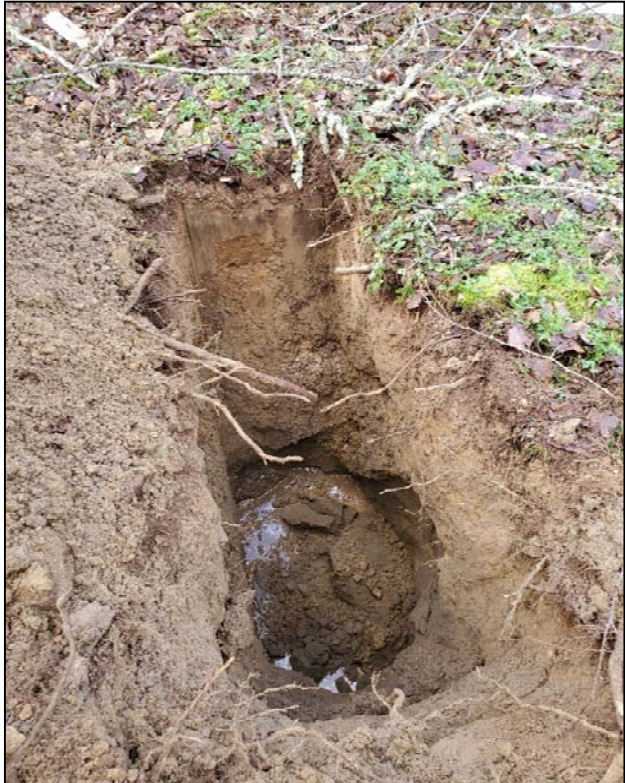
<b>ROBINSON NOBLE</b>  Kostenick Property 3395-004A <b>Figure 9</b>
--	--

Depth (ft.)	Soil Description	USC	View of Test Pit 6
0.0 - 0.5	Dark brown sandy silt with organics, wood and roots (loose, moist) <b>(Duff)</b>	ML

0.5 - 1.0	Brown sandy silt with gravel trace roots and cobbles (medium dense, moist)	ML	
1.0 - 3.0	Rust stained brownish-gray sandy silt to silty fine to coarse sand with gravel and cobbles (loose to medium dense, wet)	ML/SM	
3.0 - 3.5	Rust mottled brownish-gray fine to medium sand trace to with silt trace gravel (dense, moist)	SP/SP-SM	
3.5 - 7.0	Rust mottled brownish-gray fine to medium sand trace to with silt trace gravel (dense, wet)	SP/SP-SM

**Glacial Till:** This material was encountered underlying the surficial topsoil and/or weathered glacial till in all explorations except possibly Test Pit 6 (discussed below). The till generally consisted of gray dense to very dense silty sand to sandy silt with gravel and varying amounts of cobbles and boulders. We observed that the uppermost 1.0 to 3.0 feet of the glacial till was generally brownish gray, medium dense to dense and exhibited rust mottling. We interpret this till as weathered from the seasonally perched water above it. The transition between the rust mottled till and the unweathered till was generally encountered between depths of 3.0 and 4.0 feet. The glacial till extended to the depths explored in all test pits.

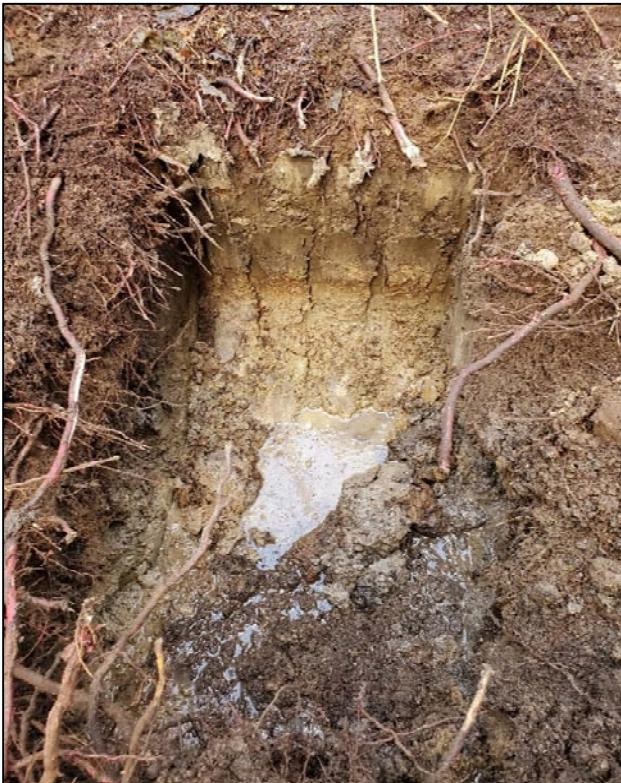
Depth (ft.)	Soil Description	USC	View of Test Pit 7
0.0 - 0.5	Dark brown sandy silt with organics, wood and roots (loose, moist) <b>(Duff)</b>	ML

0.5 - 1.5	Dark brown to black organic silt with roots and gravel (loose, wet)	OL	
1.5 - 2.0	Brown sandy silt with gravel trace roots and cobbles (loose, wet)	ML	
2.0 - 3.0	Rust stained brownish-gray sandy silt to silty fine to coarse sand with gravel and cobbles (medium dense, wet)	ML/SM
