**WETLAND DELINEATION UPDATE
AND PRELIMINARY BUFFER
ENHANCEMENT PLAN**

**Toll 44th Street
Marysville, Washington**

Title: Wetland Delineation Update and Preliminary Buffer
Enhancement Plan for
Toll 44th Street
Marysville, Washington

RAI Project Number: 2021-056-100

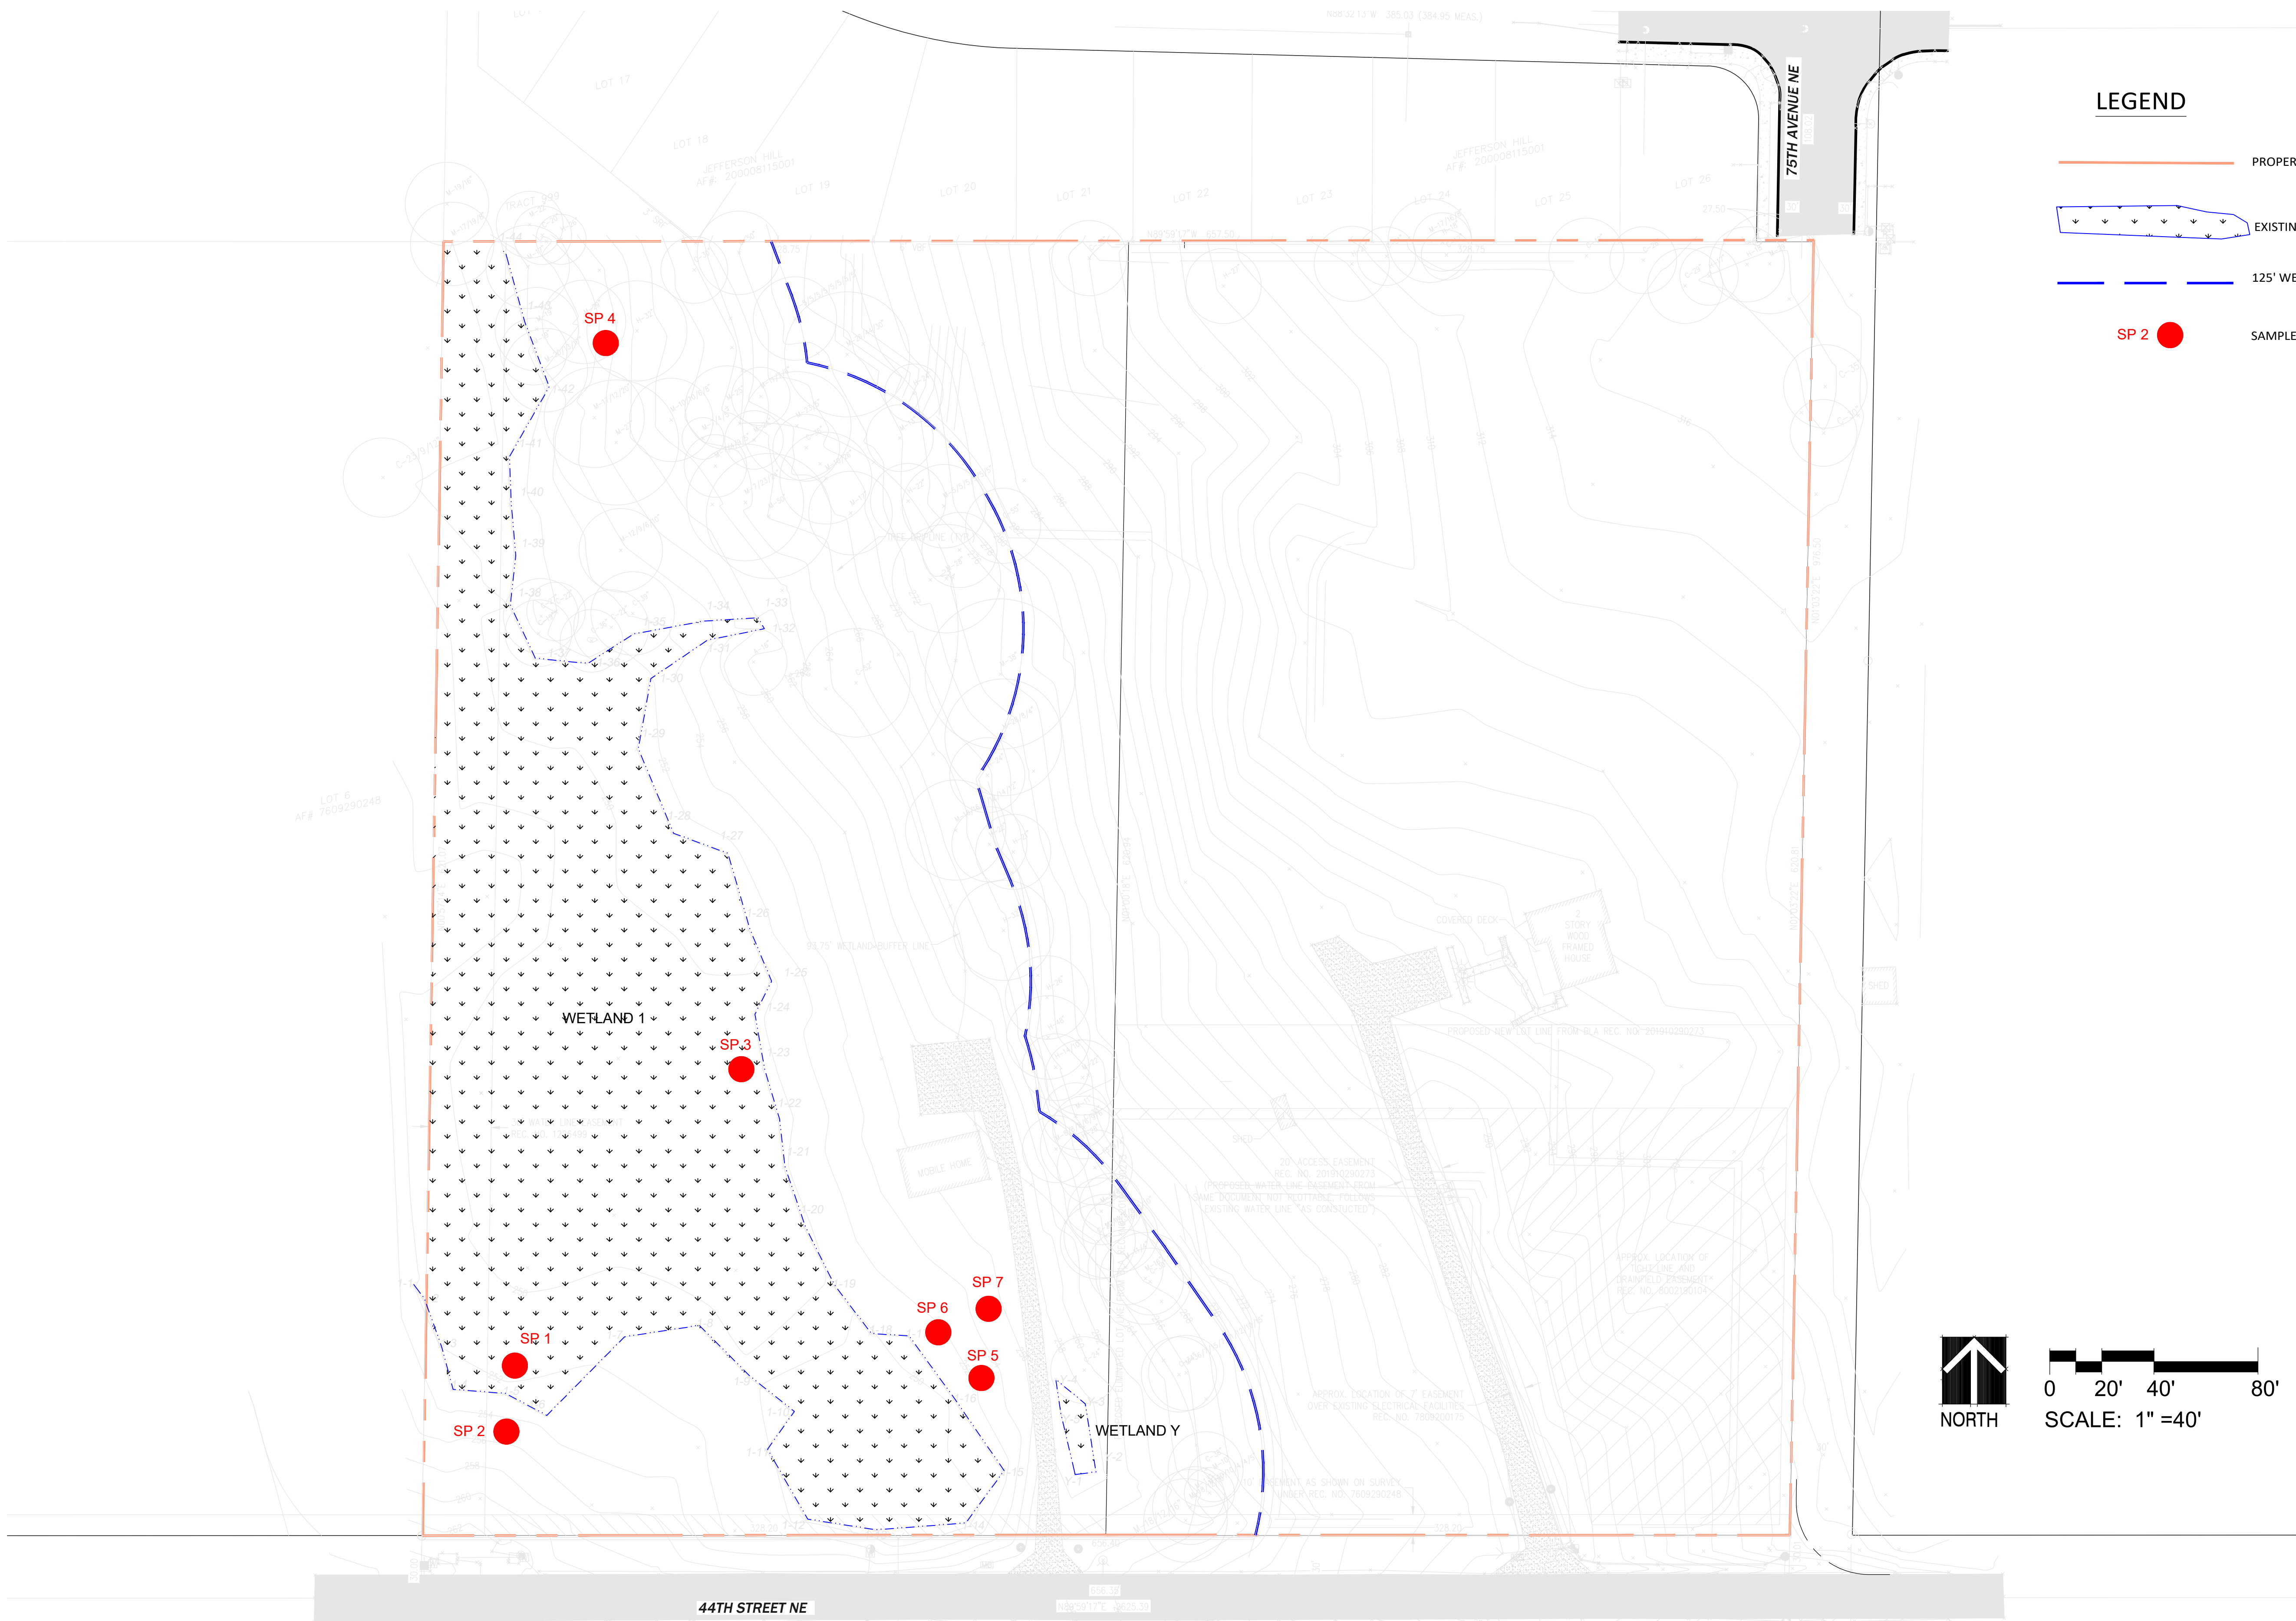
FIG 2
 SHEET
 1 OF 4

EXISTING CONDITIONS
 TOLL BROTHERS
 44TH STREET MARYSVILLE
 MARYSVILLE, WA

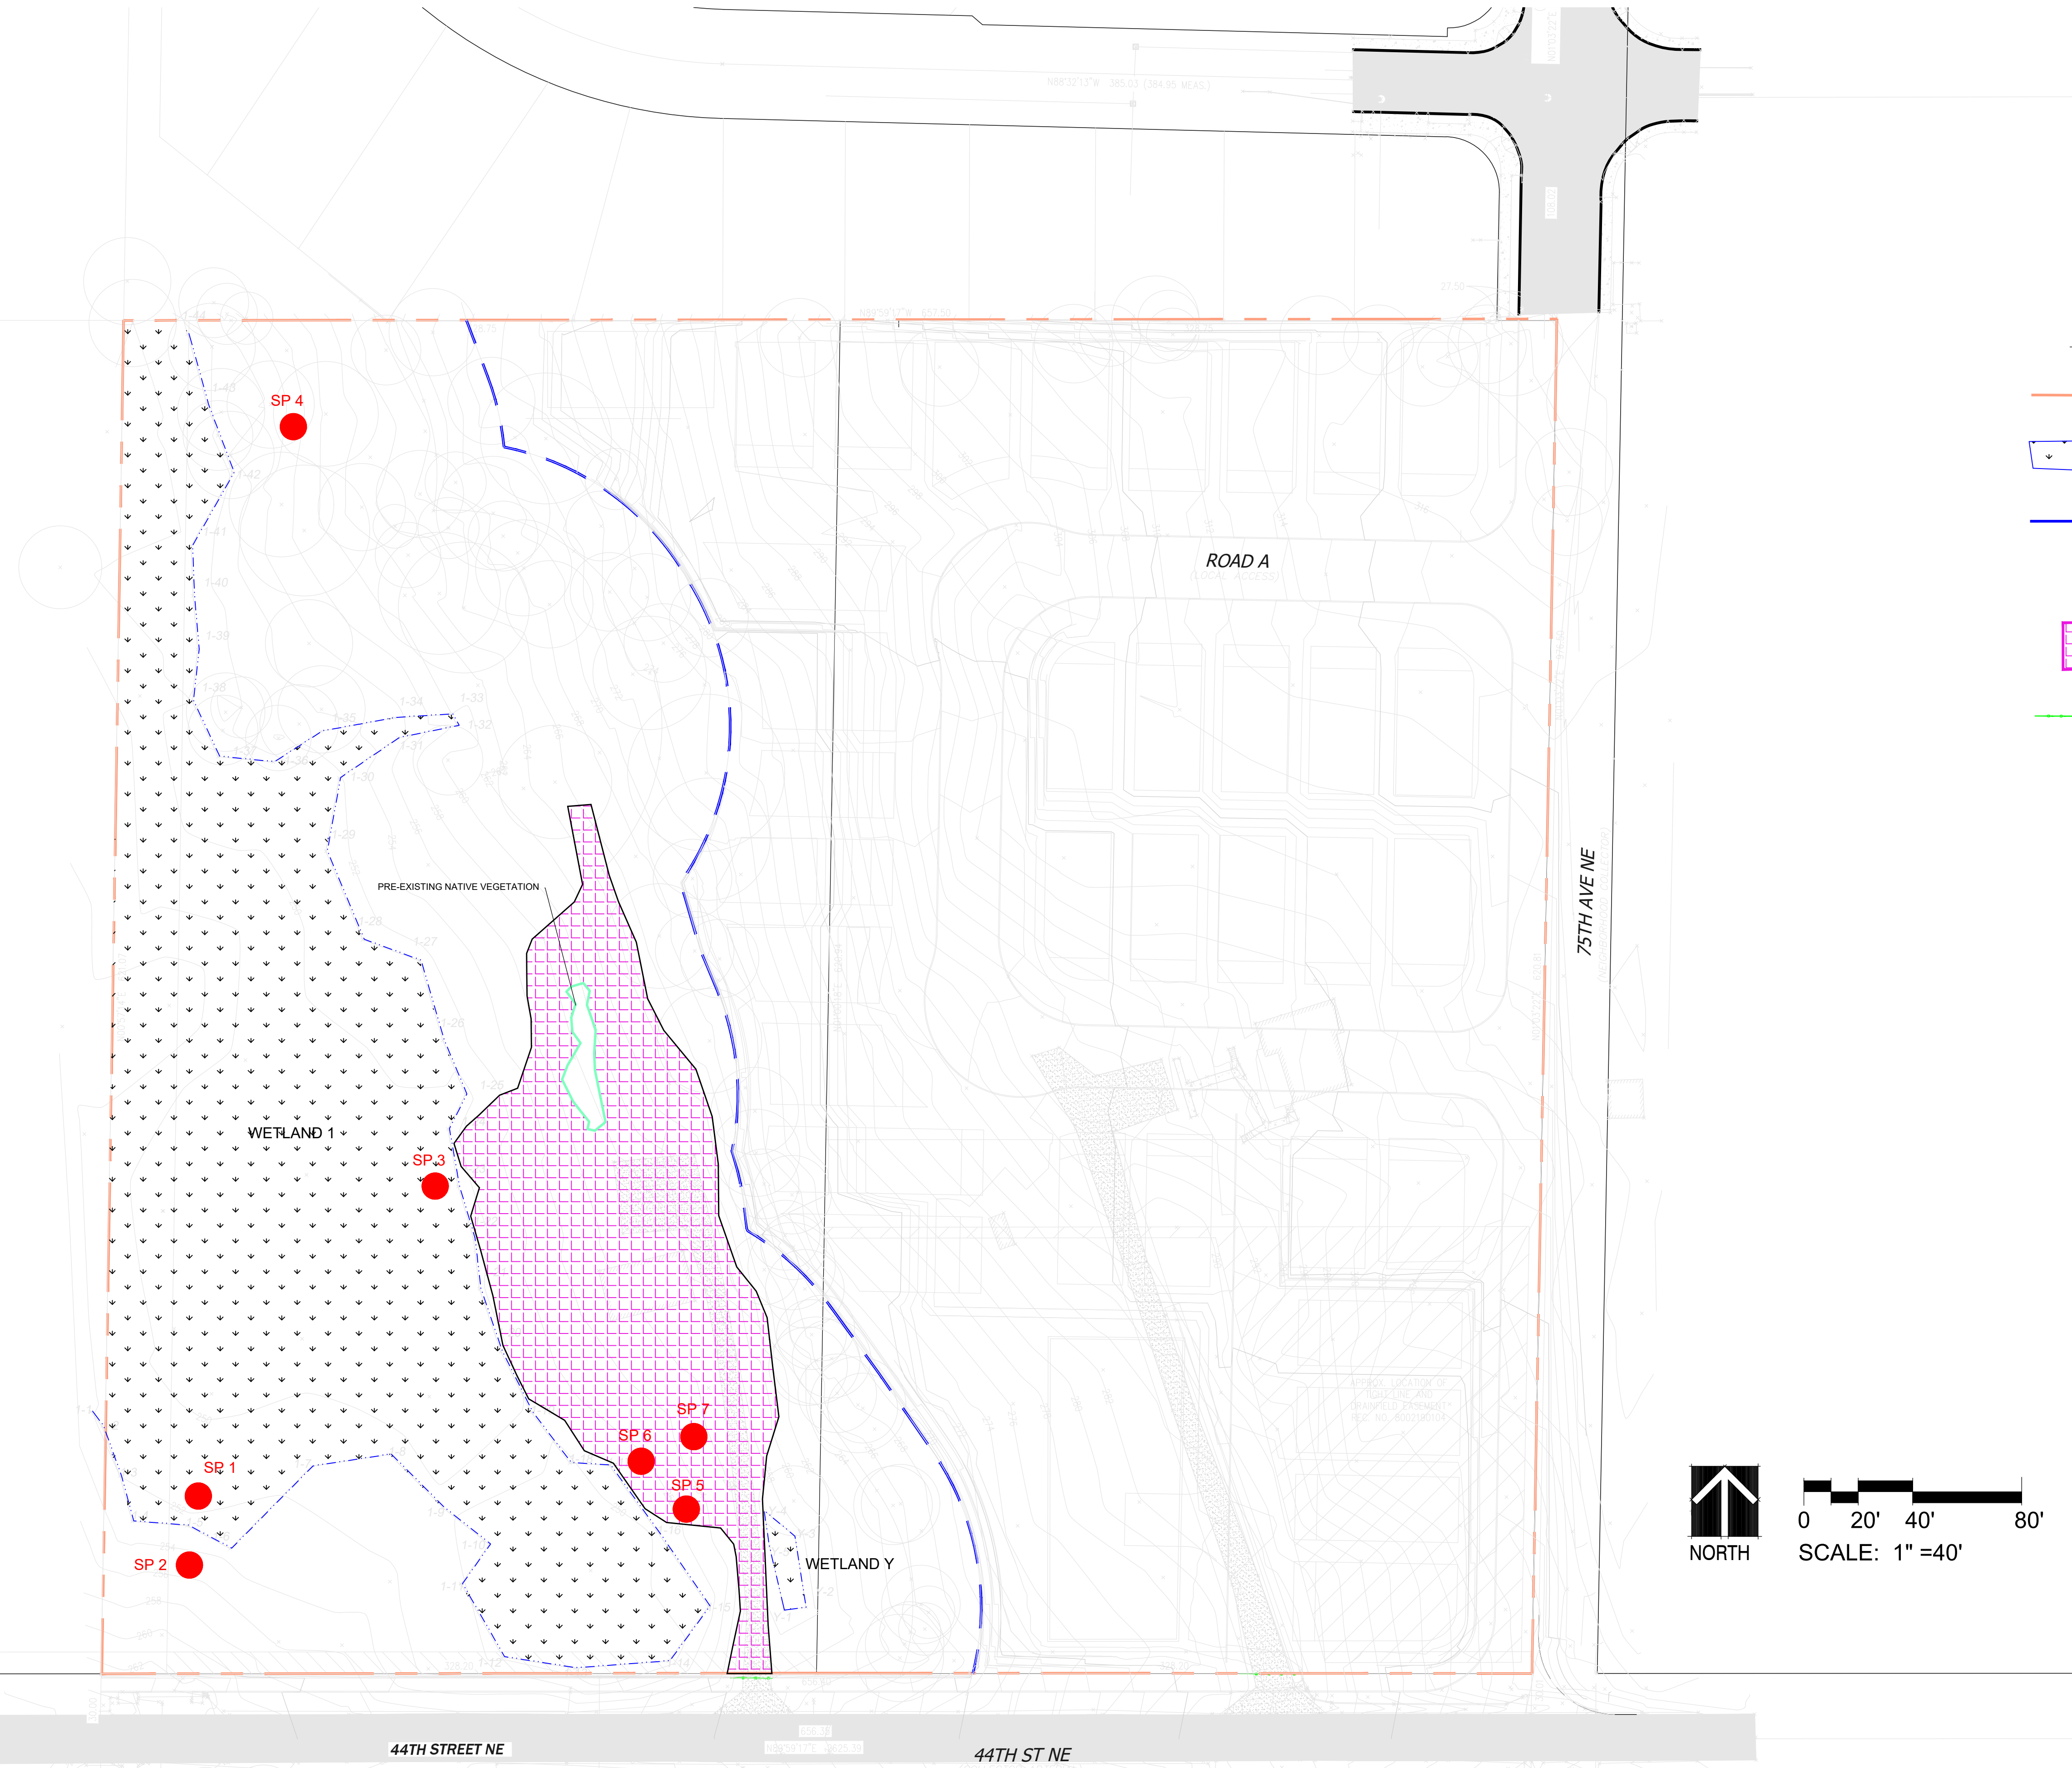
PROPERTY LINE
	EXISTING WETLAND
	125' WETLAND BUFFER
	SAMPLE POINT
	BUFFER RESTORATION (26,582 SF)
	CRITICAL AREAS SIGN AND FENCE (SEE SHEET 3, DETAILS 3 AND 4)

MITIGATION PLAN
TOLL BROTHERS
44TH STREET MARYSVILLE
MARYSVILLE, WA

2019: Wetland 1 receives a 125 feet wide buffer and Wetland Y receives a 75-foot wide-buffer. The buffer for Wetland 1 extends beyond that of Wetland Y and consequentially the wetland buffer is shown on our figures and site plans as the contiguous 125-foot wetland buffer. Degraded areas within the buffer have been identified (as depicted on the Buffer Enhancement plan sheets) and total approximately 26,582 square feet.

A preliminary buffer enhancement plan has been prepared for the degraded areas of the wetland buffer (Sheets 2-4; see Figures 3-5). The location and extent of the degraded portion of the buffer was field identified using a handheld GPS unit and approximate. The total enhancement area size is estimated at 26,582 square feet. Native trees and shrubs have been selected based on site conditions and surrounding native vegetation.

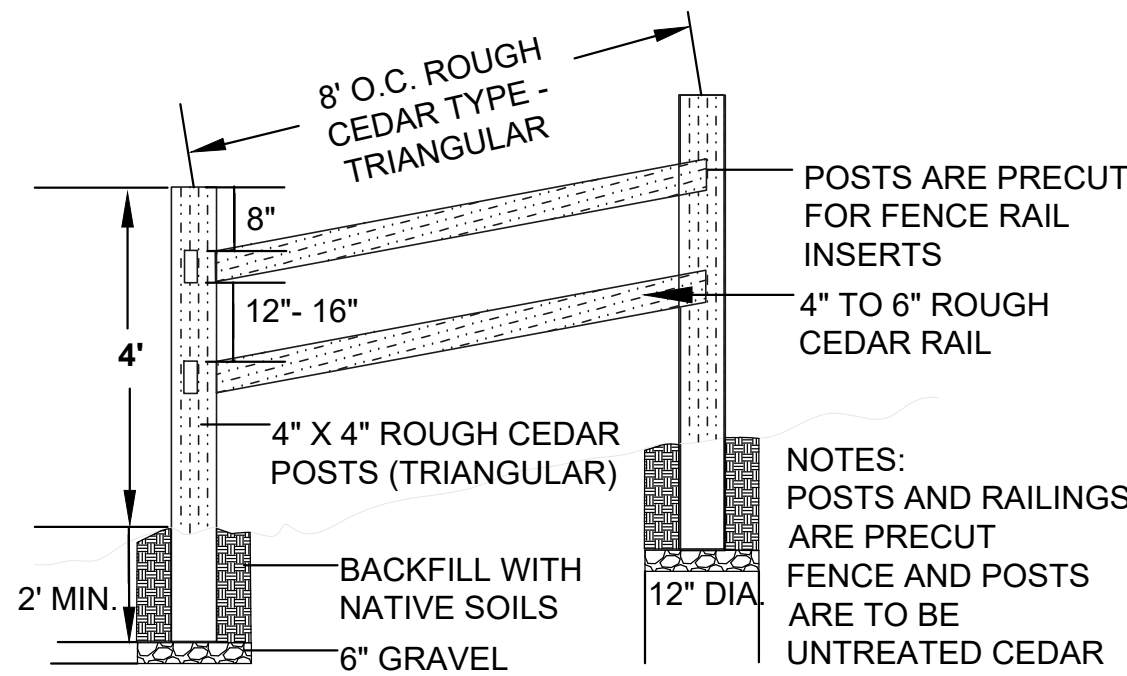
2 NGPA SPLIT RAIL CEDAR FENCE OR SIMILAR NTS

- A PERMANENT SPLIT RAIL, OPEN SLATTED WITH AT LEAST 18 INCHES BETWEEN EACH SLAT, WROUGHT IRON, CHAIN LINK, OR SIMILAR NONSOLID FENCE BETWEEN THREE (3) AND SIX (6) FEET IN HEIGHT MUST BE INSTALLED ALONG THE ENTIRE EDGE OF THE BUFFER;
- SOLID FENCING IS NOT PERMITTED;
- EXCEPT FOR SPLIT RAIL, A GATE IS REQUIRED FOR PEDESTRIAN ACCESS TO THE BUFFER;

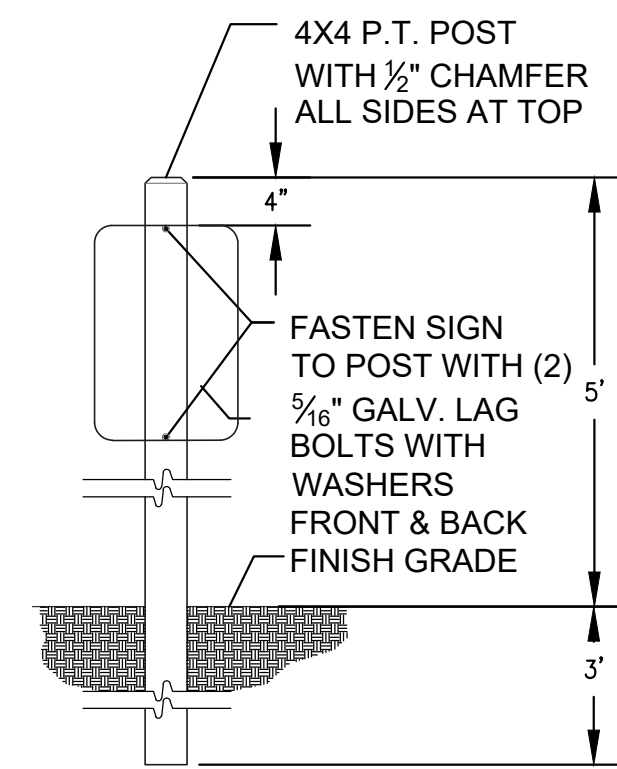
3 CRITICAL AREAS SIGN DETAIL NTS

- NOTES:**
- UPON COMPLETION OF THE PROJECT, PERMANENT SIGNAGE SHALL BE ATTACHED TO THE FENCE STATING THAT THE PROTECTED CRITICAL AREA AND BUFFER MUST NOT BE DISTURBED OTHER THAN NECESSARY FOR MAINTENANCE OF VEGETATION;
 - THE SIGNS MUST BE MAINTAINED AND REMAIN IN PERPETUITY;
 - SIGNAGE SHALL MEET THE ADMINISTRATIVE STANDARDS OF THE PLANNING AND BUILDING DEPARTMENT FOR DESIGN, NUMBER AND LOCATION;
 - THE PLANNING OFFICIAL SHALL INSPECT THE SIGNAGE PRIOR TO FINAL INSPECTION.

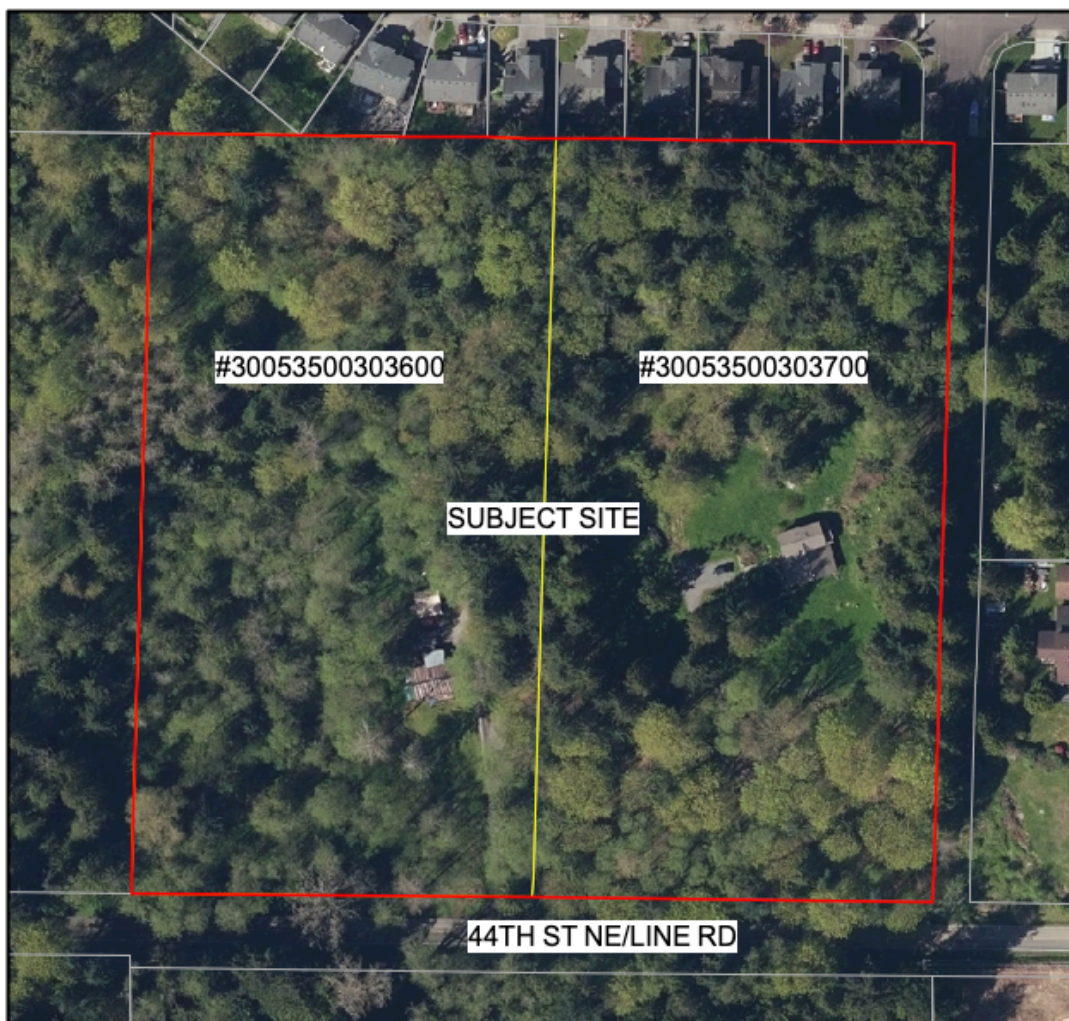
Figure 1: Aerial view of the subject site. (Not to scale)

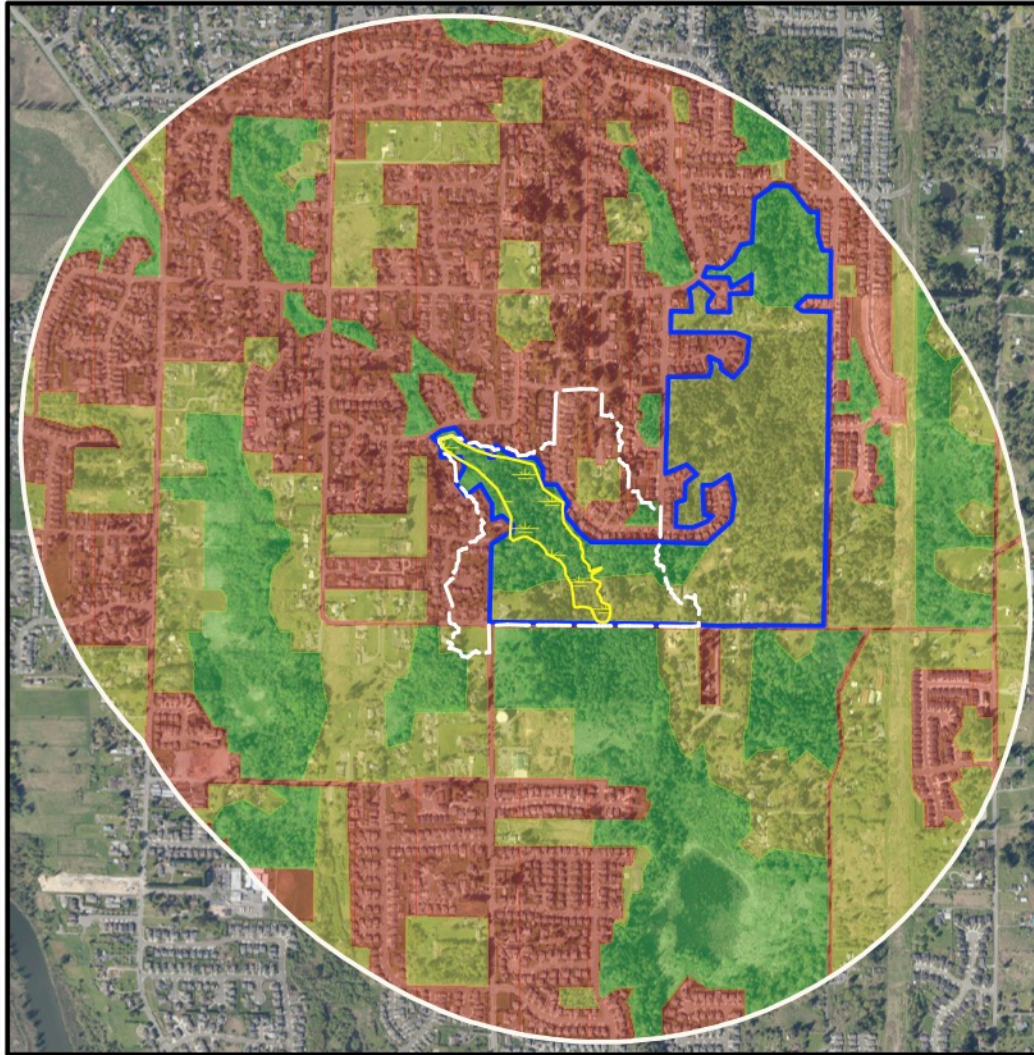
Figure A-2
 WRI Job #18289
 Drawn by:AR

18289 ADELFA - MARYSVILLE
 WETLAND RATING FIGURE 2 - WETLAND A

**CONTRIBUTING BASIN
 AREA RELATIVE TO
 WETLAND UNIT IS 5:1**

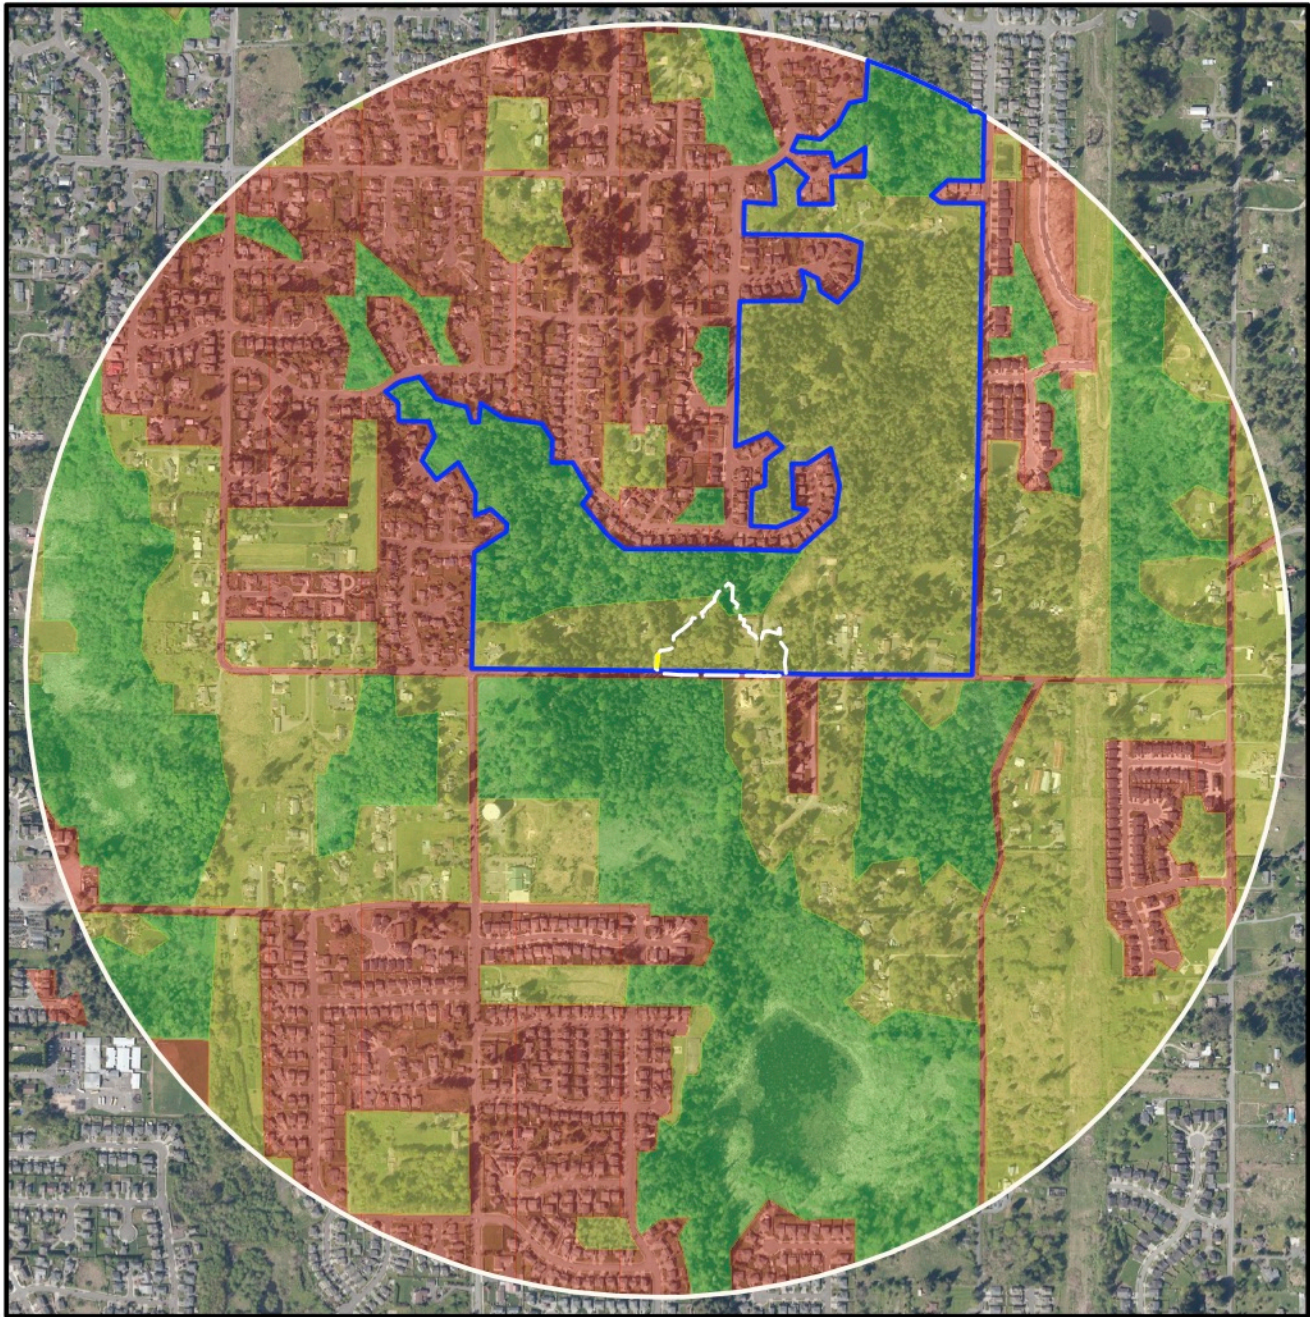
Figure B-2
 WRI Job #18289
 Drawn by:AR

18289 ADELFA - MARYSVILLE
 WETLAND RATING FIGURE 2 - WETLAND B

**CONTRIBUTING BASIN
 AREA RELATIVE TO
 WETLAND UNIT IS 239:1**

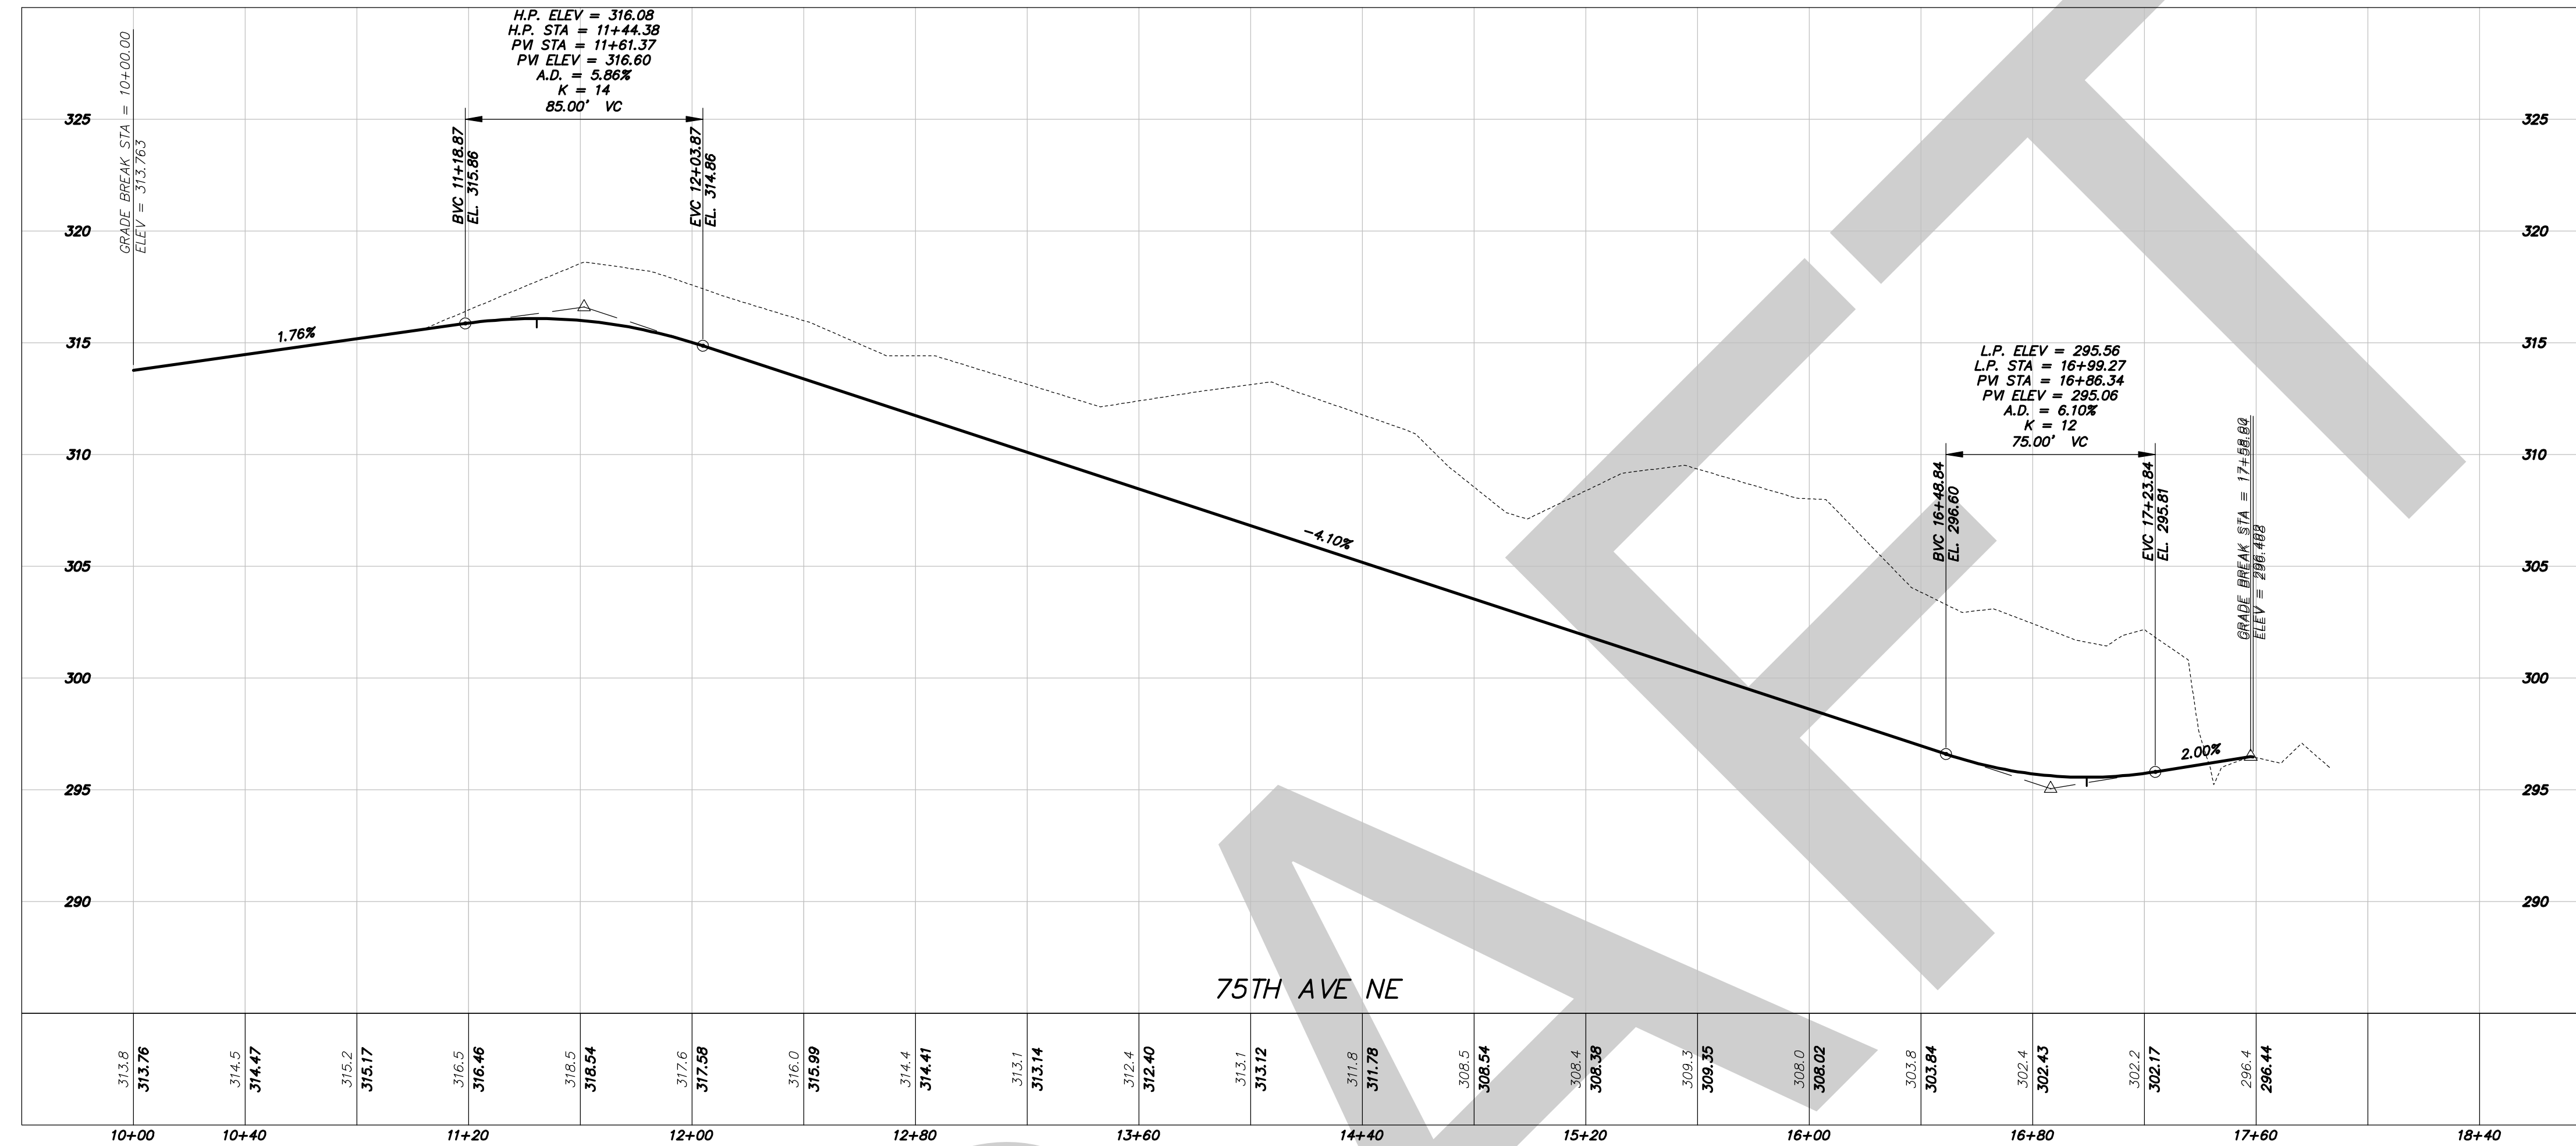
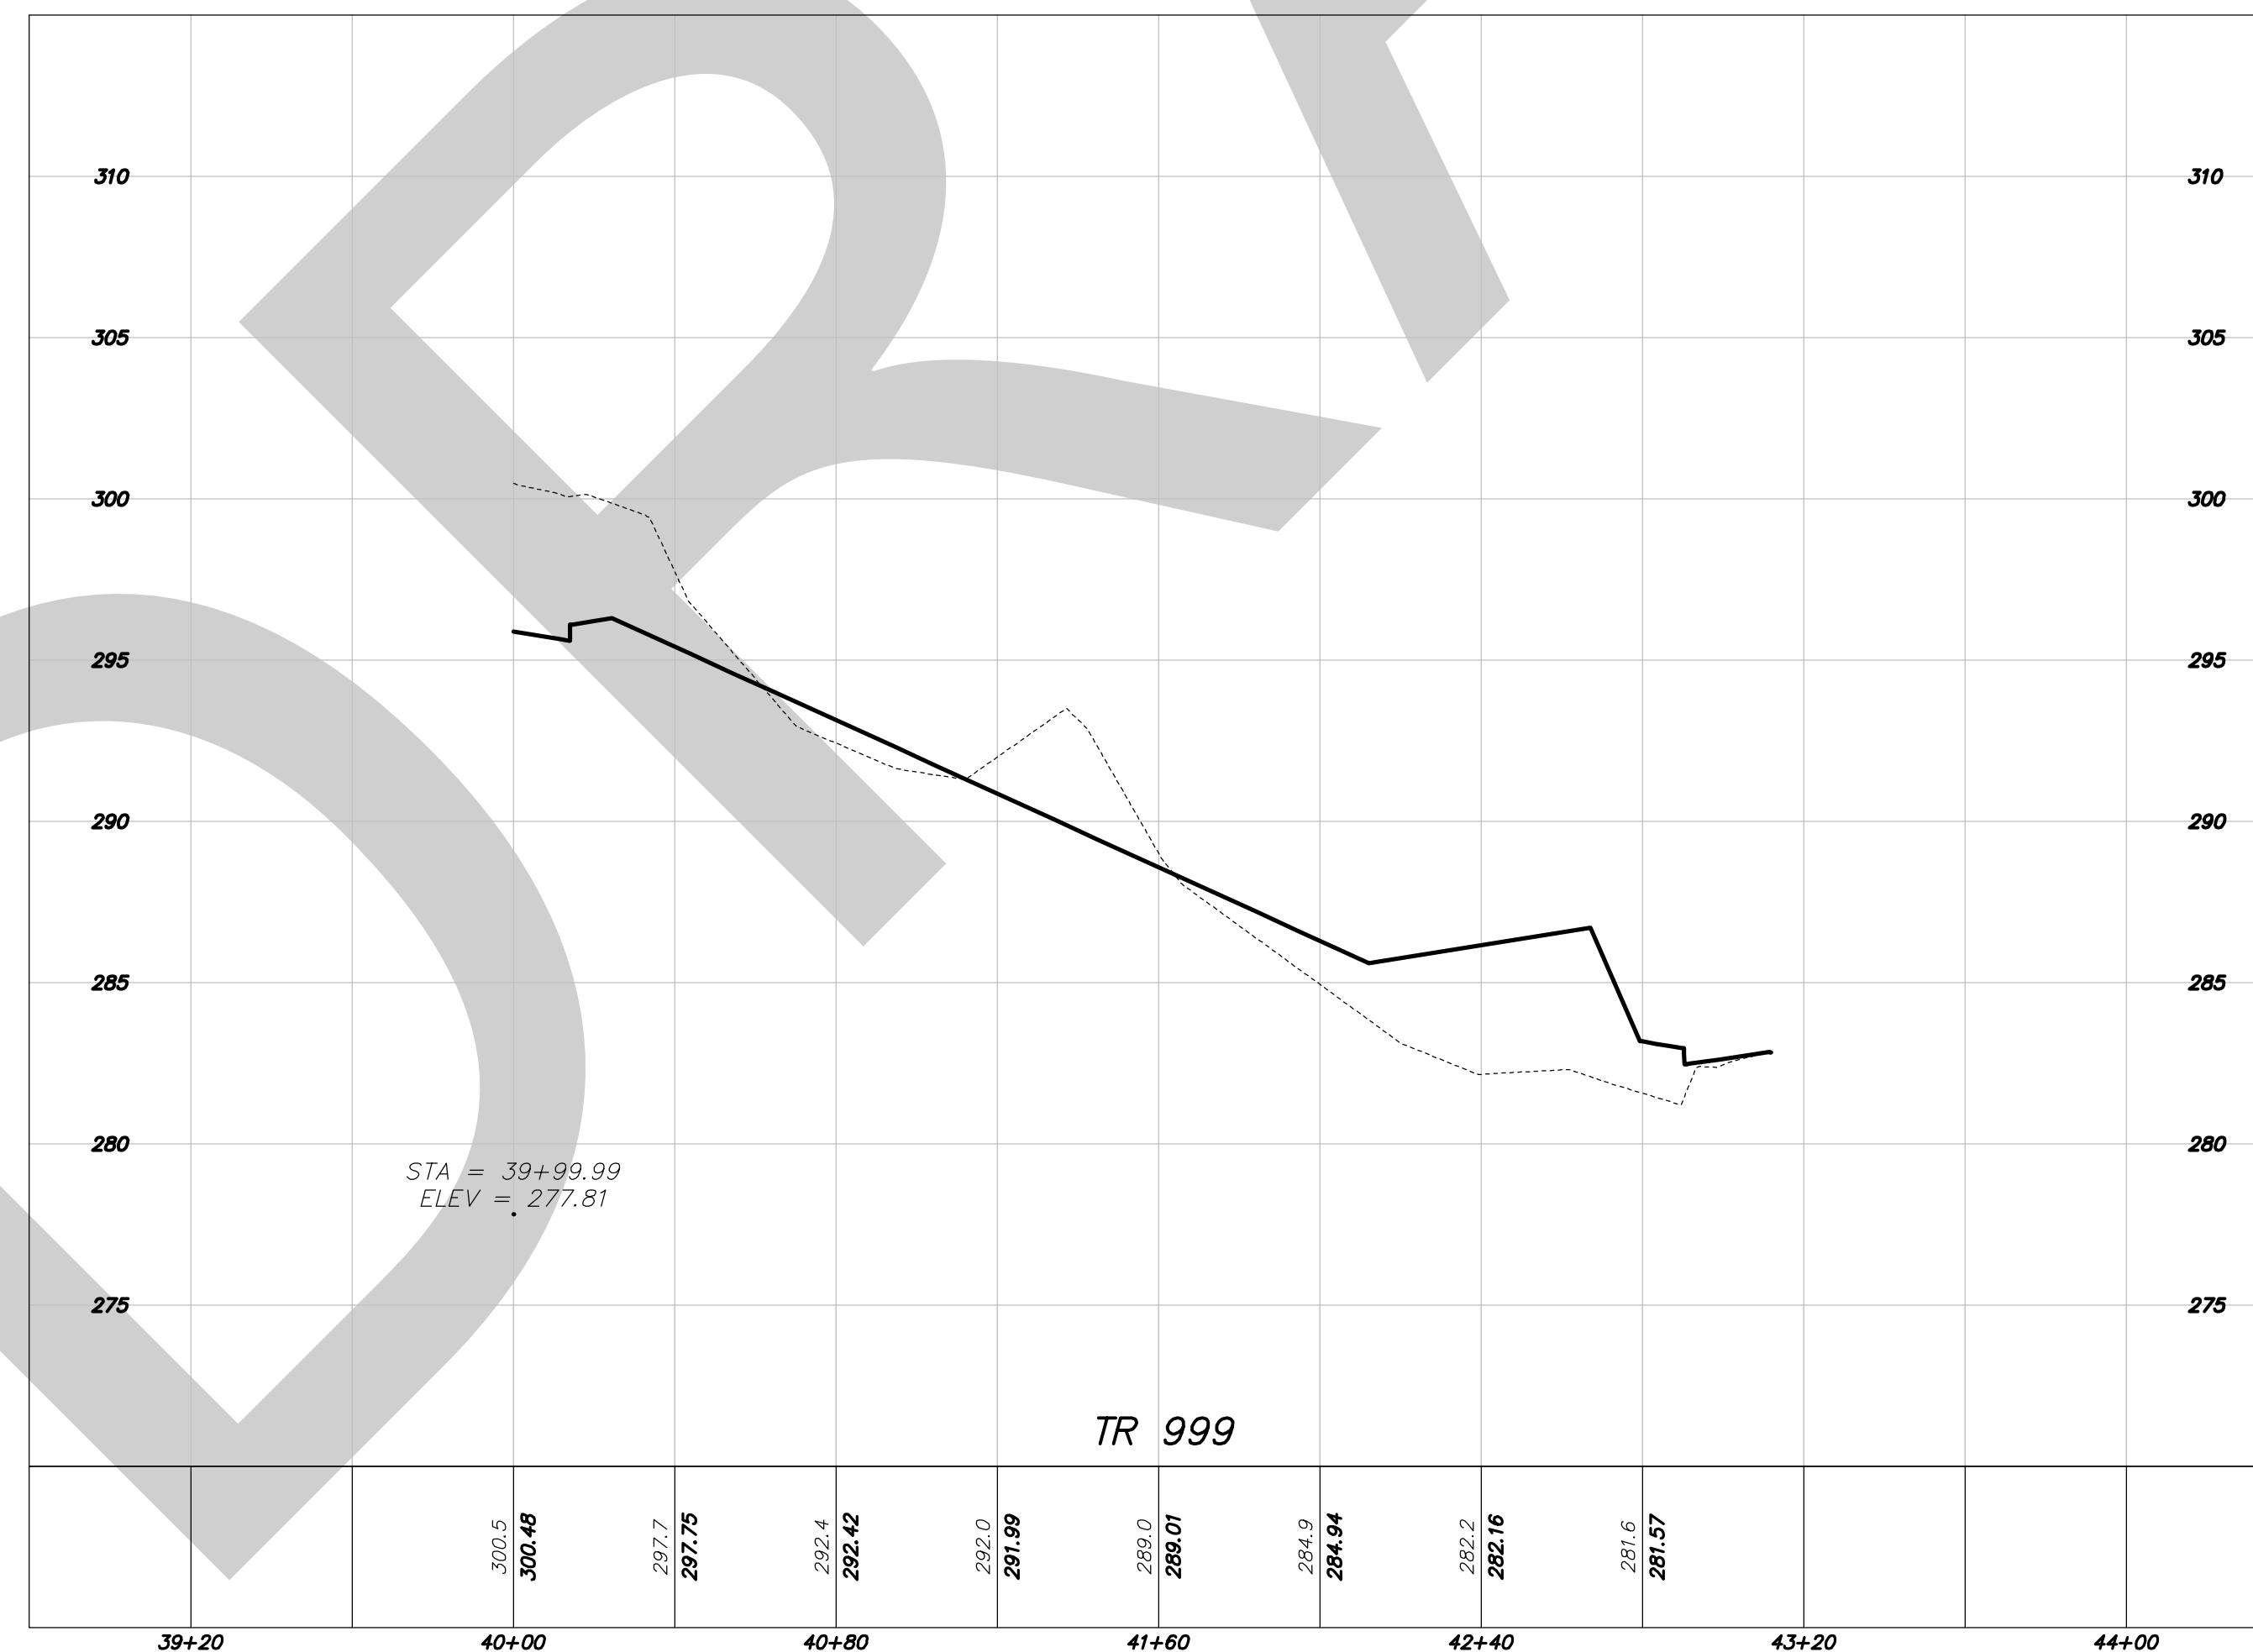
CONCEPTUAL ROAD PROFILES
 7315 & 7417 - 44TH ST NE
 MARYSVILLE, WA
 PARCELS 3005350030-3600,-3700
