RE: Critical Area Reconnaissance Report for Kallicott Plat; 8507 87th Avenue NE; Parcels 00590700016201 and 00590700016202

CRITICAL AREA RECONNAISSANCE MAP KALLICOTT PLAT

CRITICAL AREA RECONNAISSANCE MAP KALLICOTT PLAT MARYSVILLE, WA

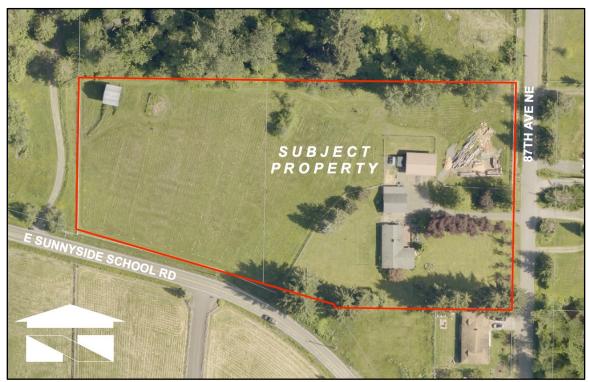
Figure 1 – Aerial Photograph of the Subject Property

The 4.2-acre parcel assemblage is located in a residential setting, east of 87th Avenue NE and north of East Sunnyside School Road. The eastern parcel along 87th Avenue NE is developed with a single family residence, associated outbuildings, maintained lawn, landscaping, and pasture area to the north and west. The western parcel along East Sunnyside School Road is mostly pasture, with a barn structure located in the northwest corner.

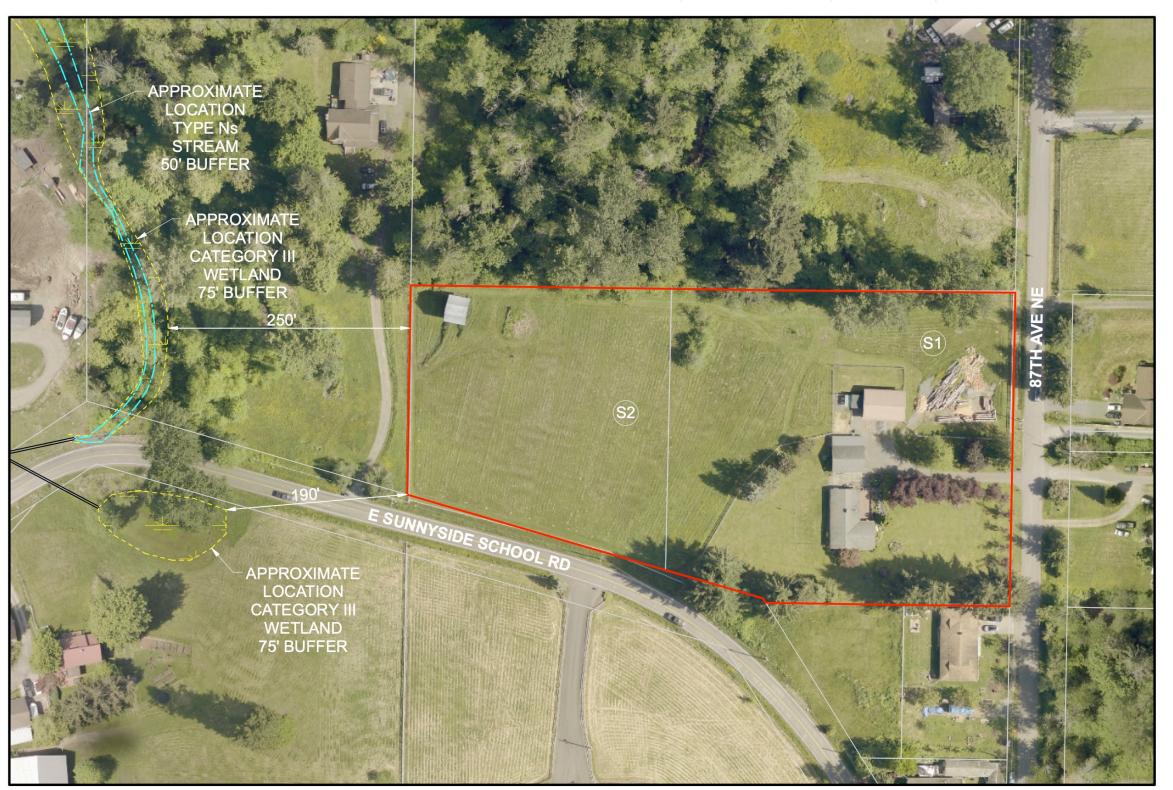
No wetlands, streams, or buffers are located on or near the site.

Wetland and stream conditions were evaluated within 300 feet of the project boundaries. A Category III wetland is located off-site to the west, approximately 250 feet from the western property boundary. Category III wetlands receive 75-foot buffers, so the buffer from this wetland does not reach the subject property. A Type Ns stream is located within the off-site wetland described above. Type Ns streams receive 50-foot buffers, so the stream buffer does not reach the subject property. Another Category III wetland is located approximately 190 feet southwest of the site, on the south side of East Sunnyside School Road. The 75-foot buffer associated with this wetland does not reach the site. Development of the subject property will not impact any critical areas or buffers.
