RE: Camnel Site Commercial Development Wetland and Stream Determination, Marysville, WA

Project No: PA-16049

**Project Name:** Camnel Properties Smokey Point Blvd. Commercial Development

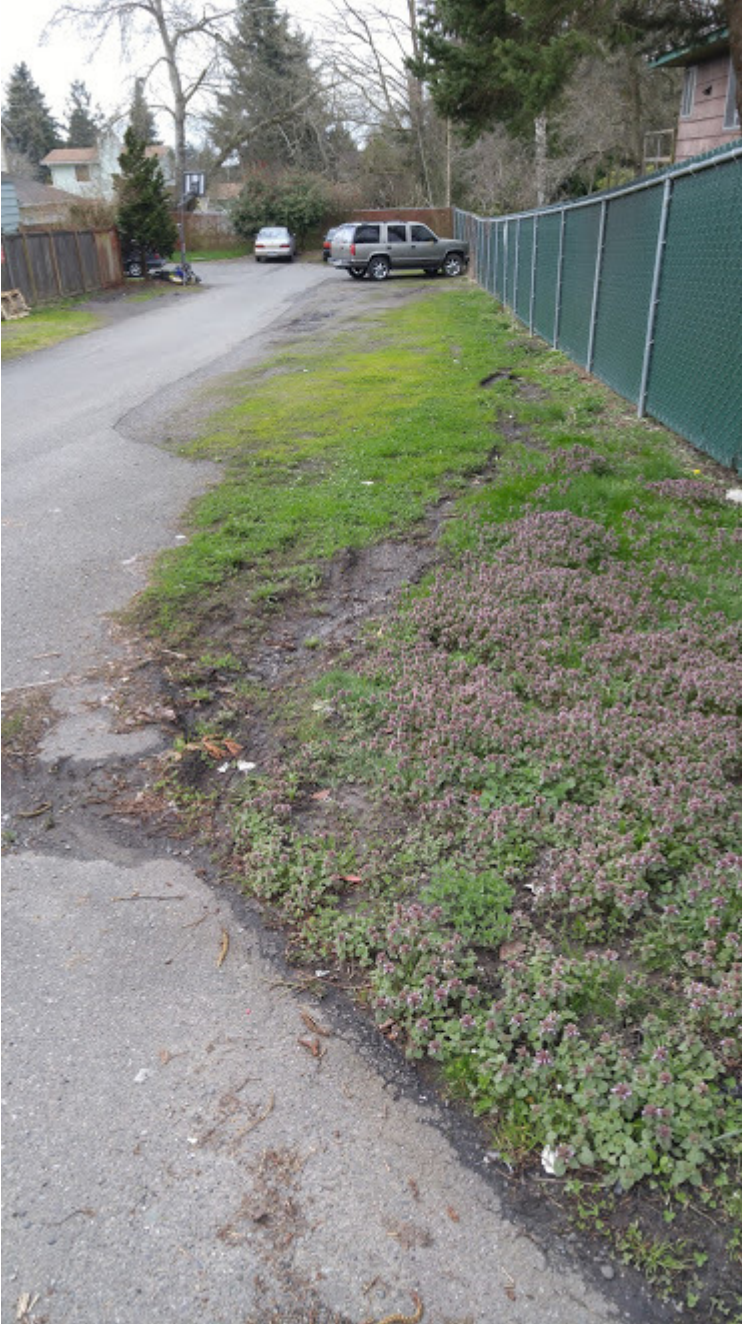
Storm water from 40<sup>th</sup> Ave W onto site, creating scour

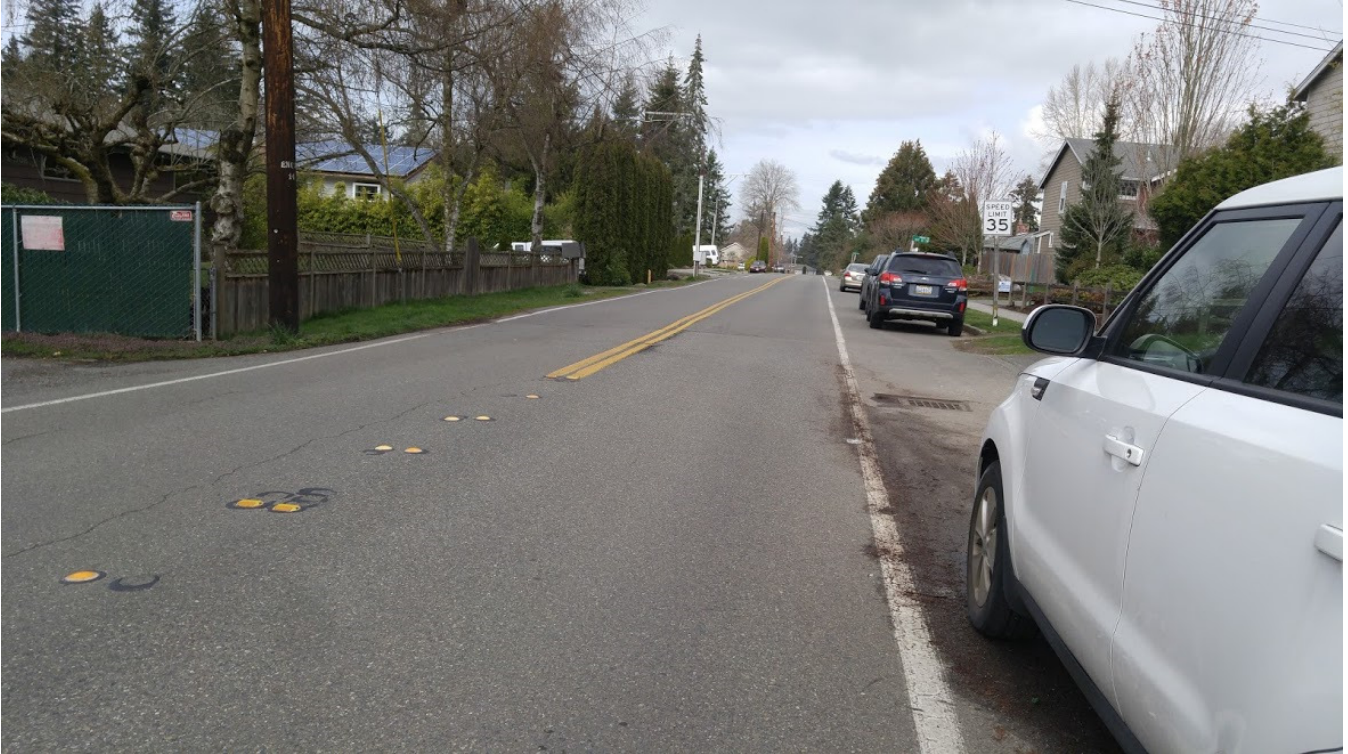
Storm water from 40<sup>th</sup> Ave W overflows from storm drain, flows across road to corner of Jahn property, creates scour, flows to center of yard.
