**STORMWATER
TECHNICAL INFORMATION REPORT
STRAWBERRY FIELDS CONVERSION
MARYSVILLE, WASHINGTON**

**Submitted by:
CEKO, L.L.C.
2255 Squak Mountain Loop, SW
Issaquah, Washington 98027**

October 31, 2022

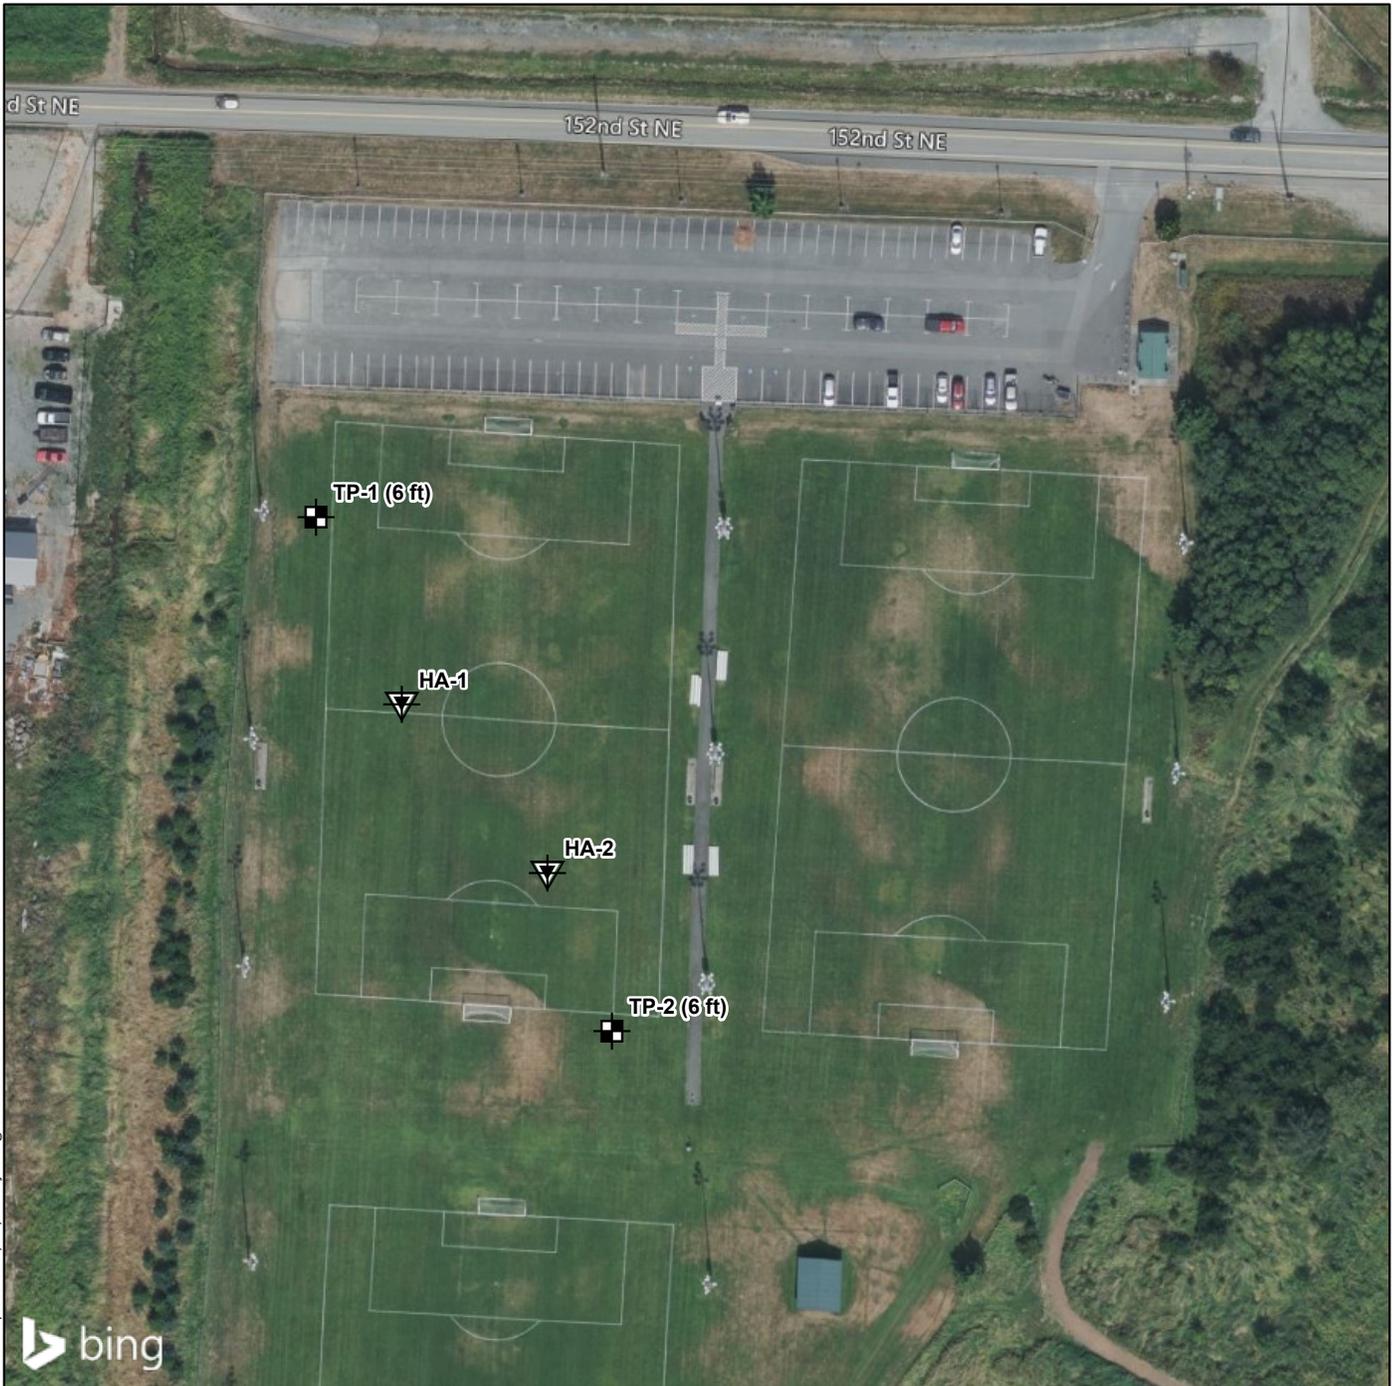
Subsurface soil conditions were evaluated by completing two hand augers (HA-1 and HA-2) to depths of 5.5 and 5.3 feet below the existing ground surface (bgs), respectively. Two test pits (TP-1 and TP-2) were also completed to depths of 6 feet bgs on August 3, 2022 using a mini excavator. All explorations were completed at the approximate locations shown on the Figure 2, Site Plan attached to this memo. The explorations were
