## **Kennedy/Jenks Consultants**

### Remedial Investigation/ Feasibility Study (RI/FS) Report

Interfor Pacific  
Marysville

31 December 2018

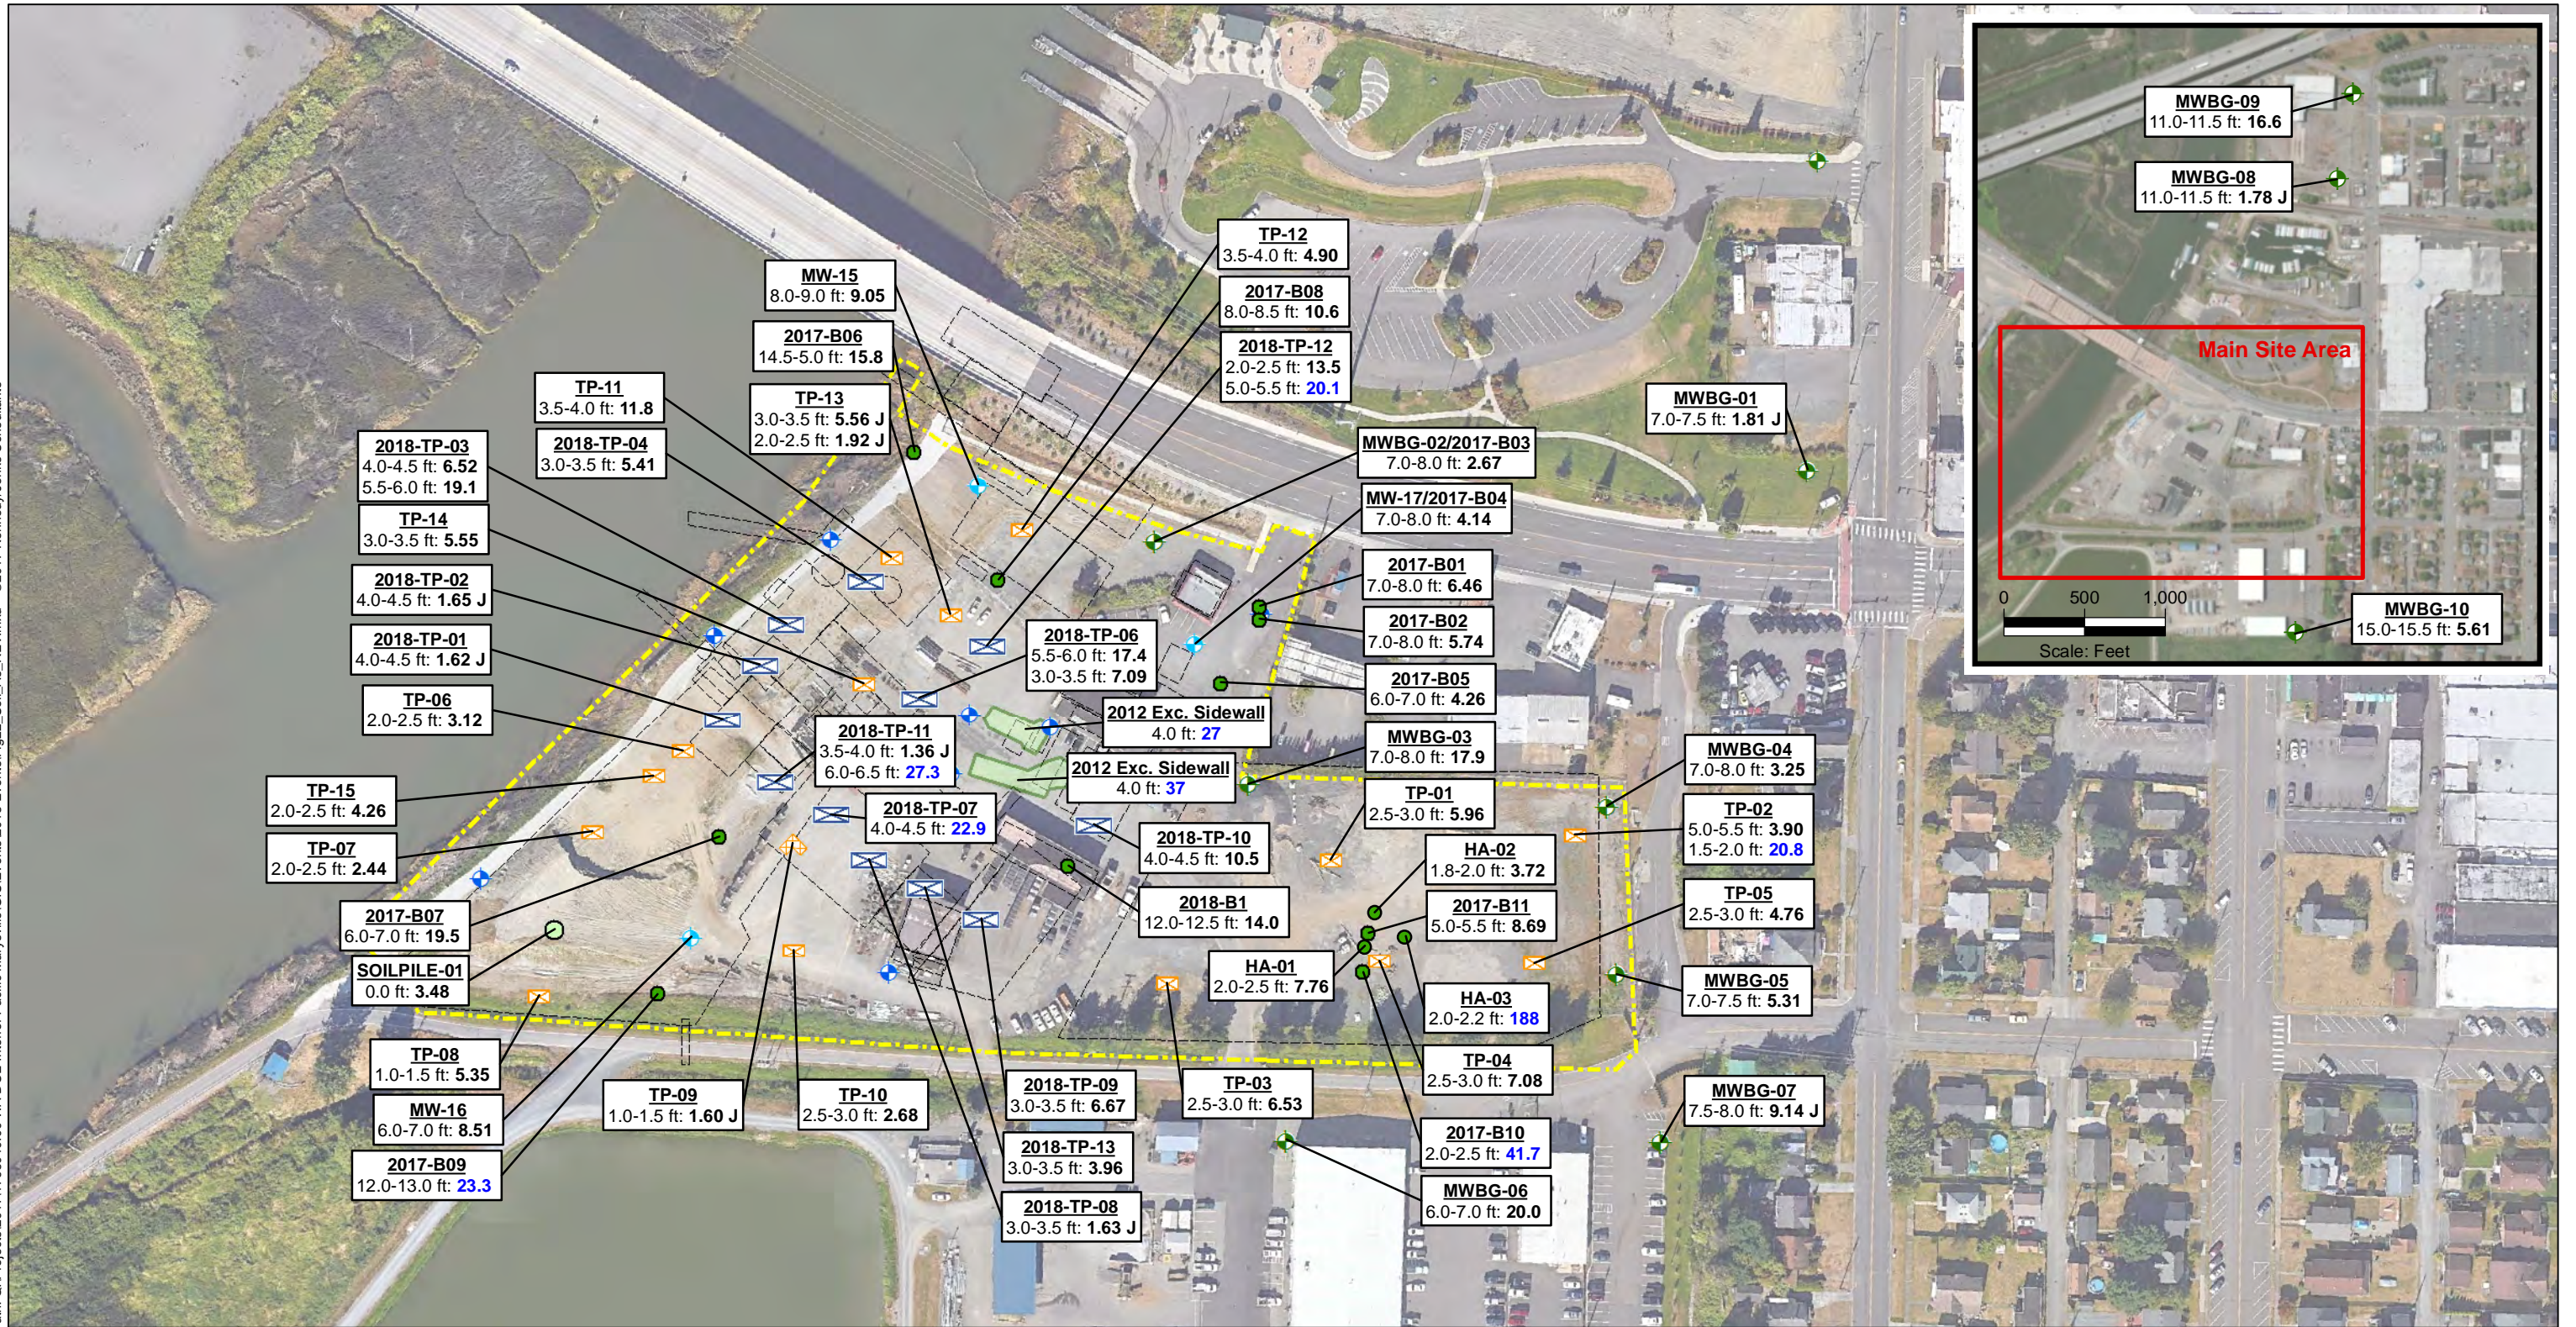
**Soil COC Concentration Map - Arsenic**

Arsenic was detected in all 65 soil samples submitted for laboratory analysis at concentrations of 1.36 mg/kg (with a laboratory "J" data flag) to 188 mg/kg. Soil samples collected from test pit 2017-TP-2 (1.5-2.0 feet bgs), 2018-TP-07 (4.0-4.5 feet bgs), 2018-TP-11 (6.0-6.5 feet bgs), 2018-TP-12 (5.0-5.5 feet bgs), borings 2017-B09 (7.5-8.5 feet bgs), 2017-B10 (2.0-2.5 feet bgs), and HA-03 (2.0-2.2) contained concentrations of arsenic above the screening level of 20 mg/kg. A deeper soil sample collected from 2017-TP-2 (5.0-5.5 feet bgs) did not contain arsenic at a concentration above the screening level (deeper samples from the listed soil borings were not analyzed for arsenic). The soil samples with detected arsenic concentrations above the screening level were collected from the former South Log Yard (2017-B09 and 2018-TP-07), North Log Yard (2017-B10, 2017-TP-2, and HA-03), areas (AOC 4), and Site-wide shallow soil areas (2018-TP-12) (AOC 6). See Figure 22 for arsenic concentrations in soil.

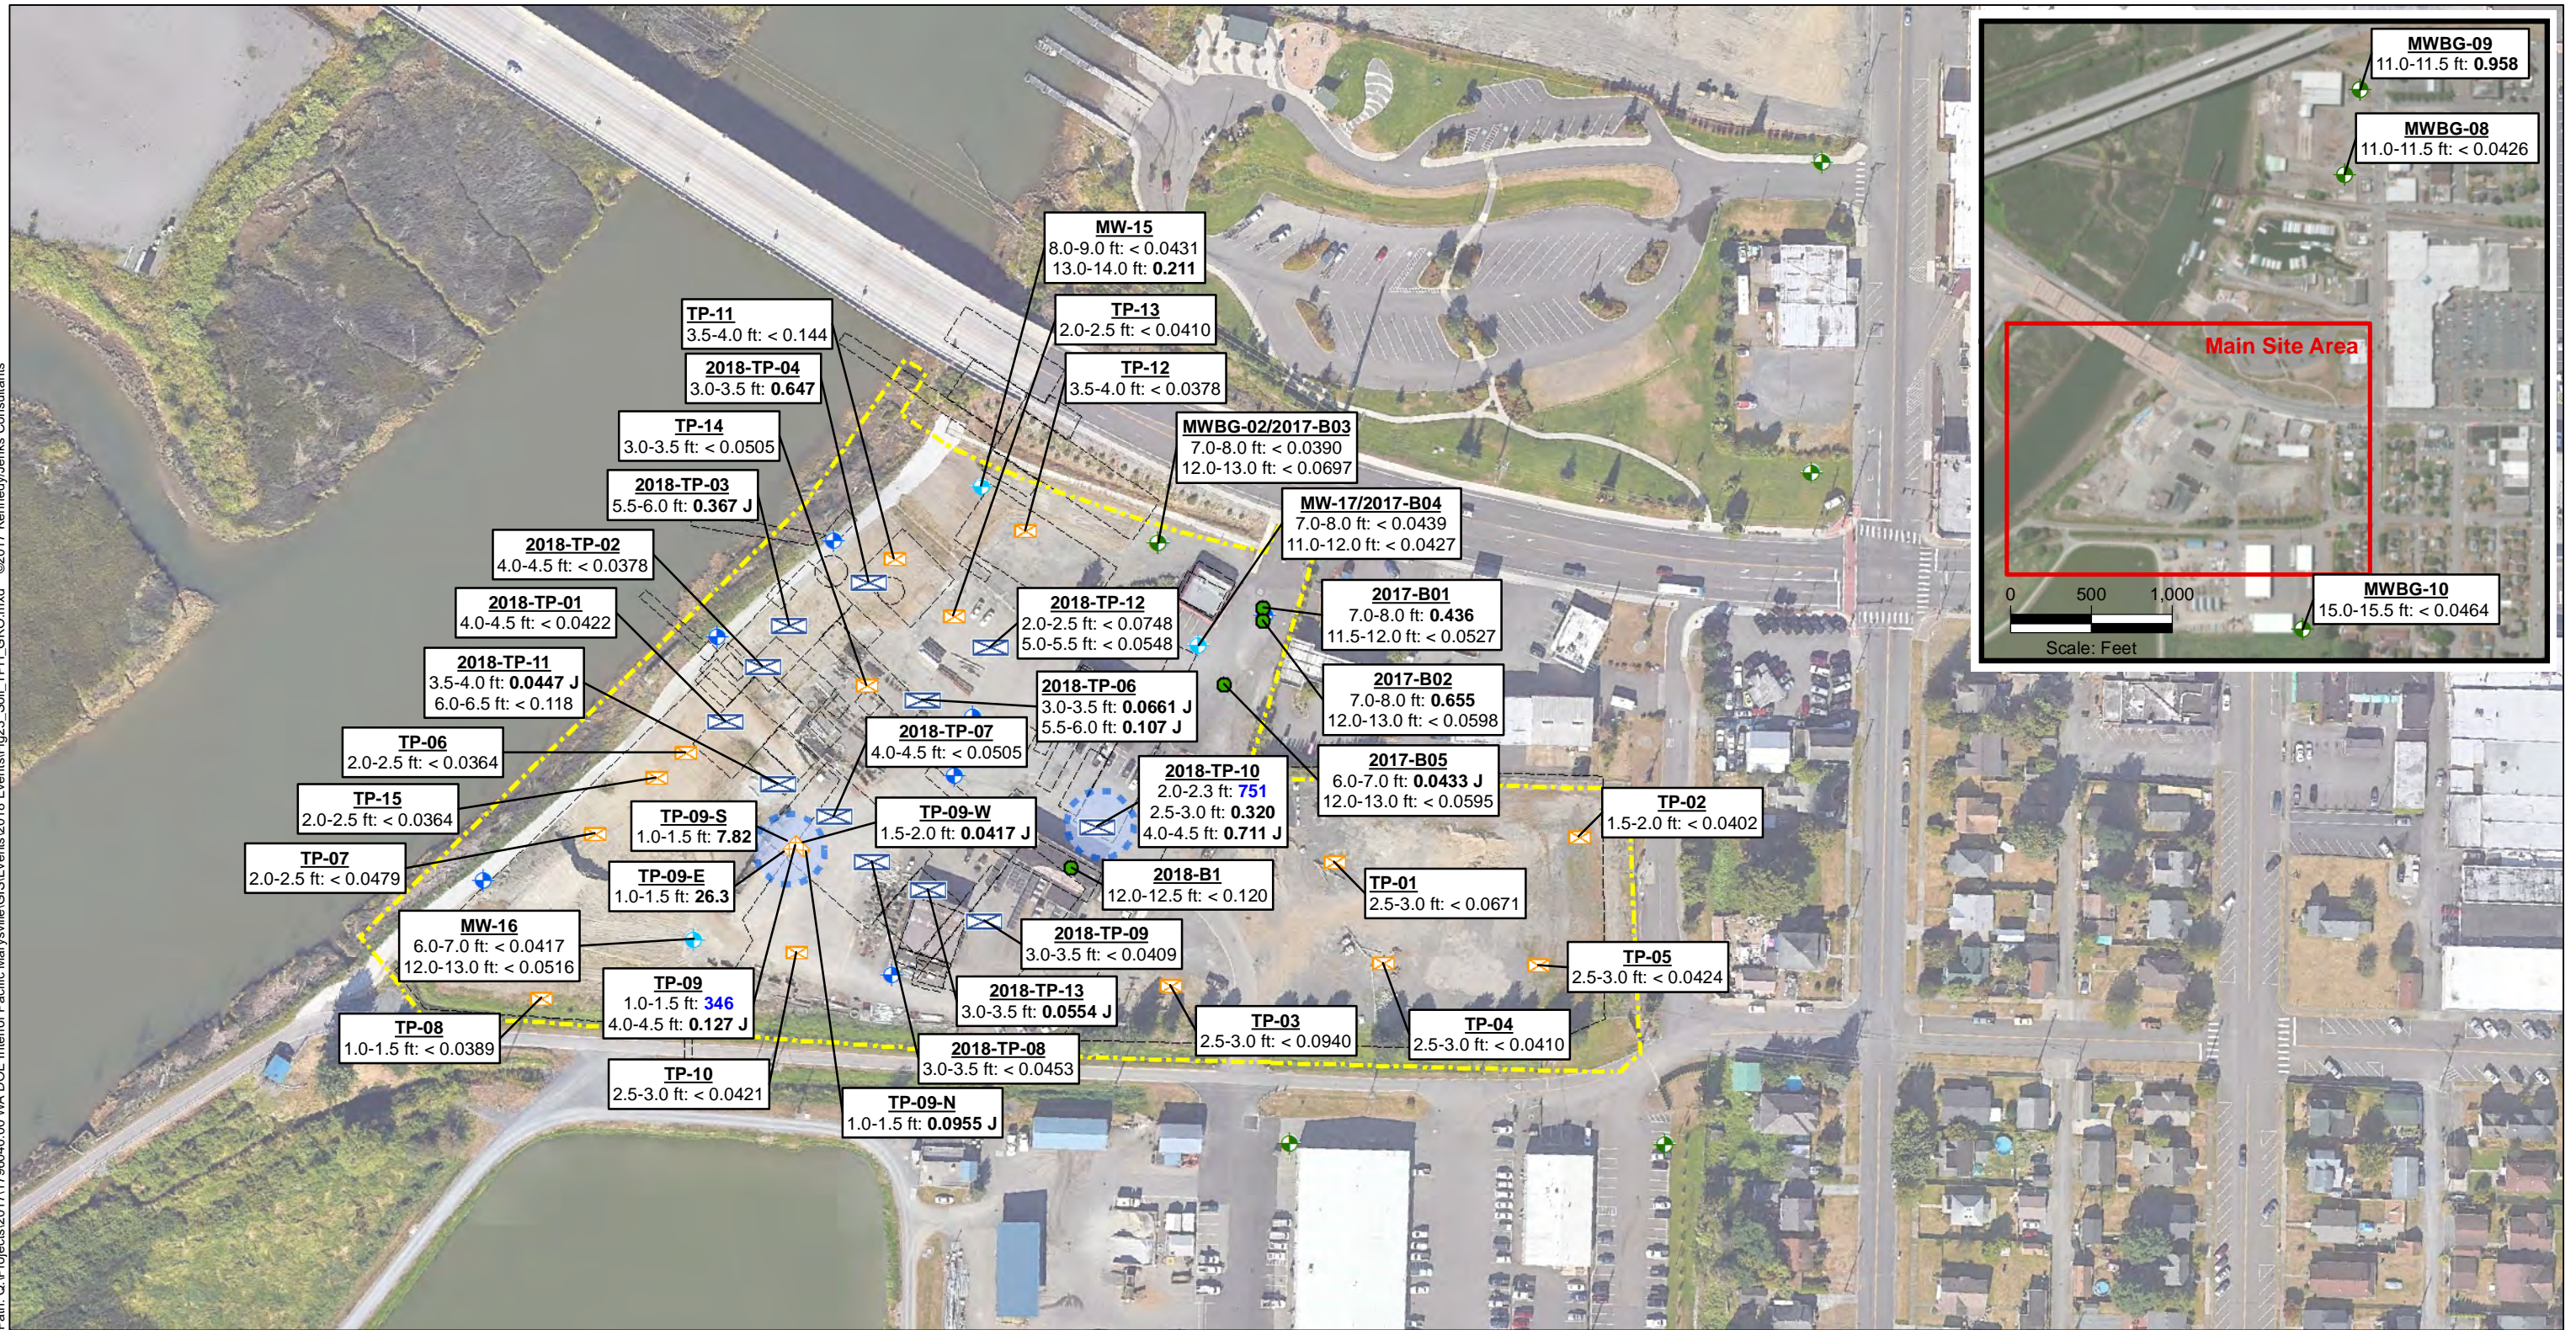
**Soil COC Concentration Map - GRO**

The TP-9 sample was collected from the center of the test pit at a depth of 1.0 to 1.5 feet bgs and contained 346 mg/kg of GRO. Additional soil samples collected from TP-9 below and lateral to the first sample (after TP-9 was expanded to collect additional characterization samples) also contained GRO [0.0417 mg/kg (“J” flagged) to 26.3 mg/kg] but at concentrations below the screening level. [Note: ORO was also detected above the screening level in TP-9, see below]. One sample from 2018-TP-10 (2.0-2.5 feet bgs) contained 751 mg/kg of GRO. Samples collected below the first sample at 2018-TP-10 (from 2.5 to 3.0 feet bgs and from 4.0-4.5 feet bgs) also contained GRO [0.320 and 0.711 (“J” flagged) mg/kg respectively], but at concentrations below the screening level. Based on field observations and analytical results, the areas of elevated GRO appear to include localized hotspots in the immediate vicinity of TP-9 and 2018-TP-10. See Figure 23 for GRO concentrations in soil.

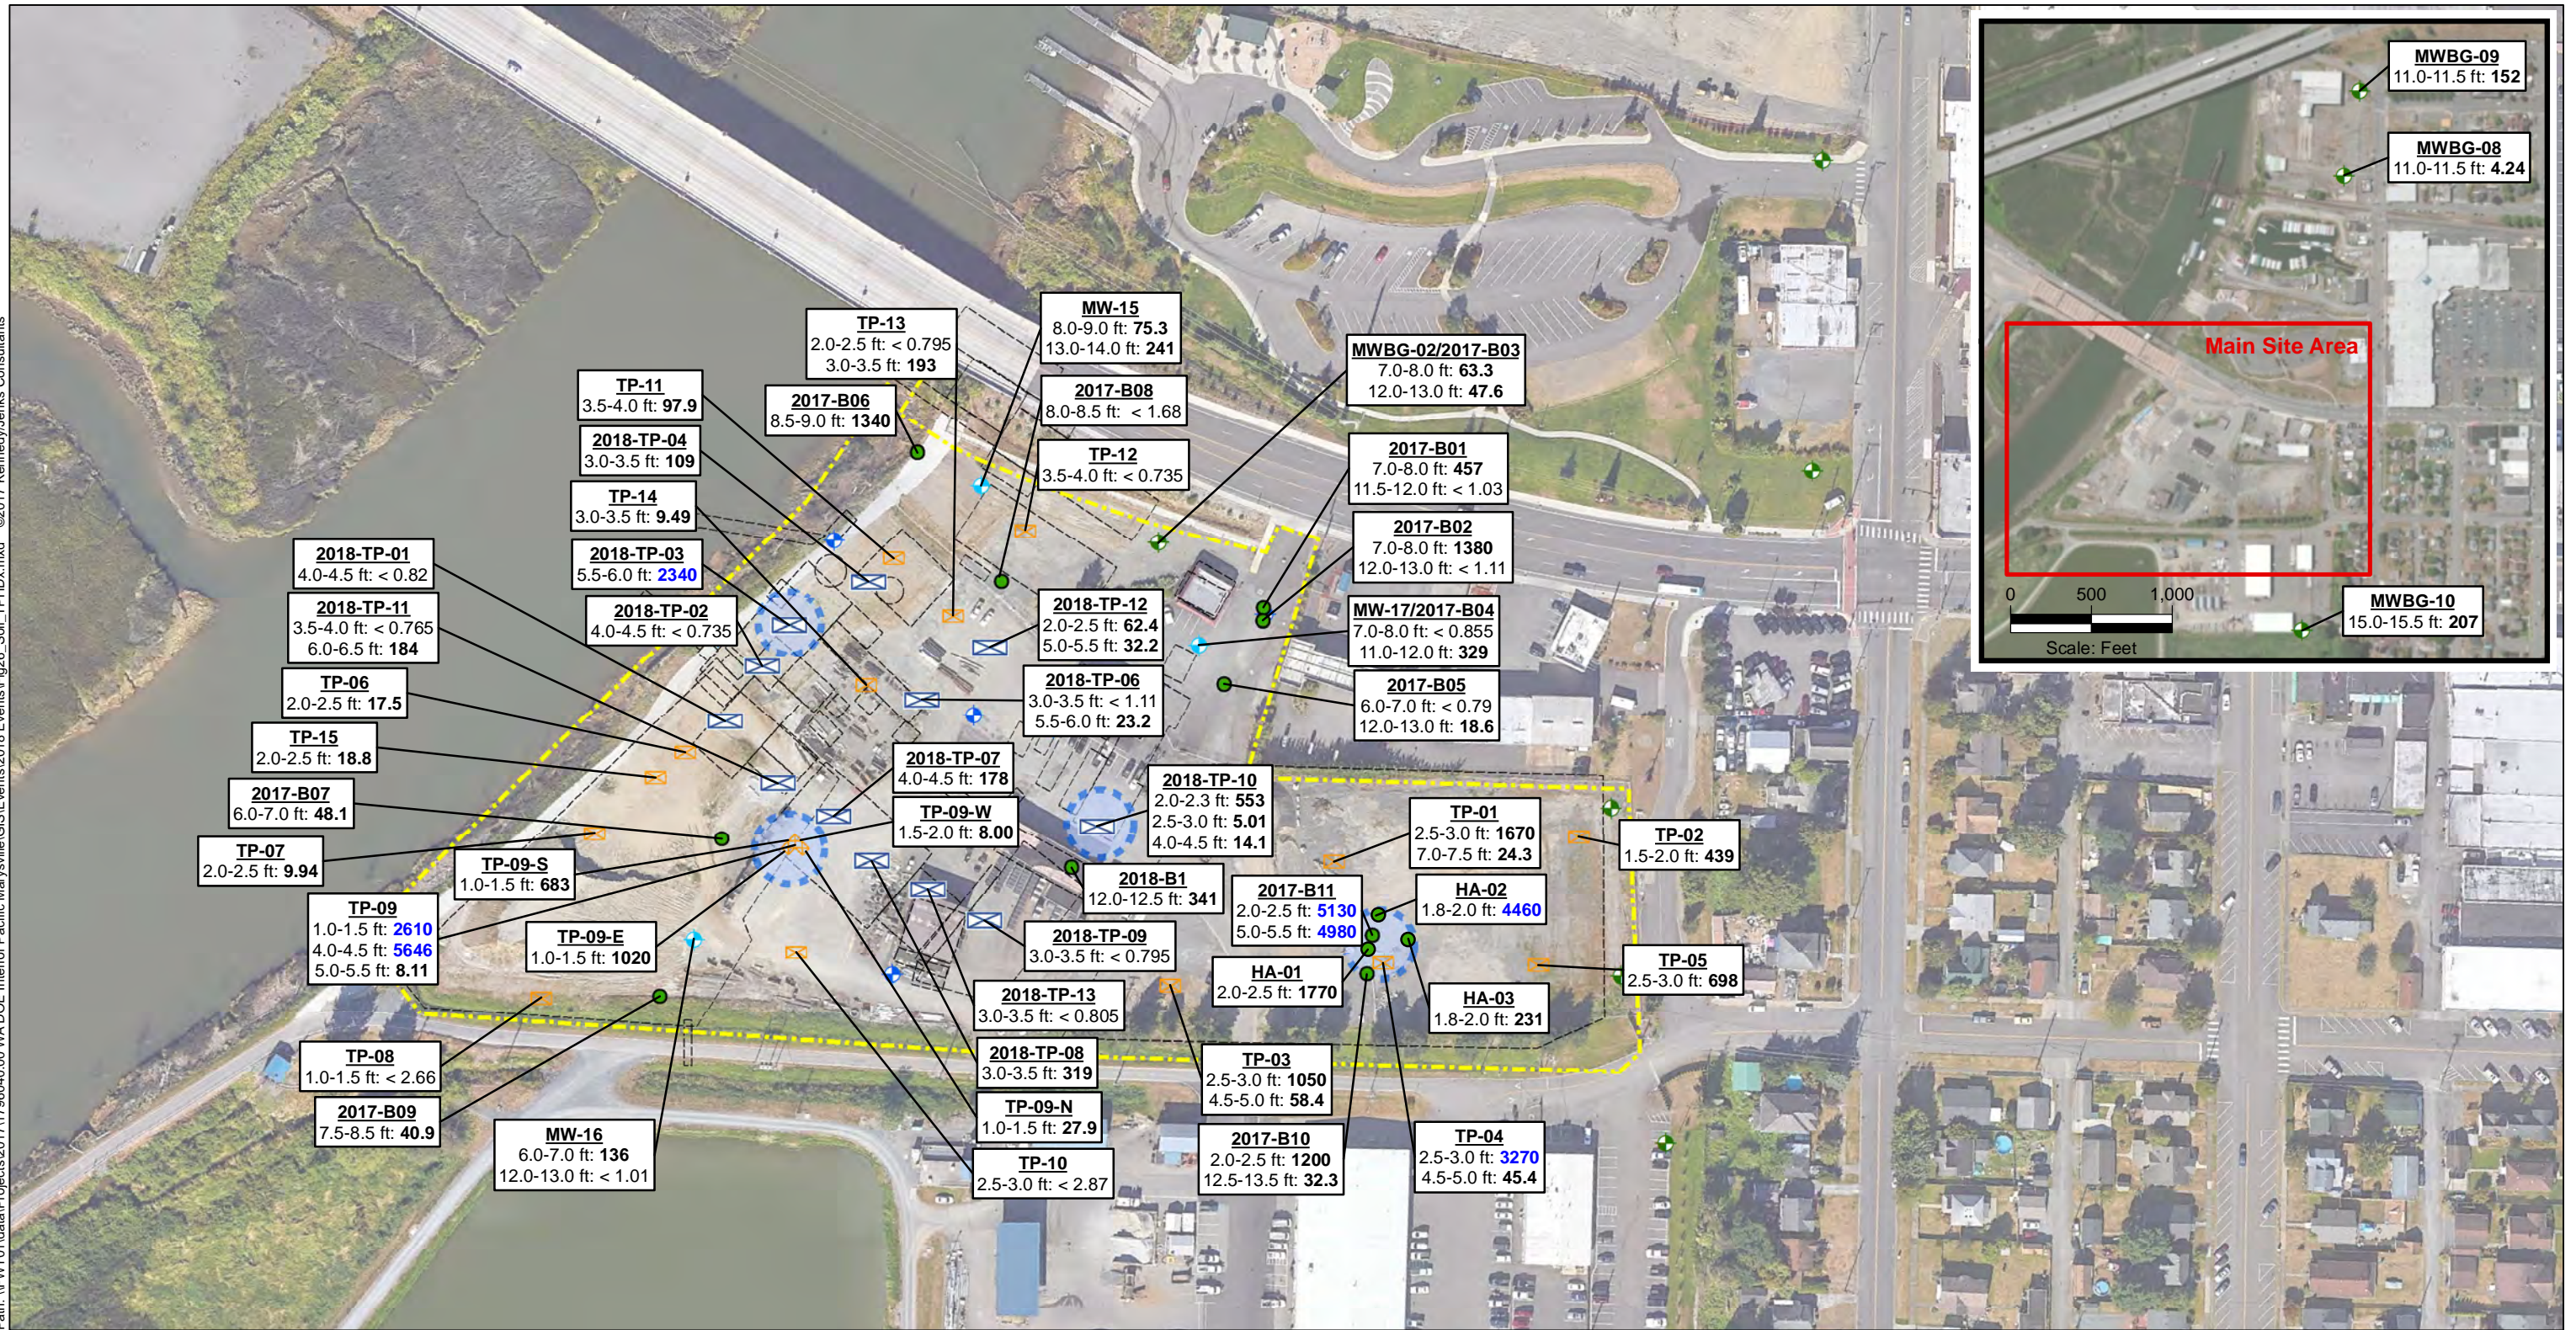
ORO was detected at concentrations above the screening level of 2,000 mg/kg in soil samples collected from 2017-TP-4 (3,120 mg/kg at 2.5-3.0 feet bgs), 2017-TP-9 (4,850 mg/kg at 4.0-4.5 feet bgs), 2017-B11 (4,900 mg/kg at 2.0-2.5 feet bgs; 4,820 mg/kg at 5.0-5.5 feet bgs), and HA-02 (4,140 mg/kg at 1.8-2.0 feet bgs). The summed DRO+ORO concentrations also exceeded the screening level for the samples listed above, plus one additional soil sample collected from TP-09 (2,610 mg/kg at 1.0-1.5 feet bgs). Based on field observations, the elevated ORO concentrations appear to represent localized hotspots in the vicinity of TP-9 (which also has elevated GRO concentrations) and in the vicinity of TP-4 and 2017-B11. See Figure 25 for ORO concentrations in soil, and Figure 26 for DRO+ORO concentrations.

Soil sample results for GRO, DRO, ORO, BTEX, VOCs, and PAHs are discussed below. Soil sample results for GRO, DRO, ORO, and DRO+ORO are presented on Figures 23, 24, 25, and 26, respectively. All organics data are listed in Table 4.

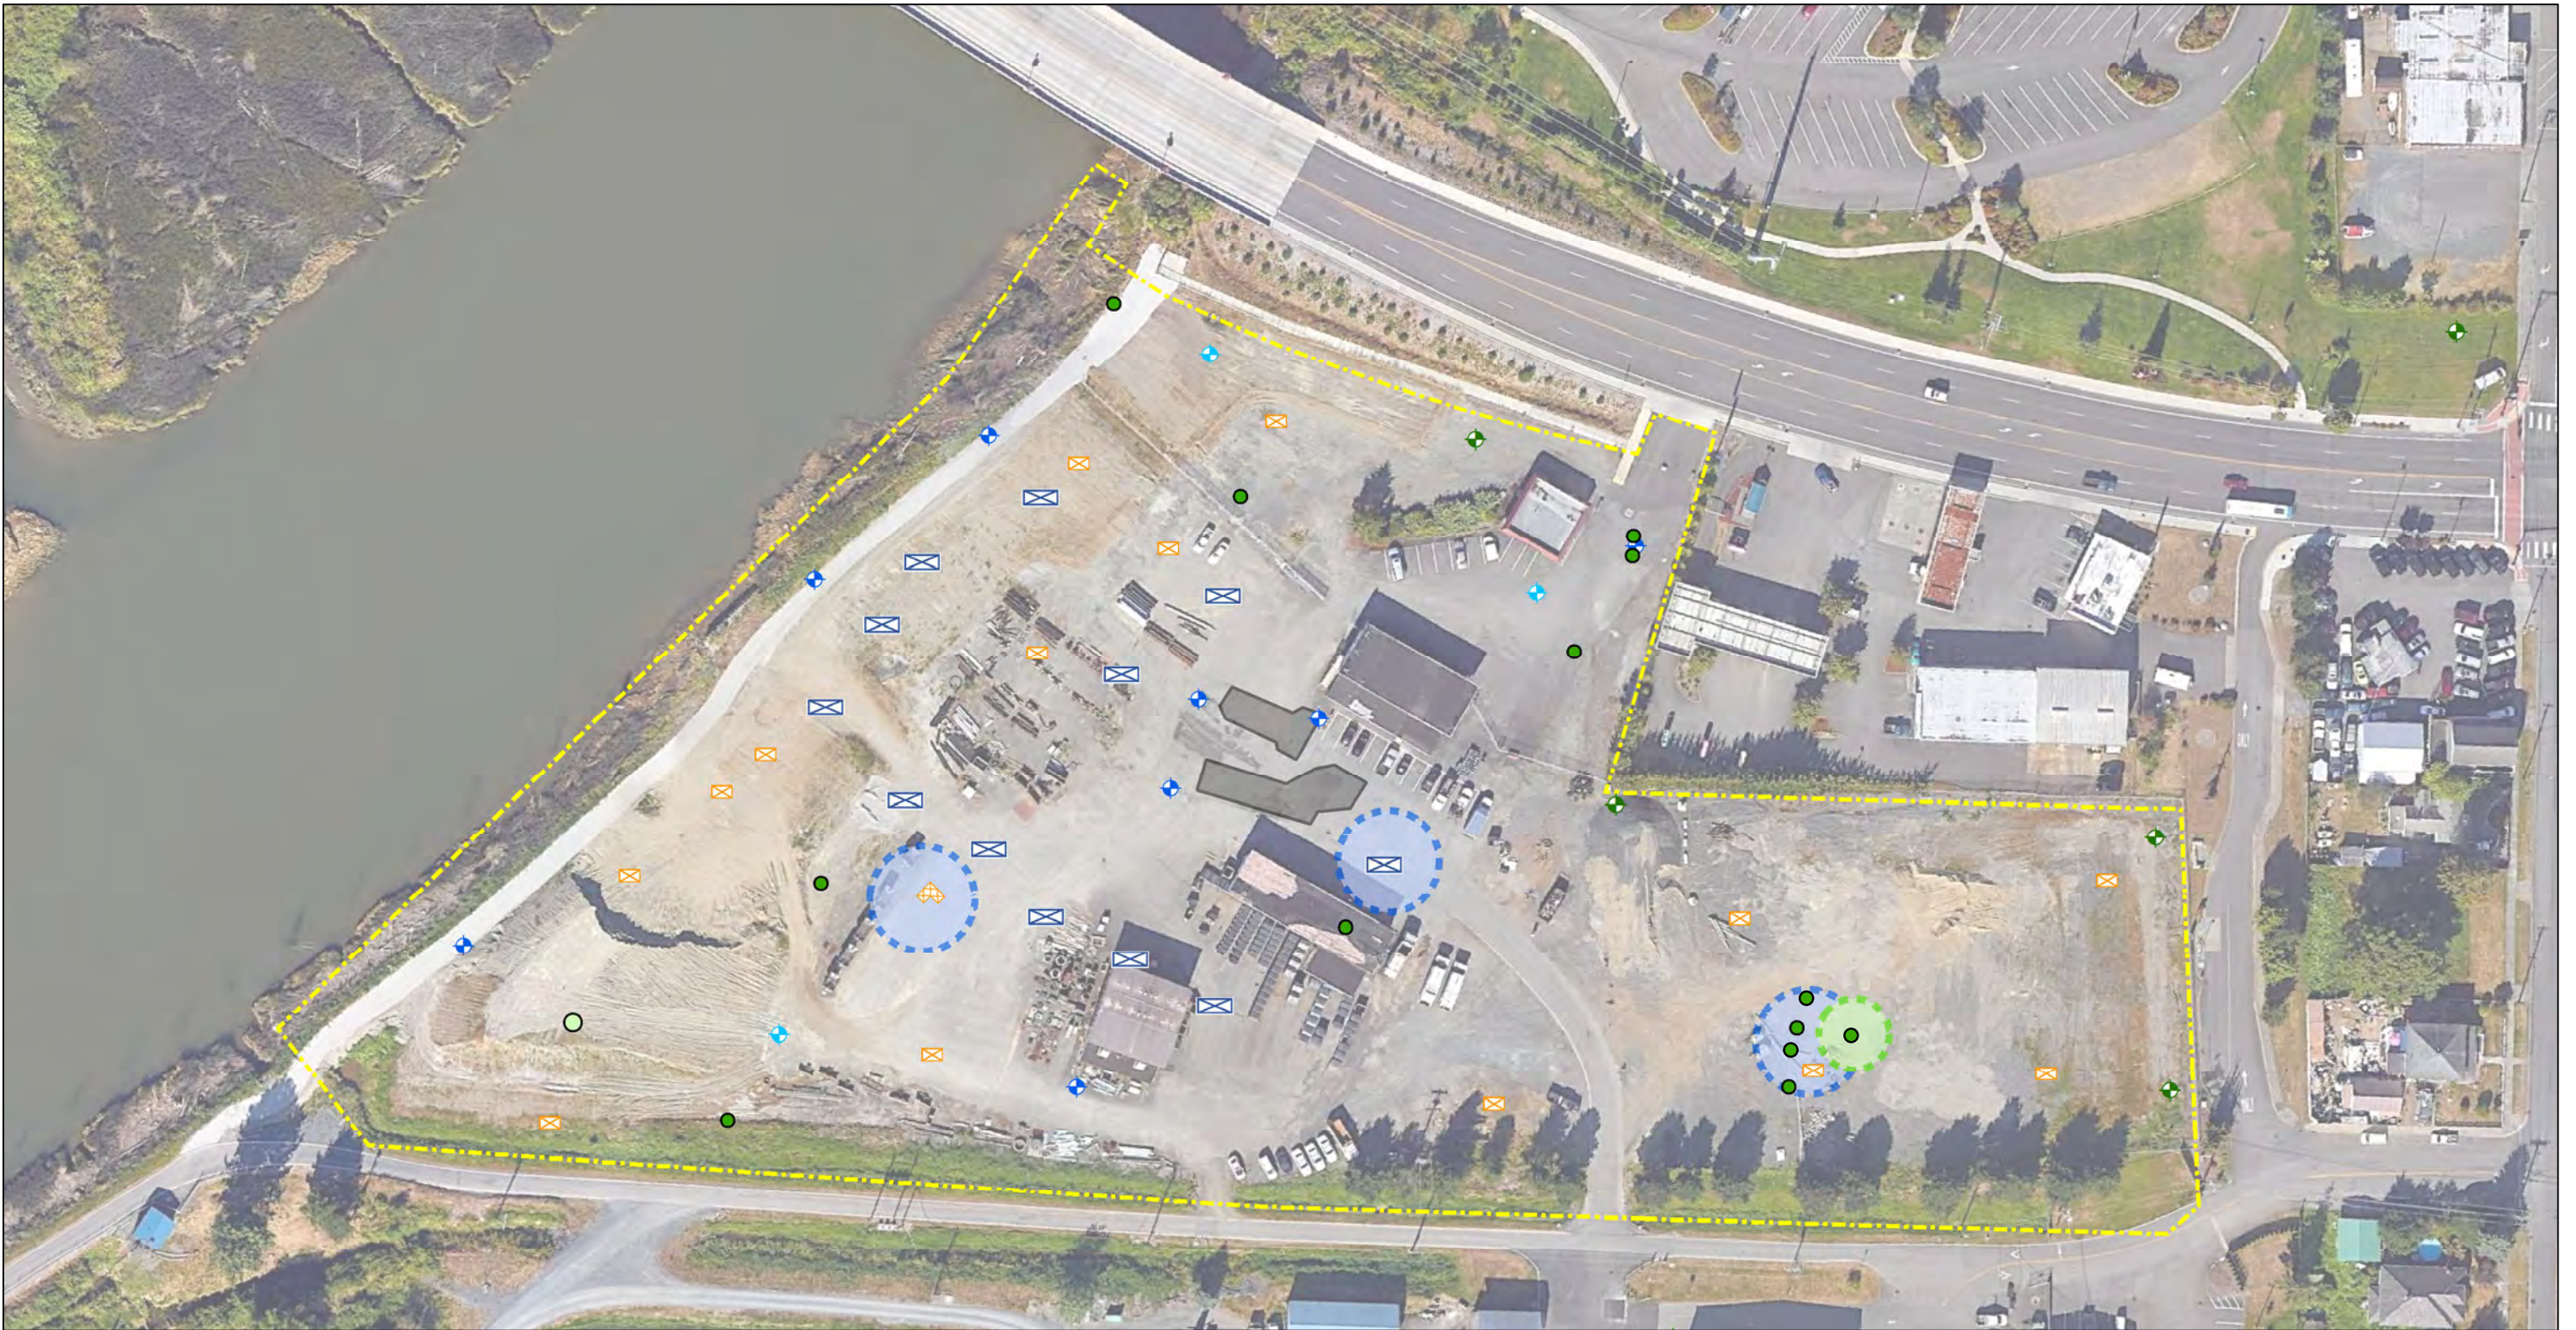
**Figure 33**

The estimated volume of impacted soil, based on the proposed soil cleanup standards presented in Section 8, is approximately 1,500 cy. Soil with one or more COCs (primarily TPH-related contaminants and arsenic) at concentrations above the proposed CULs occurs only in three separate areas of the Site, as shown on Figure 33.

Alternative 6 is identical to Alternative 5 except that hydraulic control is not provided. This alternative involves excavation and disposing of affected soils offsite as described in Alternative 2, construction of a low permeability slurry wall in the approximate location of the Site boundary without hydraulic control of groundwater within the slurry wall. The slurry wall would be designed so that the top of the slurry wall is at least 4 feet below grade to prevent site flooding. (Note: It is acknowledge that, in some parts of the site, seasonal water levels may exceed this depth.) Long-term groundwater quality monitoring, ECs, and ICs will also be elements of this alternative. The excavation and offsite disposal of impacted soil will be conducted as described in Alternative 2. The slurry wall will be installed as described in Alternative 5 to provide a low permeability barrier to contain groundwater impacted with arsenic from migrating offsite and discharging to surface water. Excavation and offsite disposal will be conducted as described in Alternative 2. In addition, soil generated during construction of the slurry wall will be managed using the same protocol as for the primary impacted soil excavation; however, a portion may be used during construction of the slurry wall. The elements of Alternative 6 are shown on Figures 33 and 35 and include:

As impacted groundwater moves through the PRB, arsenic III and arsenic V are coprecipitated with iron oxyhydroxides and adsorption to iron oxide surfaces. A pilot study would be conducted to evaluate PRB installation methods and reactive materials, which may include mixtures of zero valent iron (such as iron filings) and possibly an organic carbon source (wood chips, compost, etc). The pilot study would also include an evaluation of the potential effect of reverse flow through the PRB during high tide conditions. Soil generated during construction of the PRB will be managed using the same protocol as for the primary impacted soil excavation. Construction of the PRB includes the following elements (see Figures 33 and 34):

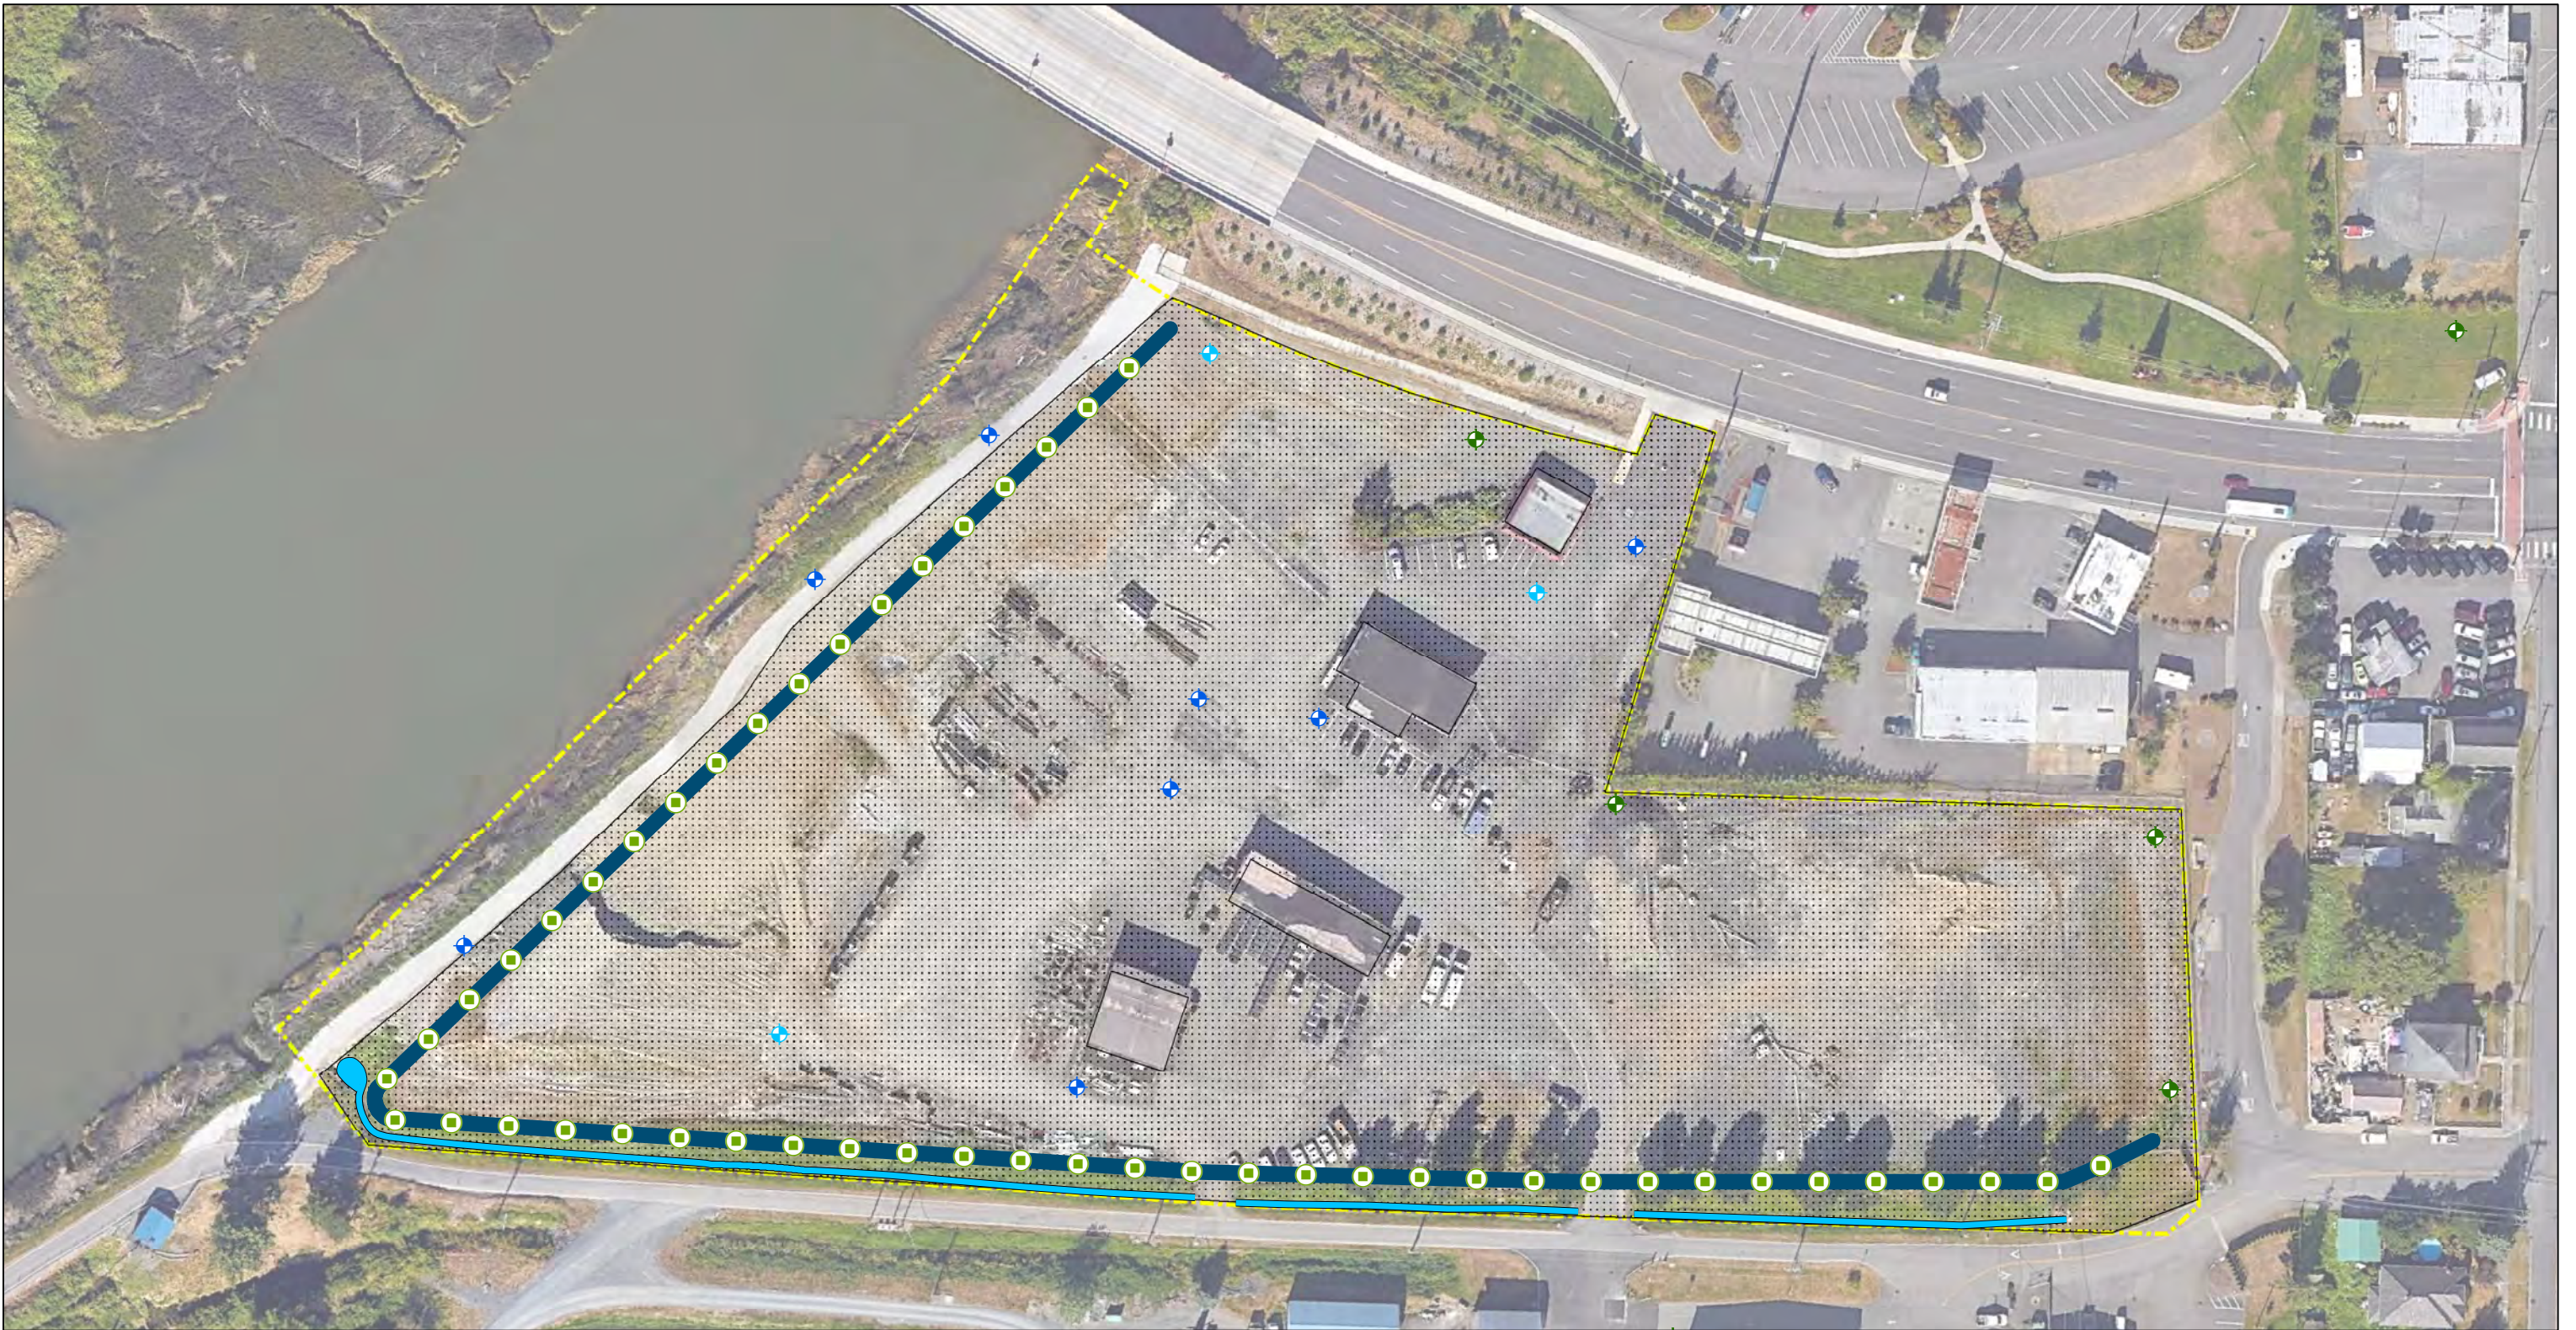
**Figure 34**

Alternative 3 includes the following elements (see Figure 34):
