Infiltration Feasibility Assessment

Proposed Twin Lakes Landing 2 Development

**Regarding: Infiltration Feasibility Assessment
Twin Lakes Landing 2 Development
Parcel #: 31052900300100
Property at West End of 164th Street NE
Marysville, WA 98270**

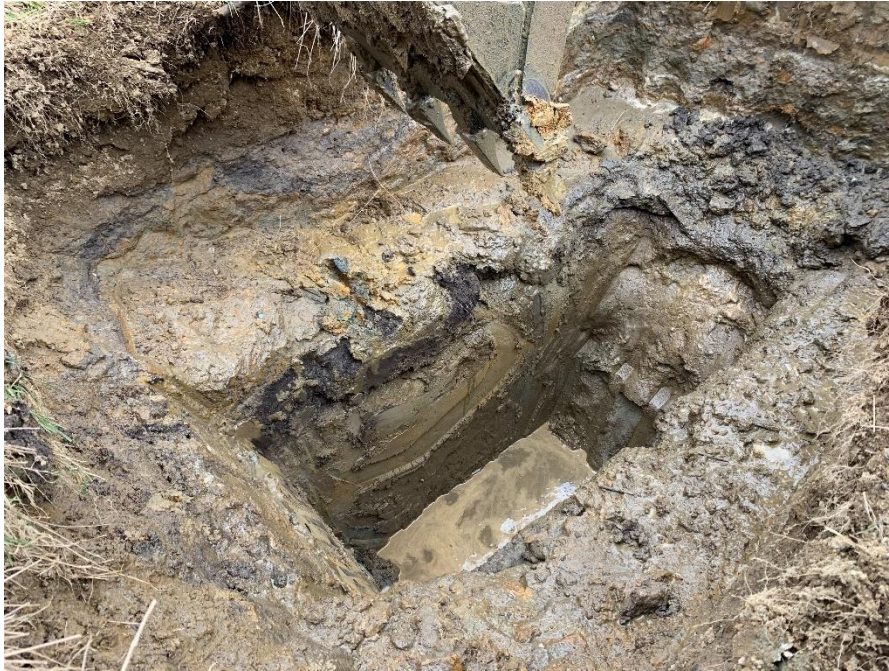
Image 1. Pilot Infiltration Test 1 excavations exposing 3.5' of dredged fill and relict topsoil overlying slightly gravelly, Marysville Sands with rapid seepage occurring at 6.8' below ground surface (BGS).

The subsurface soils encountered during our infiltration testing were in general accordance with previous explorations on the site. In the eastern half of the site, GeoTest observed an approximately 6 to 12-inch thick topsoil horizon underlain by a relict fill horizon that was observed to extend up to 4.5 feet below existing site grades. Underlying the relict fill was native silty sand, grading toward a slightly silty sand with trace gravel, with occasional thin silt/clay interbeds at depth (identified as glacial outwash, commonly referred to as "Marysville Sand"). GeoTest did not observe any dredged fill in explorations west of TP-7 and PIT-2. The native material was interpreted to be representative of Marysville Sand to the full depths explored. See the attached Site and Exploration Map (Figure 2) for the approximate locations of the subsurface explorations.

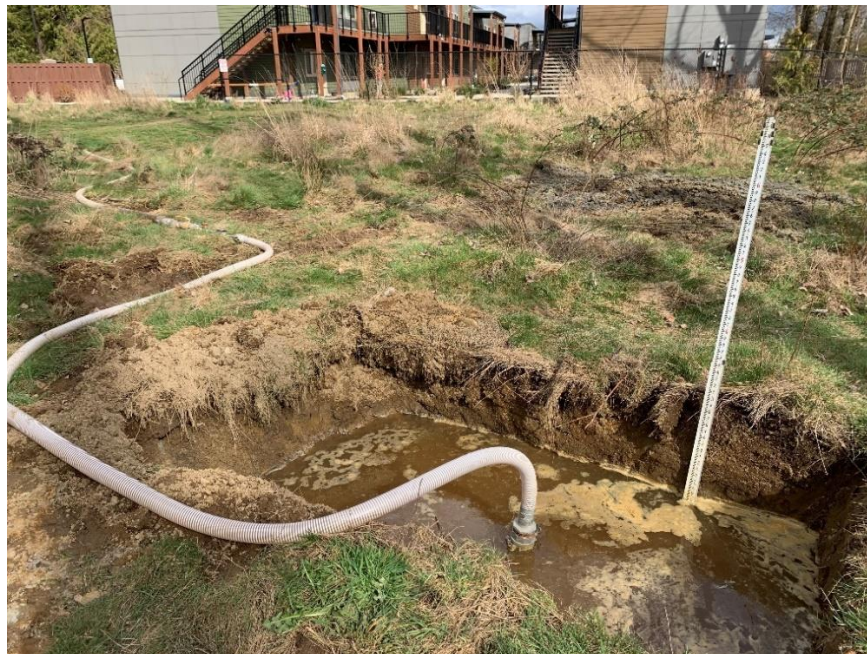
Image 2. Pilot Infiltration Test 1 set up at 2.75' BGS in the southeastern quadrant of the site within the relict topsoil unit.

We conducted Pilot Infiltration Testing at locations PIT-1 and PIT-2 to determine in-situ long term design infiltration rates. PIT testing was conducted using a method in general accordance with the procedure described for in the 2019 SMMWW. Infiltration testing was conducted by discharging water into a flat-bottomed pit of known dimensions. The intent of the PIT's was to allow enough flow into the excavated area to allow the soils in the immediate vicinity of the excavation to become saturated. During introduction of water into the excavation, a water meter was used to monitor and adjust flow rates. Water was brought onto the site using 2½ inch fire hose attached to a City of Marysville hydrant located on an adjacent property to the east. Testing took approximately seven hours, six hours of which consisted of pre-soak and flow stabilization followed by one hour of data collection.

PIT's at locations PIT-1 and PIT-2 yielded expected infiltration rates due to variable silt contents within the fill soils in the upper 4.5 feet of the site, as well as the presence of thin silt/clay interbeds at depth within the native Marysville Sand. These tests were conducted as falling head tests through native soil and into saturated native soil at depth.
