# **Green Canopy**

## **STORMWATER SITE PLAN**

SUNNYSIDE VILLAGE COHOUSING  
AUGUST 19, 2022

**STORMWATER SITE PLAN**

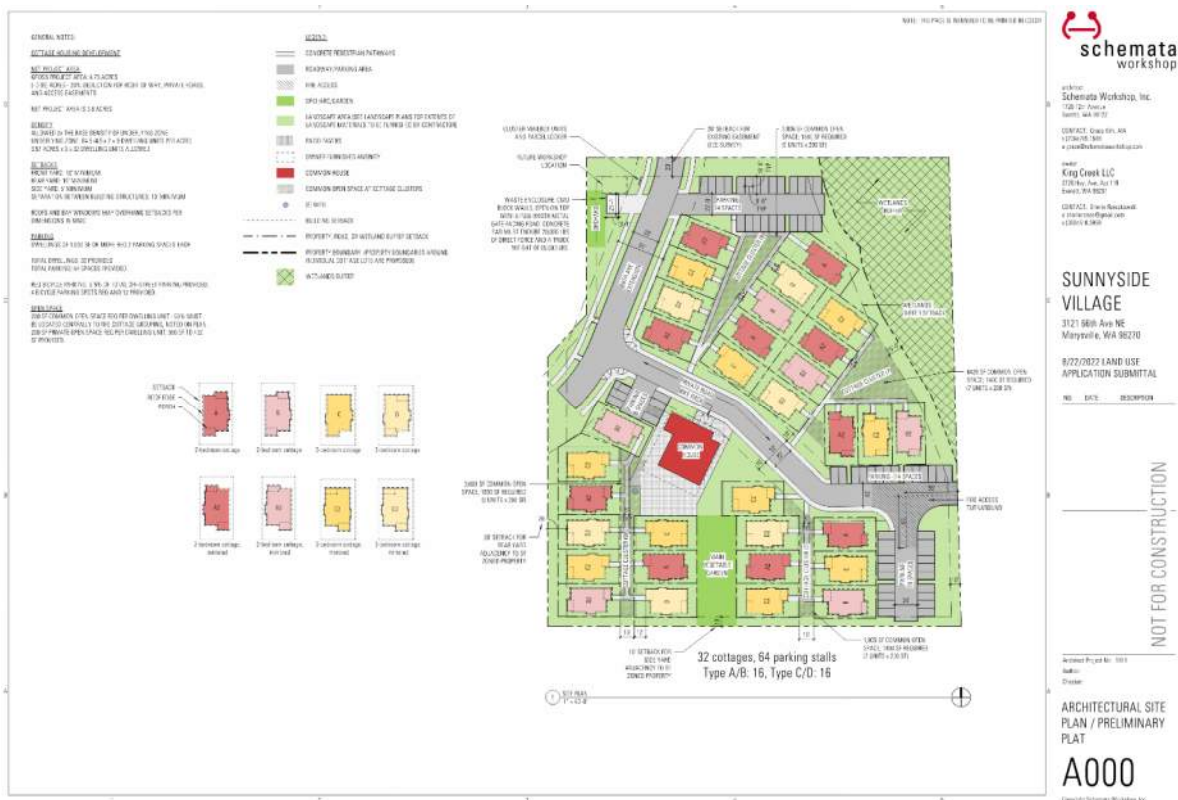
Figure 5 – Developed Condition

The Developed condition includes demolishing the existing pavement and buildings and redeveloping with 32 residential buildings, new sidewalks and a private road, parking lots, and community buildings.

Improvements include dedicating right of way for extending 66<sup>th</sup> Ave NE. A summary of proposed conditions is provided in Table 2, below. See Figure 5 – Developed Conditions and Figure 6 – Developed Drainage Subbasins.

Stormwater runoff from the developed part of the site will be conveyed to a stormwater detention vault located under the southeast parking lot. See Figure 6 – Developed Drainage Subbasins. Discharge from the detention vault will be via a Dispersal Trench and overland flow at the natural point of discharge. A stormwater duplex pump system will be required to convey stormwater from the detention vault's flow control structure to the dispersal trench.

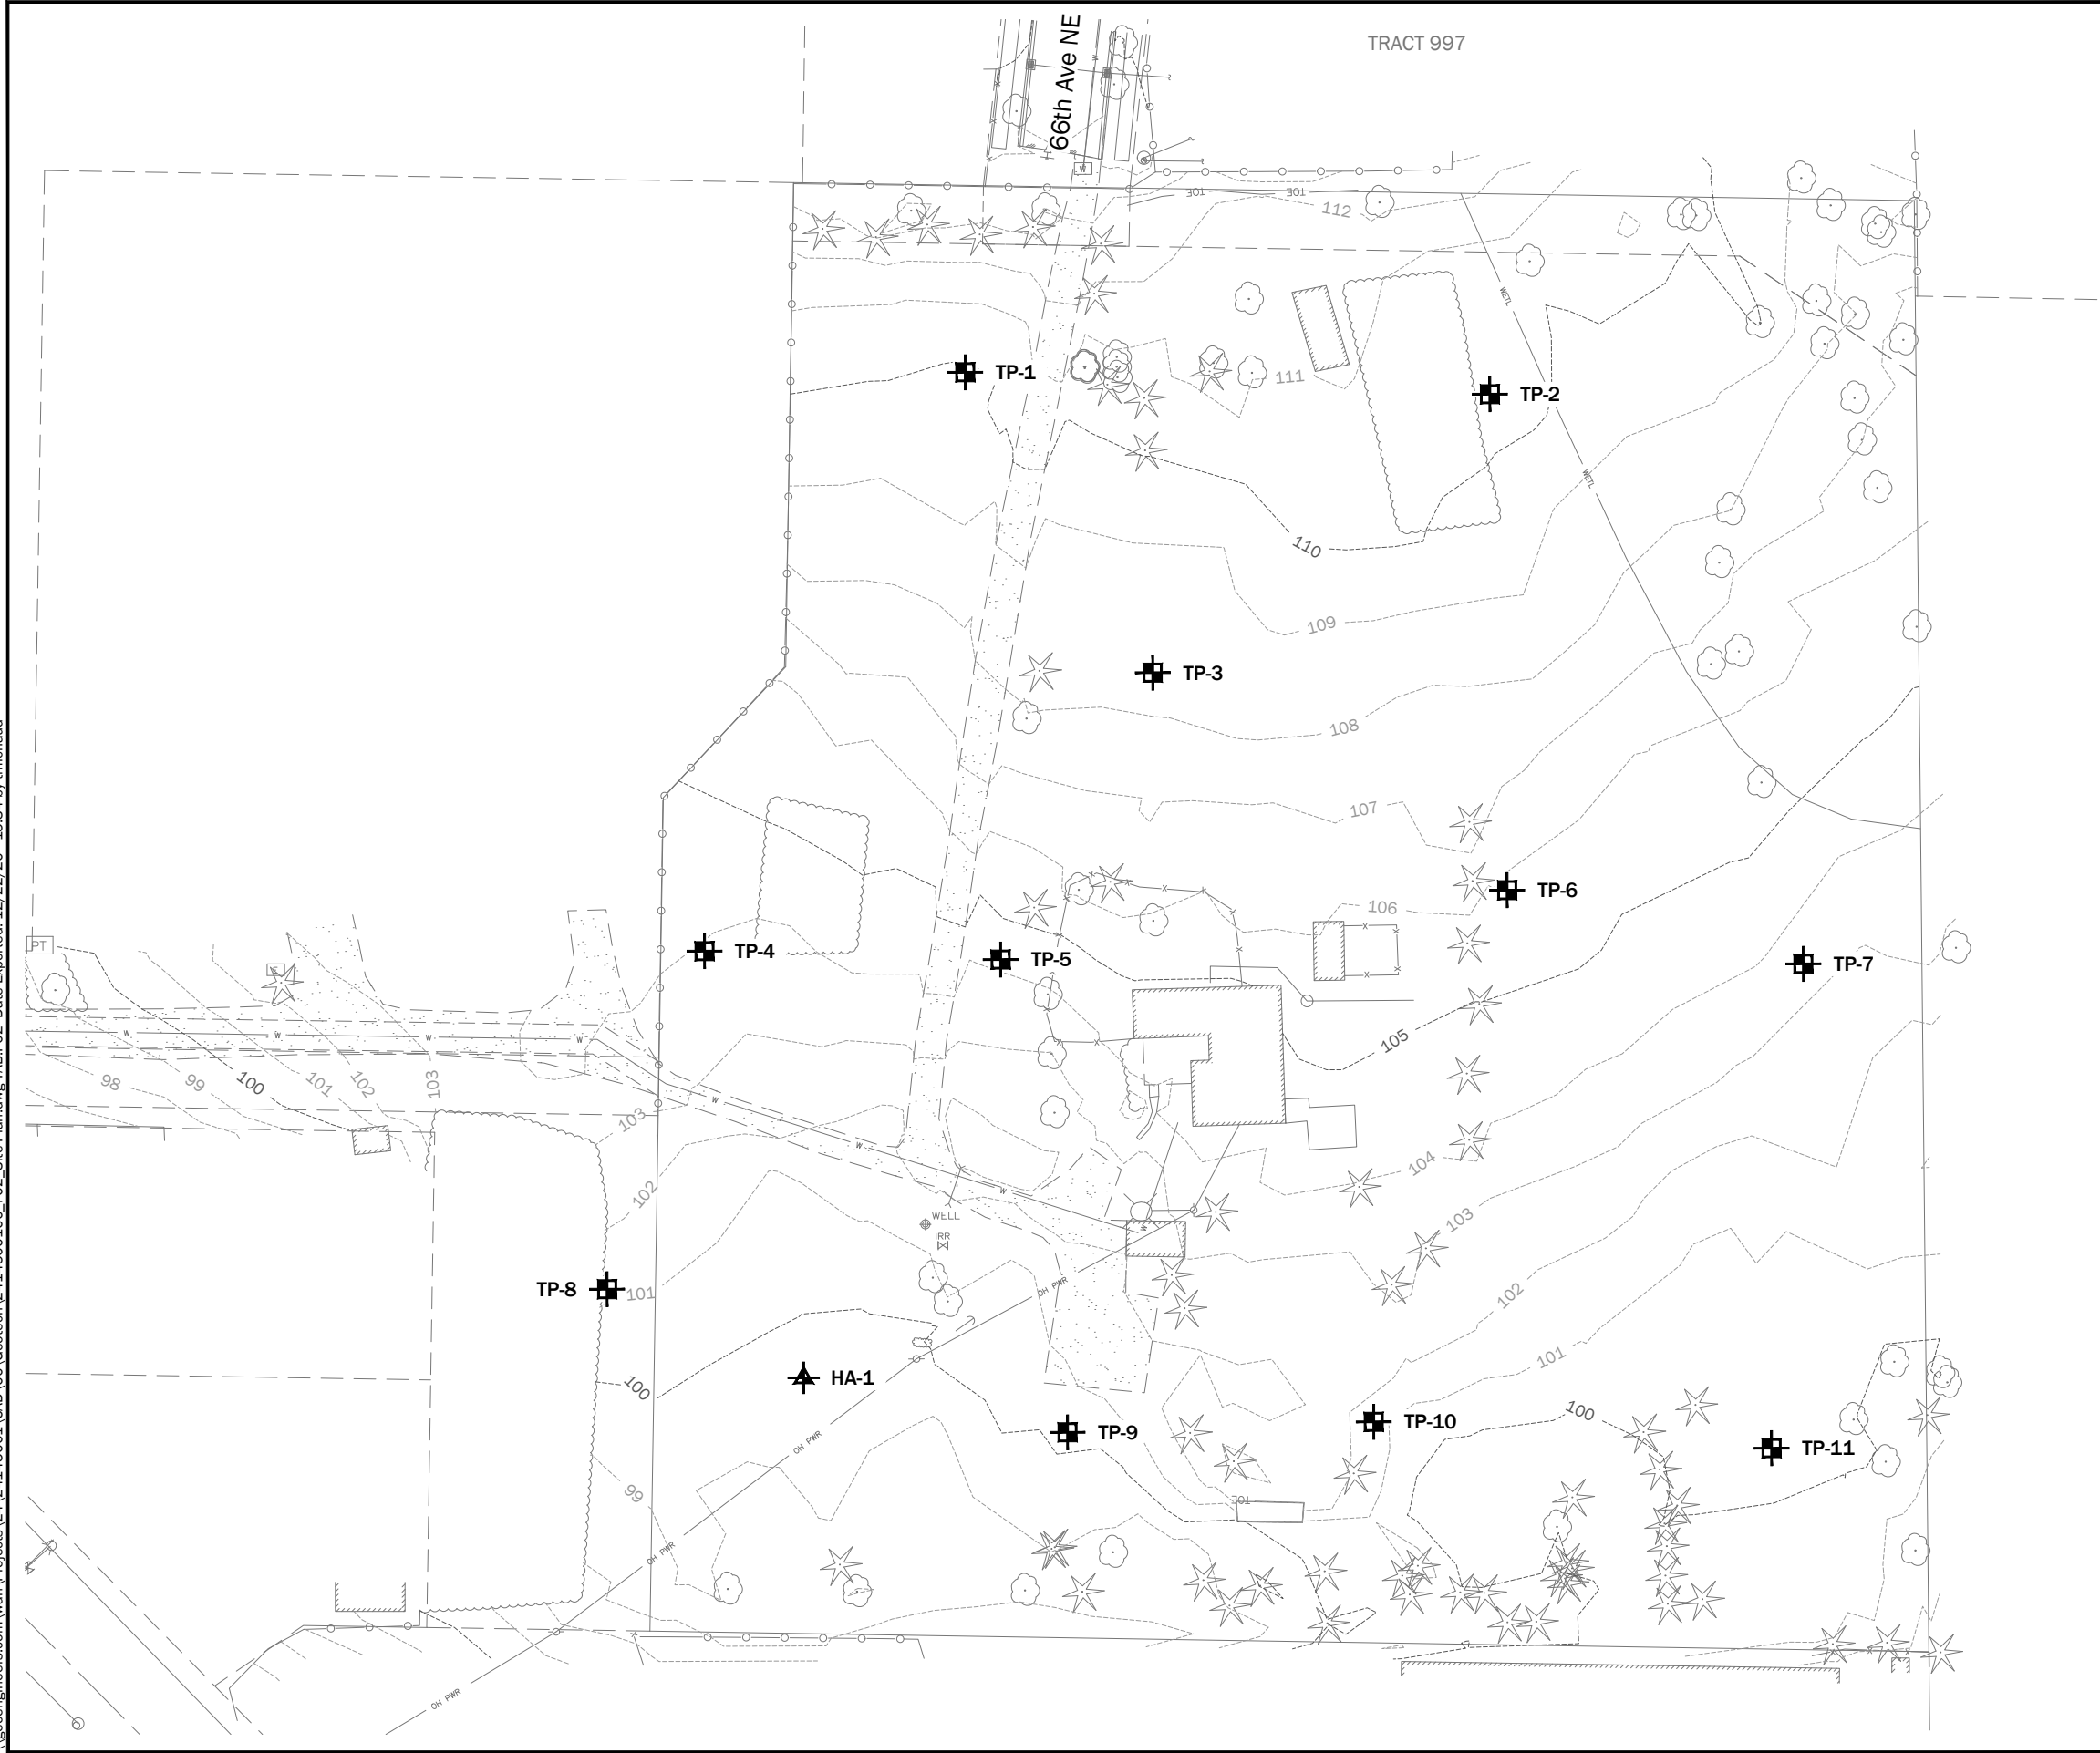
<b>Figure 2</b>

Subsurface conditions were evaluated through a field exploration program that consisted of excavating and sampling 11 test pits and completing one hand auger. The test pits and hand auger were completed on January 27, 2020. The test pits were completed using a rubber-tired backhoe subcontracted to GeoEngineers. The hand auger was completed using a 3-inch-diameter manually operated hand auger. The approximate locations of the explorations are shown on Figure 2.

The test pits were completed using a rubber tire-mounted Komatsu WB 140 backhoe owned and operated by Kelly's Excavating under subcontract to GeoEngineers. The test pit locations were determined in the field using a hand-held GPS. The approximate test pit locations are shown on Figure 2. The test pits were continuously monitored by a geotechnical engineer from our firm who reviewed and classified the soils encountered, obtained representative soil samples, observed groundwater conditions and prepared a detailed log of each exploration. Disturbed samples of representative soil types were obtained from the excavator bucket at representative depths before probing the bottom of the pit with a ½-inch-diameter steel probe rod to provide a measure of the relative density of granular soils and the relative consistency of cohesive soils. Soils encountered in the test pits were classified in the field in general accordance with ASTM International (ASTM) D 2488, the Standard Practice for Classification of Soils, Visual-Manual Procedure, which is summarized in Figure A-1, Key to Exploration Logs. Logs of the test pits are provided in Figures A-2 through A-12.

A hand auger was continuously monitored by a geotechnical engineer from our firm who reviewed and classified the soils encountered, obtained representative soil samples and observed groundwater conditions. The hand auger location was determined in the field using a hand-held GPS and the approximate location is shown on Figure 2. The soils encountered were generally sampled at 1-foot vertical intervals with a 3-inch inside-diameter, manually-operated hand auger. Soils encountered were visually classified in general accordance with the classification system described in Figure A-1. A key to the hand auger log symbols is also presented in Figure A-1. A log of the hand auger is presented in Figure A-13.

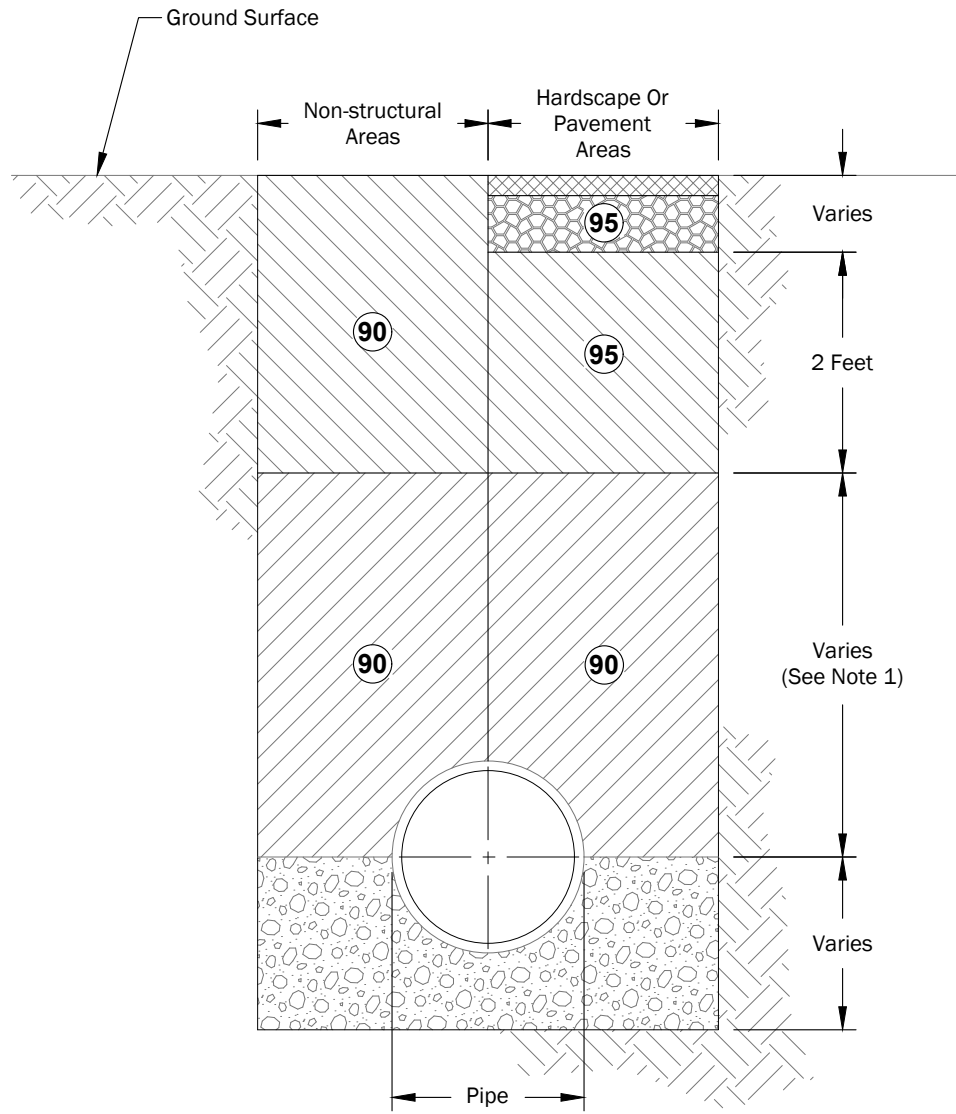
<b>Compaction Criteria for Trench Backfill</b>	
Sunnyside Village Cohousing Marysville, Washington	
 	<b>Figure 3</b>

Utility trench backfill should consist of structural fill and should be placed in lifts of 12 inches or less (loose thickness) when using heavy compaction equipment or 6 inches or less when using hand-operated equipment, such that adequate compaction can be achieved throughout the lift. Each lift must be compacted prior to placing the subsequent lift. Prior to compaction, the backfill should be moisture-conditioned to within 2 percent of the optimum moisture content, if necessary. The backfill should be compacted in accordance with the criteria discussed above and as shown on Figure 3.

1. Structural fill placed below floor slabs and foundations, and against foundations, should be compacted to at least 95 percent of the MDD.
2. Structural fill in new pavement and hardscape areas, including utility trench backfill, should be compacted to at least 90 percent of the MDD, except that the upper 2 feet of fill below final subgrade should be compacted to at least 95 percent of the MDD, as shown in the Compaction Criteria for Trench Backfill, Figure 3.
3. Structural fill placed as crushed rock base course below pavements should be compacted to 95 percent of the MDD.
4. Non-structural fill, such as fill placed in landscape areas, should be compacted to at least 90 percent of the MDD.

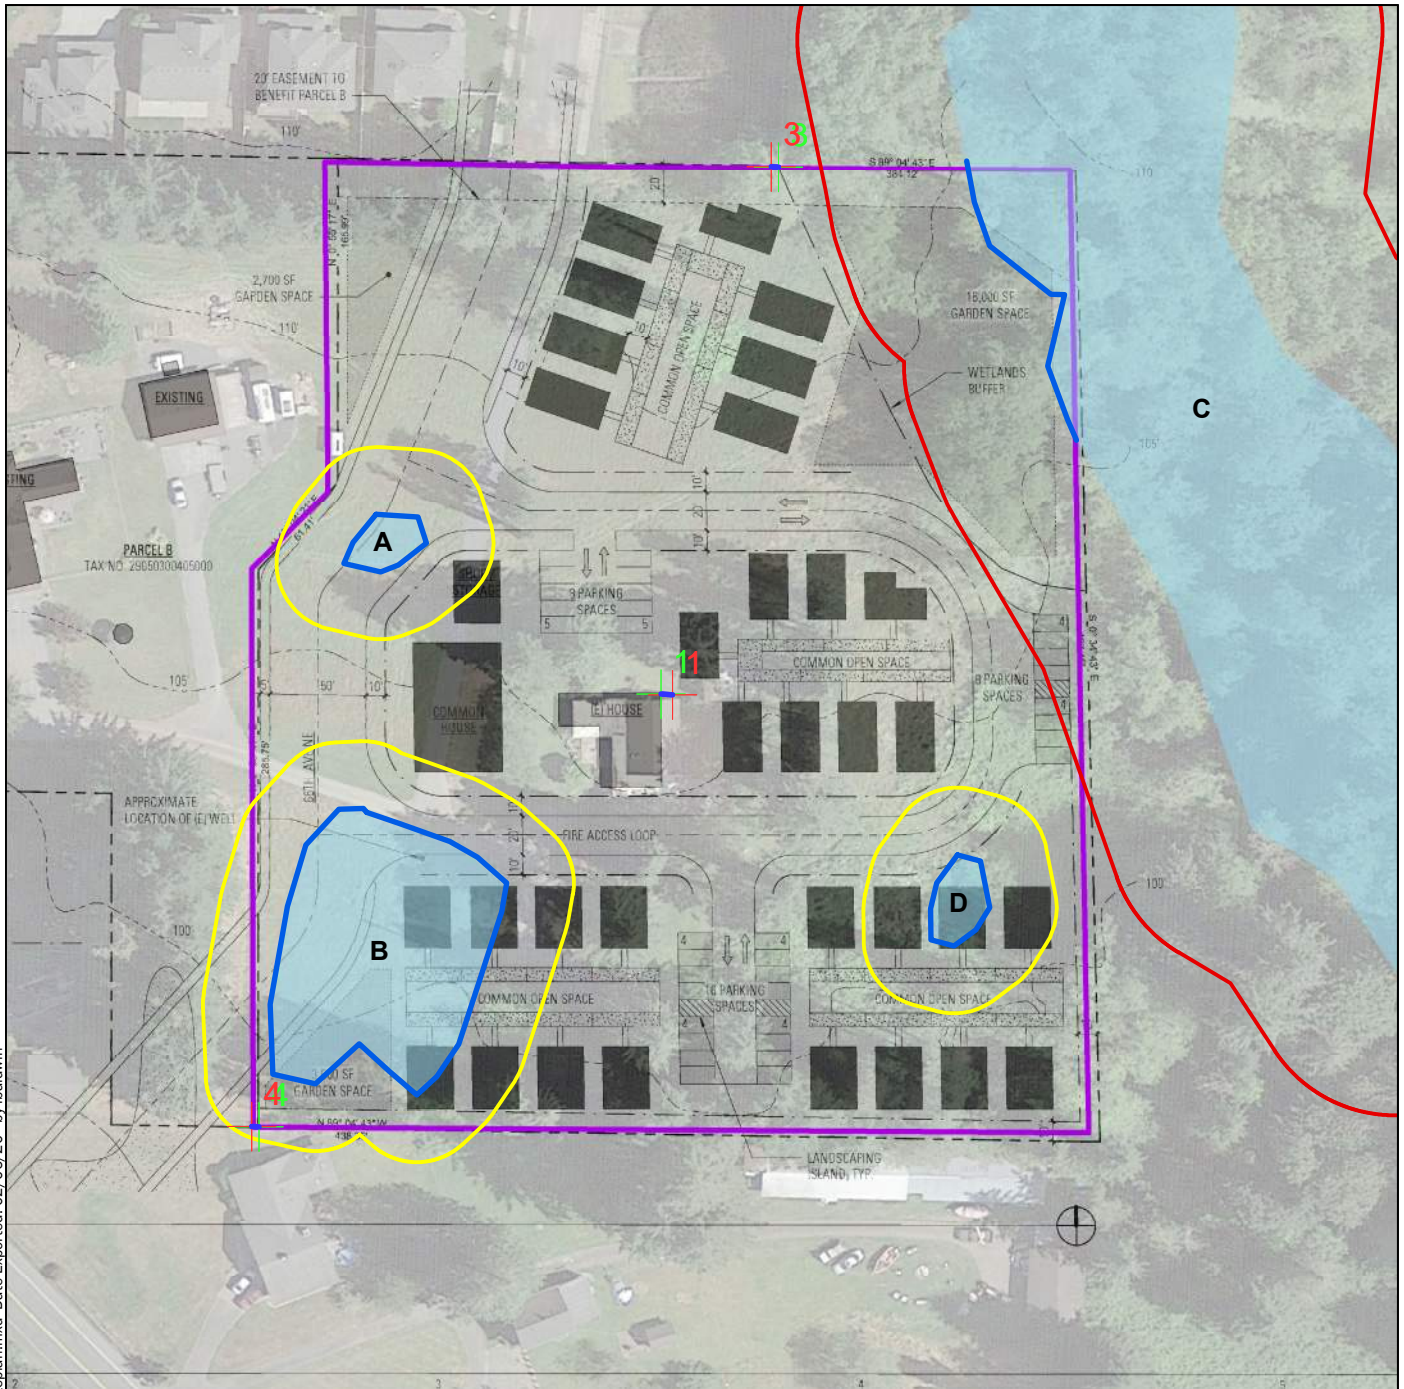
<b>Site Plan</b>	
Sunnyside Village - Cottage Housing Marysville, Washington	
	<b>Figure 1</b>

- Assessment Area
- Wetland Buffer (35-ft)
- Wetland
- Wetland Buffer (75-ft)
