GEOTECHNICAL REPORT

**L123
5811 – 87th Avenue Northeast
Marysville, Washington**

Project No. T-5640-2

Terra Associates, Inc.

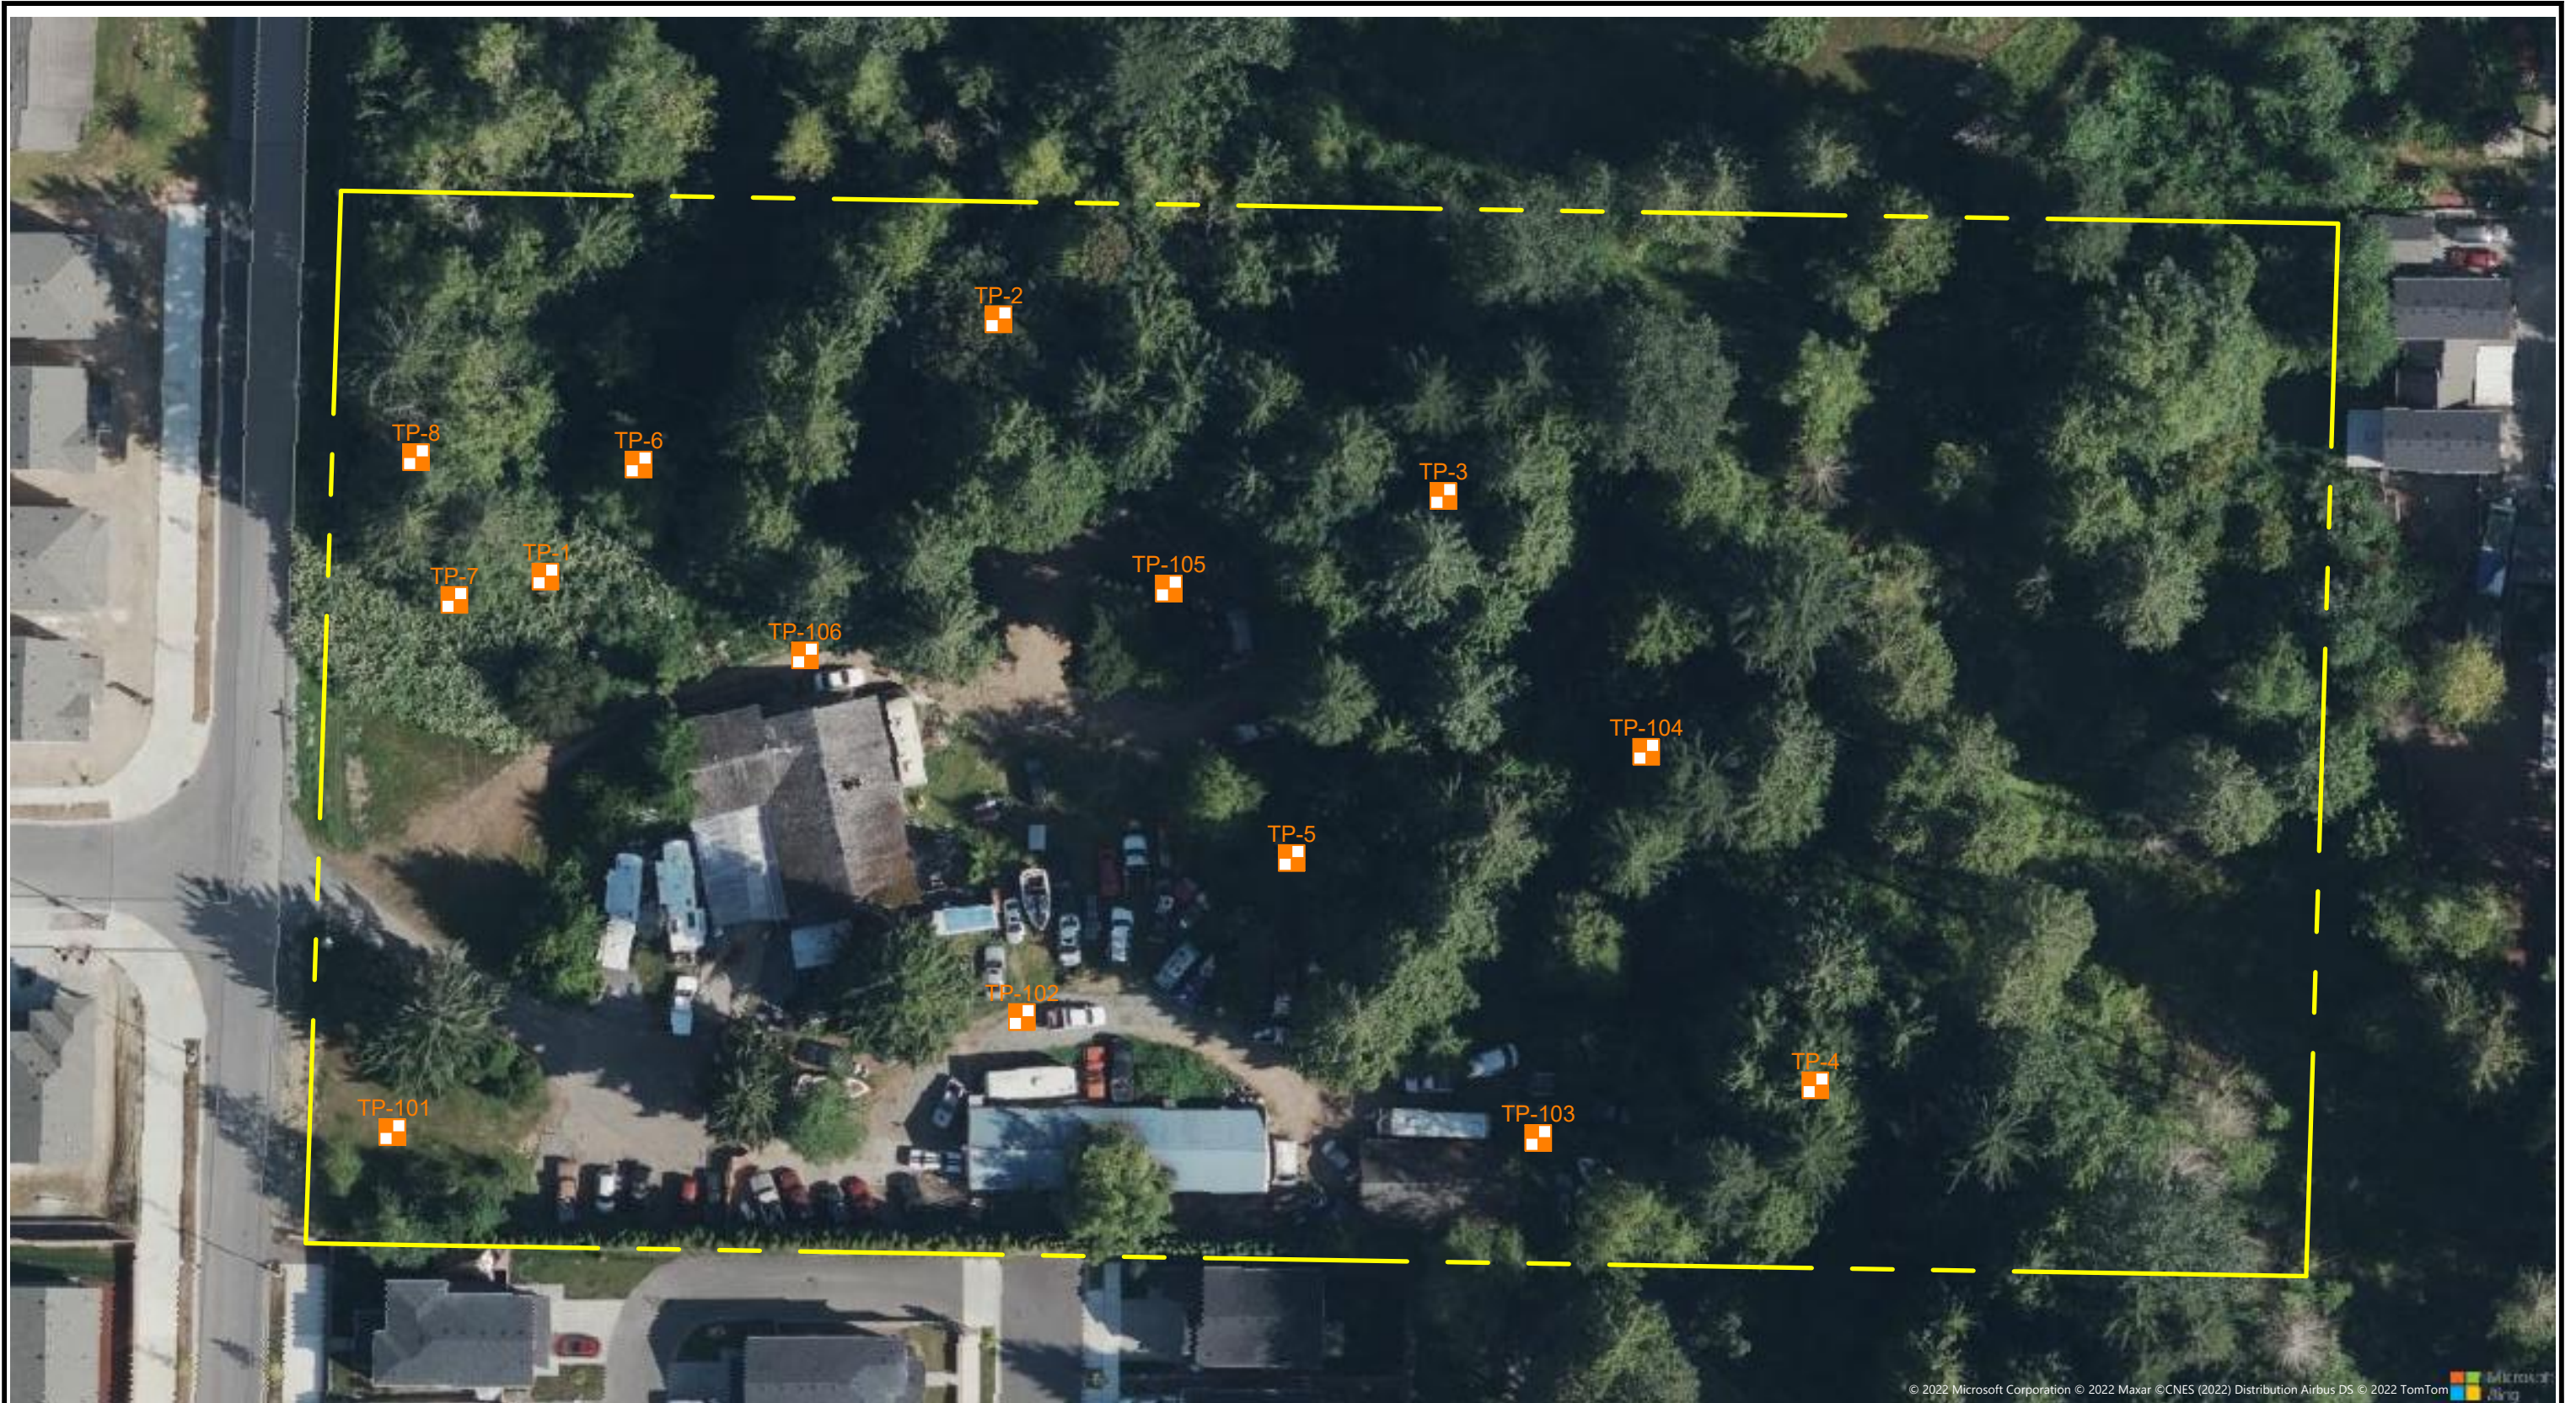
Figure 2

The preceding discussion is intended to be a general review of the soil conditions encountered. For more detailed descriptions, please refer to the Test Pit Logs in Appendix A. The approximate location of the test pits are shown on the Exploration Location Plan, Figure 2.

On December 1, 2005, we observed soil and groundwater conditions at 8 soil test pits excavated with a mini-excavator to maximum depths of approximately 6 to 11 feet below existing grades. On May 9, 2022, we supplemented this data by excavating 6 test pits with a track-mounted excavator to maximum depths of approximately 8 to 12 feet below existing grades. The test pit locations were approximately determined in the field using GPS coordinates and by sighting and pacing from existing surface features. The approximate test pit locations are shown on Figure 2. The Test Pit Logs are presented as Figures A-2 through A-11.
