White Barn Commercial: Lot 2

Preliminary Drainage Report

LDC | Surveying
Engineering
Planning

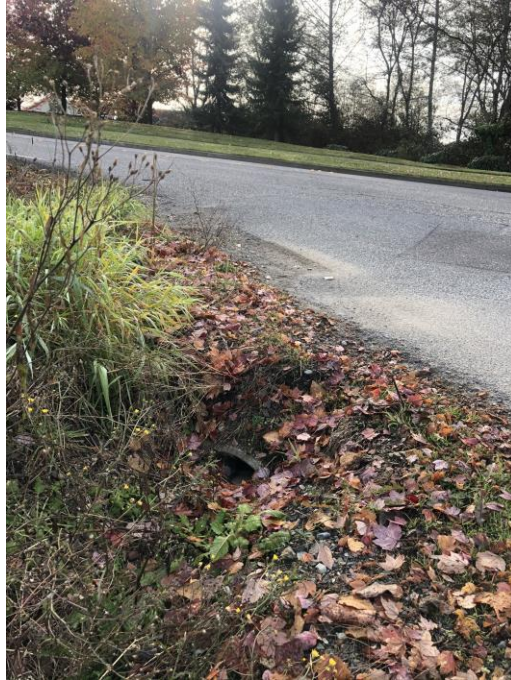
Image ❶: Facing southward from the southwestern corner of the White Barn Commercial property, at the intersection of Soper Hill Road and 87th Ave NE. Flows discharging from Threshold Basin A flow southward through a 12" CMP culvert across Soper Hill Road and enter the existing Soper Hill collection and conveyance system.

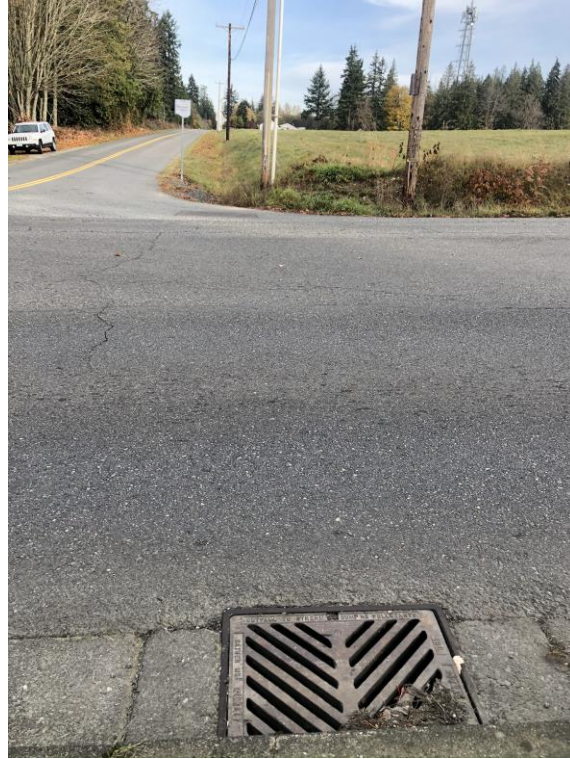
Image 2: Facing northward from the southern edge of Soper Hill Road, at its intersection with 87th Ave NE. Discharged flows enter the existing Soper Hill collection and conveyance system on the southern edge of the road, and convey westward through closed pipe beyond the 0.25-mile boundary of analysis.

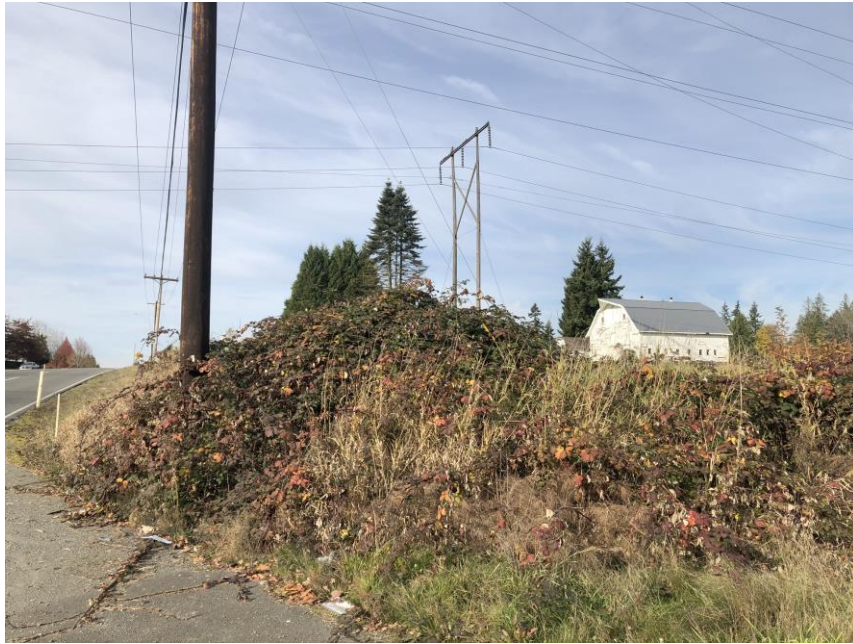
Image ③: Facing northwestward toward the southeast corner of the White Barn Commercial property, where overland flow associated with Threshold Basin B discharges to Soper Hill Road & Highway 9.

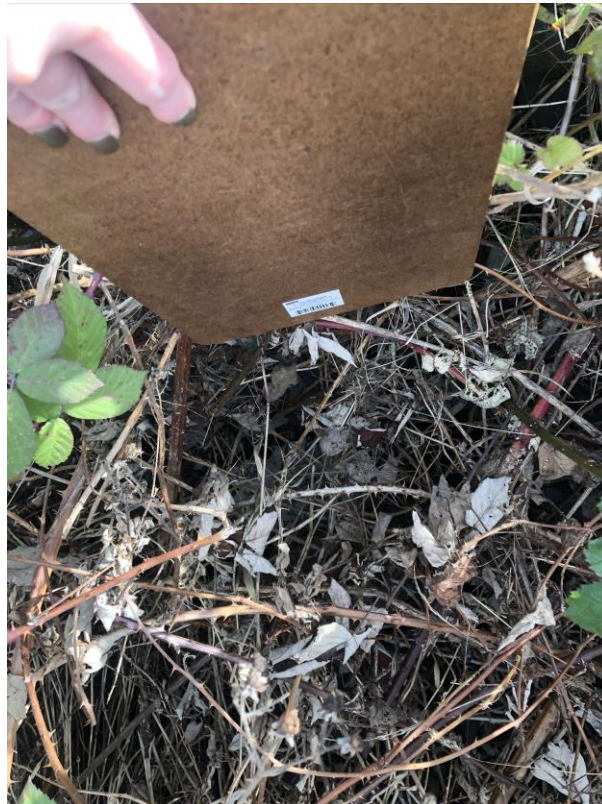
Image ④: Discharged flows are collected into an existing CMP culvert and conveyed southeastward to the existing Highway 9 collection and conveyance system.

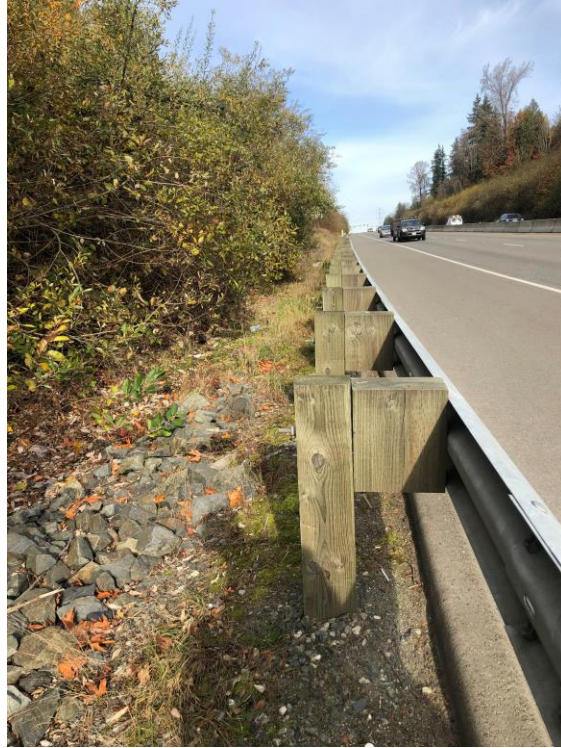
Image 6: Facing northward from the western edge of Highway 9. Discharged flows are conveyed to the existing Highway 9 collection and conveyance system and continue southward within that system until crossing beyond the 0.25-mile boundary of analysis.
