# State Avenue Corridor Improvements Project 100th Street to 116th Street Storm Drainage Report

HDR Engineering, Inc.  
929 108th Avenue NE, Suite 1300  
Bellevue, WA 98004  
425.450.6200  
[www.hdrinc.com](http://www.hdrinc.com)

## **City of Marysville**

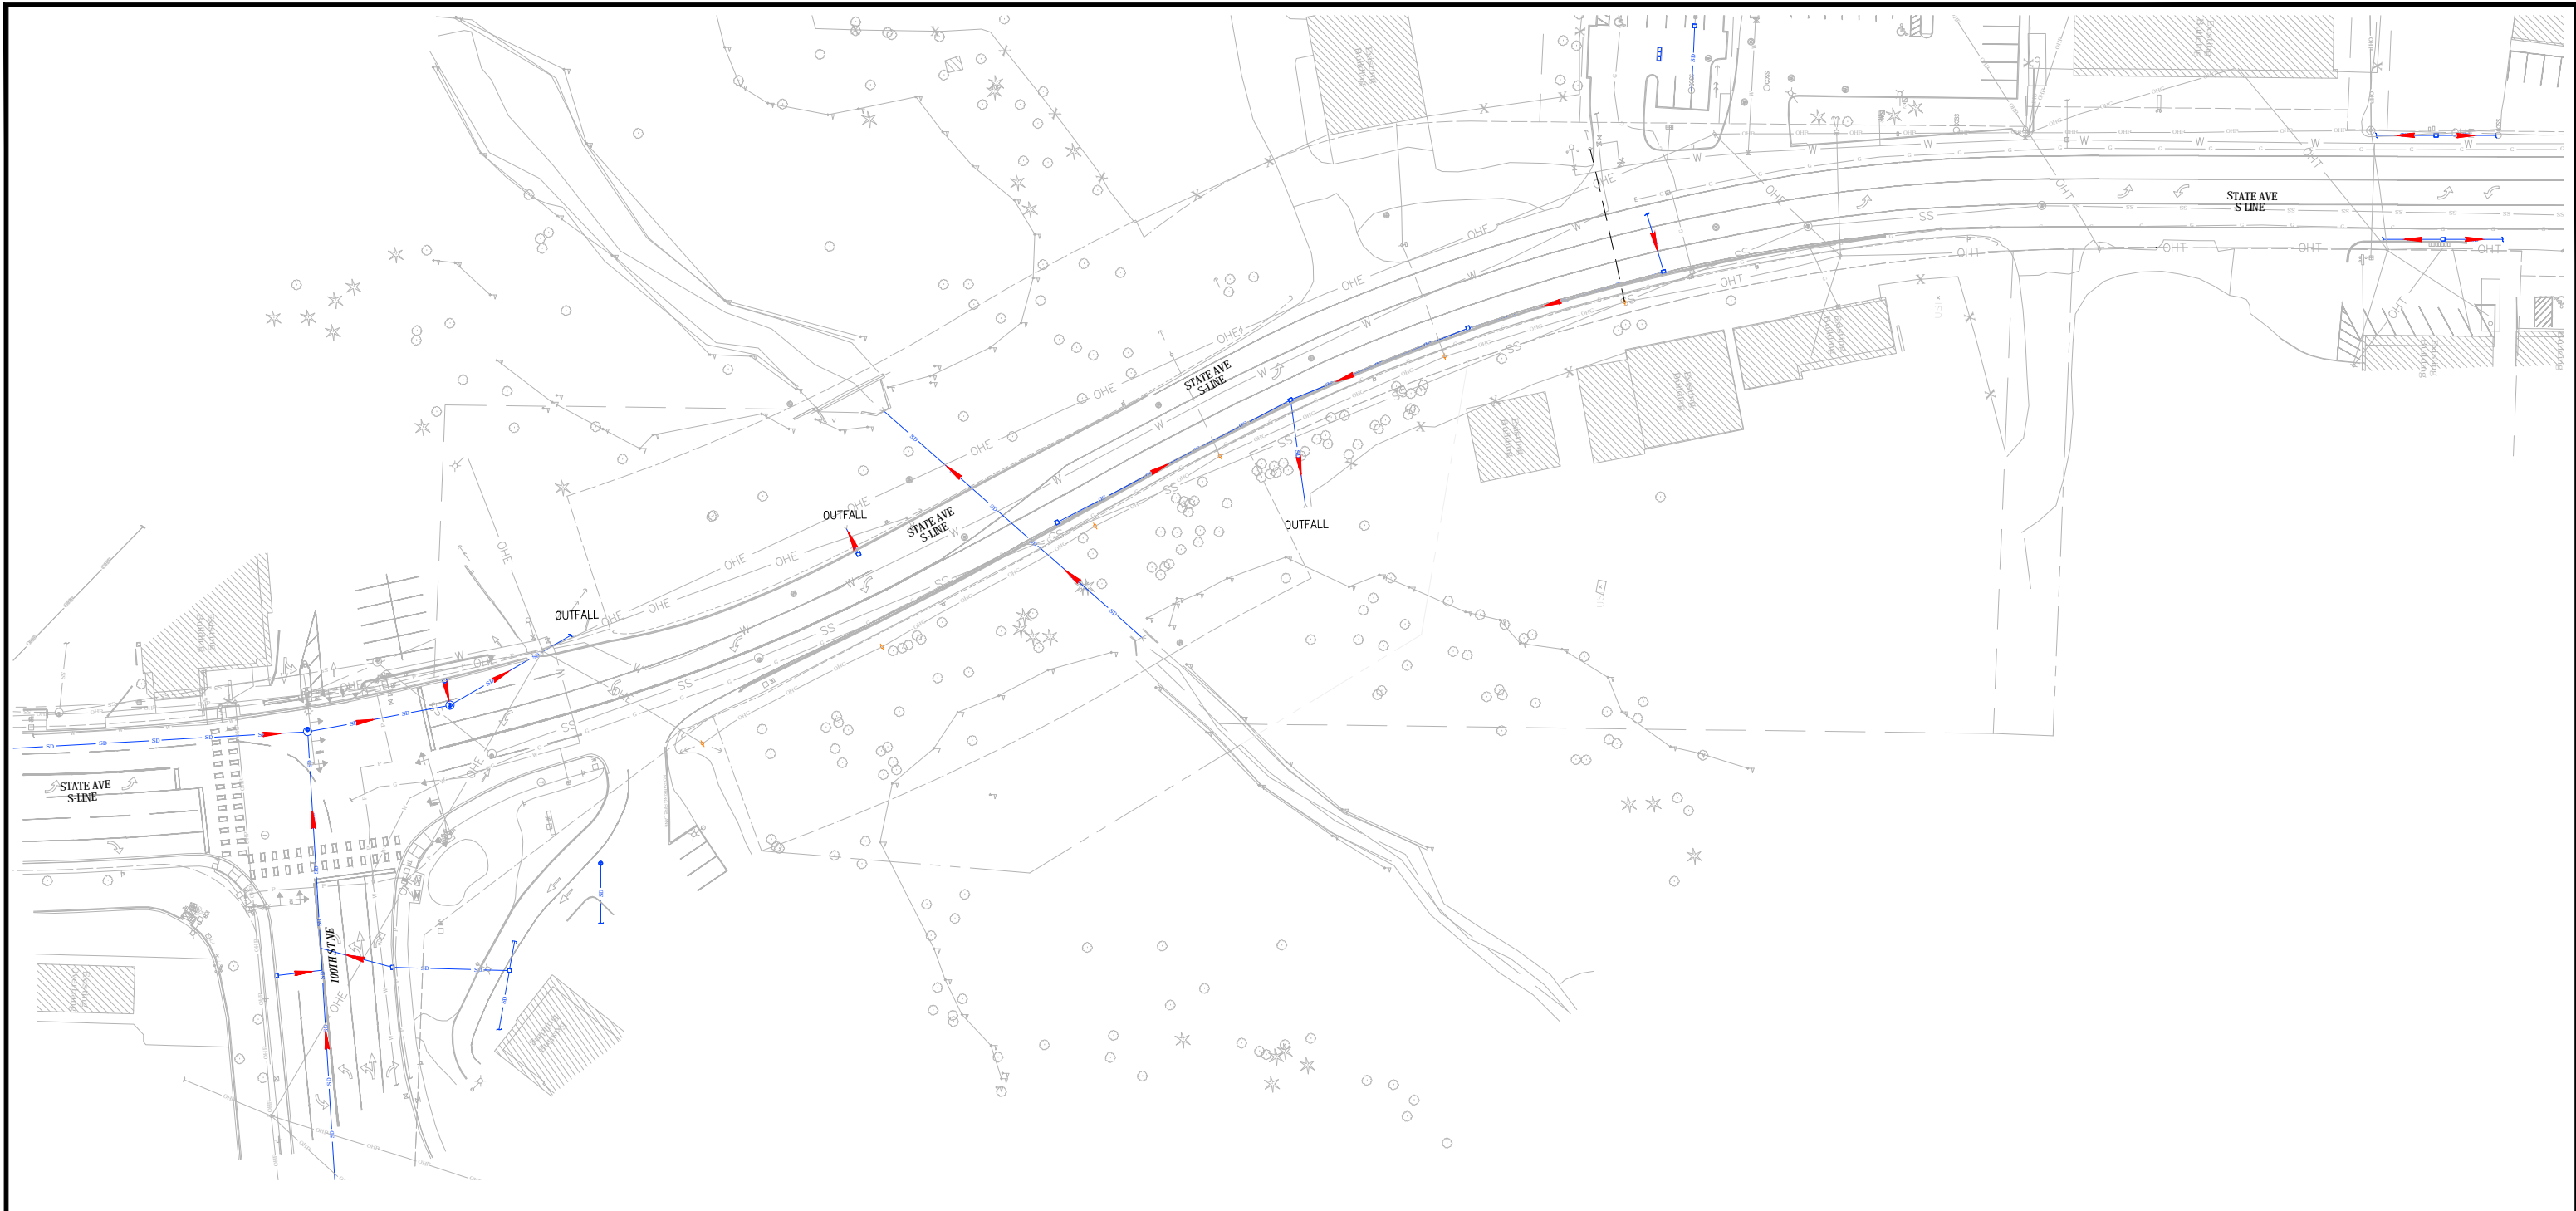
FIGURE  
2A

CITY OF MARYSVILLE  
STATE AVENUE CORRIDOR WIDENING PROJECT  
(100TH STREET NE TO 116TH STREET NE)  
EXISTING CONDITIONS

The existing system can be depicted in Figures 2A through 2C.

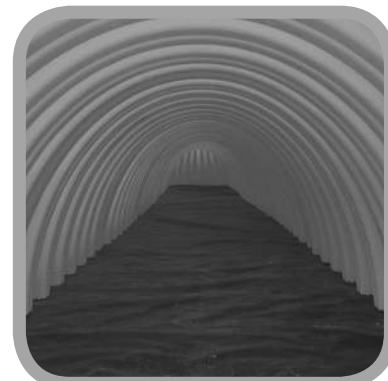
Looking down the Isolator Row from the manhole opening, woven geotextile is shown between the chamber and stone base.

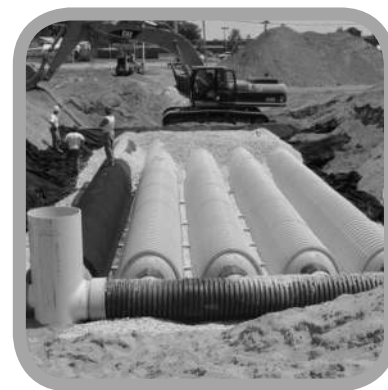
StormTech Isolator Row with Overflow Spillway (not to scale)
