# E. Sunnyside PRD

*City File # PA 22-033*

## Construction Drainage Report

**LDC** | Surveying  
Engineering  
Planning

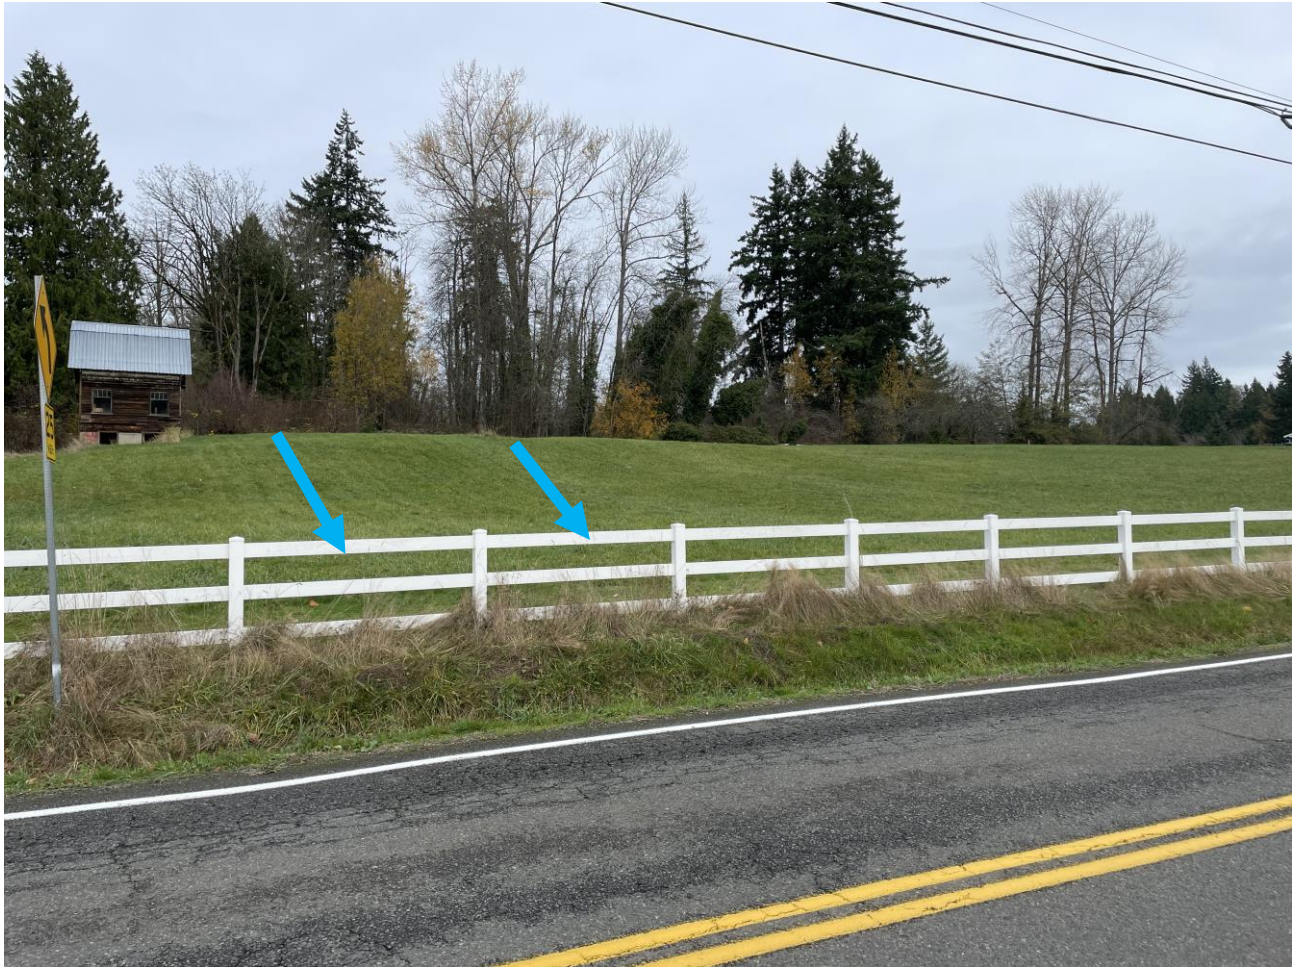
Image 1: Facing north along Sunnyside School Road towards the southwest side of the site where flow is discharged from the site into the ditch south of the fence.

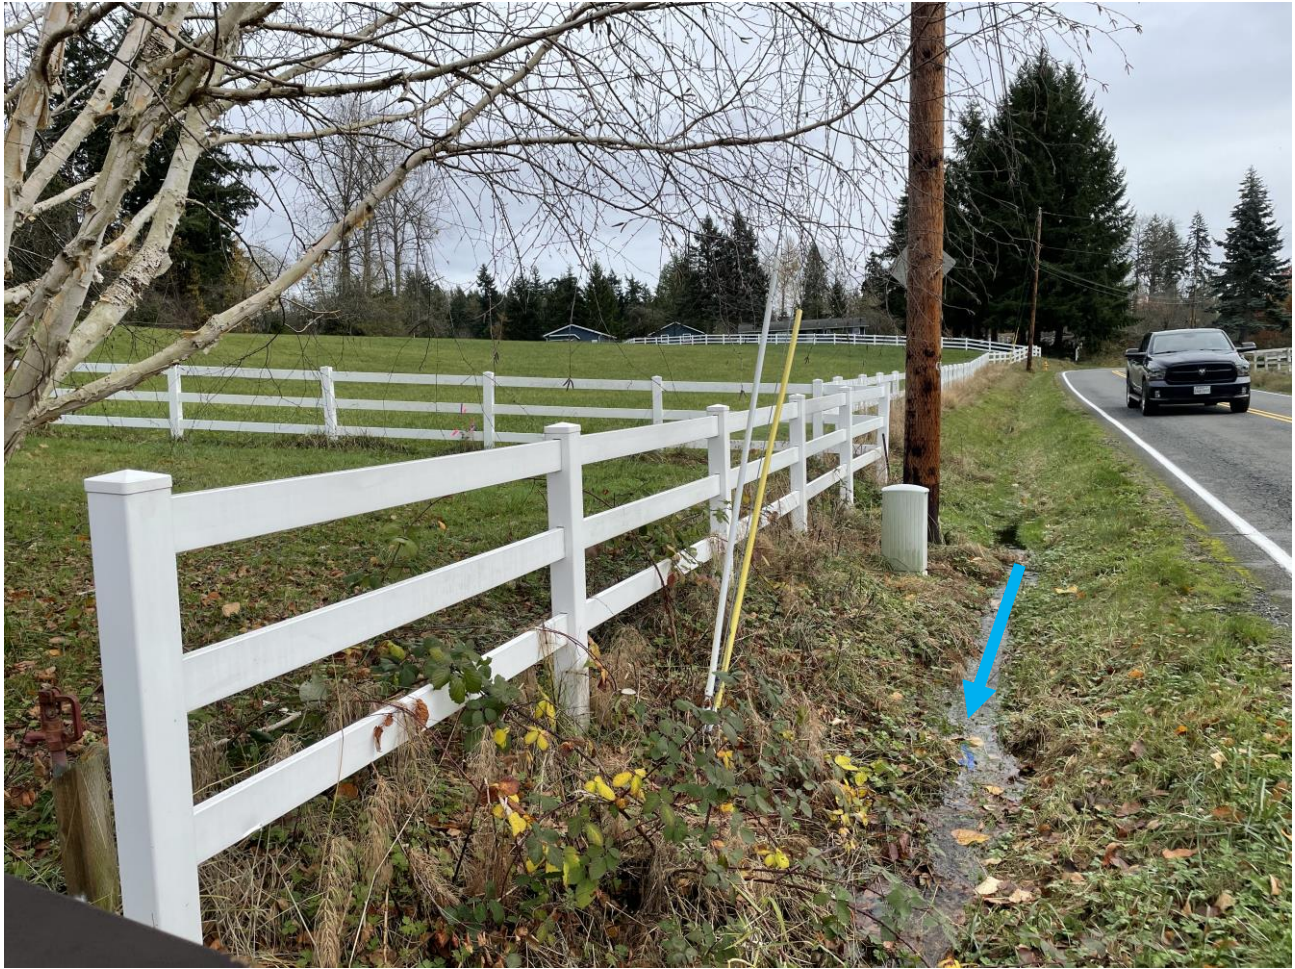
Image 2: Facing east towards the site. Flow from the site is discharged into a ditch that flows to the west towards the 83<sup>rd</sup> Ave and Sunnyside School Road intersection.

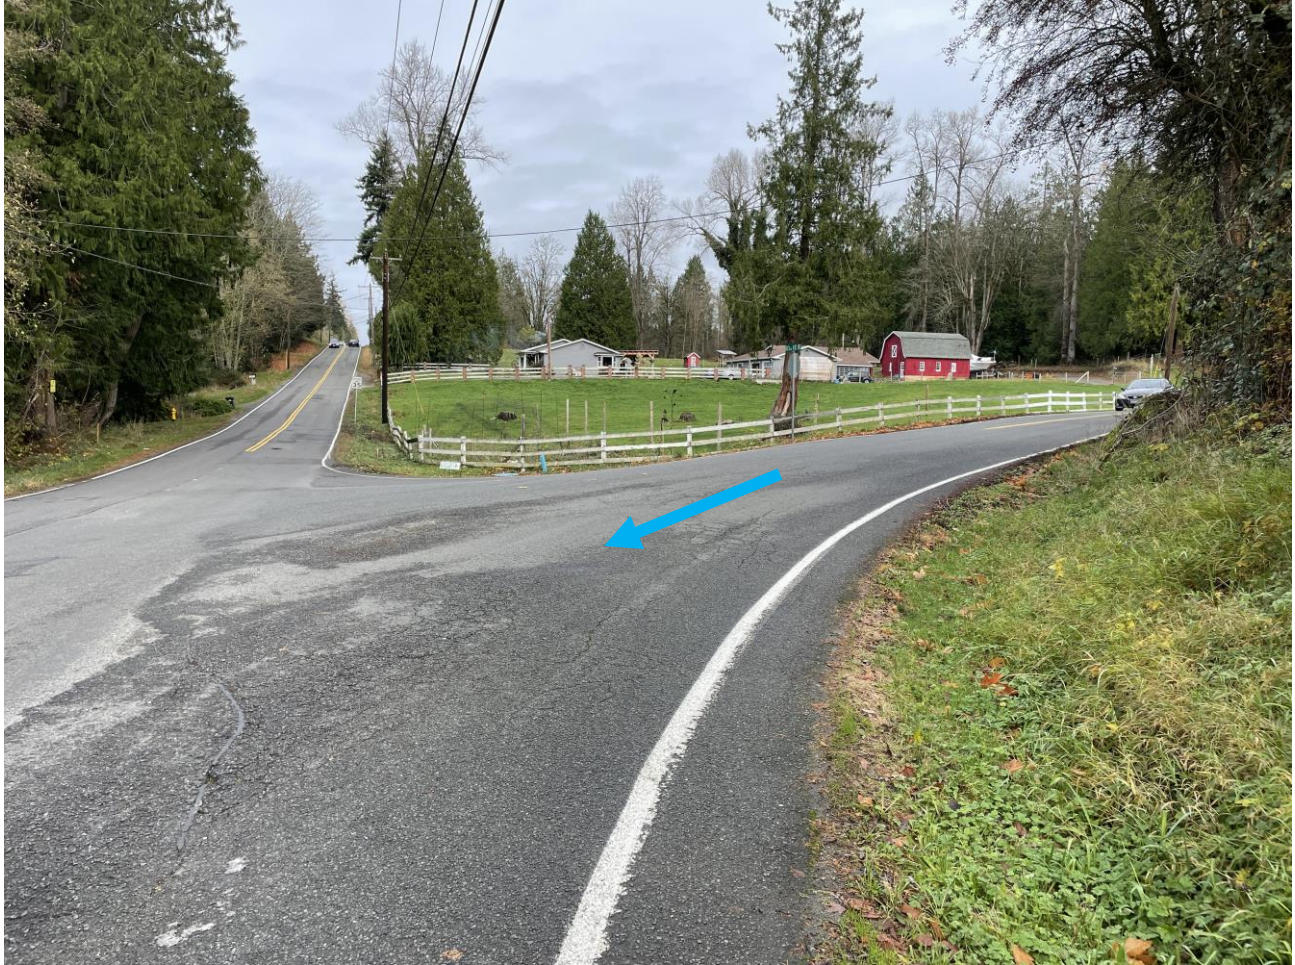
Image 3: Facing north at the intersection of 83<sup>rd</sup> Ave and Sunnyside School Road near the quarter-mile buffer. Runoff from the project site's western basin flows to the west from Sunnyside School Road and continues west/southwest (left on picture) to King Creek. Flows continue along King Creek past the quarter-mile boundary of analysis and flows into Ebey Slough, which eventually discharges into the Possession Sound.

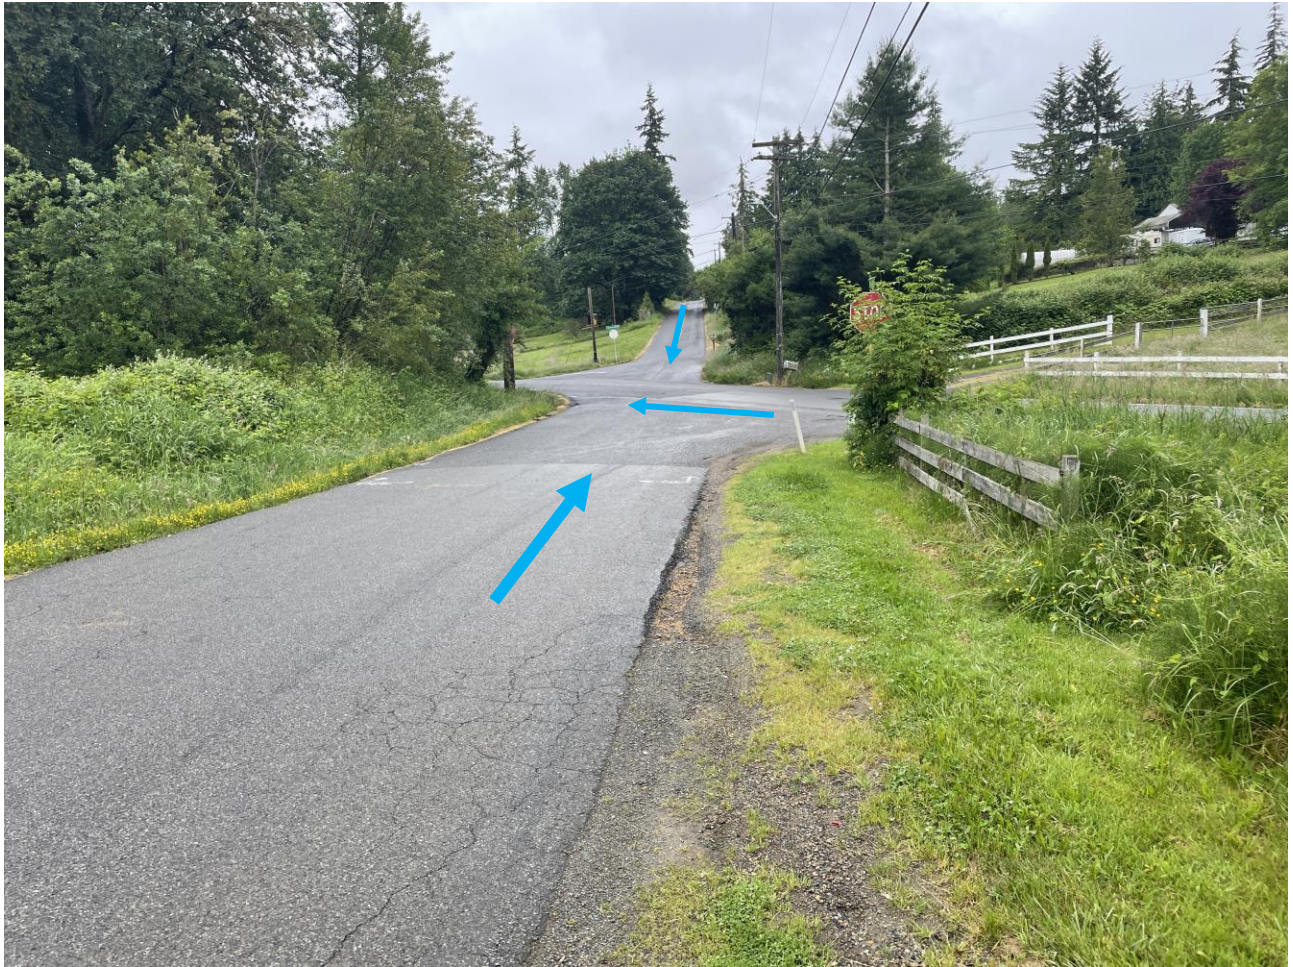
Image 4: Facing south near the intersection of 87<sup>th</sup> Ave and Sunnyside School Road. Flow from the eastern portion of the site will flow to the south towards the intersection and then continue southeast along Sunnyside School Road.

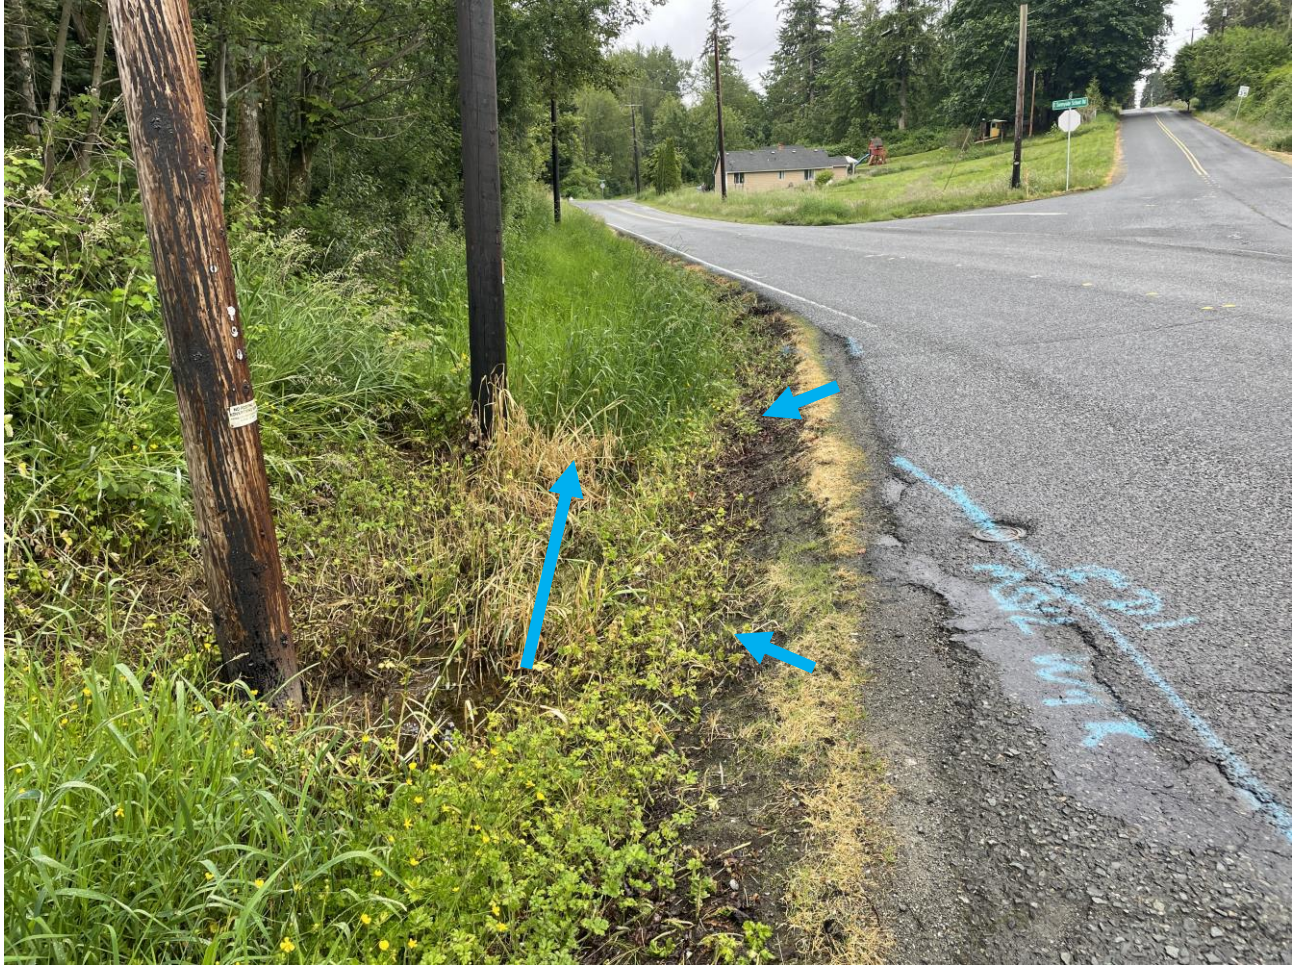
Image 5: Facing southeast from the northeast corner of the Sunnyside School Road and 87<sup>th</sup> Ave intersection. The project site's eastern basin runoff along and near the project frontage flows south along 87<sup>th</sup> Ave NE and discharges into the swale along the north side of Sunnyside School Road at the intersection of Sunnyside School Road and 87<sup>th</sup> Ave. Runoff continues southeast along the Sunnyside School Road past the quarter-mile boundary of analysis until discharging into the unnamed stream tributary to Steven's Creek.

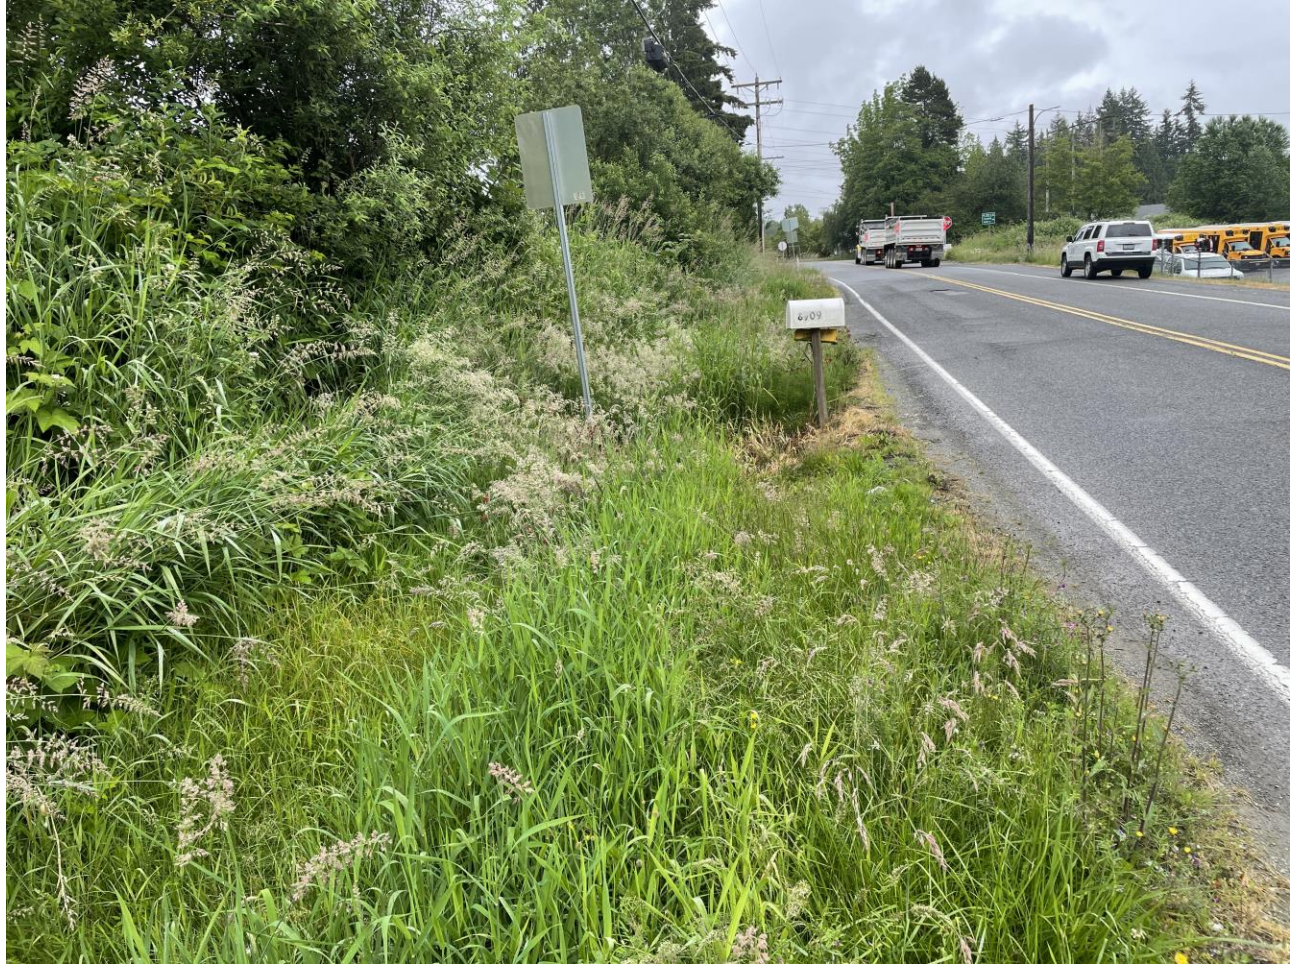
Image 6: Facing southeast at the quarter-mile boundary of analysis along the northside of Sunnyside School Road. The swale continues past the quarter-mile boundary for the downstream analysis. Per Snohomish County GIS, the swale discharges into an unnamed creek tributary to Stevens Creek.

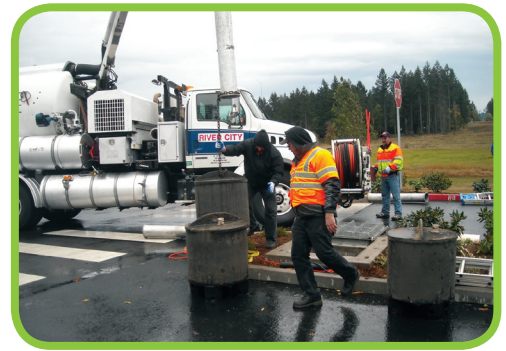
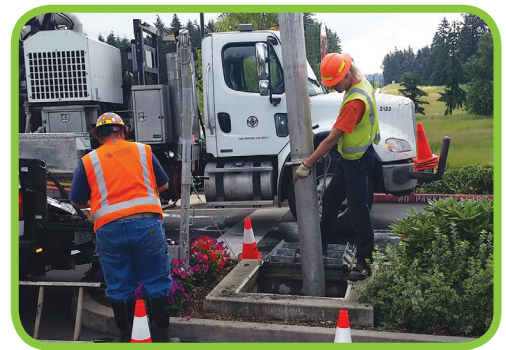
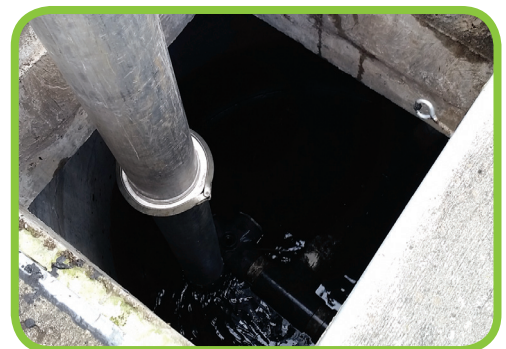
1. Contact BaySaver Technologies for replacement filter cartridge pricing and availability at 1-800-229-7283.
2. Remove the manhole covers and open all access hatches.
3. Before entering the system make sure the air is safe per OSHA Standards or use a breathing apparatus. Use low O<sub>2</sub>, high CO, or other applicable warning devices per regulatory requirements.
4. Using a vacuum truck remove any liquid and sediments that can be removed prior to entry.
5. Using a small lift or the boom of the vacuum truck, remove the used cartridges by lifting them out.
6. Any cartridges that cannot be readily lifted can be easily slid along the floor to a location

BayFilter System Cleanout

Vactor Truck Maintenance

Jet Vactoring Through Access Hatch

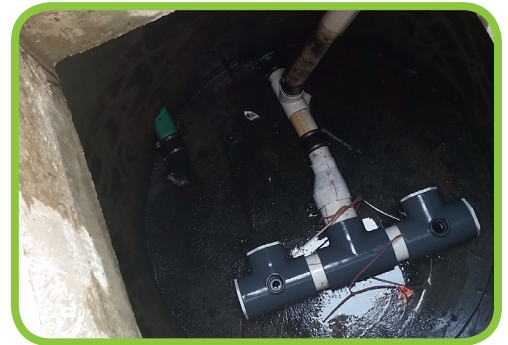
7. When all the cartridges have been removed, it is not practical to remove the balance of the solids and water. Loosen the stainless clamps on the Fernco couplings for the manifold and remove the drain pipes as well. Carefully cap the manifold and the Ferncos and rinse the floor, washing away the balance of any remaining collected solids.
8. Clean the manifold pipes, inspect, and reinstall.
9. Install the exchange cartridges and close all covers.
10. The used cartridges may be sent back to BaySaver Technologies for recycling.

**Manifold Tee View of a Cleaned System**
