**GEOTECHNICAL ENGINEERING STUDY
87TH AND 40TH PRD
4218, 4112, 4018, AND 3922 – 87TH AVENUE NORTHEAST
MARYSVILLE, WASHINGTON**

ES-7754

87TH & 40TH JV

September 2, 2022

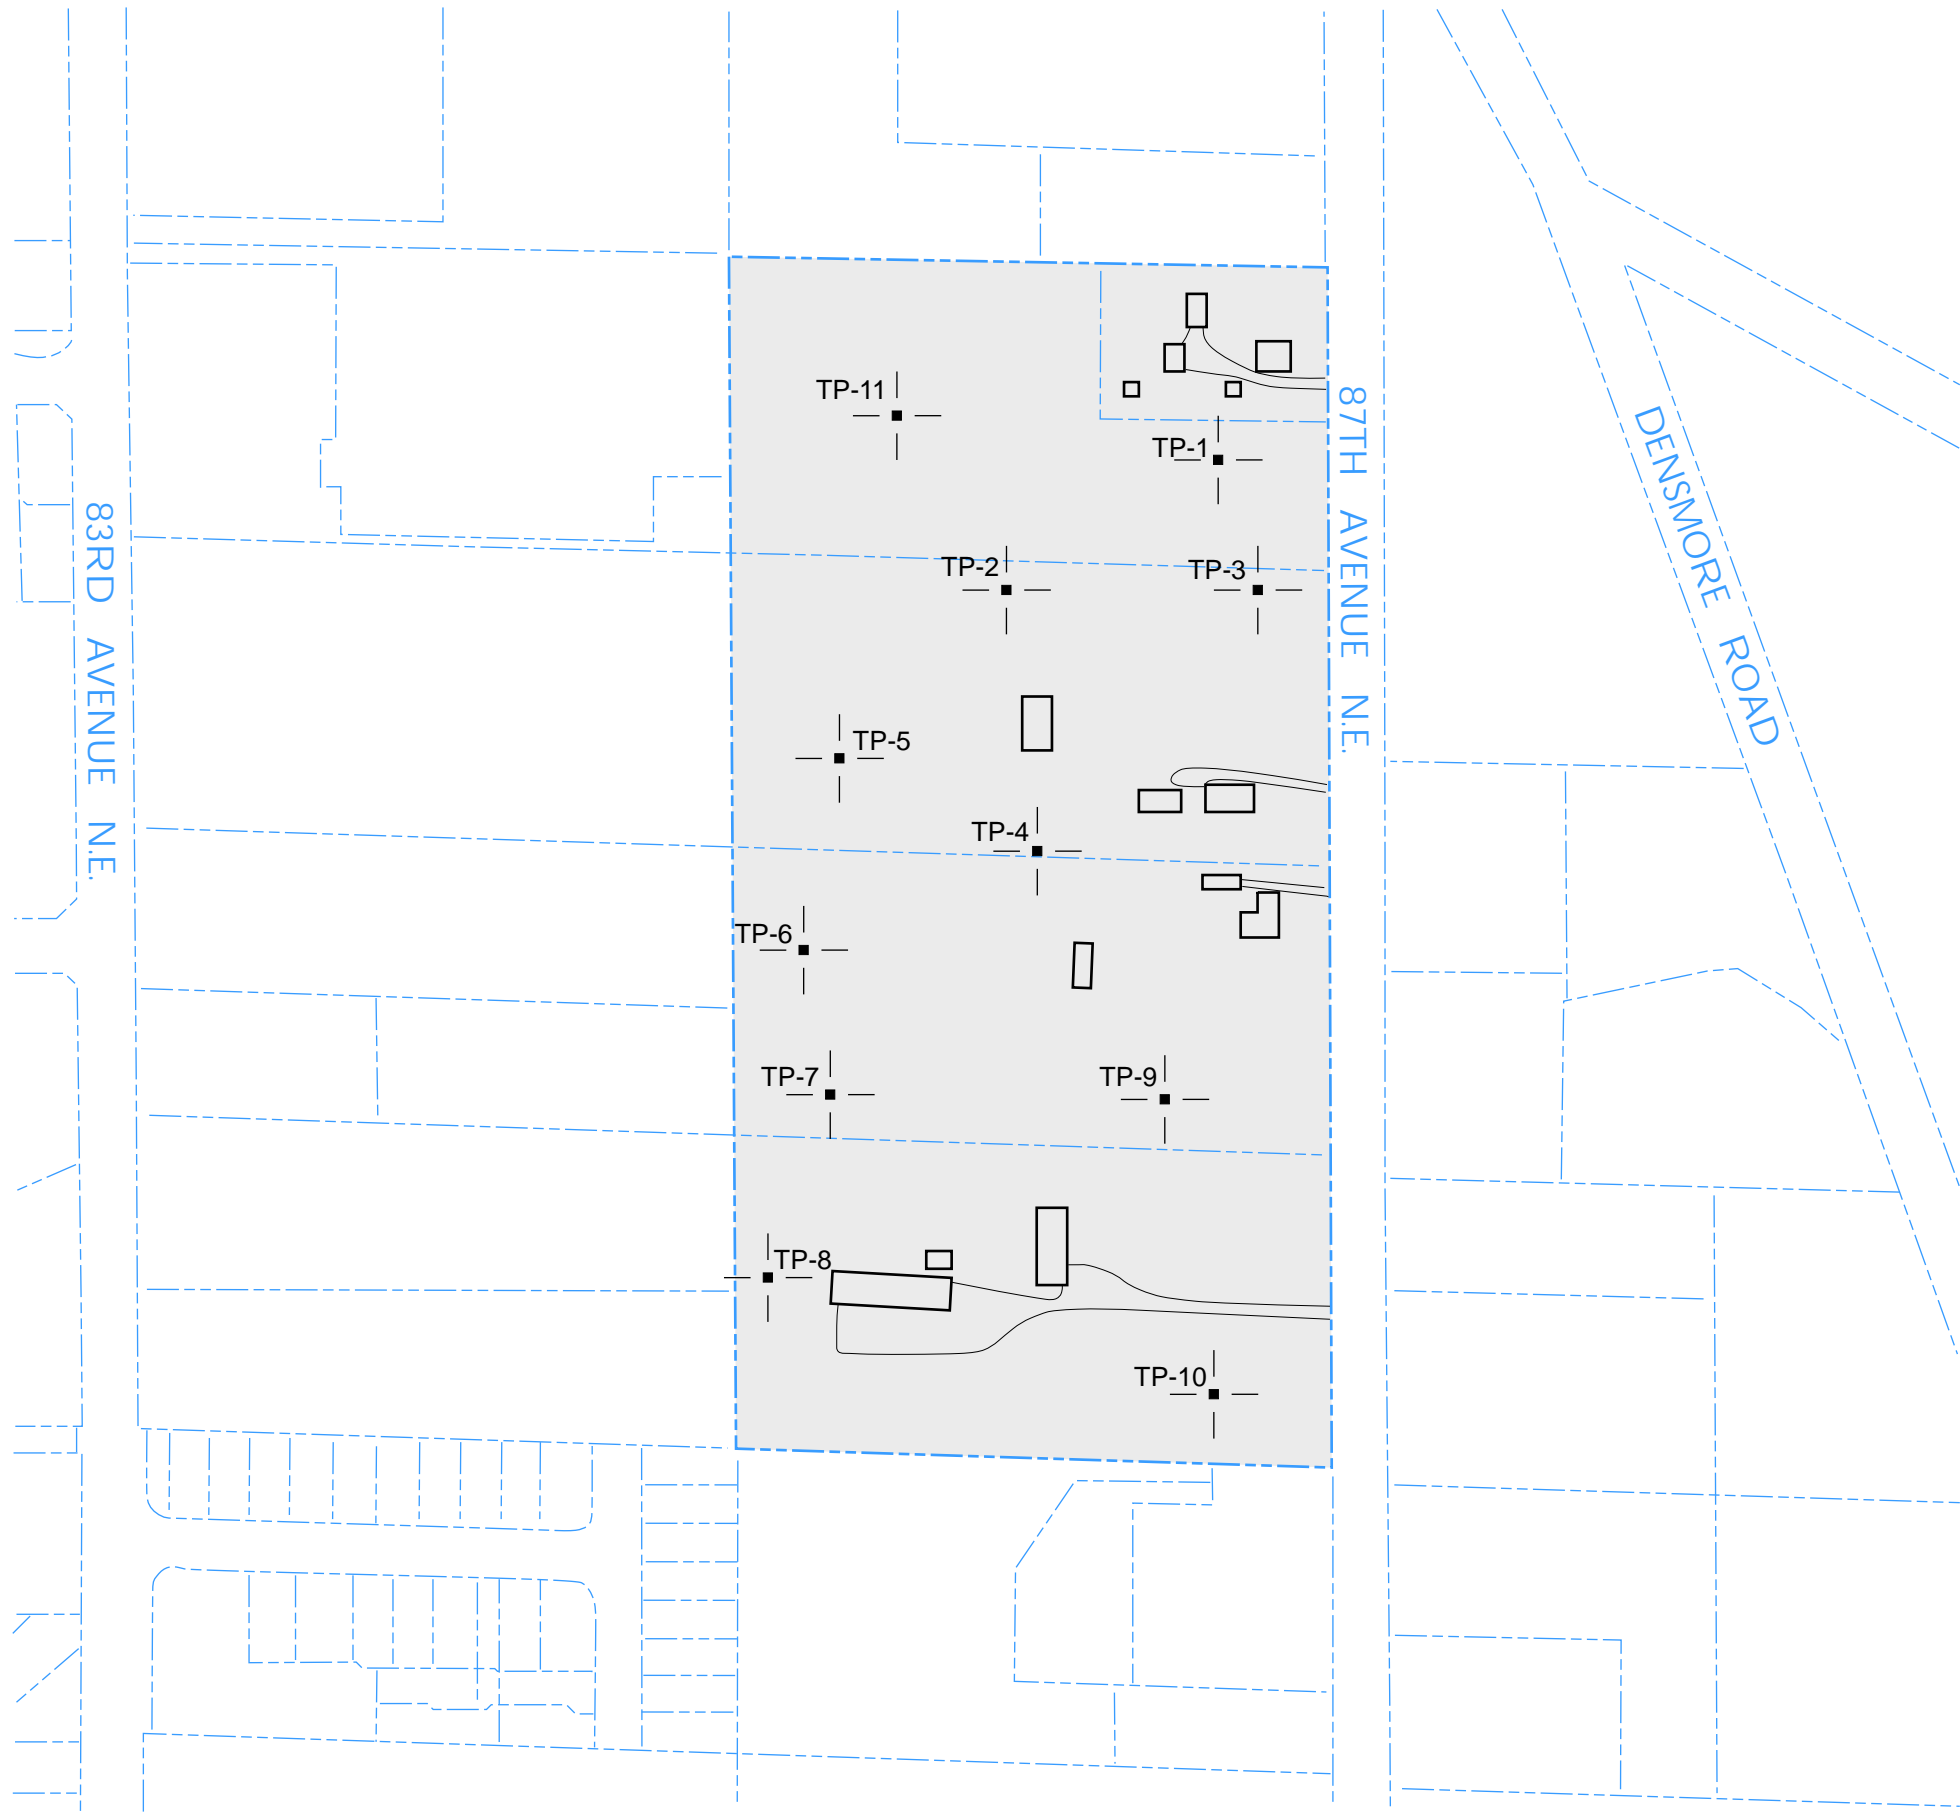
Drwn. By MRS
Checked By BCS
Date 09/08/2022
Proj. No. 7754
Plate 2

- TP-1 | — Approximate Location of ESNW Test Pit, Proj. No. ES-7754, July 2022
- Subject Site
- Existing Building

ESNW representatives observed, logged and sampled 11 test pits across accessible portions of the site. The test pits were advanced using an excavator and operator retained by ESNW, and advanced to a maximum depth of nine and one-half feet. The approximate location of the test pits is depicted on the Test Pit Location Plan (Plate 2). Please refer to the soil logs provided in Appendix A for a more detailed description of the subsurface conditions.

The subsurface conditions at the site were explored by excavating a total of 11 test pits across accessible portions of the property. The subsurface explorations were completed in July of 2022. The approximate test locations are illustrated on Plate 2 of this report. Logs of the test pits are provided in this Appendix. The test pits were excavated to a maximum depth of nine and one-half feet below existing grades.

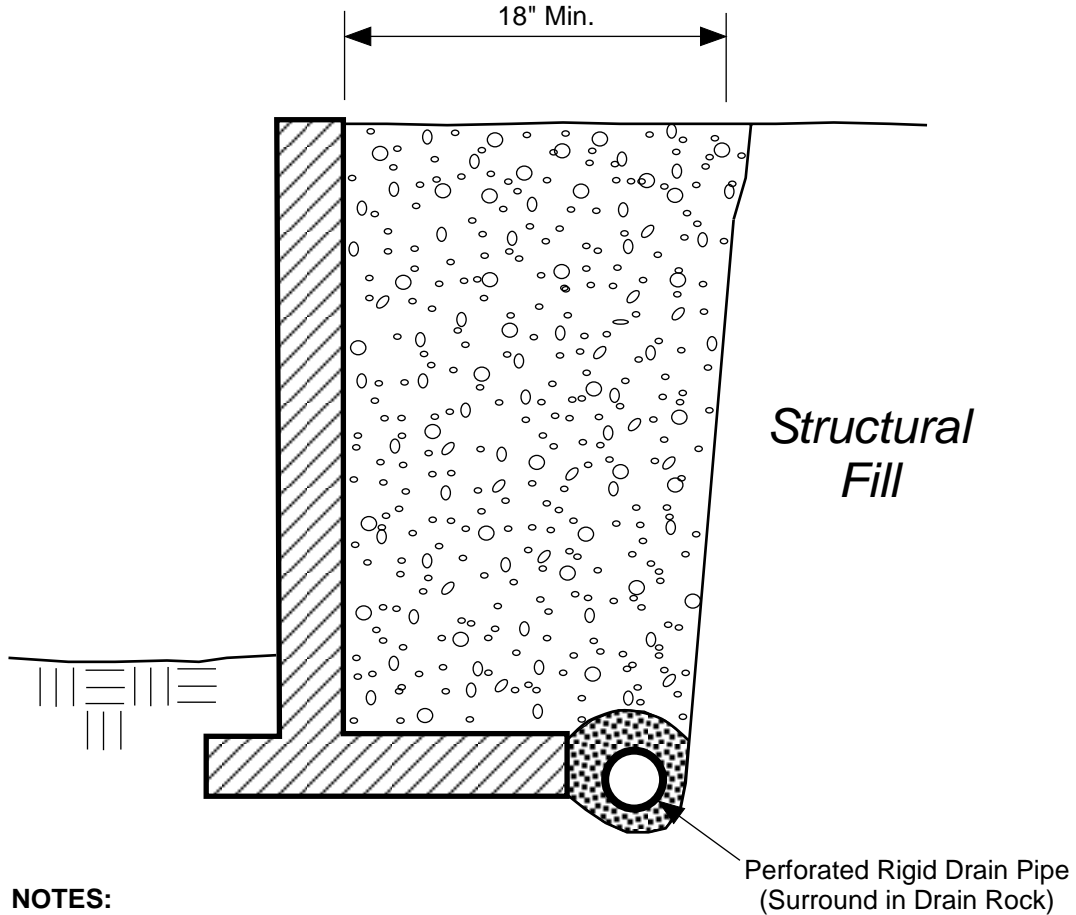
Earth Solutions NW_{LLC} Geotechnical Engineering, Construction Observation/Testing and Environmental Services	
Retaining Wall Drainage Detail 87th and 40th PRD Marysville, Washington			
Drwn. MRS	Date 09/08/2022	Proj. No. 7754	
Checked BCS	Date Sept. 2022	Plate 3

- Free-draining Backfill should consist of soil having less than 5 percent fines. Percent passing No. 4 sieve should be 25 to 75 percent.
- Sheet Drain may be feasible in lieu of Free-draining Backfill, per ESNW recommendations.
- Drain Pipe should consist of perforated, rigid PVC Pipe surrounded with 1-inch Drain Rock.

1-inch Drain Rock

Retaining walls should be backfilled with free draining material that extends along the height of the wall, and a distance of at least 18 inches behind the wall. The upper one foot of the wall backfill can consist of a less permeable soil, if desired. A perforated drain pipe should be placed along the base of the wall and connected to an approved discharge location. A typical retaining wall drainage detail is provided on Plate 3.

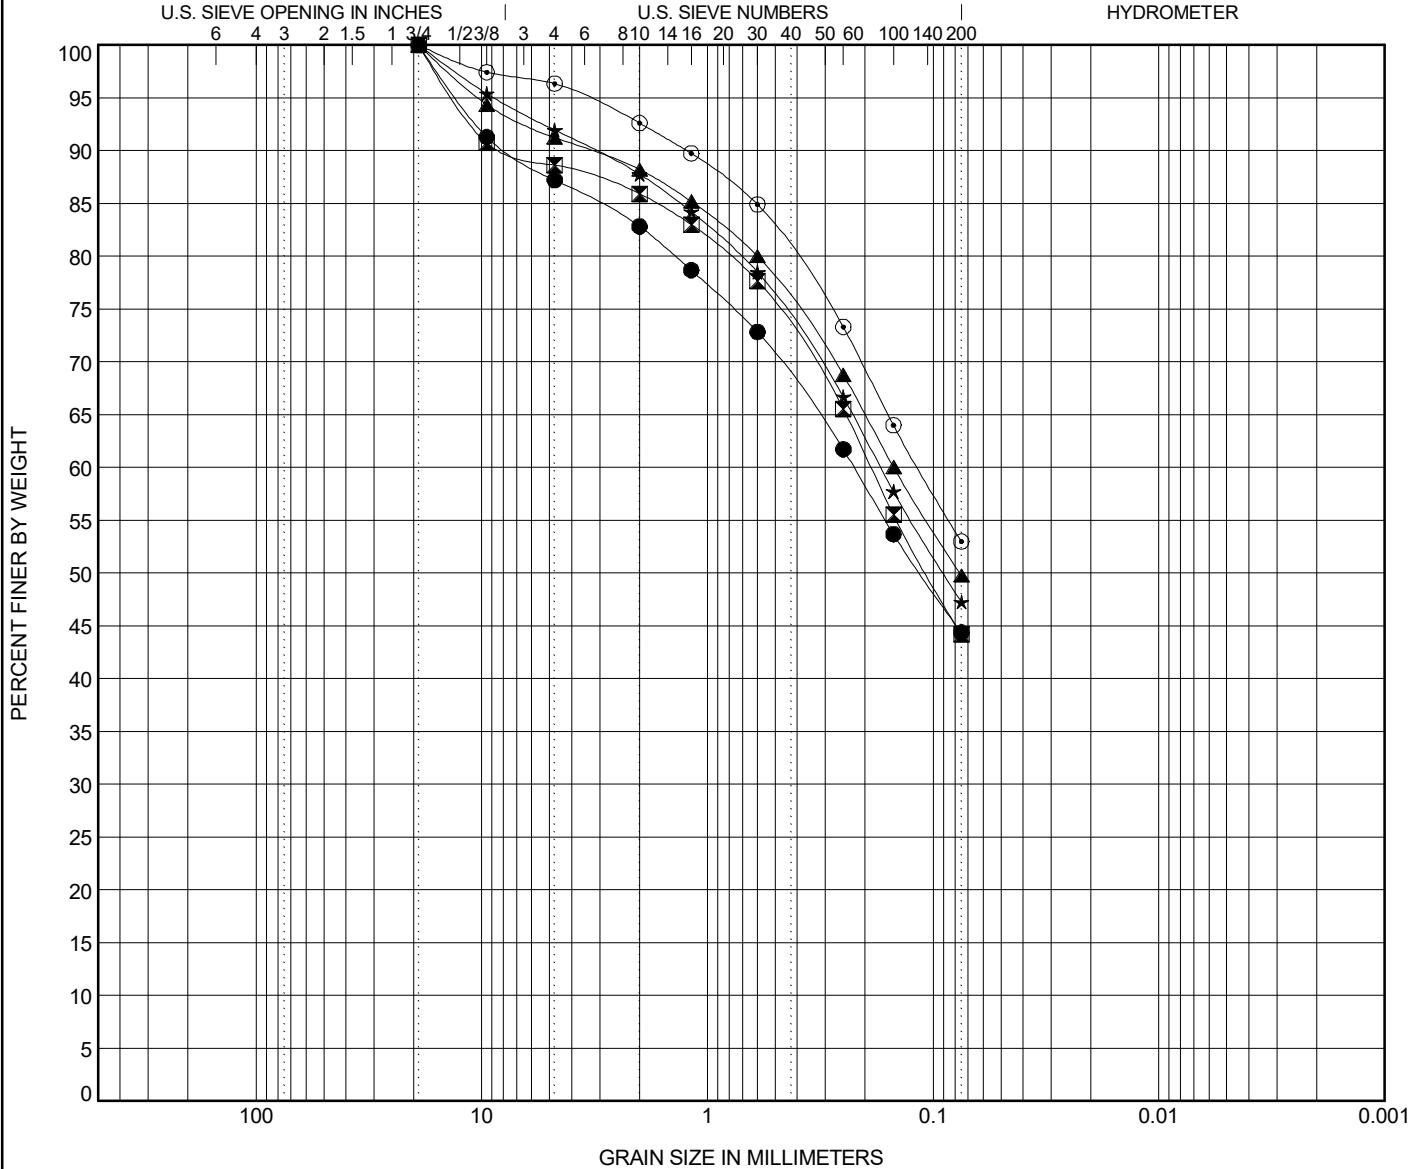
COBBLES	GRAVEL		SAND			SILT OR CLAY
	coarse	fine	coarse	medium	fine

Specimen Identification	Classification						Cc	Cu	
● TP-01 5.00ft.	USDA: Gray Gravelly Loam. USCS: SM.								
☒ TP-01 9.00ft.	USDA: Gray Slightly Gravelly Loam. USCS: SM.								
▲ TP-03 4.50ft.	USDA: Gray Slightly Gravelly Loam. USCS: SM.								
★ TP-03 8.00ft.	USDA: Gray Slightly Gravelly Loam. USCS: SM.								
◎ TP-04 8.50ft.	USDA: Gray Slightly Gravelly Loam. USCS: Sandy ML.								
Specimen Identification	D100	D60	D30	D10	LL	PL	PI	%Silt	%Clay
● TP-01 5.0ft.	19	0.224						44.4	
☒ TP-01 9.0ft.	19	0.188						44.2	
▲ TP-03 4.5ft.	19	0.149						49.8	
★ TP-03 8.0ft.	19	0.171						47.3	
◎ TP-04 8.5ft.	19	0.117						53.0
