Olympic Vista PRD

Preliminary Drainage Report

LDC | Surveying
Engineering
Planning

Job No: C21-210

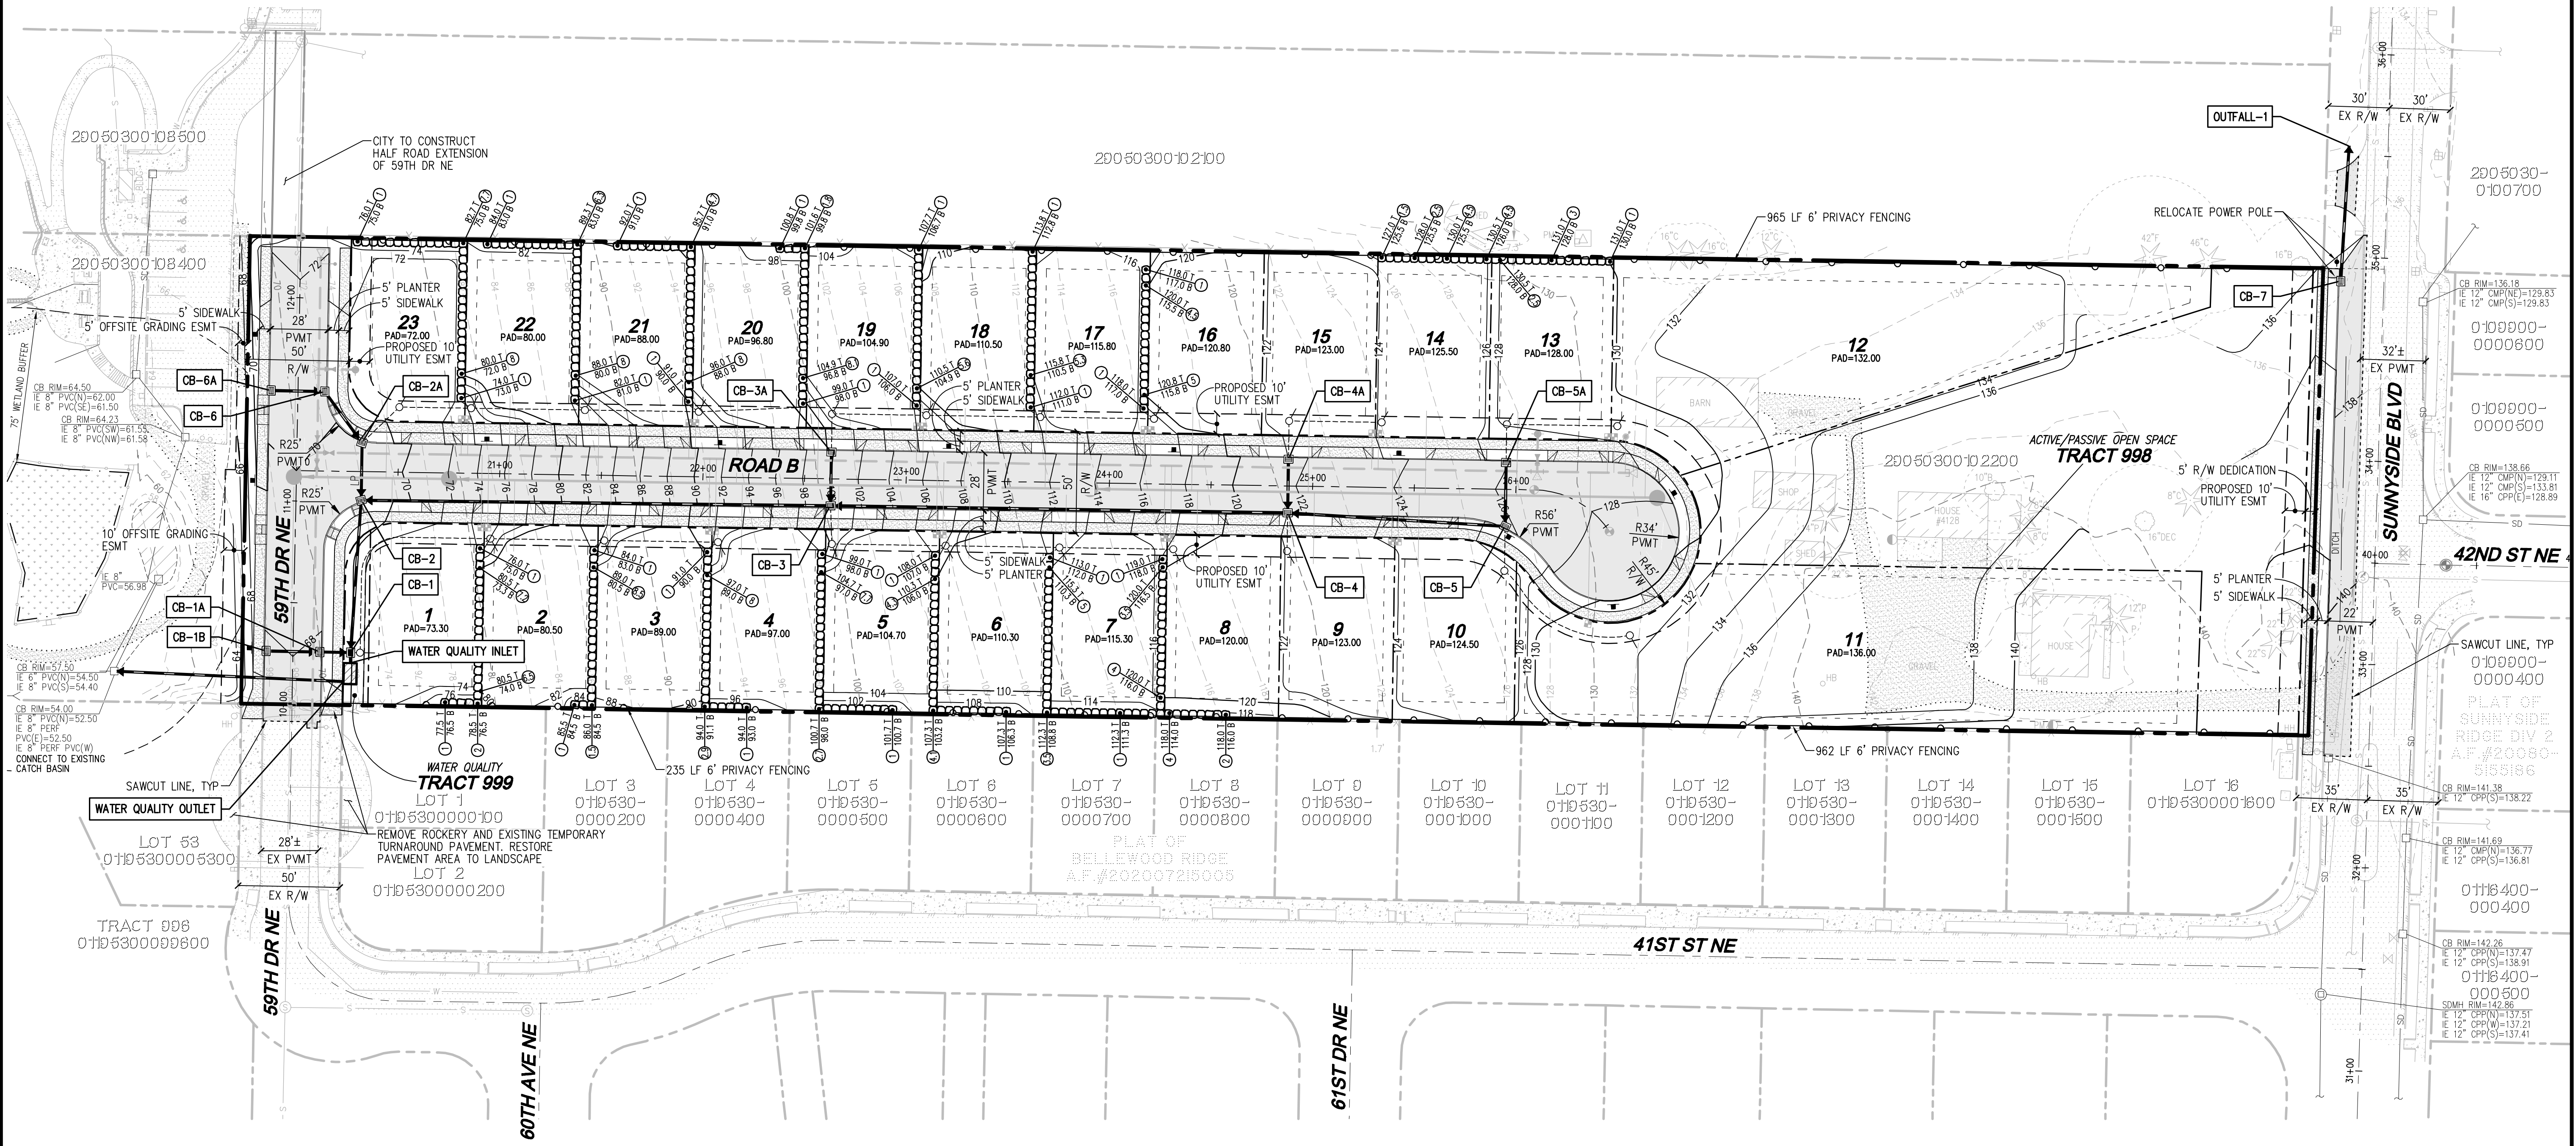
NOTES
 1. SEE SHEETS PR-01 AND PR-02 FOR ROAD PROFILES.
 2. SEE SHEET PR-02 FOR ROAD SECTIONS.

KEYSTONE LAND, LLC.
OLYMPIC VISTA PRD
 ROAD, STORM DRAINAGE AND GRADING PLAN

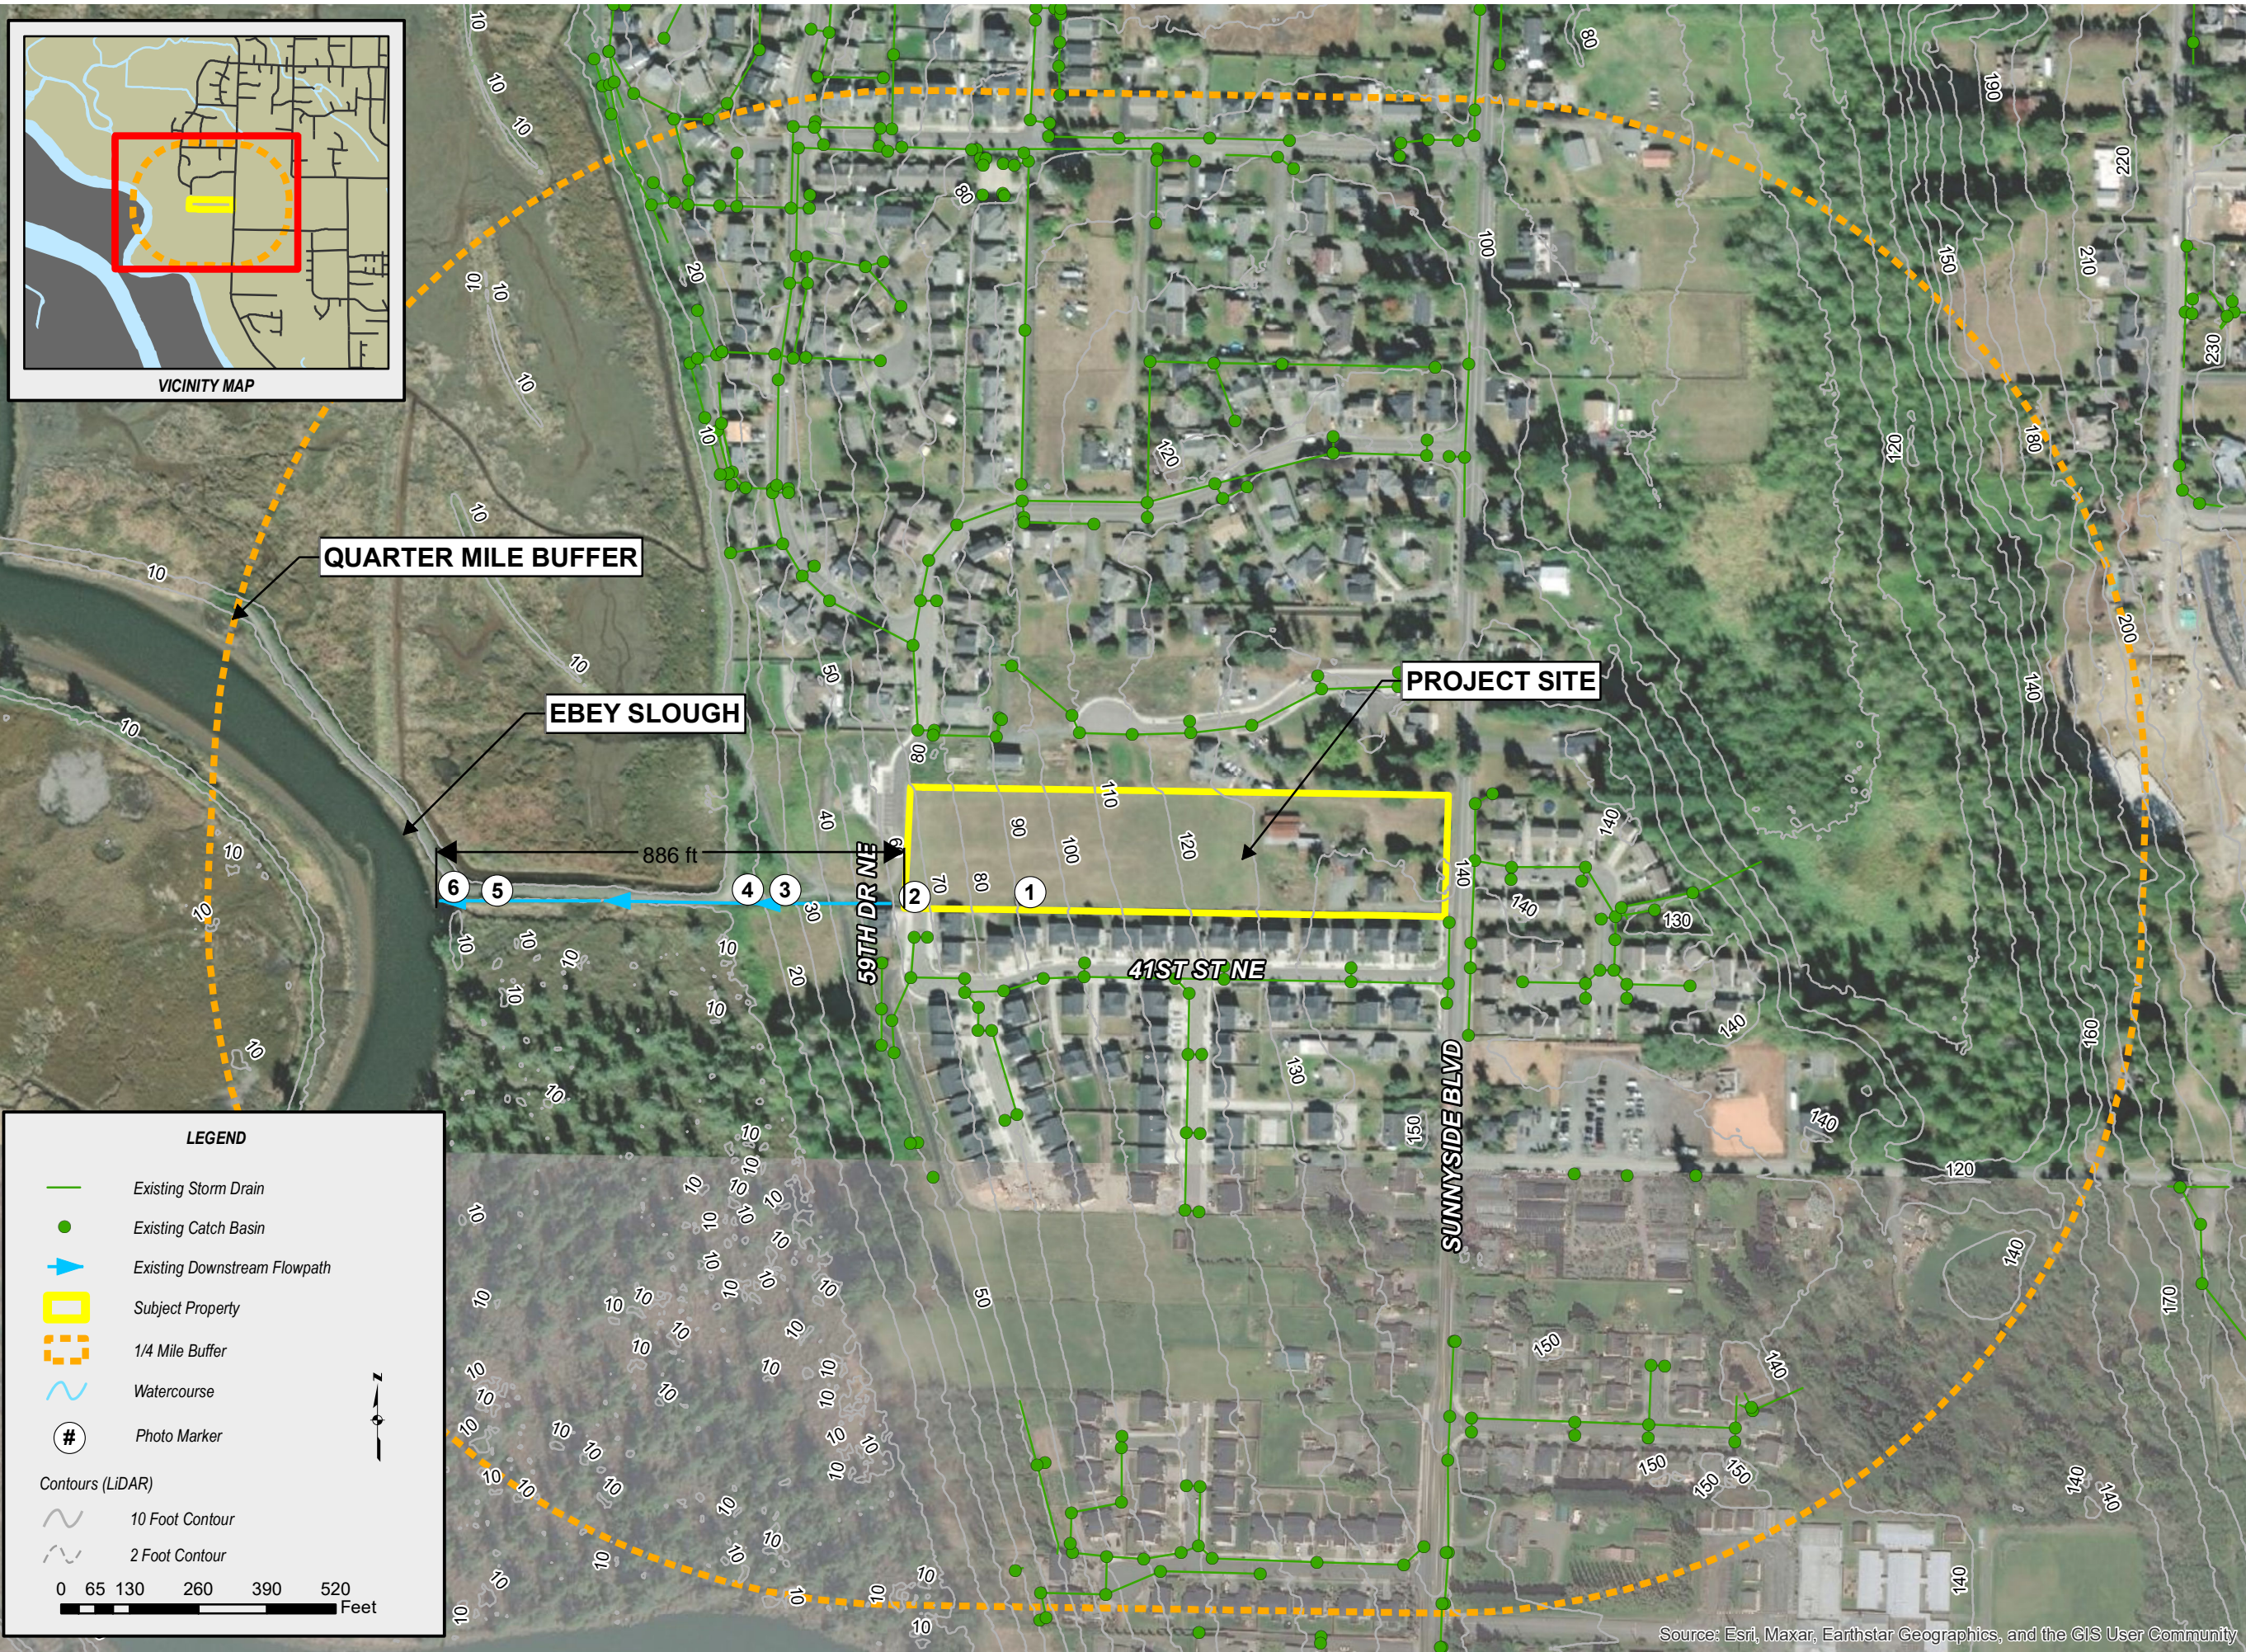
FIGURE:
3.0

- Existing Storm Drain
- Existing Catch Basin
- ▶ Existing Downstream Flowpath
- Subject Property
- 1/4 Mile Buffer
- ~ Watercourse
- # Photo Marker

KEYSTONE LAND, LLC.
OLYMPIC VISTA
DOWNSTREAM ANALYSIS MAP

This site is located within the Allen-Creek Sub-Basin, which is in the Snohomish Basin. Discharge from the proposed development will outfall to the existing storm drain within Olympic View Park, just west of the site, which outfalls a wetland that connects directly to the Ebey Slough. The Ebey Slough is within 900 ft of the project site. See Figure 3.0 for flow paths and the delineation of the Onsite Basin.

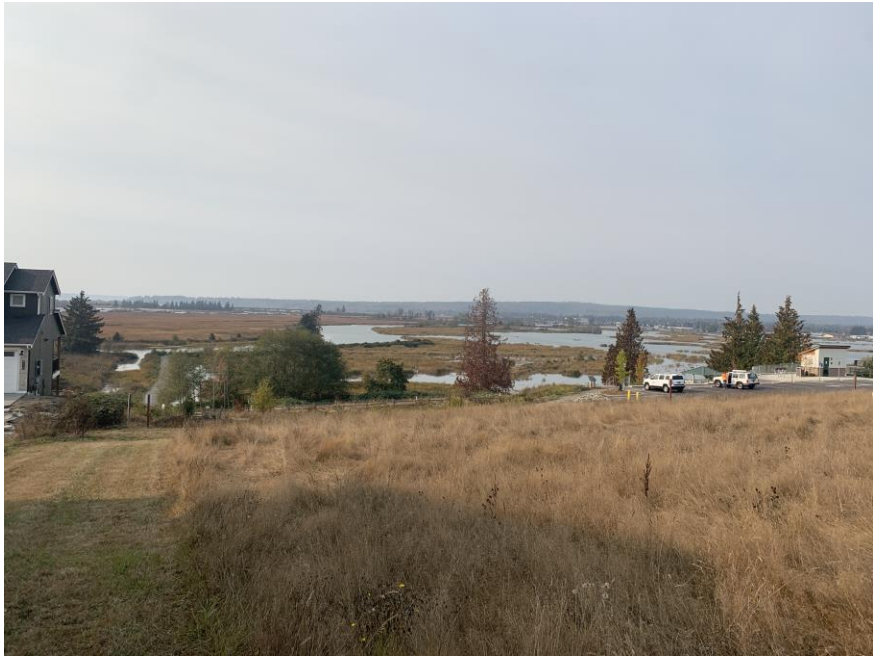
Image 1: Looking west across the corner of the site towards the Olympic View Park and Ebey Slough.

The subject property consists primarily of lawn and pasture (Image 1). The east edge of the site contains two single family residences as well as multiple sheds and a barn. Onsite flows travel east to west before leaving the west boundary of the site and sheet flowing towards the Olympic View Park. The downstream flow path then enters a French drain (Image 2) that is part of the existing storm drain within Olympic View Park. The downstream flow path continues west through Olympic View Park in an 8 inch storm pipe that outfalls to a vegetated swale within a Native Growth Protection Area (Image 3 and 4) and then outfalls to a wetland (Image 5). The wetland connects to the Ebey Slough (Image 6) which extends beyond the 1/4-mile boundary of analysis.

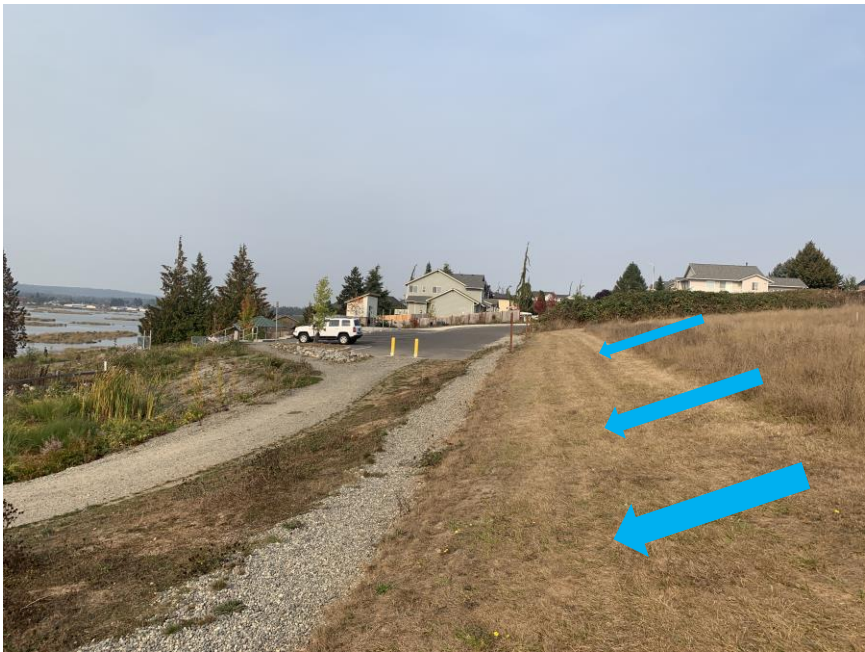
Image 2: The French drain at the east edge of Olympic View Park collects sheet flow from the Olympic Vista project site.

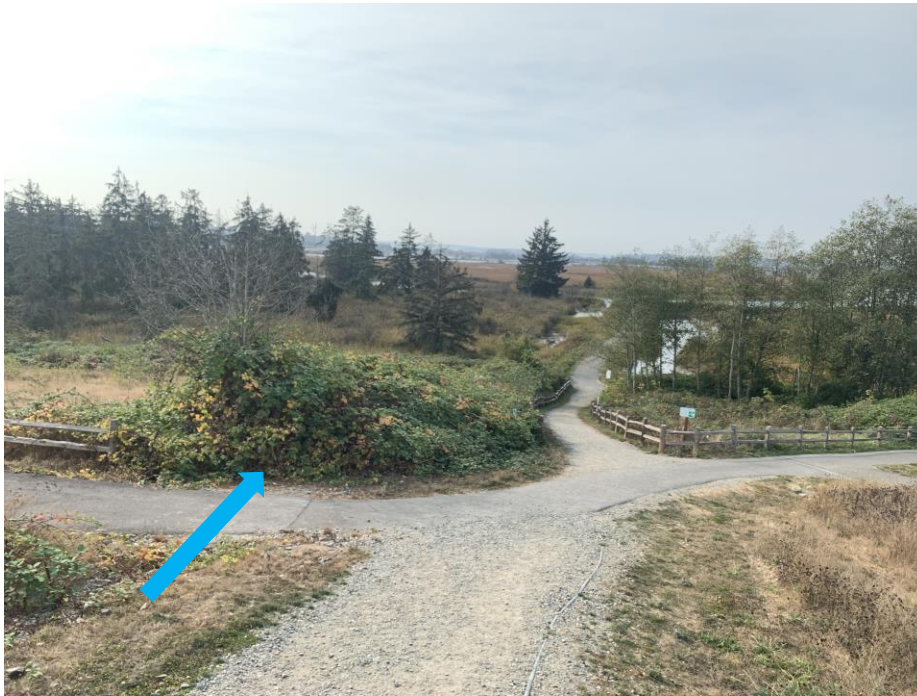
Image 3: The 8" diameter storm drain crosses under the paved pathway and outlets to a vegetated swale within the NGPA.

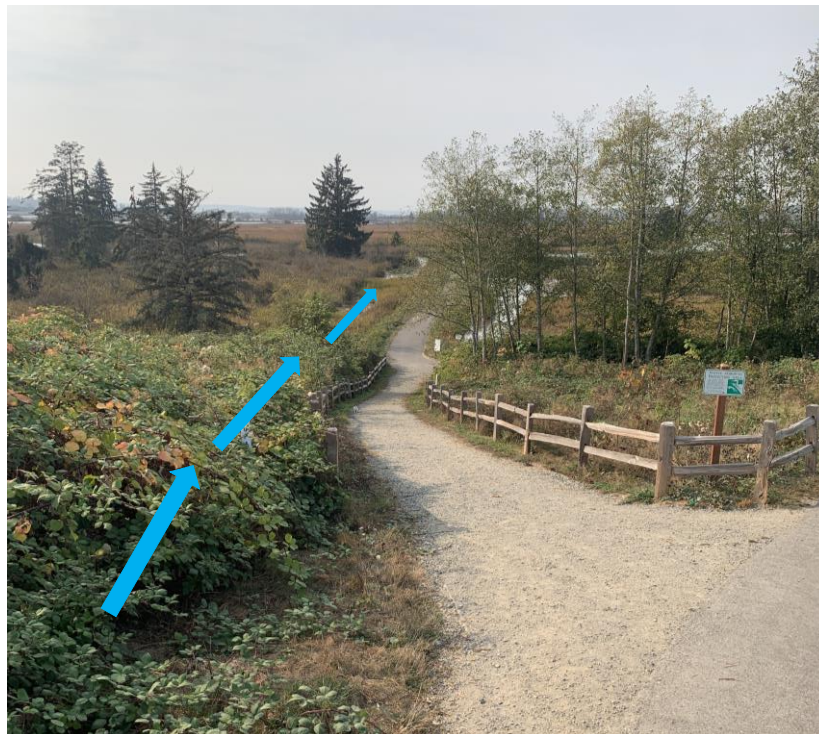
Image 4: The swale continues west through the vegetation within the NGPA on the left side of the gravel path.

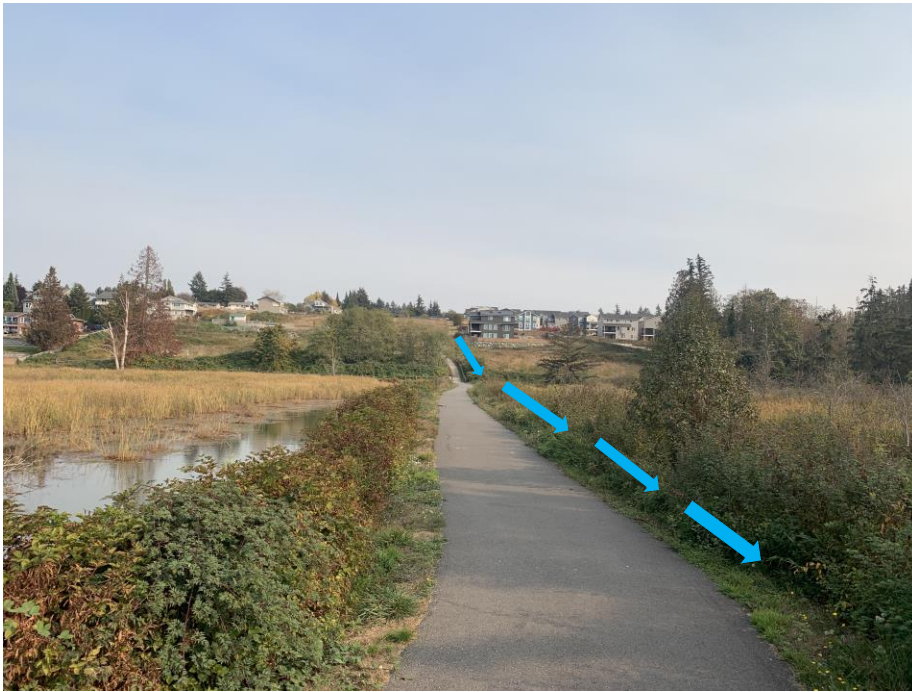
Image 5: Looking east towards the site, the flowpath outlets into a wetland on the right side of the trail.

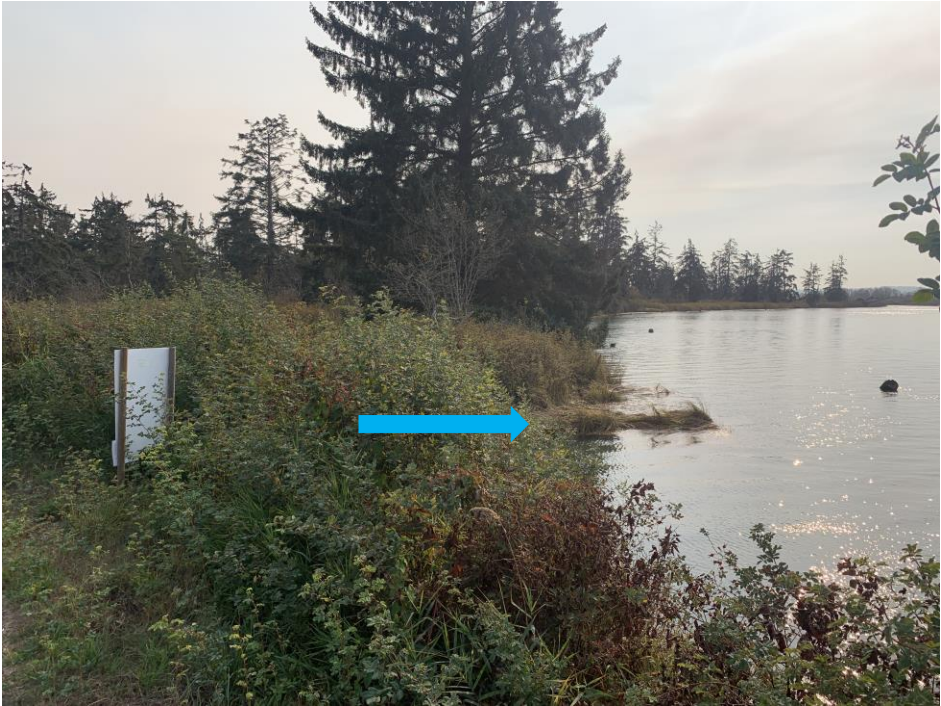
Image 6: The flowpath and wetland connect to Ebey Slough.
