RAY TOWNHOMES

Drainage Report

PACE Project No. 415-001-18

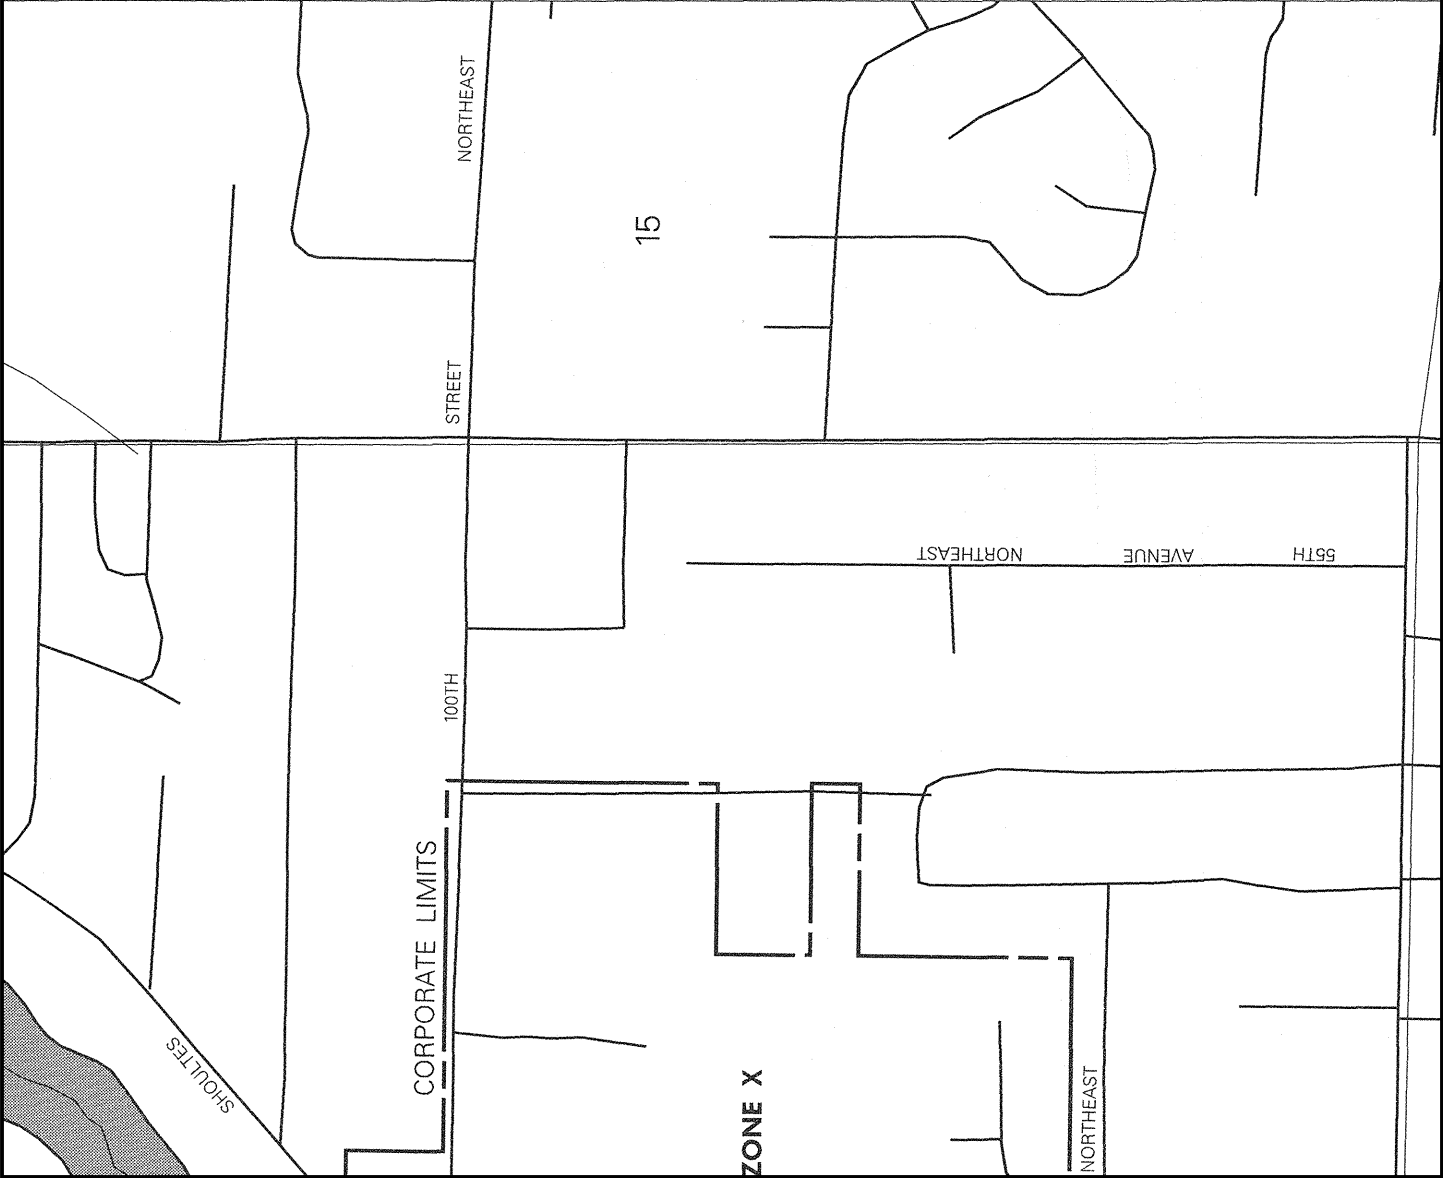
NATIONAL FLOOD INSURANCE PROGRAM

FIRM
FLOOD INSURANCE RATE MAP
 SNOHOMISH COUNTY,
 WASHINGTON AND
 INCORPORATED AREAS

The federal Emergency Management Agency (FEMA) identifies the project site on Flood Insurance Rate Map (FIRM) panel #53061C0708E and is not shown to be in a flood hazard area. A FEMA map has been provided in **Appendix ‘A’** of this report.
