Minor Property

Preliminary Drainage Report

Job No: 23-0011

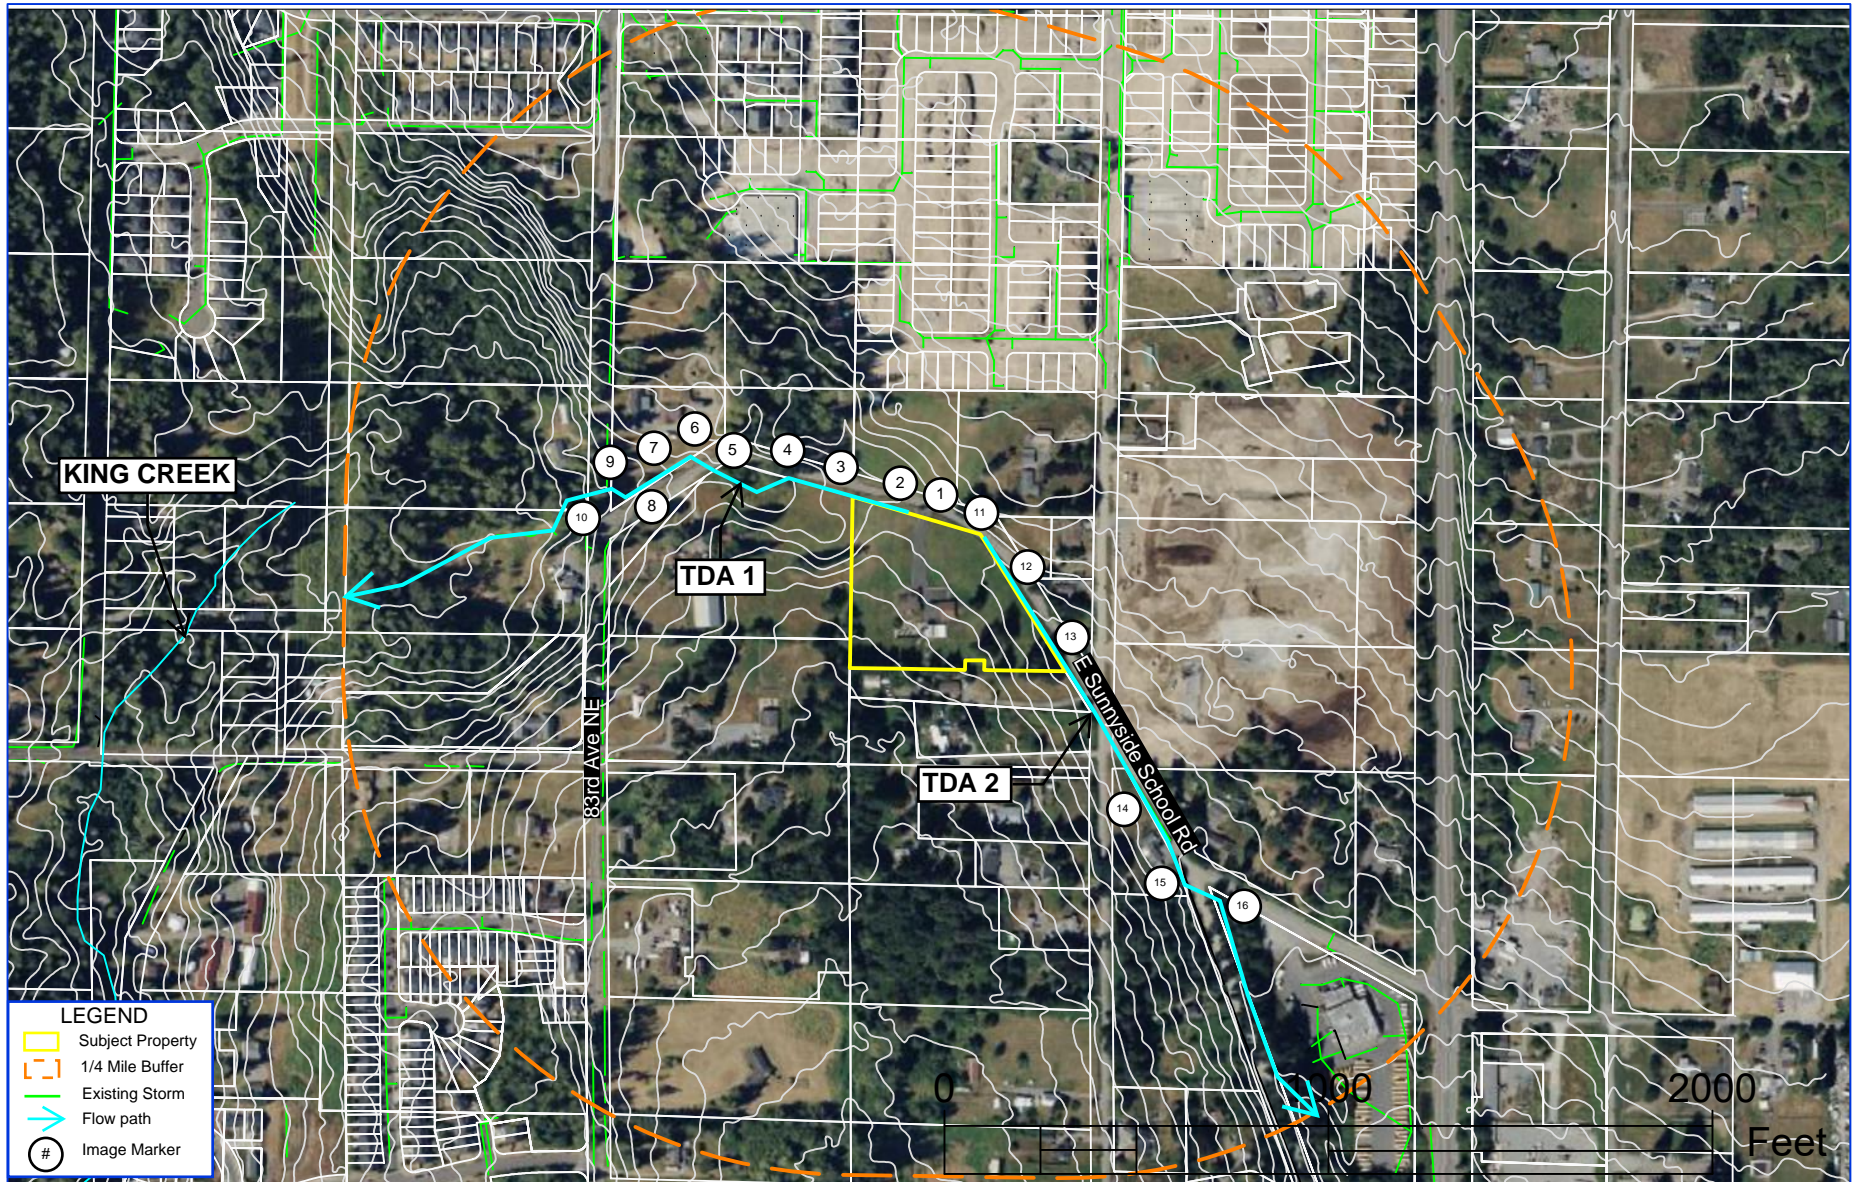
- LEGEND**
- Subject Property
 - 1/4 Mile Buffer
 - Existing Storm
 - Flow path
 - # Image Marker

Two flow paths have been identified leaving the east and west sides of the parcel that do not converge within one quarter mile of the site. As a result, the site is located within two threshold discharge areas (TDAs). Both flow paths are formed where runoff travels north towards E Sunnyside School Rd on either the west or east side of the TDA basin split (Image 1).

TDA #1 / Flowpath 1 – Overland flows traveling northwest are collected by an existing roadside ditch along E Sunnyside School Rd (Images 2 & 3). The ditch carries runoff to an existing pond/wetland area (Image 4) located on the neighboring property to the west. Overflow from the pond/wetland travels back to E Sunnyside School Rd (Image 5), crossing under the road to the north side (Image 6). Flow becomes more concentrated as it continues along the north side of E Sunnyside School Rd towards the intersection with 83rd Ave NE. Flow converges at a pipe crossing west under 83rd Ave NE (Image 9) The pipe outlets on the west side of 83rd Ave NE (Image 10), where King Creek continues beyond the quarter mile boundary.

TDA #2 / Flowpath 2 – Overland flows traveling northeast are collected by an existing roadside ditch along E Sunnyside School Rd (Images 11 & 12). The roadside ditch continues east along E Sunnyside School Rd to the eastern property corner (Image 13). E Sunnyside School Road begins to turn southeast beyond the property and the ditch continues under several driveway-culvert crossings (Image 14) until it reaches Densmore Rd. The flow crosses under Densmore Rd (Image 15) and continues southeast beyond the quarter mile buffer (Image 16), eventually joining Stevens Creek.

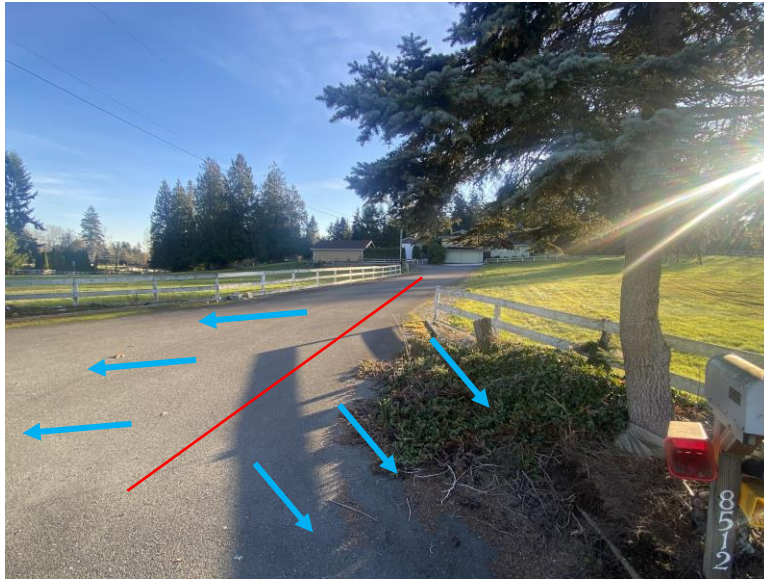
Image 1: Middle of existing driveway along E Sunnyside School Rd where TDA #1 & #2 split west or east

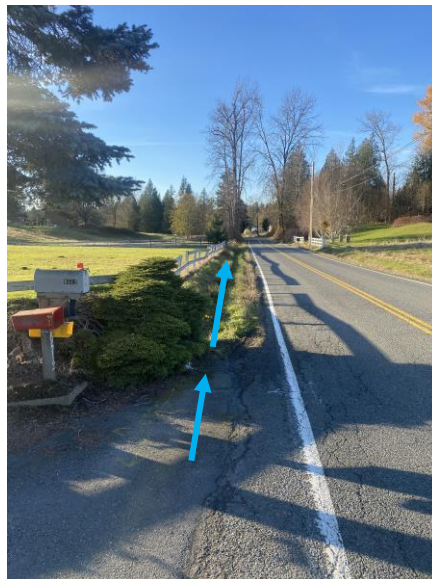
Image 2: Facing west along E Sunnyside School Rd where Flowpath 1 continues in a roadside ditch

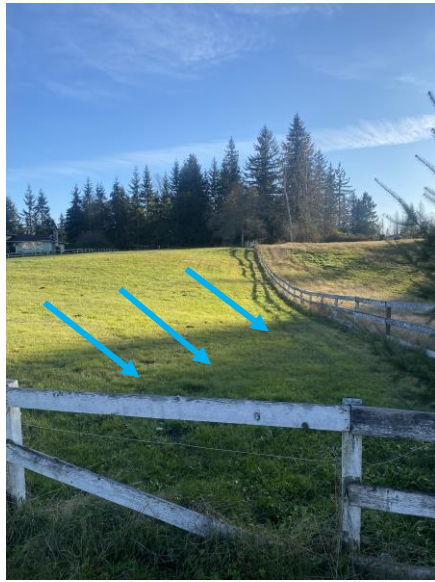
Image 3: Northwest property corner where runoff sheet flows west down existing slopes

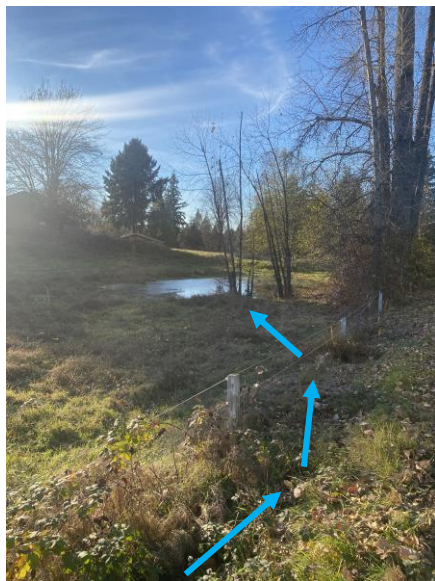
Image 4: Property west of project site along E Sunnyside School Rd where runoff enters existing pond/wetland

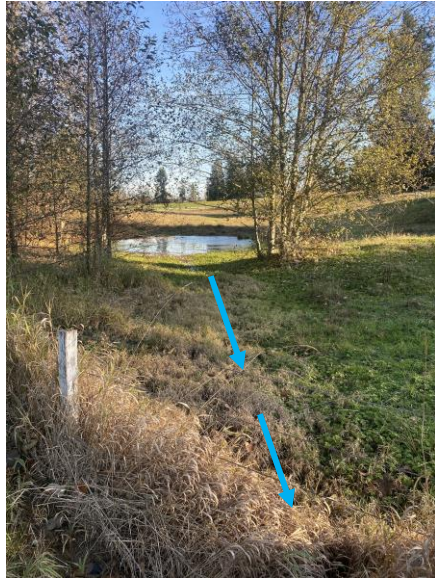
Image 5: west of existing pond/wetland where overflow runoff continues back to cross under E Sunnyside School Rd

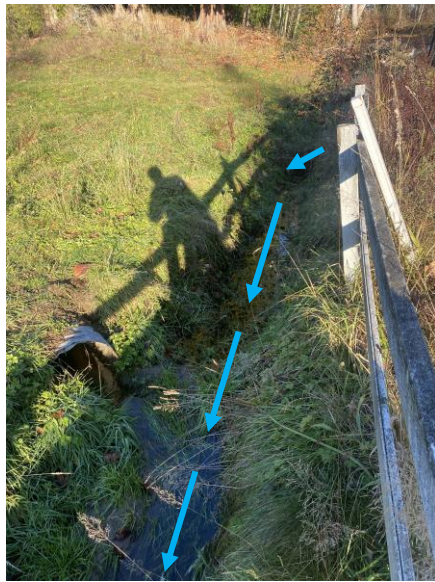
Image 6: north side of E Sunnyside School Rd where channelized flow continues west

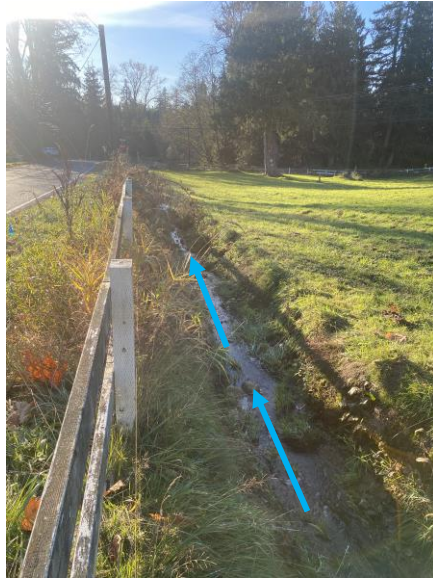
Image 7: north side of E Sunnyside School Rd where channelized flow continues west

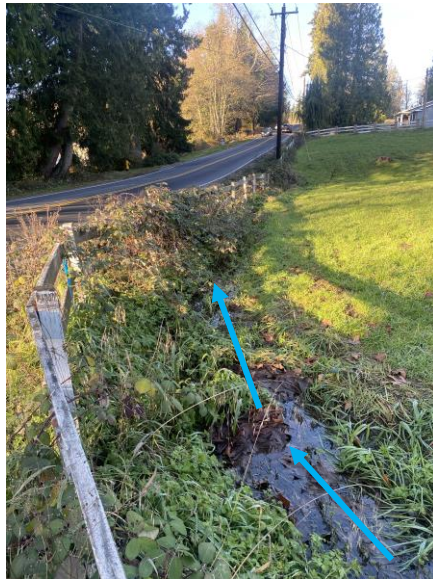
Image 8: Intersection of E Sunnyside School Rd and 83rd Ave NE

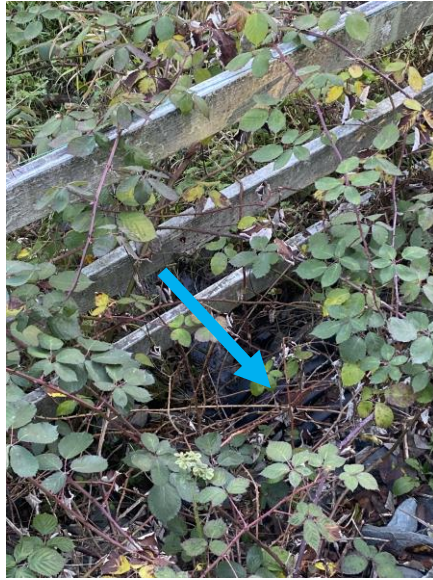
Image 9: Intersection of E Sunnyside School Rd and 83rd Ave NE where flow crosses west under 83rd via culvert

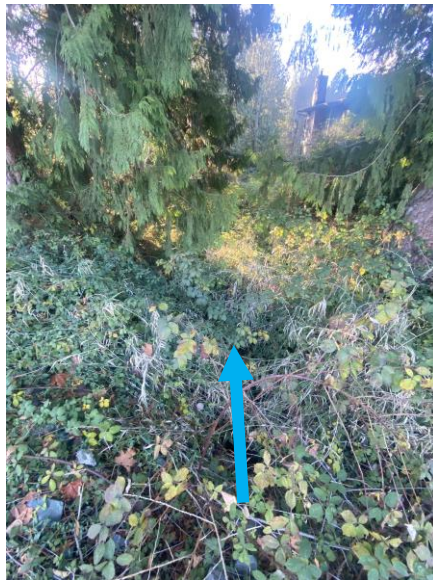
Image 10: Culvert outlet west of 83rd where King Creek continues to quarter mile boundary

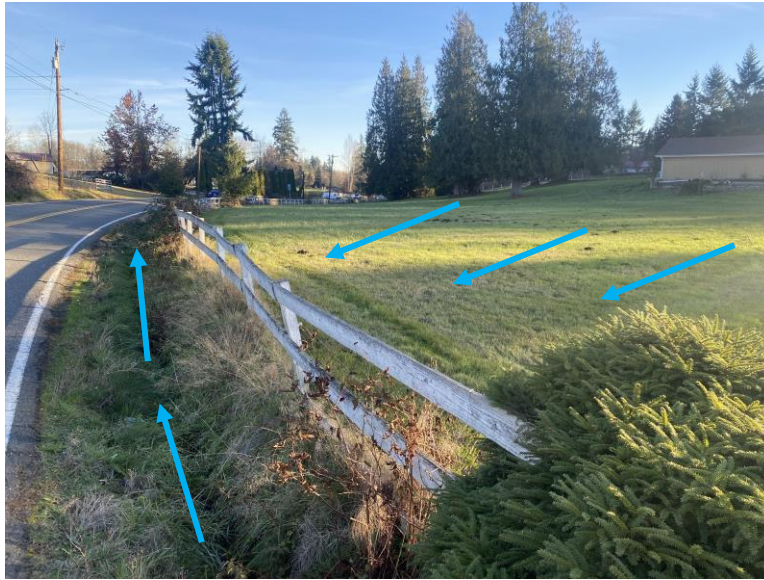
Image 11: Facing east along E Sunnyside School Rd where Flowpath 2 continues in a roadside ditch

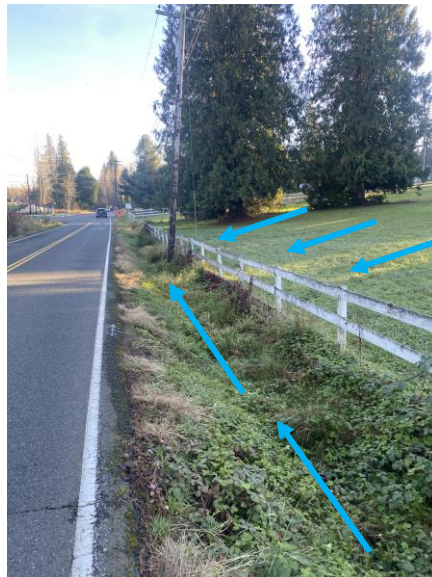
Image 12: Facing southeast along E Sunnyside School Rd where Flowpath 2 continues in a roadside ditch

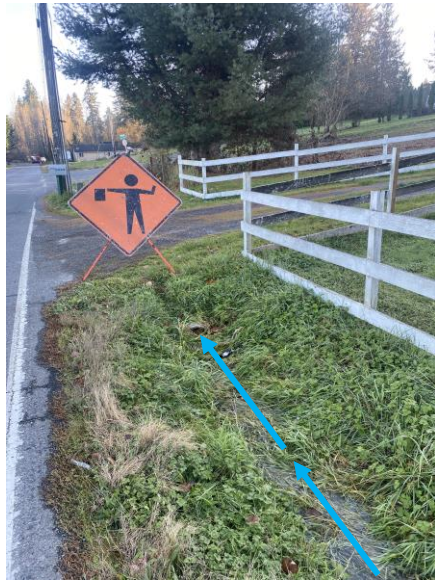
Image 13: east property corner along E Sunnyside School Rd where Flowpath 2 continues

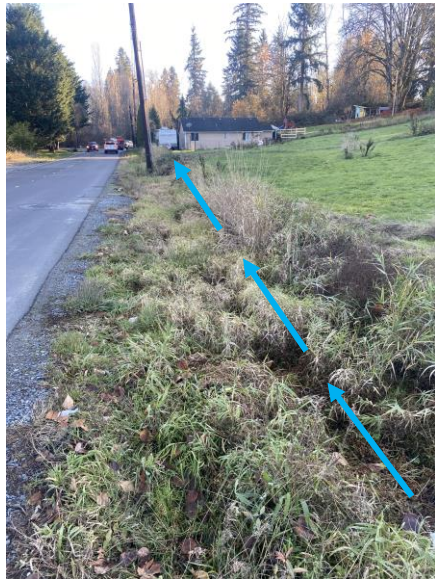
Image 14: along E Sunnyside School Rd where Flowpath 2 continues

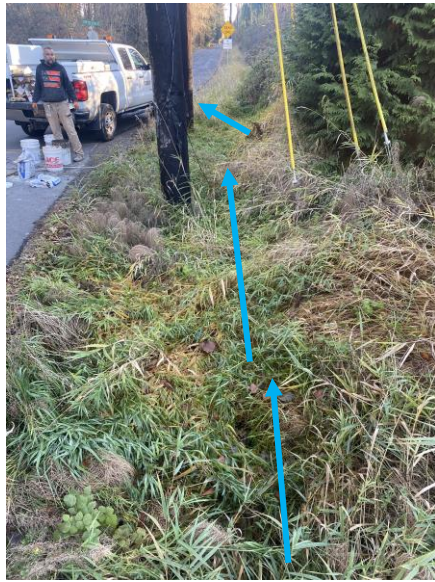
Image 15: near intersection of E Sunnyside School Rd and Densmore Rd, flow crosses east under Densmore Rd

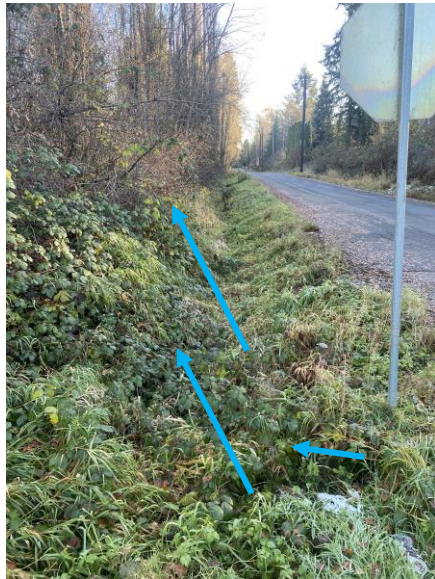
Image 16: east side of Densmore Rd, flow continues southeast beyond quarter mile boundary

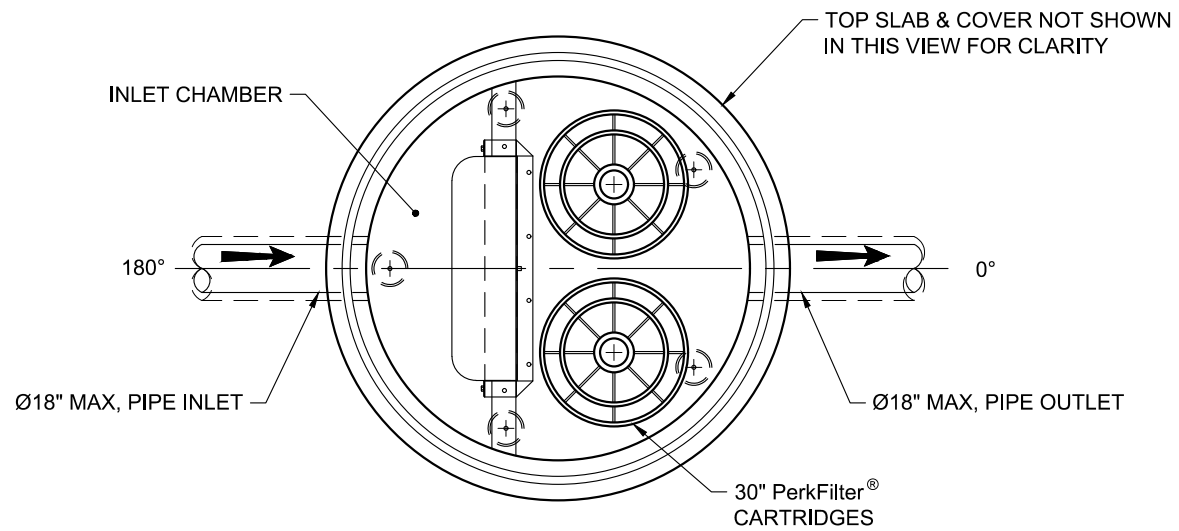
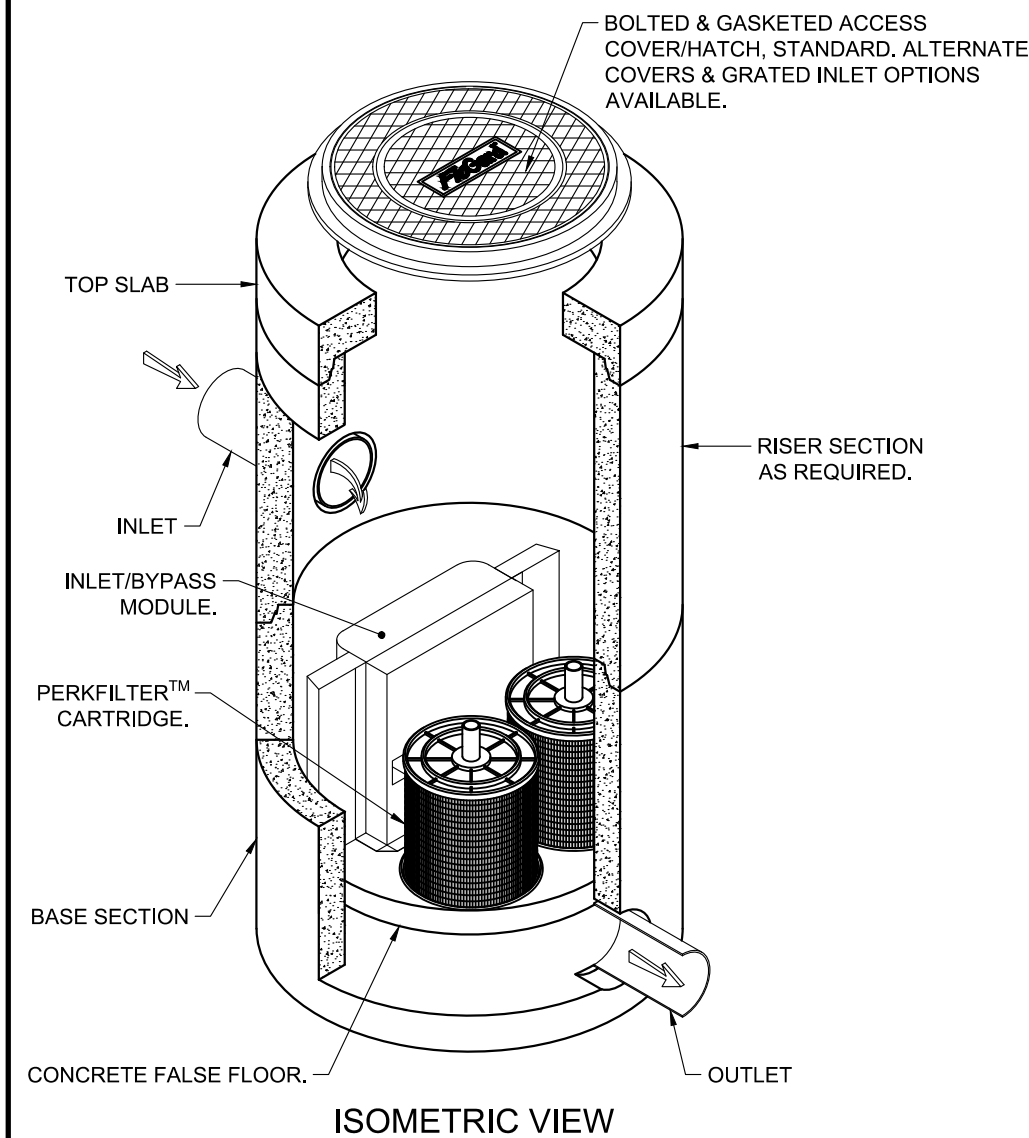
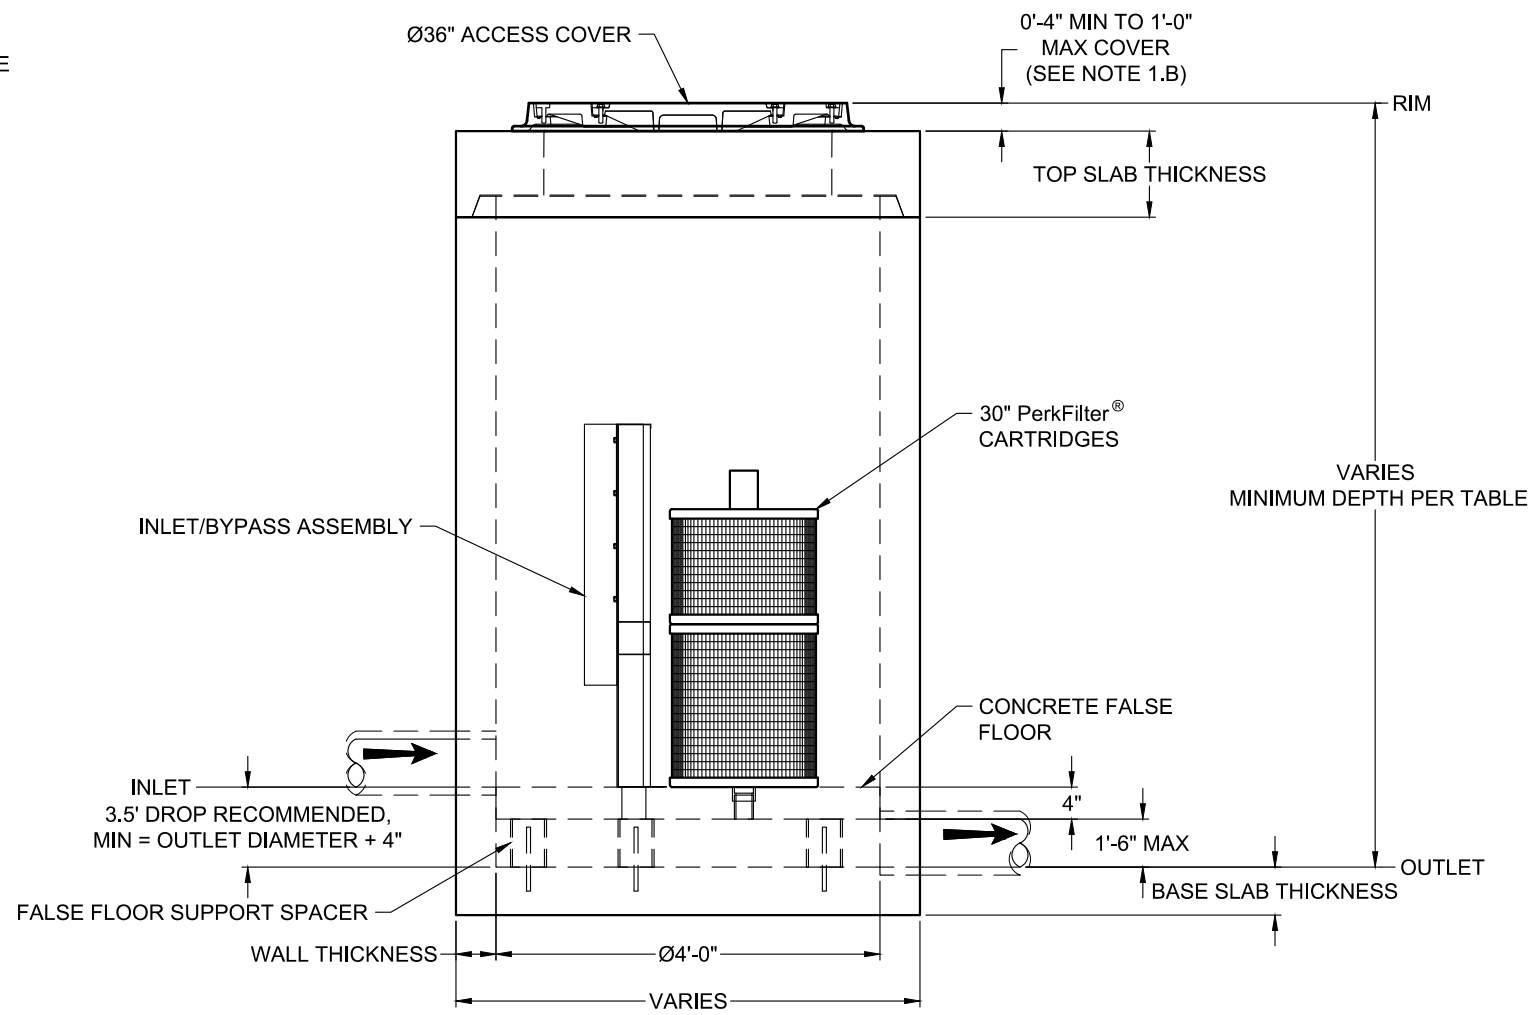
PERFORMANCE SPECIFICATIONS	
Peak Treatment Capacities: ¹	
Max. Cartridge Quantity	2
NJDEP 80% Removal, 75 micron	68 gpm / 0.151 cfs
WA Ecology GULD - Basic & Phosphorus	34 gpm / 0.075 cfs
Max. Bypass Capacity	3.62 cfs

PLAN VIEW

ISOMETRIC VIEW

ELEVATION VIEW

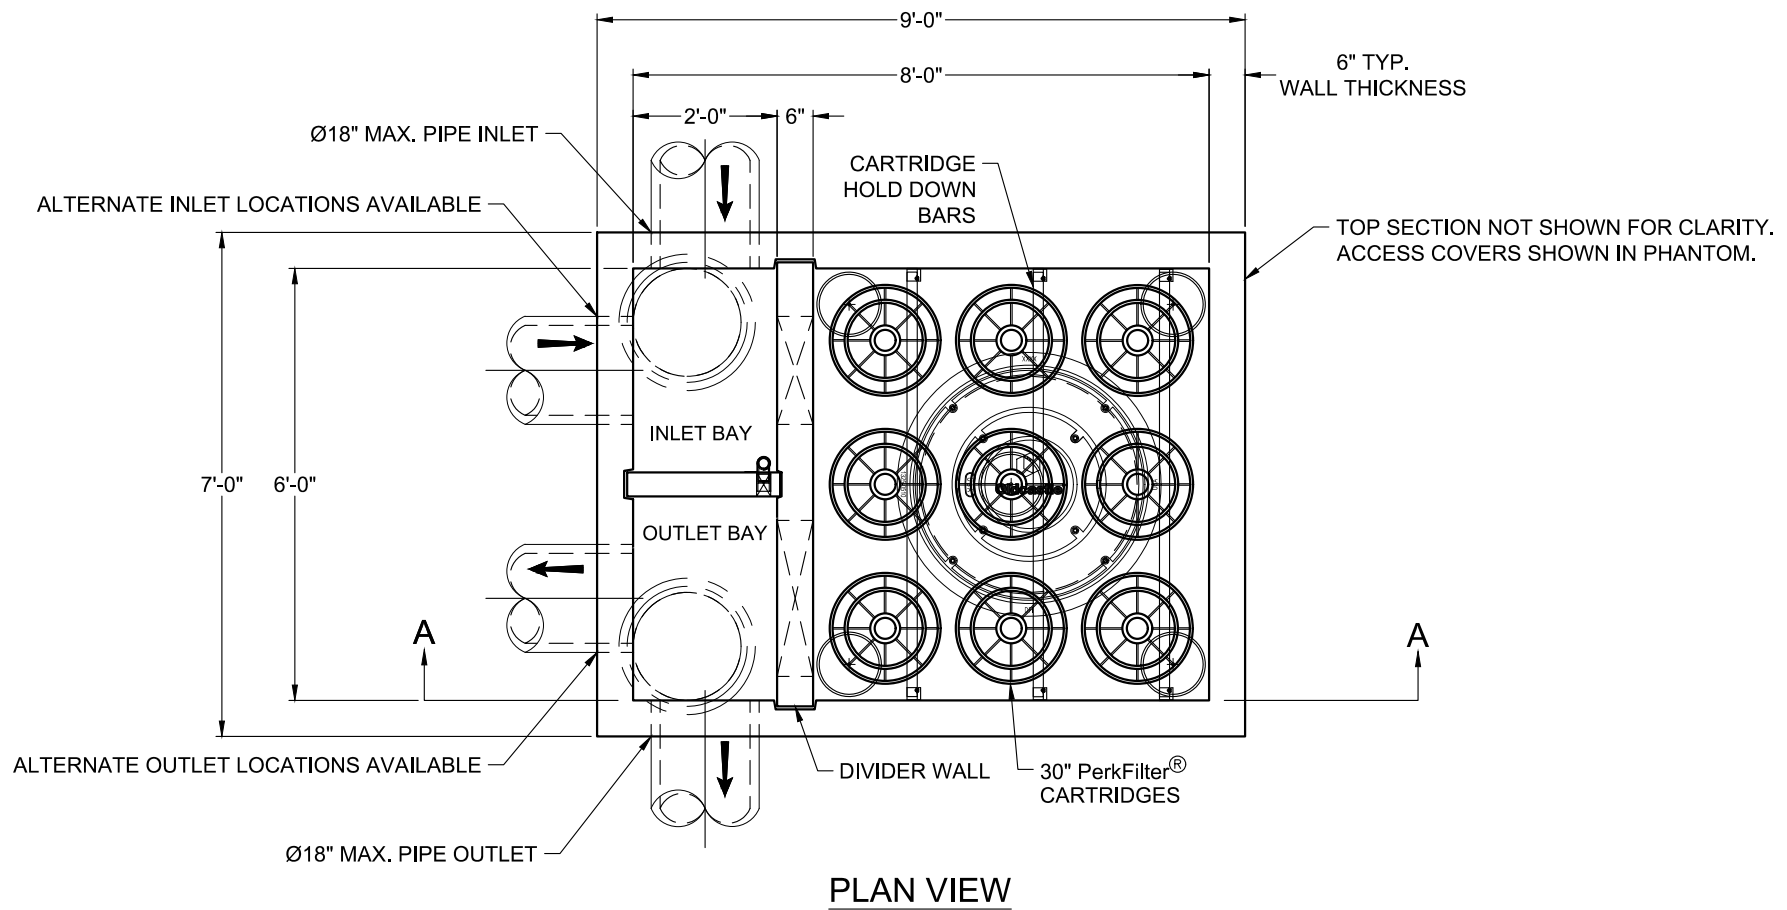
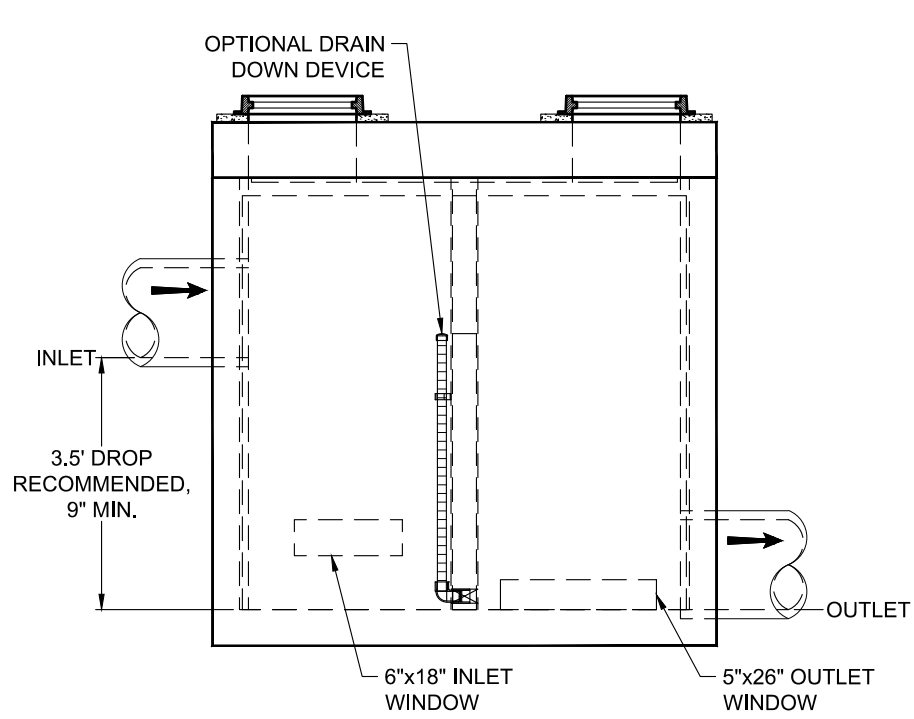
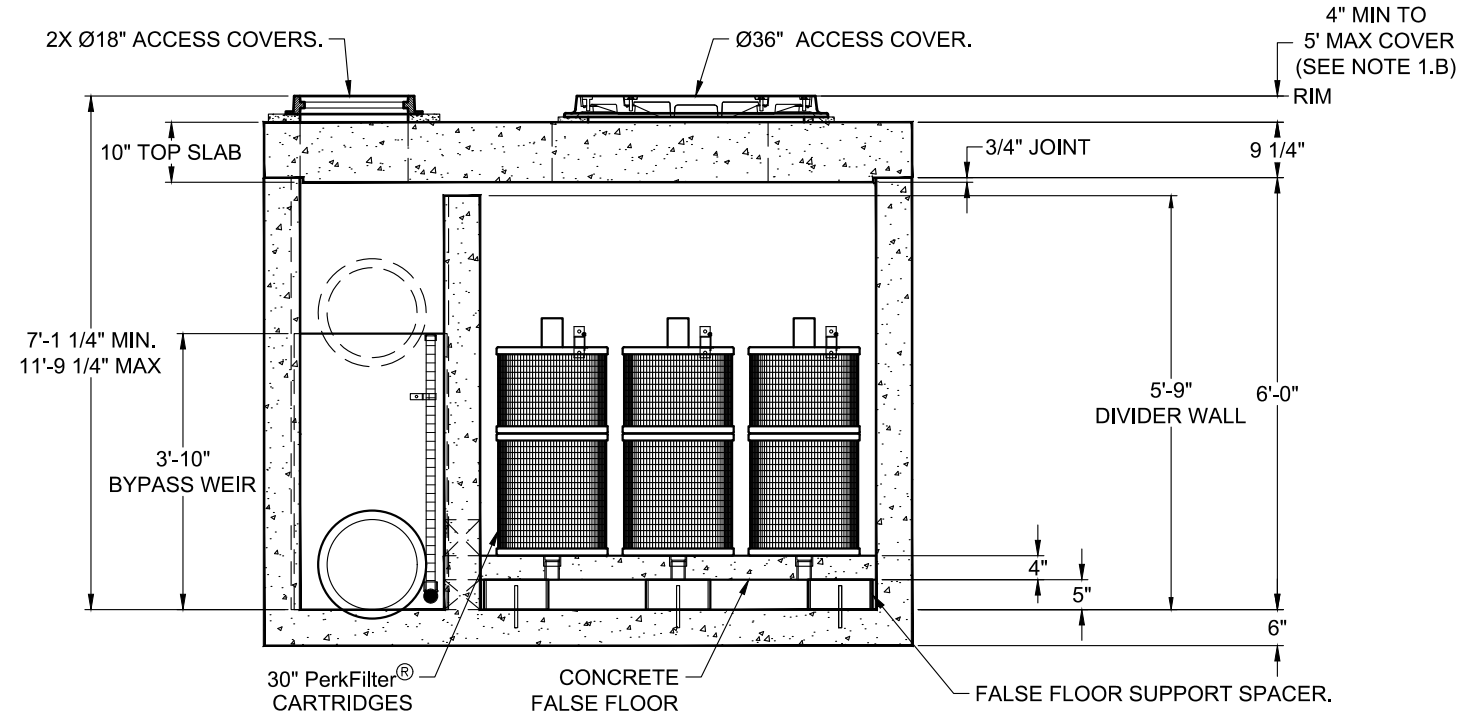
PLAN VIEW

LEFT END VIEW

SECTION A-A

- NOTES:**
- DESIGN LOADINGS:
 - AASHTO HS-20-44 (WITH IMPACT)
 - DESIGN SOIL COVER: 5'-0" MAXIMUM
 - ASSUMED WATER TABLE: BELOW BASE OF PRECAST (ENGINEER-OF-RECORD TO CONFIRM SITE WATER TABLE ELEVATION)
