Creekside PRD

Preliminary Drainage Report

Horizon View Holdings, Inc.

LDC, Inc.

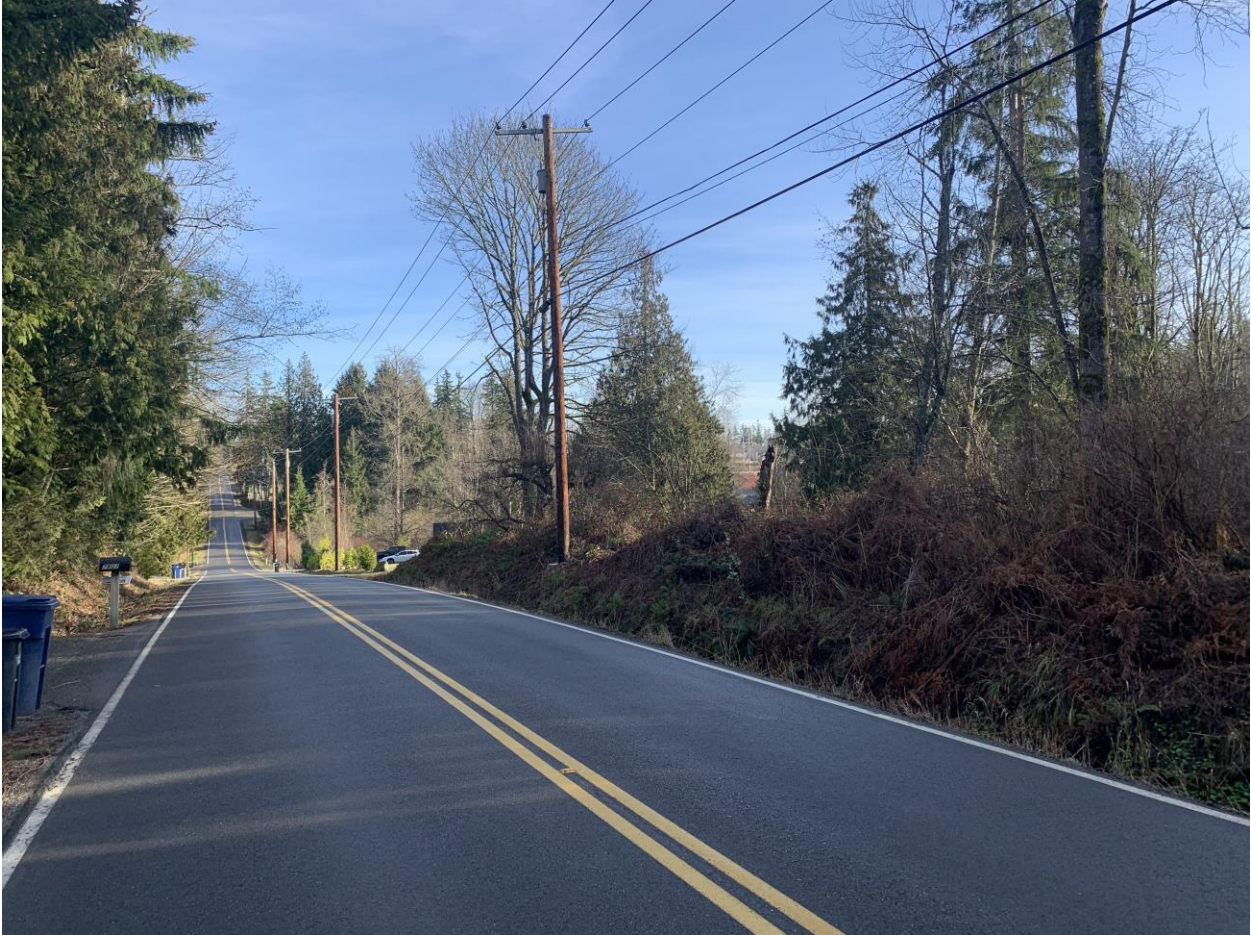
Image 1: Facing easterly near the NW corner of the project site where road and topography slopes east towards the low point at the King Creek inlet to the site. Negligible upstream runoff north of 44th St NE. See Image 6 for description of upstream runoff from the west.

Frontage flows are broken up into the Line Road/44th St NE and 79th Ave NE frontages. The 44th St NE frontage and road has a low point at the inlet location of King Creek near the NE corner of the project site (Images 1 and 2). The 79th Ave NE frontage and road generally slopes south towards the intersection of 40th St NE and 79th Ave NE. Along 40th St NE at the southern edge of the project site, there is a low point at the outlet location of King Creek near the SE corner of the project site (Image 3). All site runoff from the development area flows generally flows in a southeasterly direction. Flow at the Southwest corner continues back Southeast/east back to King Creek (Image 5) along the primary Flow path A. Flow path A continues for approximately 1,600-feet offsite prior to exiting the quarter mile boundary of analysis. These flow paths will remain the same in the developed condition.

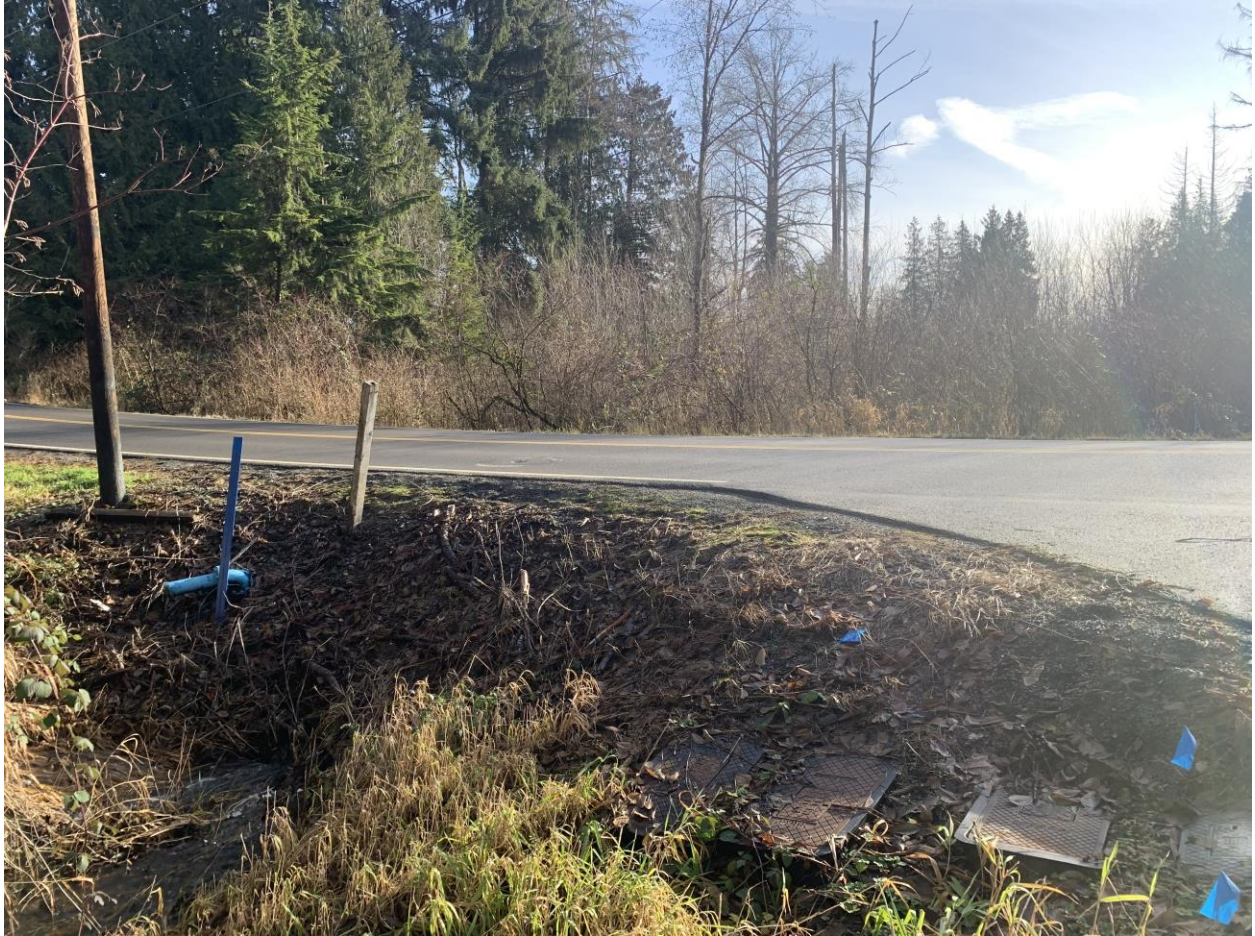
Image 2: Facing southerly at the King Creek inlet to the project site at a low point along 44th St NE near the NE corner of project site. King Creek continues through the project site wetland areas near the eastern edge before discharging from the site at the southern edge.

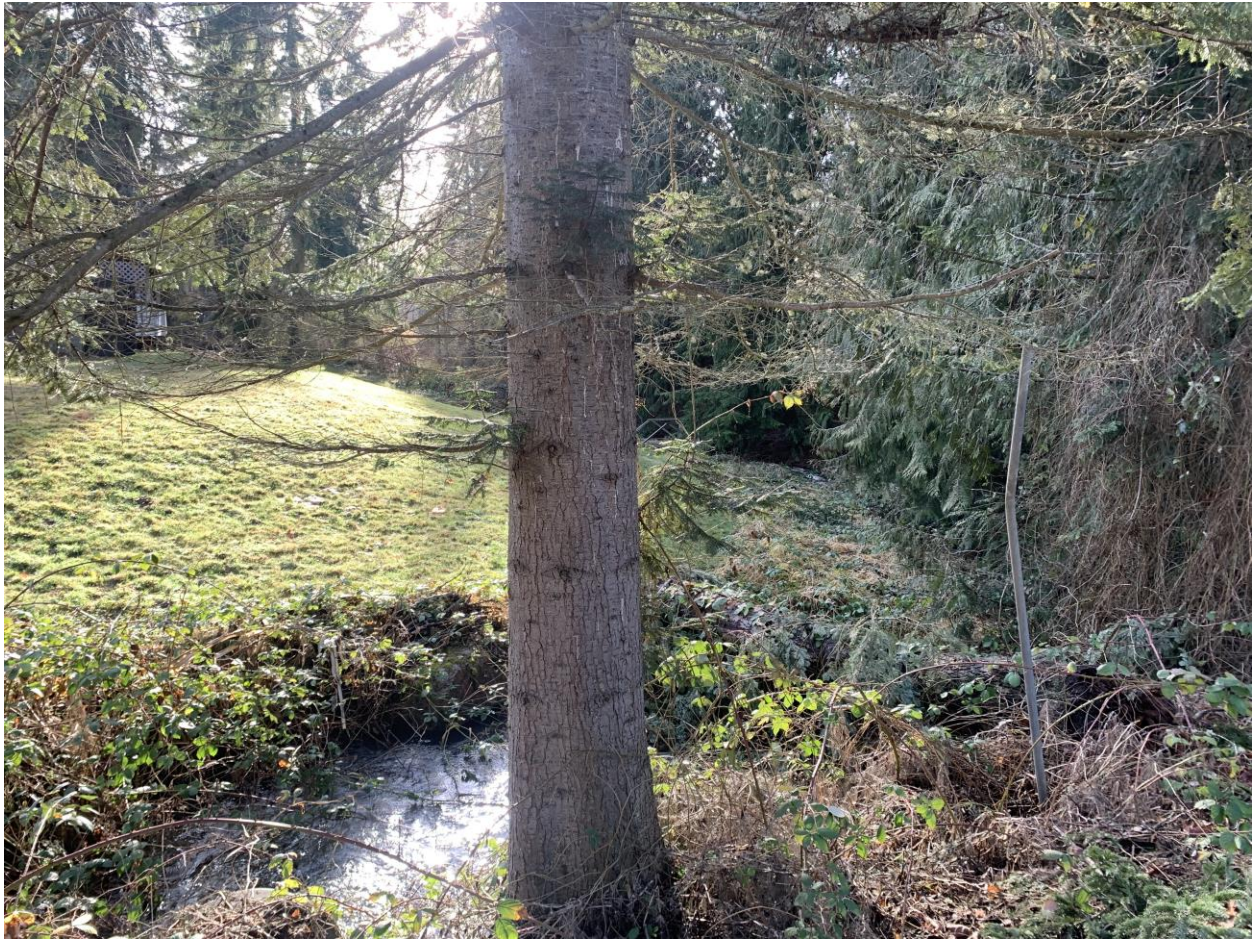
Image 3: Facing southerly at the southern edge of the project site along 40th St NE at the discharge location of King Creek from the project site. King Creek continues south/southwesterly for approximately 1600-feet to the quarter-mile boundary of analysis. King Creek converges with Ebey Slough past the quarter-mile buffer.

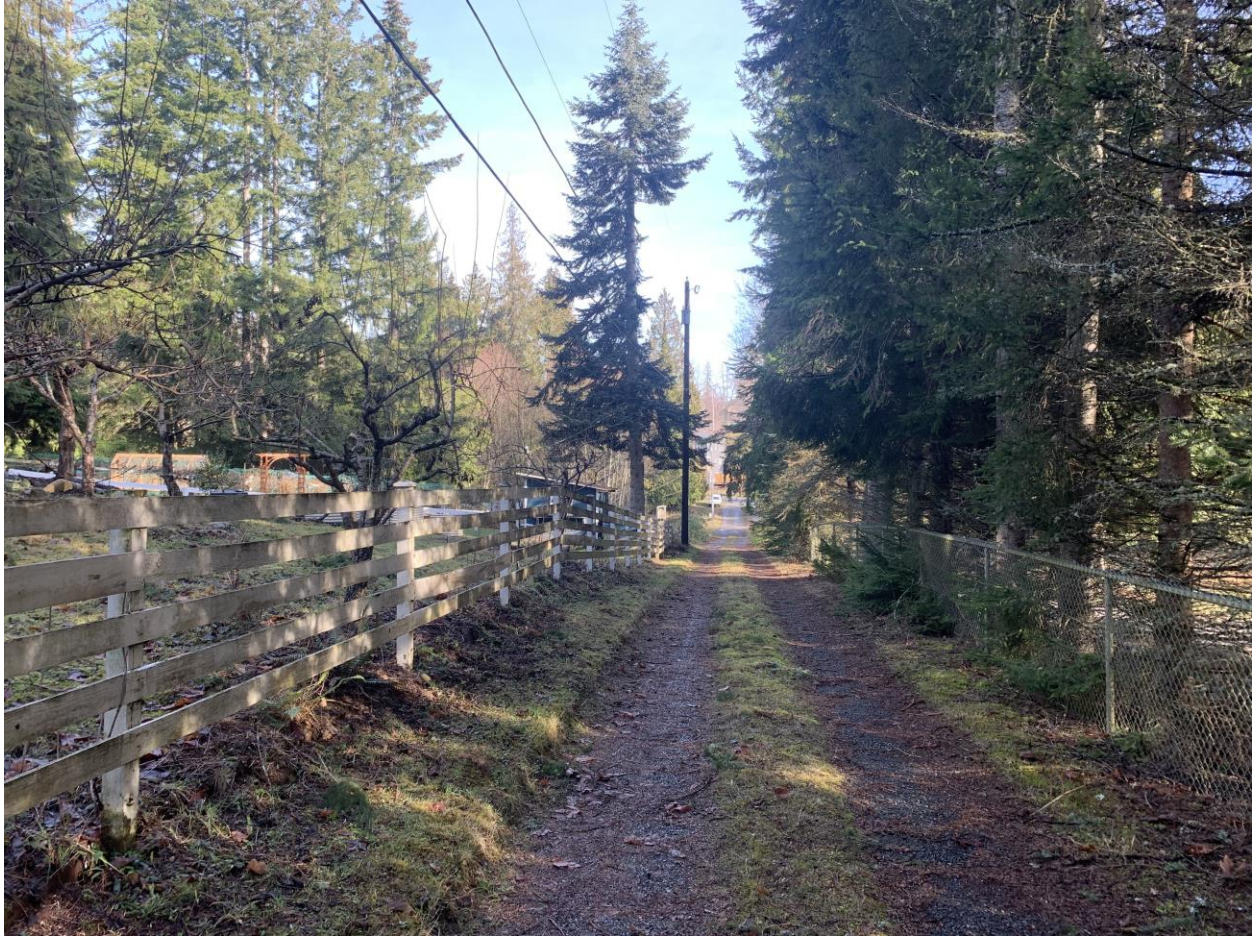
Image 4: Facing east at the SW corner of the project site along 40th St NE where road and topography slopes east towards the low point at the King Creek outlet from the site. See Image 5 for description of onsite runoff from the north. See Image 6 for description of upstream runoff from the west.

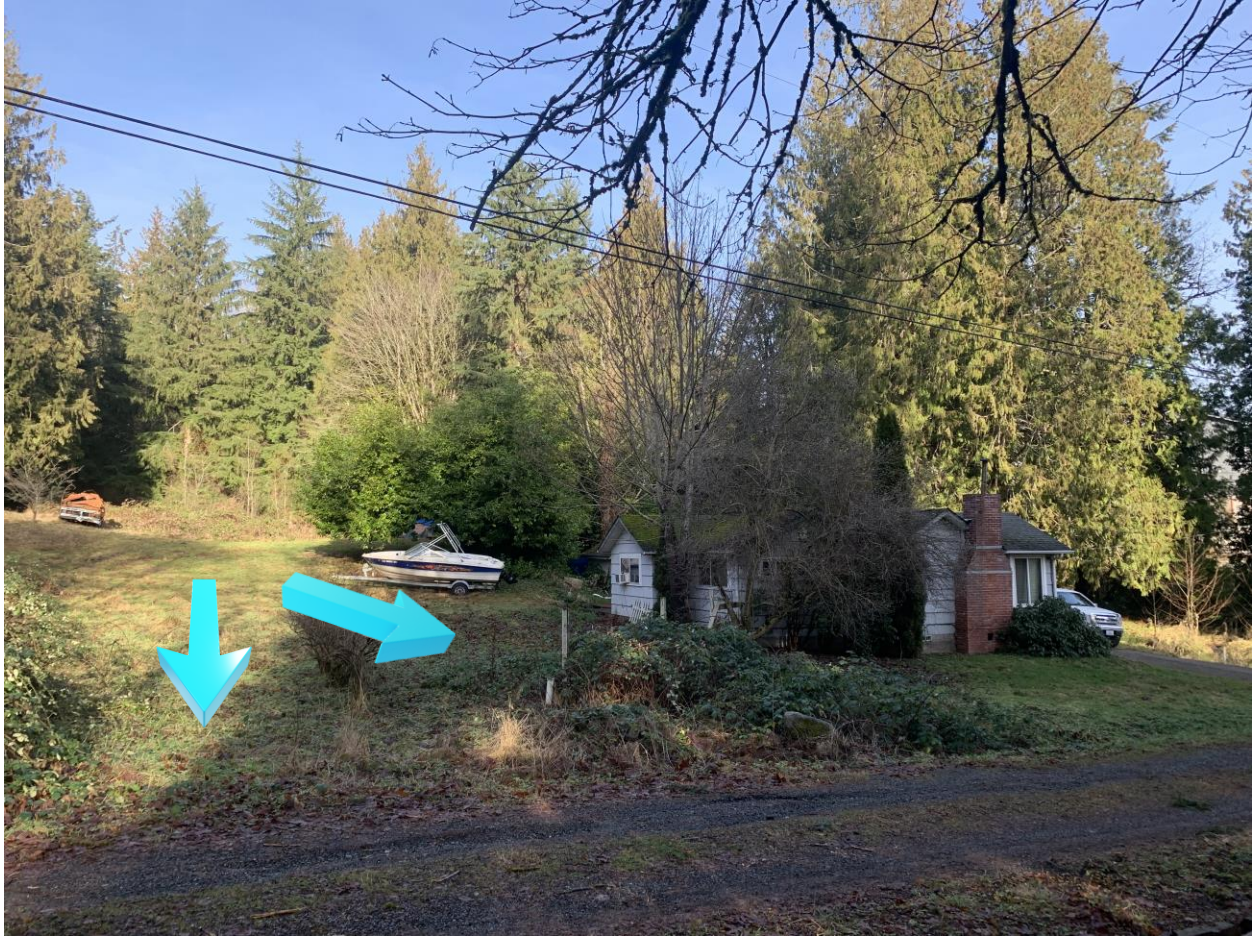
Image 5: Facing northeasterly at the southern edge of project site along 40th St NE. Onsite stormwater runoff flows south towards 40th St NE or east towards the low point at the King Creek discharge location from the site.

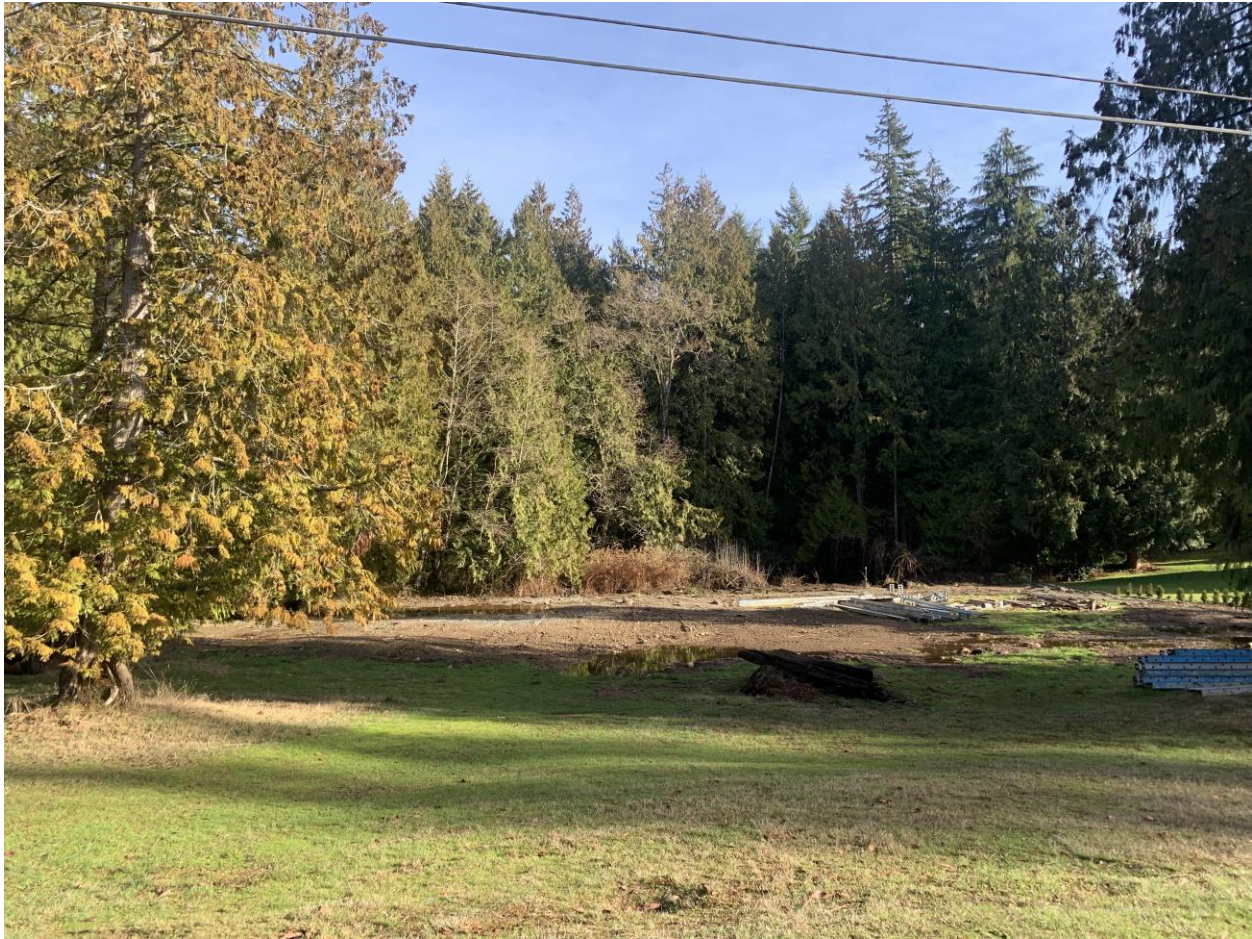
Image 6: Facing southeasterly at the uphill of the project site along 76th Dr NE. Upstream runoff from the west of the project site is from residential/lawn area and descends across gentle slopes onto the site.

There are no significant upstream basin areas tributary to the project site from neighboring properties. Any upstream runoff from the west of the project site is interpreted as residential/lawn stormwater sheet flow across gentle slopes onto the project site, which will not incur any flow control or water quality risk considerations. Located east of the project site, there is an insignificant volume of upstream runoff west of 79th Ave NE due to the minimal size of the offsite area. Therefore, there is a negligible volume of upstream stormwater runoff onto the project site. See image 6 in Appendix 3 for description of upstream stormwater runoff analysis.

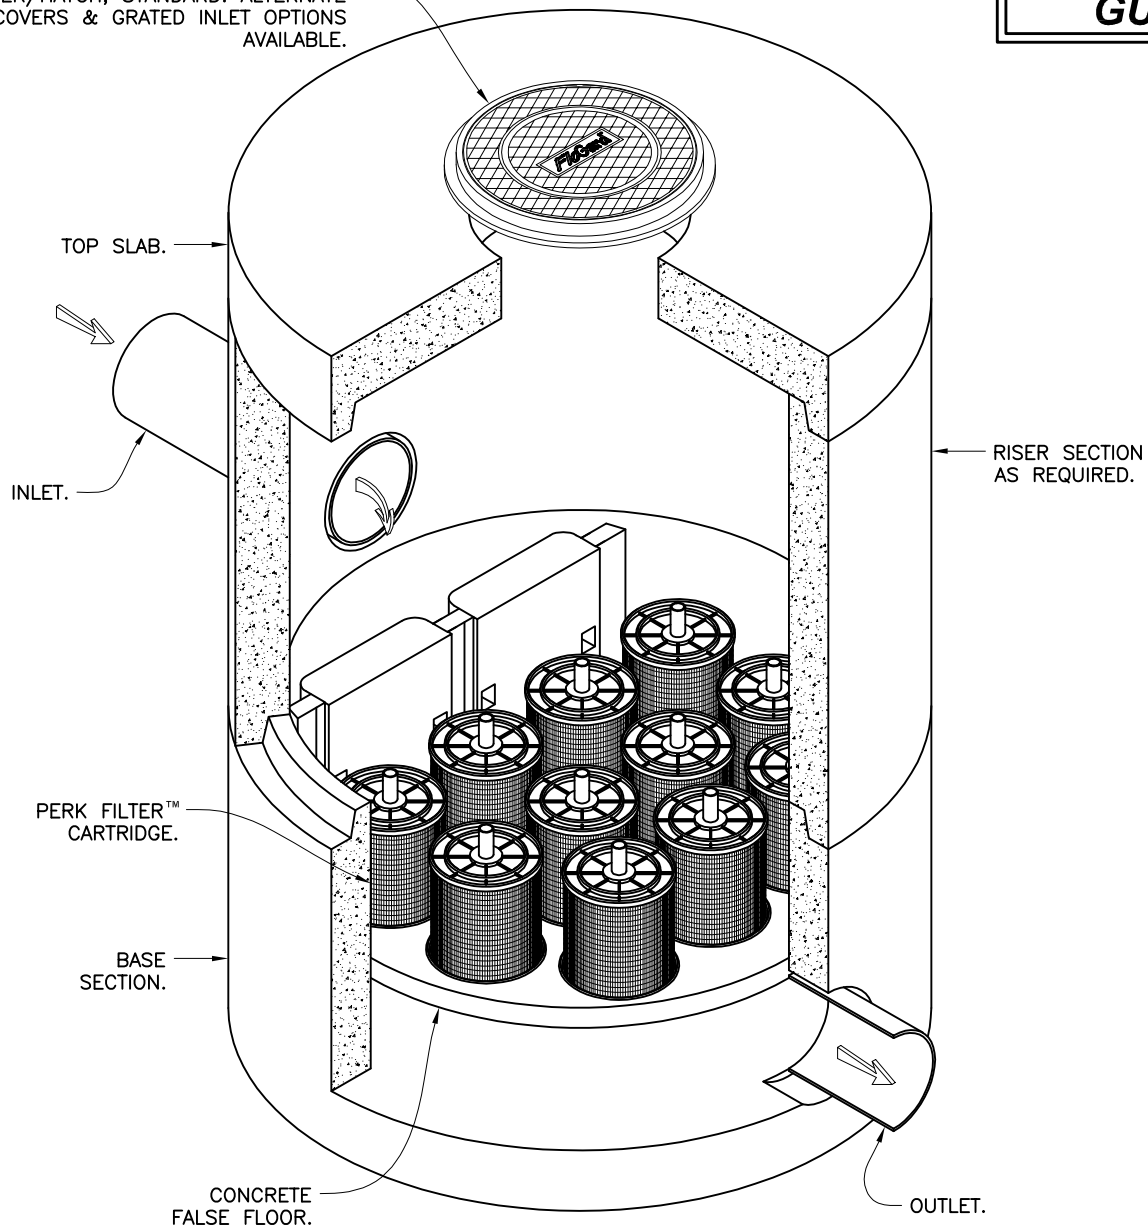
DRAWING NO. PF-MH-96-WA	REV NR	ECO ECO-0132	DATE ISM 4/27/15	SHEET 1 OF 2
----------------------------	-----------	-----------------	---------------------	--------------

BOLTED & GASKETED ACCESS COVER/HATCH, STANDARD. ALTERNATE COVERS & GRATED INLET OPTIONS AVAILABLE.

1. Precast concrete structure shall be manufactured in accordance with ASTM Designation C478.
2. Filter system shall be supplied with traffic rated (H20) bolted & gasketed Ø36" circular access covers with risers as required. Field poured concrete collar required, by others.
3. Inlet & outlet pipe(s) are to be Ø24.00" maximum. Inlet pipes must enter the structure in the inlet bay.
4. Inlet chamber shall be supplied with drain-down device designed to remove standing water between storm events.
5. Minimum separation between invert in & invert out is outlet pipe diameter plus 4.00".
6. For depths less than specified minimums contact Oldcastle® Stormwater Solutions for engineering assistance.
