GEOTECHNICAL REPORT

**Marysville 172nd and 23rd
172nd Street Northeast and 19th Avenue Northeast
Marysville, Washington**

Project No. T-8541

March 9, 2022

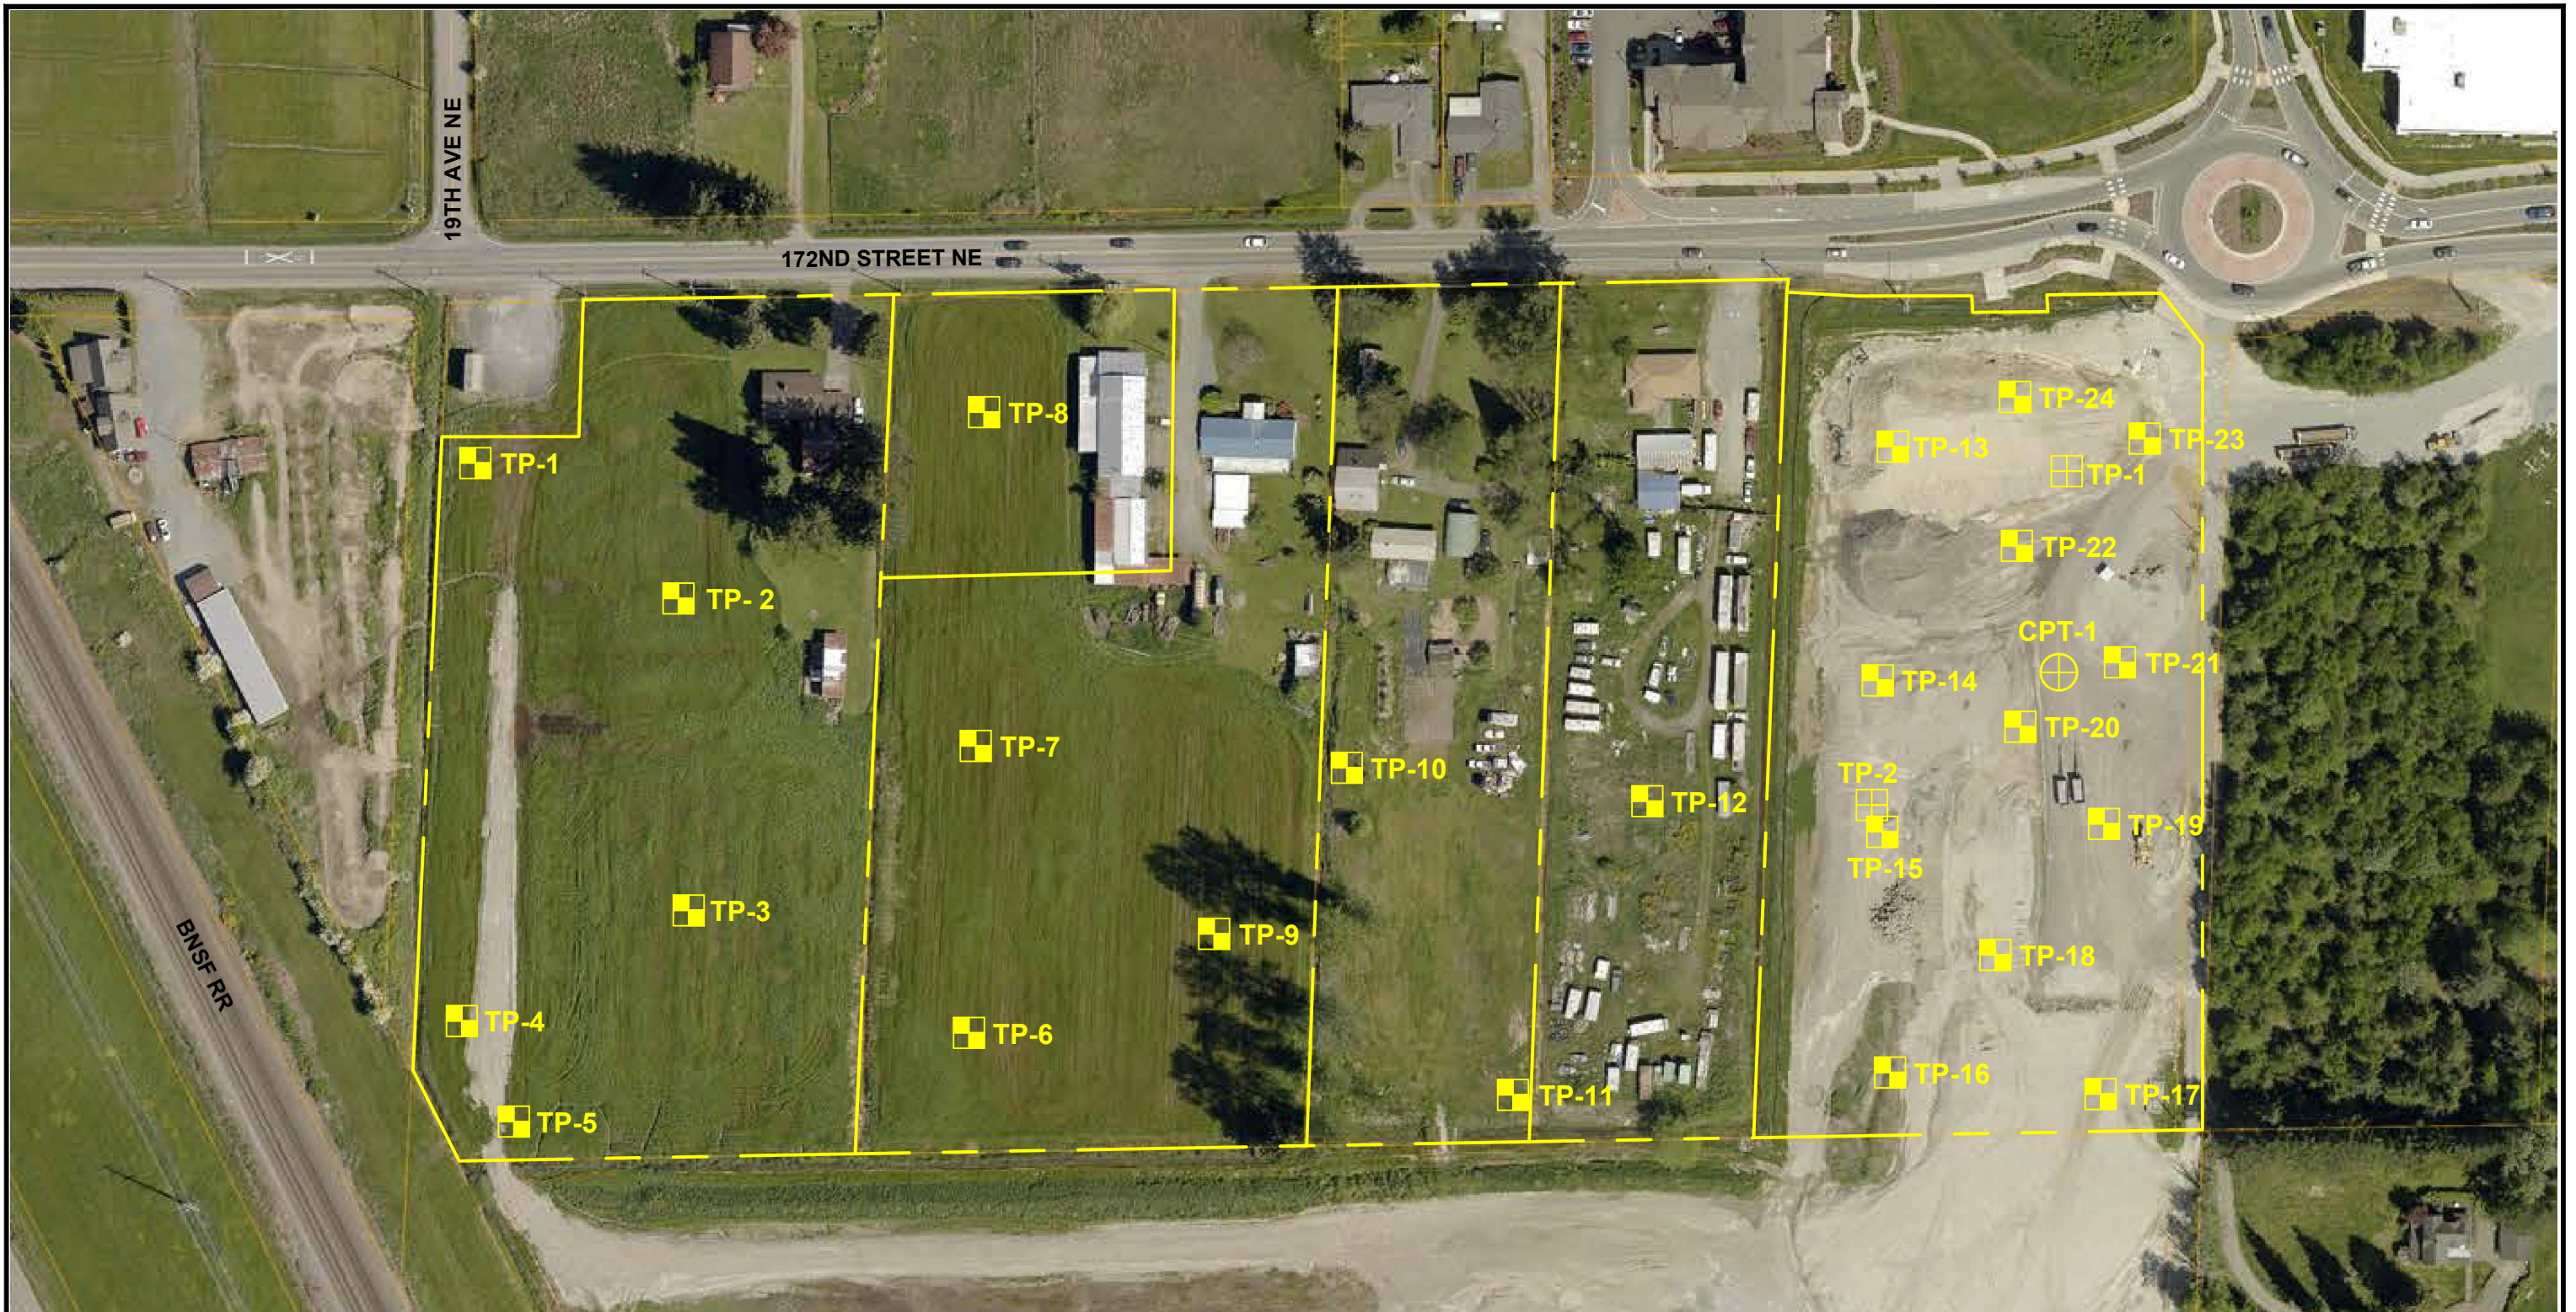
Proj. No.T-8541	Date MAR 2022	Figure 2
-----------------	---------------	----------

APPROXIMATE CPT LOCATION (JAN 2007)

**EXPLORATION LOCATION PLAN
MARYSVILLE 172ND AND 23RD
MARYSVILLE, WASHINGTON**

The preceding discussion is intended to be a general review of the soil conditions encountered in the subsurface explorations. For more detailed descriptions, please refer to the Test Pit Logs in Appendix A. The CPT data plot is also attached in Appendix A. The approximate test pit and CPT locations are shown on Figure 2.
