**GEOTECHNICAL ENGINEERING STUDY
COLVIN PROPERTY
3920 DENSMORE ROAD
MARYSVILLE, WASHINGTON**

ES-8204

PREPARED FOR
PNW INVESTORS, LLC

February 14, 2022

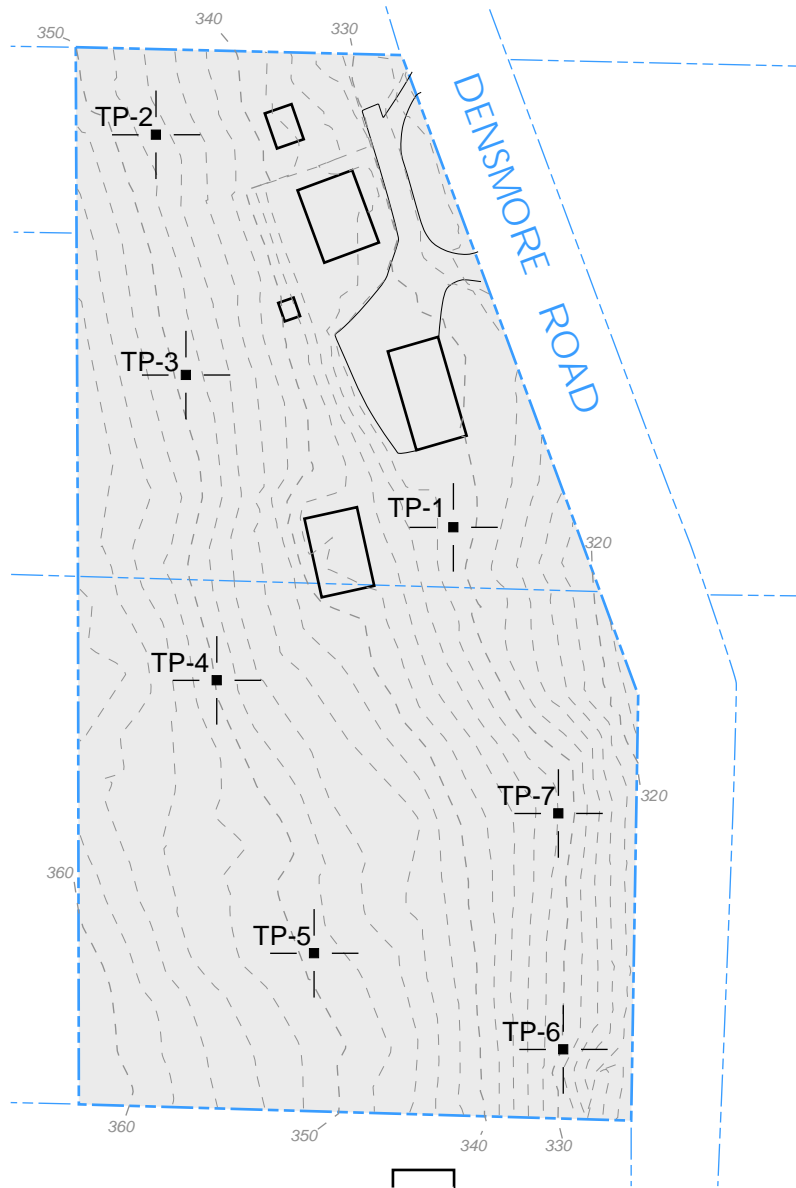
Drwn. MRS	Date 01/21/2022	Proj. No. 8204
Checked KTK	Date Jan. 2022	Plate 2

**Test Pit Location Plan
Colvin Property
Marysville, Washington**

ESNW representatives observed, logged and sampled seven test pits across accessible portions of the site. The test pits were advanced using an excavator and operator retained by ESNW, and advanced to a maximum depth of 10.5 feet. The approximate location of the test pits is depicted on the Test Pit Location Plan (Plate 2). Please refer to the soil logs provided in Appendix A for a more detailed description of the subsurface conditions.

The subsurface conditions at the site were explored by excavating a total of seven test pits across accessible portions of the property. The subsurface explorations were completed in December of 2021. The approximate test locations are illustrated on Plate 2 of this report. Logs of the test pits are provided in this Appendix. The test pits were excavated to a maximum depth of 10.5 feet below existing grades.

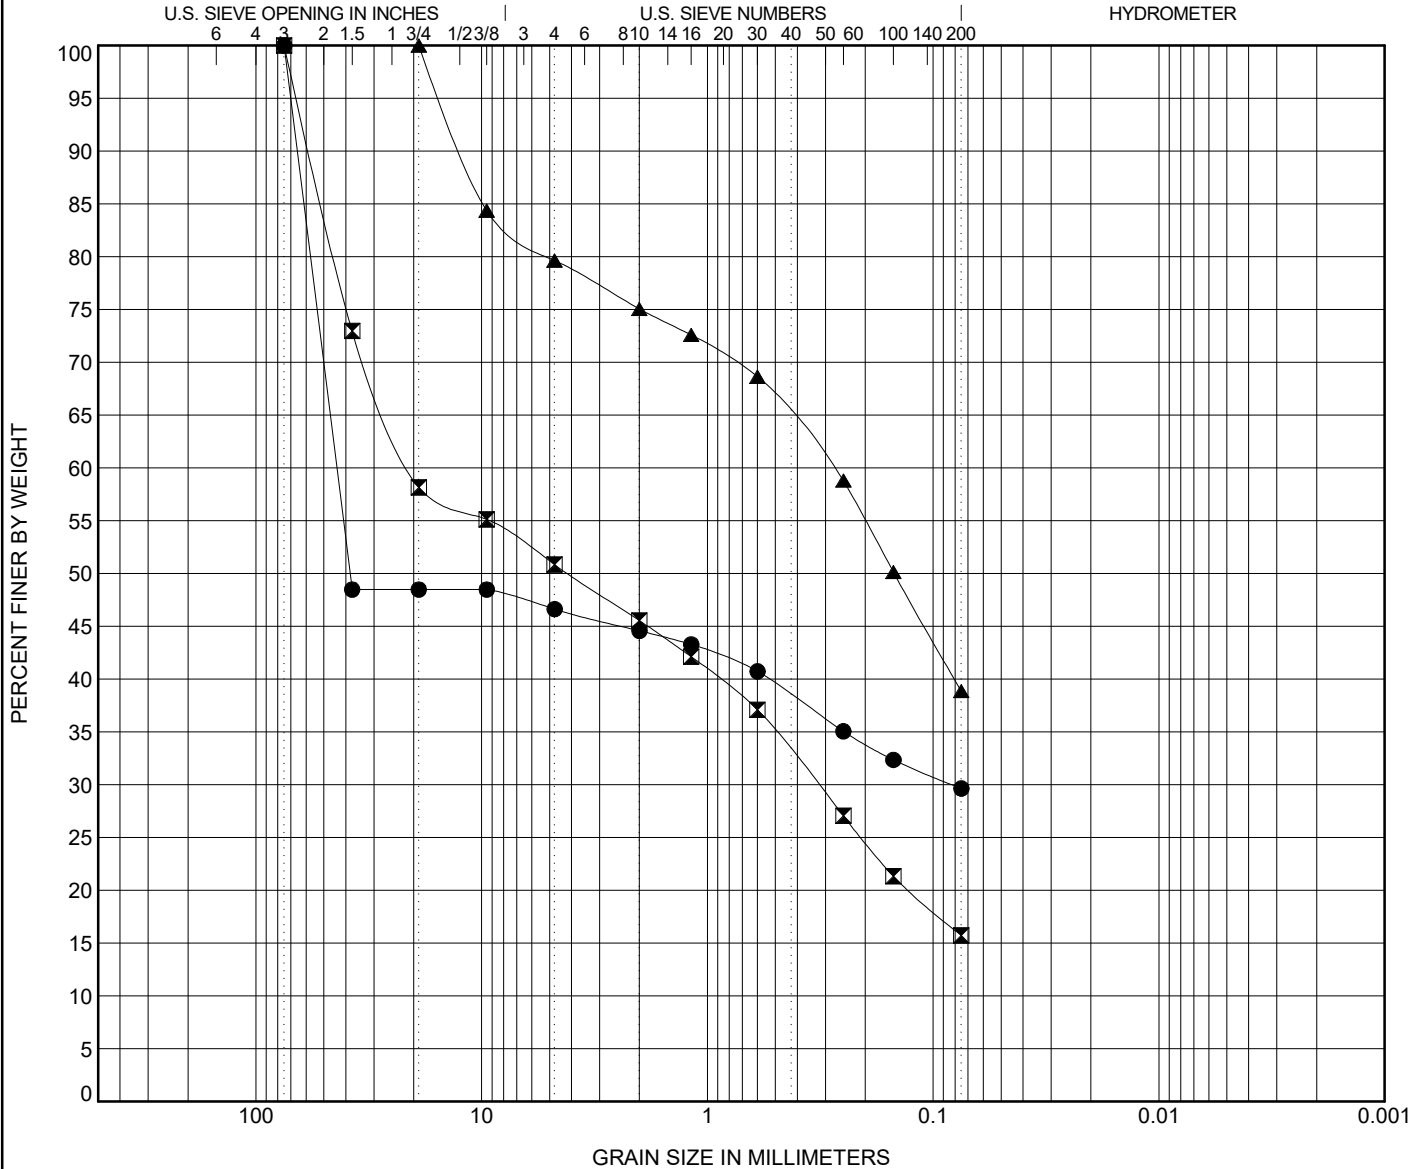
Specimen Identification	Classification								Cc	Cu
● TP-01 4.50ft.	USDA: Gray Very Gravelly Loam. USCS: GM with Sand.									
☒ TP-04 2.00ft.	USDA: Brown Very Gravelly Sandy Loam. USCS: GM with Sand.									
▲ TP-06 10.50ft.	USDA: Gray Gravelly Loam. USCS: SM with Gravel.
