HWA Project No. 2016-023-21

Subject: **PHASE I ENVIRONMENTAL SITE ASSESSMENT UPDATE**
Welco Property
Marysville, Washington

This letter report presents the results of the HWA GeoSciences Inc. (HWA) Phase I Environmental Site Assessment (ESA) Update conducted for a property located at 1218 1st Street, in Marysville, Snohomish County (Tax ID# 30053300202400), Washington (herein referred to as the Subject Property).

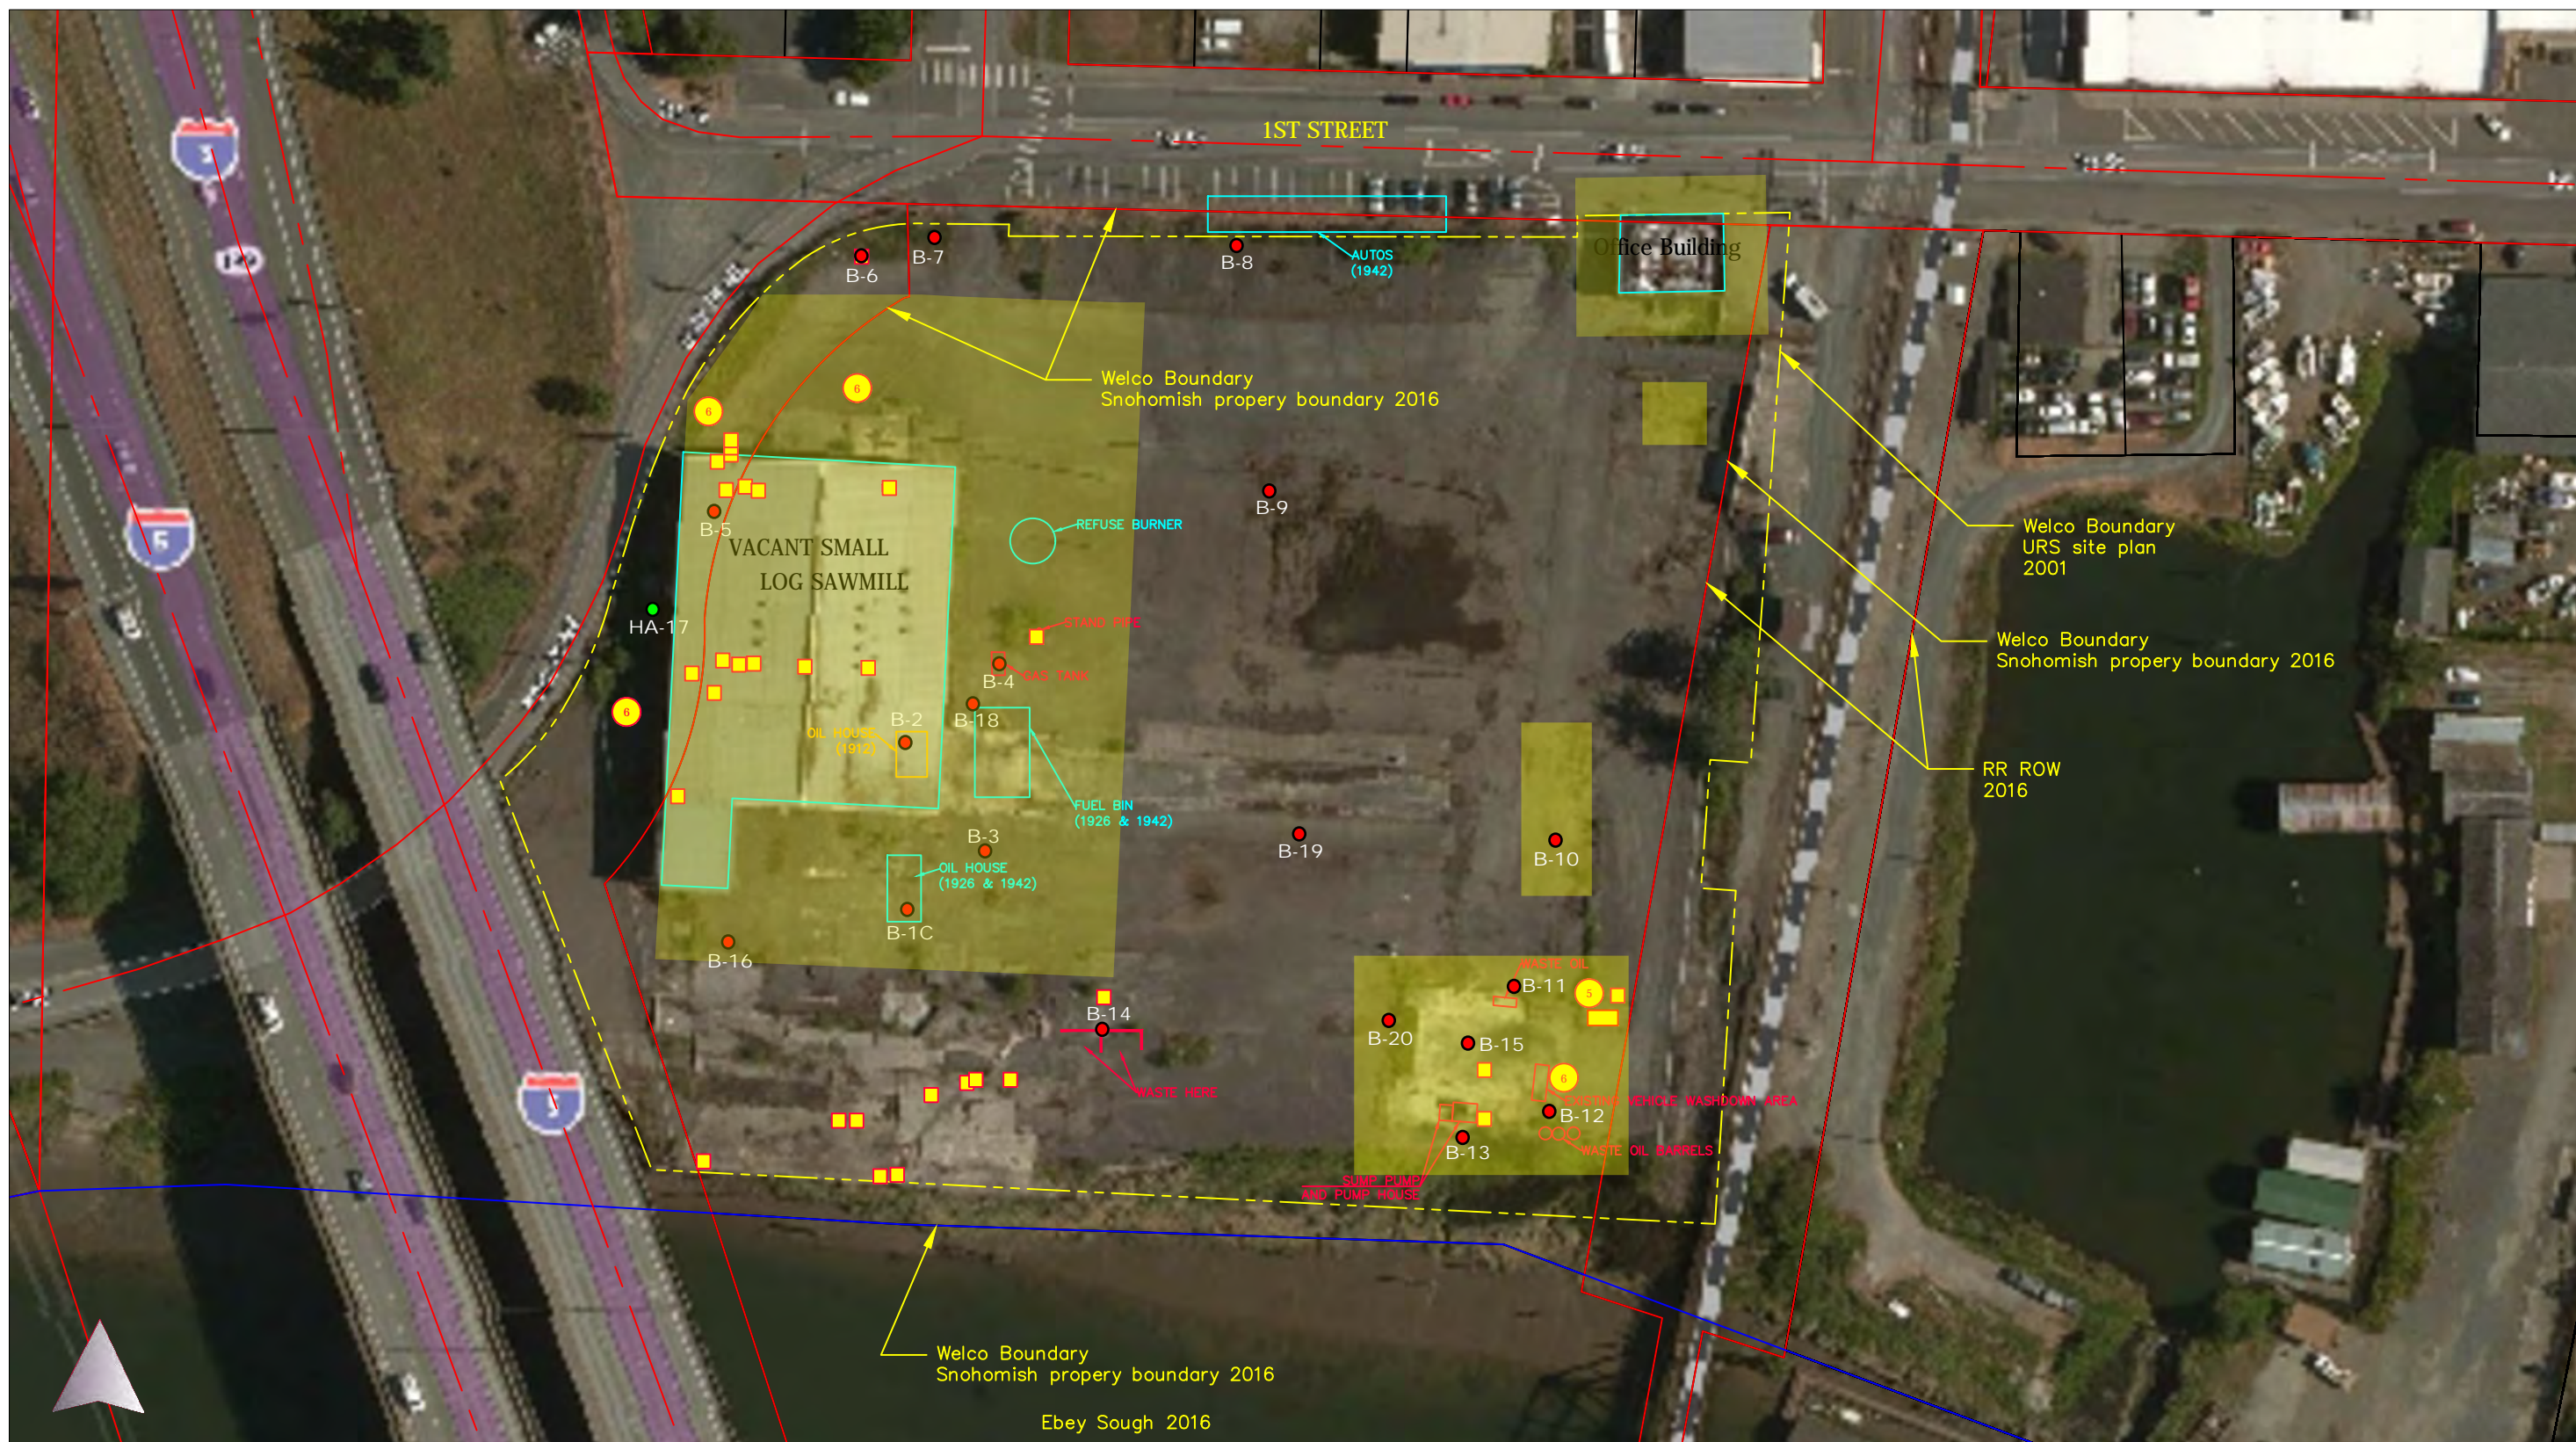
- ON-SITE WASTE STORAGE
- VEHICLE AND EQUIPMENT CLEANING
- APPROXIMATE FUEL STORAGE LOCATIONS
- GPR SURVEY OF ACCESSABLE AREAS
- B-1C - HWA BORING LOCATION
- HA-17 - HWA HAND AUGER LOCATION

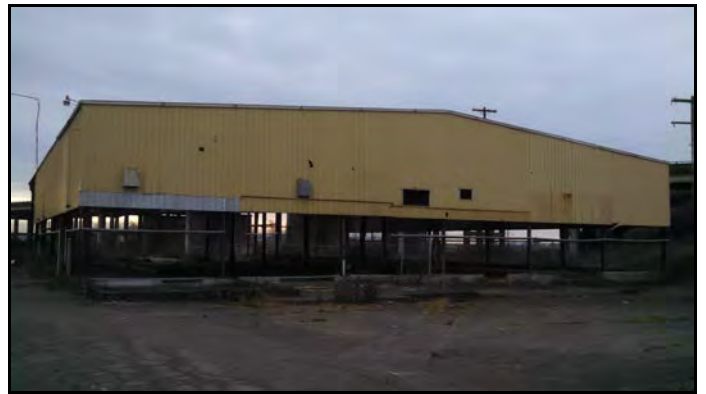
View of the vacant small log sawmill building, facing south.

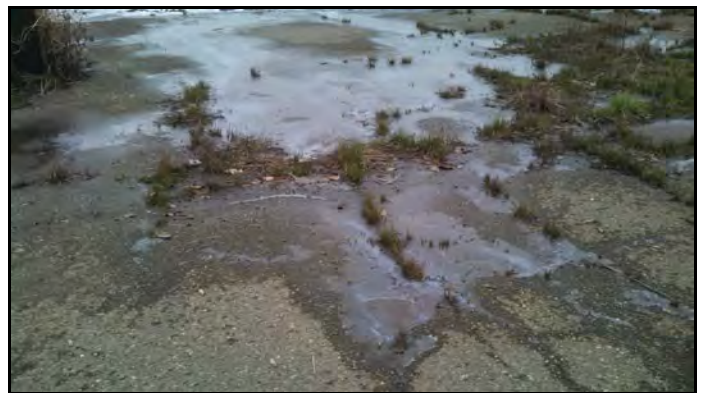
Areas of moderate staining and/or sheens were observed on asphalt surfaces and frozen standing water on the eastern and north central portions of the Subject Property. Based on the amount of

staining/sheens observed in these areas, the staining/sheens in these areas are still considered to be a REC.

Typical view of sheen observed on frozen standing water at the Subject Property.

- **Staining on Asphalt Paved Surfaces:** Moderate staining was observed on asphalt paved surfaces and frozen standing water on the north and south central portions of the Subject Property. The staining observed indicates the potential for releases of petroleum products or other hazardous materials that may have occurred on the Subject Property. The areas of stained asphalt are considered a moderate risk to the soil and/or ground water of the Subject property and are therefore a REC.

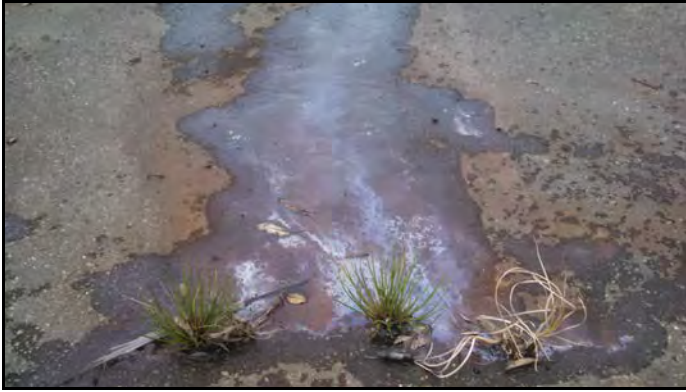
Typical view of the staining observed on the asphalt surface of the Subject Property.

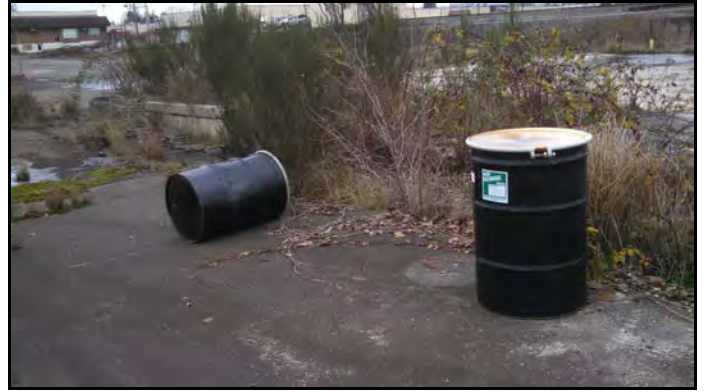
Two 55-gallon drums were observed to be stored on the asphalt surface of the southeast portion of the Subject Property. These drums store soil cuttings and purge water from HWA's April 2016 Phase II ESA drilling activities. No staining, sheens, adverse odors or other indications of spills or releases were noted in the vicinity of these drums.

View of the 55-gallon drums stored on the Subject Property from the 2016 Phase II ESA.

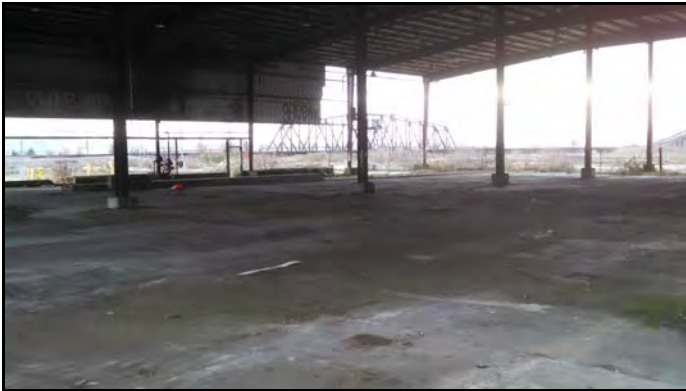
Typical interior view of the small log sawmill building on the western portion of the Subject Property.
